9th International Conference „Bridges in Danube Basin 2016“, BDB 2016

Degradation of steel footbridges with neglected inspection and maintenance

Jaroslav Odrobiňák ^{a,*}, Richard Hlinka ^a

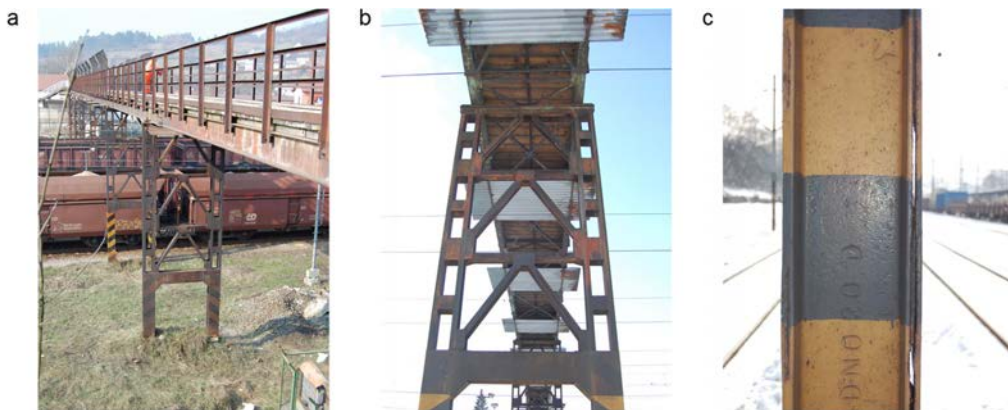
The first footbridge (#1) cross the railway yard of railway station, Fig. 1a. From the static point of view it is a continuous eight span girder steel superstructure consist on steel piers. The length of spans are 12.20 + 16.00 + 15.10 + 14.45 + 10.50 + 10.20 + 13.30 + 7.80 meters. The superstructure is formed by a pair of main girders connected through crossbeams and horizontal bracings.

Some of piers are affected by uniform corrosion, but without significant losses, Fig. 1b. However, in the case of two piers large-scale crevice corrosion formatted due to water penetration into the gap between the plate and rolled sections where improper plug welds was used to create closed cross-section of the pier columns, Fig. 1c. Crevice corrosion is also evident between plates of bearings on the top of nearly all piers.

Fig. 1. (a) overall view of the footbridge #1; (b) bottom view; (c) crevice corrosion of the pier columns.

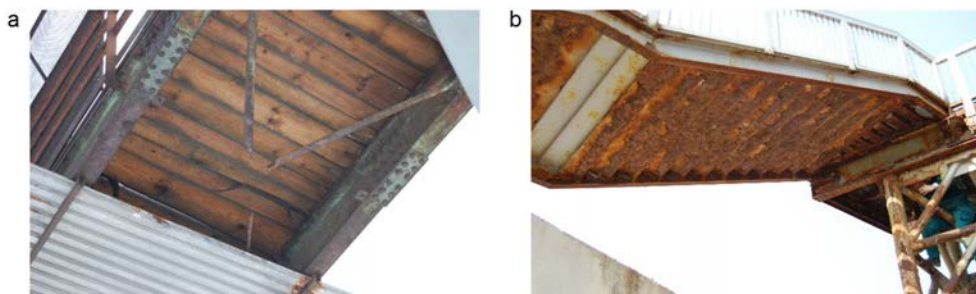
Definitely, the most affected by corrosion are the bridge deck elements, especially in older part of the footbridge. Corrosive losses on the crossbeams are significant and it is only a matter of time when their condition become emergency. Completely degraded by the corrosion are many members of horizontal bracings. Actually, some members are totally destroyed and the rest of them cannot satisfy expected static function, Fig. 2a. Application of road-spreading salt in winter leads to degradation of the individual parts of the side stairway. From the bottom view is evident degradation of steel plates creating stair steps, especially, Fig. 2b.

Fig. 2. (a) corrosion of deck members; (b) corroded steps of the staircase.

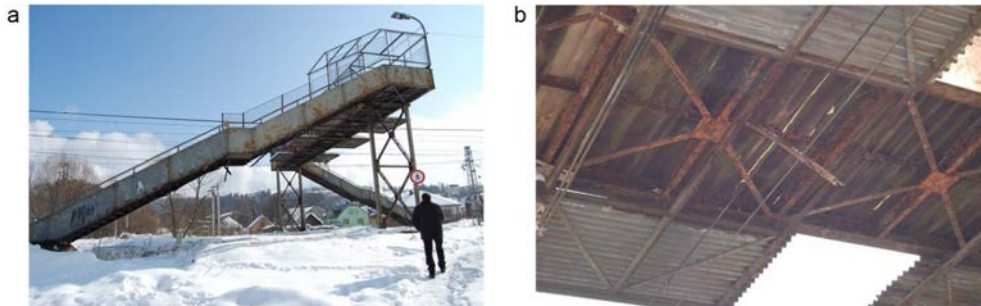
Corrosion of main girders is significant only in some typical details, e.g. in the joint of crossbeam or on the top surface of bottom flange from the inner side. As usually, worse condition can be seen at bridge deck elements. The surface of all crossbeams are highly corroded. In some cases, the area of beams' web is reduced more than 50%.

Horizontal bracings of the deck is in emergency condition. Actually, several bracings members are missing and the rest of them are in insufficient condition, Fig. 3b.

Fig. 3. (a) view of the footbridge #2; (b) corrosion of deck members and damaged horizontal bracing.

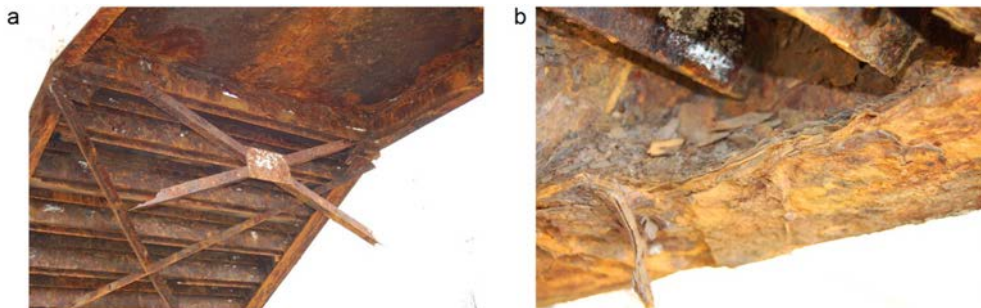
Stairway steps and landings are made of steel plates and they are all attacked by corrosion of the highest degree, locally the corrosion progress through whole thickness of steel plates, Fig. 4a. The most important problem is the corrosion of the bottom flange of the stairway main girders. In the most critical place, the corrosive losses reach such a great intension that only about 25% of the flange area remained, Fig. 4b. All horizontal stiffening rods of the stairways are heavily corroded. Some bracing members are already annihilated.

It can be stated that this footbridge is dangerous for pedestrians and for railway traffic underneath, as well.

Fig. 4. (a) corroded stairway steps and bracings, (b) bottom flange of stairway girder.

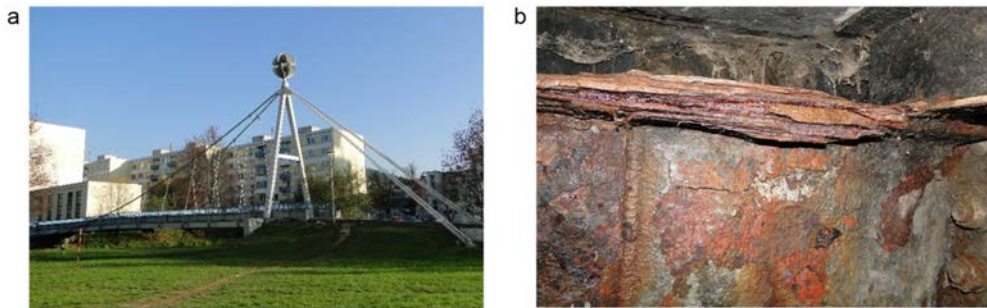
From the top, no obvious mechanical damage or corrosion attacks are visible at the main structural steel members of the bridge. From the bottom, however, significant damages caused by corrosion are evident at the steel parts of bridge deck. Inner side of the bottom flanges of main girders are considerably affected by corrosive action, especially in the connection points of crossbeams and bracing members. The end crossbeam above bearings are highly attacked by corrosion, Fig. 5b. Similarly, the same very bad condition are evident in all intermediate crossbeams, as well. For instance, at the Fig. 6a it is visible a hole in the crossbeam web caused by severe corrosion process.

Fig. 5. (a) overall view of the footbridge #3, (b) top flange of end crossbeam.

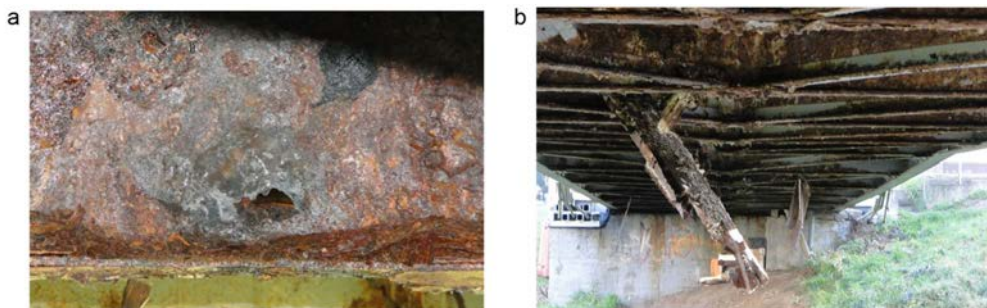
All corrugated steel sheets are totally destroyed. The thickness of sheets in large areas of the deck is reduced to nearly zero. Actually, in the most places the sheets hang from the deck, Fig. 6b. Very poor condition of the bridge deck is also documented by completely missing ribs of concrete deck, where the steel sheets have already fallen.

Fig. 6. (a) corroded through, (b) top flange of end crossbeam.

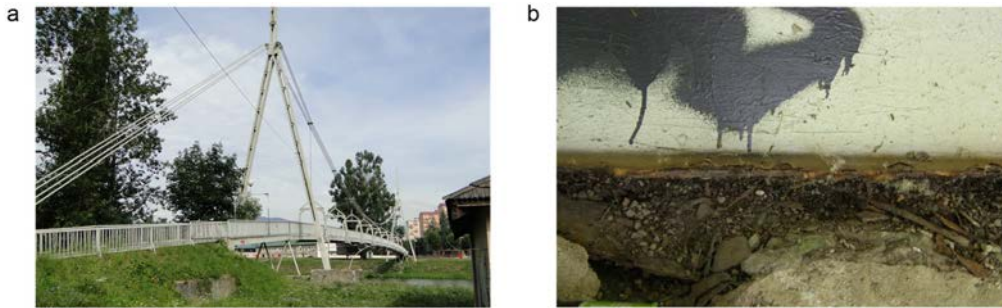
Fig. 7. (a) overall view of the footbridge #4; (b) corrosion of bearing and of bottom flange of support crossbeam.

Local corrosion of middle intension occurs only in details of joints between the deck members. Extensive corrosion occurs at bearings and at parts of end crossbeams above supports, Fig. 7b. The intensive corrosion is caused by very bad solution applied to drainage of support areas of the abutments.

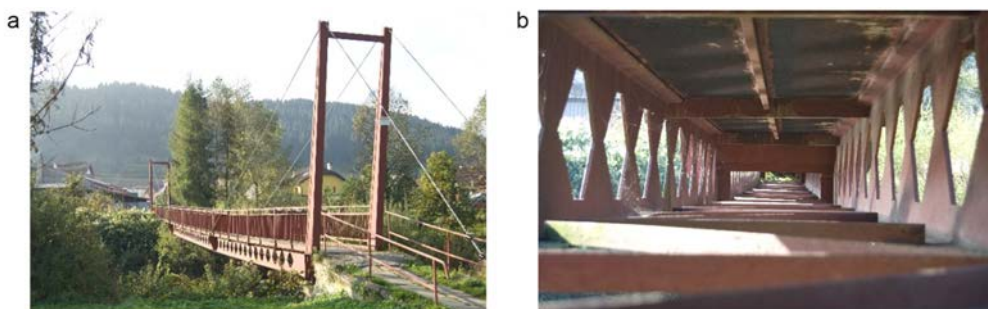
Fig. 8. (a) overall view of the footbridge #5; (b) castellated main girders and deck bracings.

From the Figs. 8b, 9b and 10b, as well, it is evident that steel sheets creating the deck surface are affected by uniform corrosion from the bottom due to humidity from the water. Similarly, all crossbeams and bracing members are of the same level of corrosion. Visible corrosion are of low intensity without influence on static function. Higher grade of corrosion can be found in support areas at the abutments. It results in higher corrosive losses of bearing in the case of footbridge #5. Within spans, the main girders of both structures are without remarkable impact of corrosion, only paint layers are unstuck in some places, Fig. 9b.

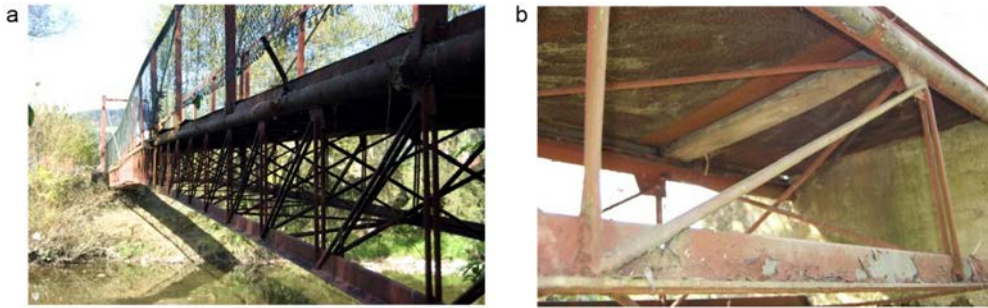
Fig. 9. (a) overall view of the footbridge #6; (b) condition main truss girder and deck plates.

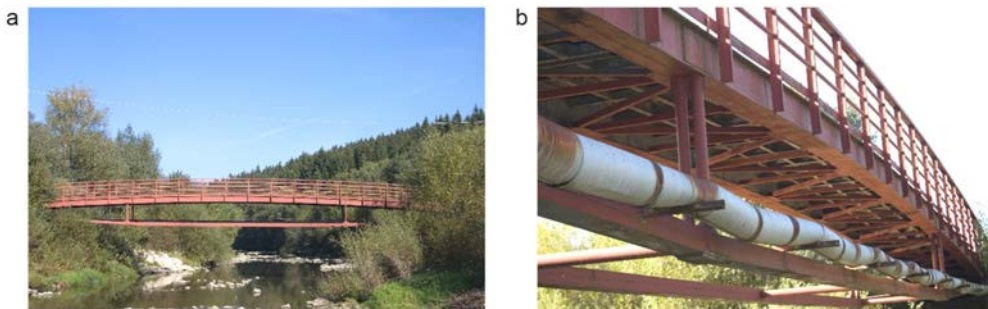
Fig. 10. (a) overall view of the footbridge #7; (b) detailed view of the superstructure.
