# Case Studies in Engineering Failure Analysis

# Failure investigation of a taper roller bearing: A case study

K. Gurumoorthy, Arindam Ghosh\*

R&amp;D, National Engineering Industries Limited, Jaipur, Rajasthan, India

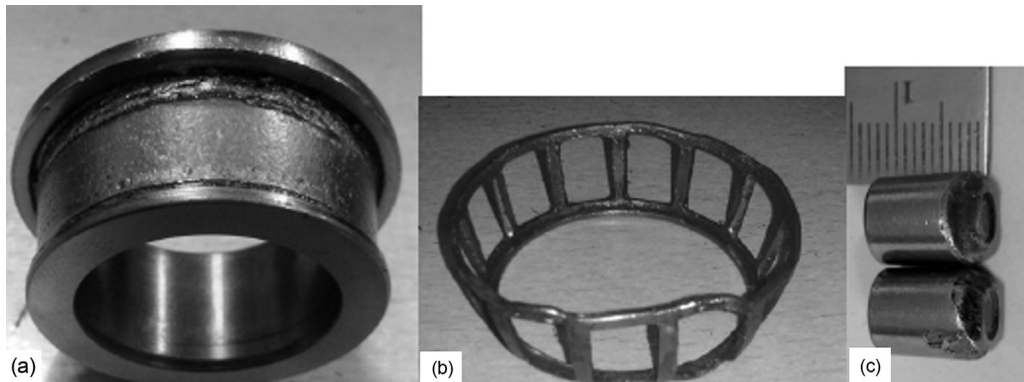
The cone, rollers and cage in as received condition are shown in Fig. 2. Under low magnification using a stereo zoom microscope, one end of the rollers was found to be severely damaged than the other. This feature was seen in all the rollers. In the cone, deep grooves were noticed along with pit marks on the race way; a crack was also observed on the inner surface of

**Fig. 2.** Premature failed bearing in as-received condition: (a) deep groove on the raceway of the cone; (b) distorted cage; (c) severely damaged tip at one side of the rollers.

The chemical composition of the bearing was in conformity with SAE 52100 material specification. The deep groove on the cone raceway and severe damage on one side of the rollers showed that there was uneven distribution of load with the roller tip experiencing higher stress during operation.

This is apparent in the damaged roller samples where one end of the roller alone shows severe damage with the other end having only deep scratches. This phenomenon was observed in all the rollers. The scratches may be due to the abrading action of the wear debris (worn parts of the roller and cone surface). The wear debris analysis had confirmed the presence of

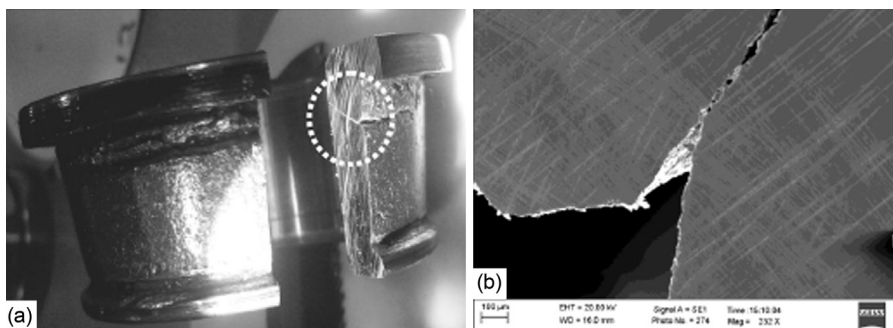
the cone aligned with the deep groove as shown in Fig. 3(a). SEM observation made on the cut section of the cone shows the deep groove and the crack originating from the groove and propagating towards the bore surface as shown in Fig. 3(b).

**Fig. 3.** Images taken on the cut section of the cone: (a) optical photograph of the cone section where a crack was observed beneath the deep groove which was propagating towards the bore surface shown within the circle; (b) SEM image showing the origination of crack from the deep groove.

The deep grooves caused by the uneven rubbing action of the roller tip along with the wear debris over the surface of the cone acted as points of weakness. Such deep grooves, acting as stress raisers, have been responsible for initiating the crack from which the fatigue failure had progressed. This was exactly observed in the present study. Had the bearing been run in this condition, the crack would have reached the back face of the cone, resulting in total collapse of the bearing by chipping of the flange portion.

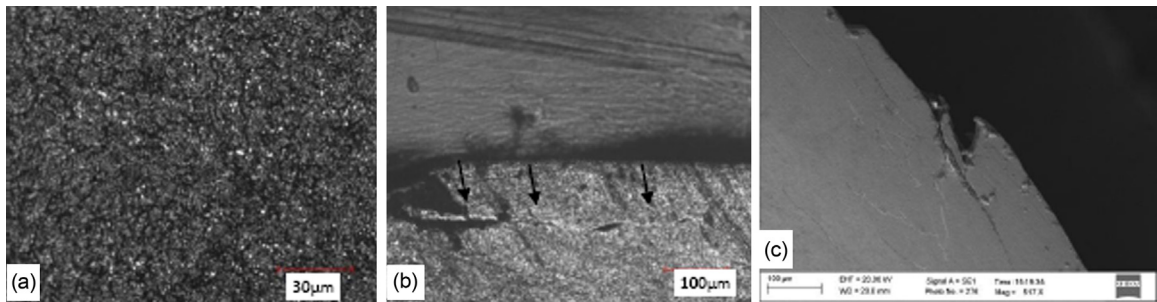
Longitudinal cut sections of a roller and cone showed fine tempered martensite with uniform distribution of carbides free from carbide network or any detrimental feature. The origin of crack was also free from decarburization indicating that the heat treatment conditions were normal. Microstructure observed on roller specimen is shown in Fig. 4(a). Near the damaged side of the roller, cracks were observed propagating towards the centre of the roller as shown in Fig. 4(b) and (c).

Fig. 4. (a) Tempered martensitic structure with uniformly distributed carbides was observed on the roller cut section. (b) Crack initiated at the tip of the roller was shown in arrows (optical micrograph). (c) SEM micrograph of damaged roller tip showing crack initiation from the tip.

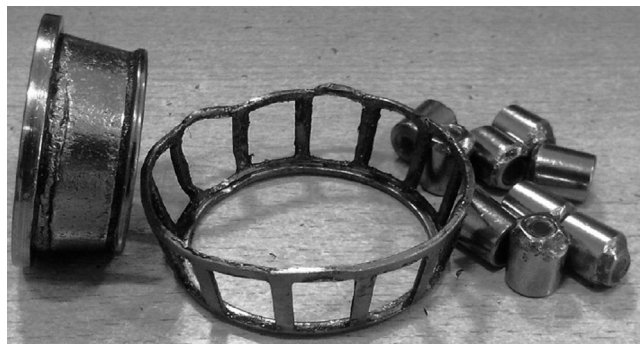
Fig. 6. As illustrated in the schematic diagram (Fig. 5), damage at roller tip and deep groove on the cone were observed on the premature failed bearing.

The above proposed mechanism is in concurrence with the failure observed in the samples as shown in Fig. 6. This misalignment may have been caused at the time of installation or during operation where the bearing would have experienced any excessive load.

The failure is not on account of any defect in material or heat treatment. This failure is predominantly due to the misalignment, which caused uneven load distribution on the roller. While the intentionally designed crowning of the rollers may accommodate very small misalignment, it cannot prevent damage when the misalignment is excessive. In the present case, the misalignment may have been excessive. This may be due to mounting error or very heavy vehicle load beyond the designed limit resulting in abnormal deflection of wheel end component. Consequently the cup and cone, unable to balance the misalignment, experienced severe stress concentration at the roller tip leading to premature failure of the bearing.
