Arthroplasty Today

Case report

Early fracture of the modular neck of a MODULUS femoral stem

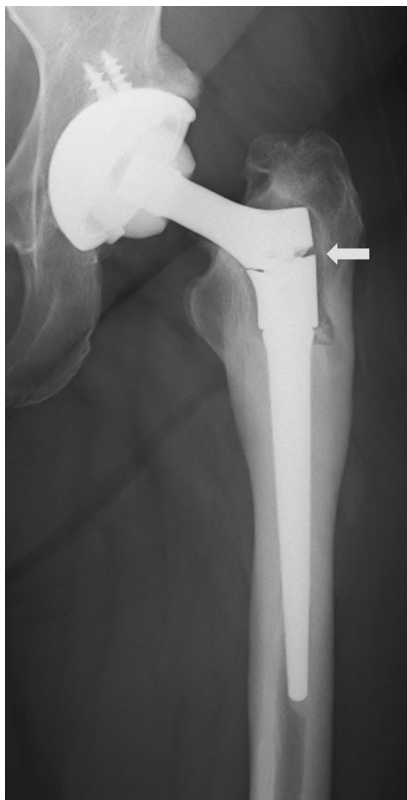
Three years and 8 months following the left-sided THA, the patient reported sudden-onset groin pain on the left side while helping a heavy patient out of bed and experienced immediate loss of weight-bearing ability. Radiography revealed a fracture of the modular neck component of the MODULUS (Lima Corporate, Villanova di San Daniele del Friuli, Italy) stem (Fig. 1). Revision surgery was performed using an anterolateral approach with the patient in the right lateral decubitus position. The hip was dislocated anteriorly and the fractured modular neck component was removed (Fig. 2; white arrow). The safety locking screw securing

Figure 1. Radiographic examination of the patient's left total hip arthroplasty at 3 years and 8 months postoperatively showing a fracture of the modular neck component.

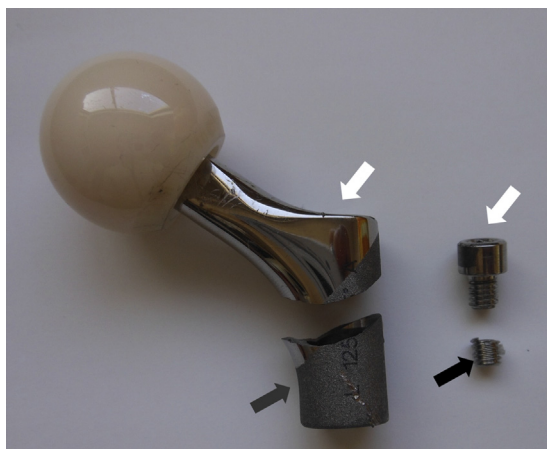
the 2 modular components was also broken. We could only remove the distal fragment of the screw, which remained within the stem, by turning it with a small flat chisel (Fig. 2; black arrow). An extended trochanteric osteotomy was performed to remove the remnant of the fractured modular neck, which was still coupled to the stem (Fig. 2; gray arrow), by hammering from the bottom rim of the component. Because the surface at the stem taper junction appeared to be scratched (Fig. 3), the surgeon attempted to replace the distal stem, but it was not possible without risking extensive damage to the bone. Leaving the distal stem in situ, the modular neck was replaced with a new 135° standard-offset modular neck

Figure 2. Picture of the broken components after retrieval.

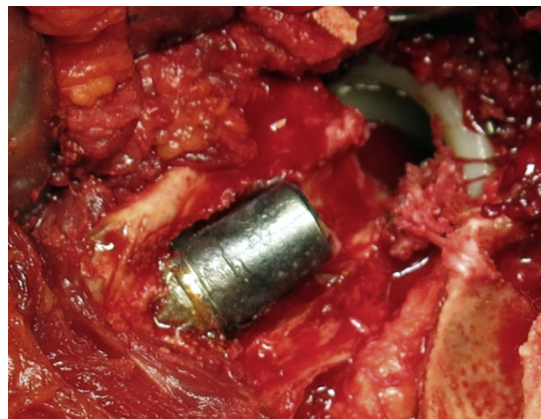
Figure 3. Intraoperative picture of the tapered portion of the proximal stem with evidence of scalloping and pitting.

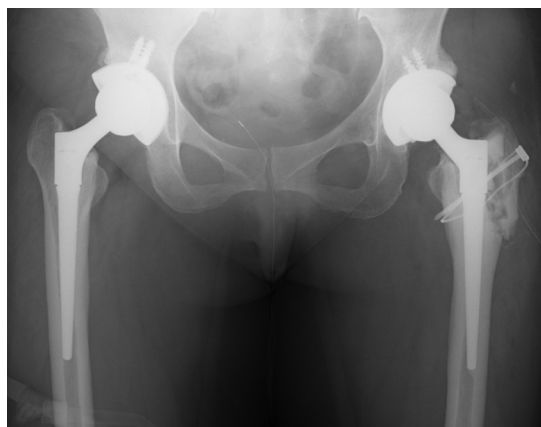
Figure 4. Immediate postoperative radiographic control image after revision of the broken components.

and a Delta ceramic head (32/0 mm). The greater trochanter was then reattached using a pin-sleeve system (AI-medica, Tokyo, Japan) [9] and ultra-high-molecular-weight polyethylene fiber cable (although the fiber cable is not observable on the radiographic images; NESPLON Cable System; Alfresa Pharma Co., Osaka, Japan) [10]. The properly fixed, cementless acetabular cup was preserved along with its highly cross-linked polyethylene liner (Fig. 4). One year postoperatively, the patient's pain resolved and she was able to return to work without using a walking aid.

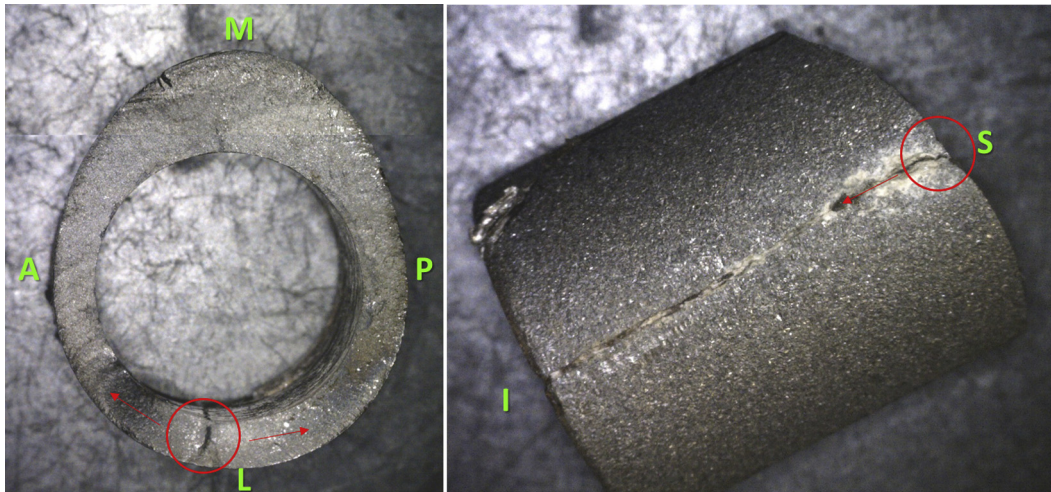
Figure 5. Pictures of the neck fracture surfaces (left: inferior fragment from the top; right: inferior fragment from the side). We identified the anterior, medial, posterior, and lateral zones of the neck with the letters A, M, P, and L, respectively. The letters I and S denote the inferior and superior parts of the neck fragments, respectively.

The fractured surfaces of the retrieved implant were inspected by optical and scanning electron microscopy (SEM) by Lima Corporate (Fig. 5). The neck fracture occurred where the small diameter of the male taper of the stem engaged the neck component. The crack originated in the lateral part of the neck (red circle) and propagated medially (red arrows). Figure 5 also shows the crack propagation along the inferior fragment of the neck. It was reported that this crack occurred in vivo and was not caused by the removal of the neck during revision surgery. Figure 6 (left) shows that the screw broke close to the minor cross-section at the level of the poly pin. The origin and propagation of the fracture are highlighted by a red circle and a red arrow, respectively (Fig. 6). SEM analysis of the retrieved broken components revealed that the system formed by the MODULUS neck and the locking screw experienced a double fatigue rupture. (1) The neck experienced a

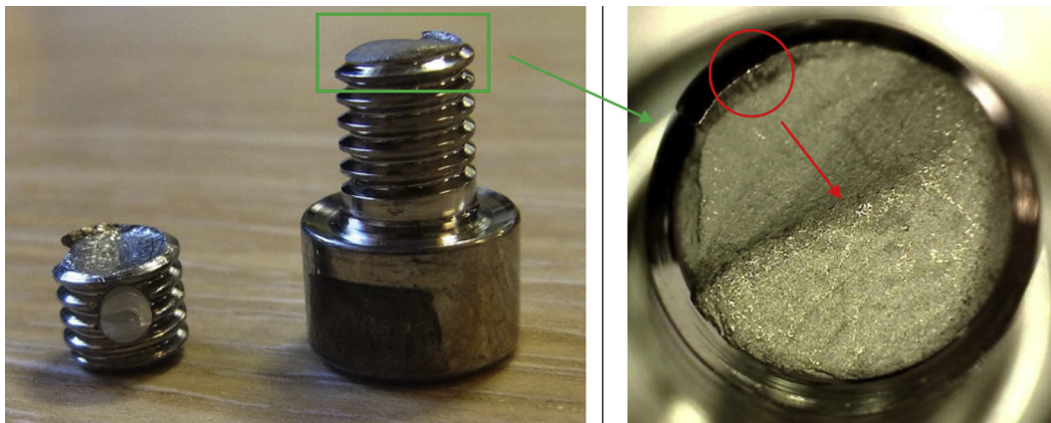
Figure 6. Broken screw (right: fracture surface of the superior screw fragment).

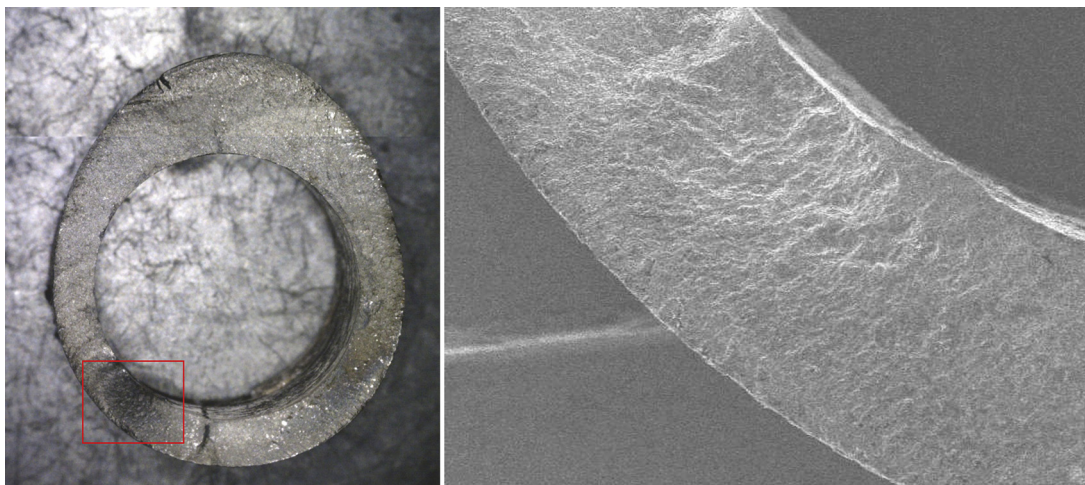
Figure 7. SEM analysis of the fractured surfaces of the neck.

bending fatigue failure induced by low stresses; breakage occurred at the level of the final threaded part where the screw was inserted. The crack started in the lateral part of the neck and propagated medially (Fig. 7). (2) The screw experienced a bending fatigue failure along the border that was induced by low-level loads, as evidenced by the flat progression and the absence of plastic deformation involving the whole section. The breakage most likely originated from the lateral part of the screw and propagated medially (Fig. 8).

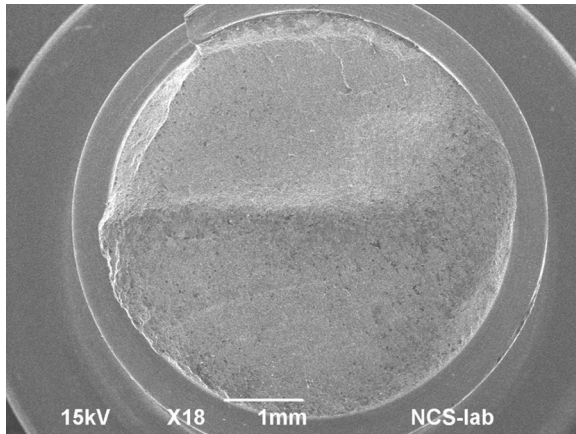
Figure 8. SEM analysis of the fractured surfaces of the screw.

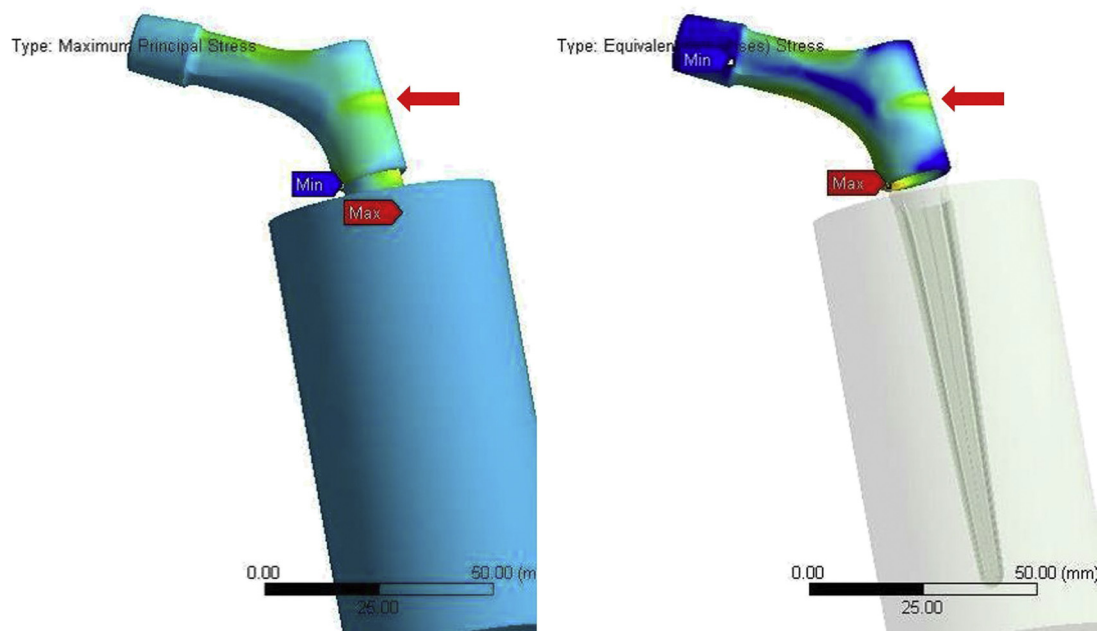
Both analyses described above demonstrated that a stress level above the maximum was required in order for the lateral side of the neck to be affected, as shown by the red arrows (Figs. 9 and 10). This region matched the origin of the fracture in the actual neck.

Figure 9. FEA of the involved components showing the stress distribution for a 13-mm neck and a 125° stem at 2400 N.

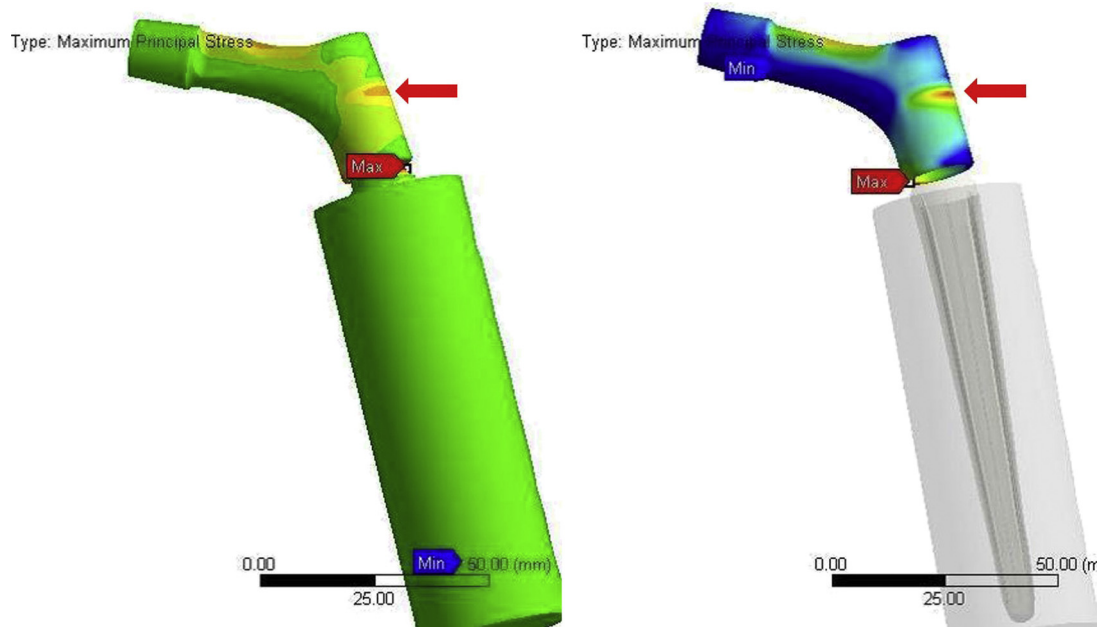
Figure 10. FEA of the involved components showing the stress distribution for a 15-mm neck and a 125° stem at 2600 N.
