# Report on a reconnaissance survey of damage in Kathmandu caused by the 2015 Gorkha Nepal earthquake

Mitsu Okamura<sup>a,\*</sup>, Netra P. Bhandary<sup>a</sup>, Shinichiro Mori<sup>a</sup>, Narayan Marasini<sup>a</sup>, Hemanta Hazarika<sup>b</sup>

#### Abstract

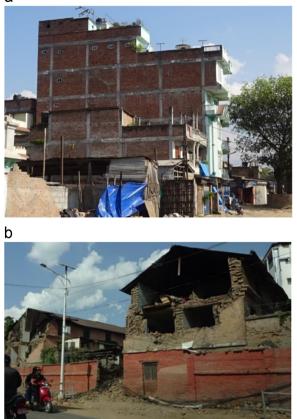
Fig. 12. Typical buildings assessed. (a) six-story RCIW residential building that suffered Grade 1 damage. (b) three-story brick URM houses that suffered Grade 4 damage.

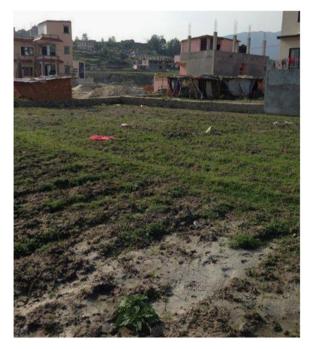
The Manamaiju area is located on the north-west of Kathmandu valley and the Bishnumati River runs through this area. On the right bank of the Bishnumati River, some sand boils were found in paddy fields (Fig. 19).

Fig. 19. Erupted sand at Manamaiju area (L5).

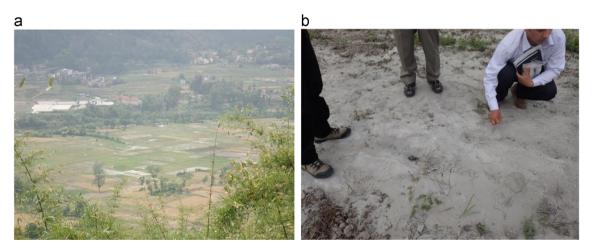
Extensive soil liquefaction occurred in the Bungamati area. This area located in the flood area of the Bagmati River and is used as fields for growing two crops of rice and wheat annually. A large number of sand volcanos were detected in this area, approximately 300 m long and 200 m wide (Fig. 17). The ejected soil was coarse to fine sand with 5–40% non-plastic silt, as shown in Fig. 16. Fissures with openings up to 15 cm wide were also detected the directions of which were mostly parallel to the river.

Fig. 17. Erupted sand boils at Bungamati (L2). (a) overview of the area (b) erupted sand.

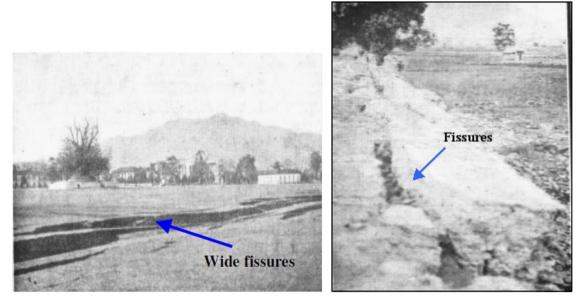
Fig. 20. Liquefaction in Tundhikhen area (labeled "LP" in Fig. 14) by the 1934 earthquake (after Rana, 1935).

Rana (1935) reported the occurrence of widespread liquefaction in the valley during the Bihar Nepal earthquake in 1934. The Tundhikhel area (labeled "LP" in Fig. 15) was severely fissured and the ejection of liquefied sand occurred, as shown in Fig. 20. Although that earthquake occurred in the dry season (January 15, 1934), most of the paddy fields and roads in the area were flooded by ejected sand boils. In the Tundhikhel area located at the center of the city, the current ground surface is mostly covered with buildings and pavement but there is a large open space remaining, the old parade ground, which has turned into a tent-city for the evacuees right after the earthquake. No evidence of liquefaction caused by the 2015 earthquake was detected in this area.

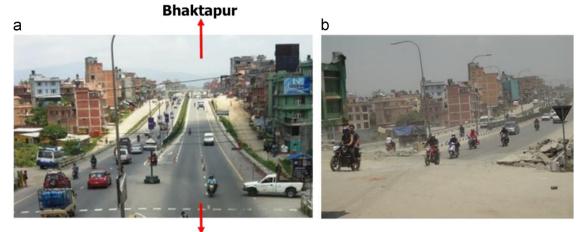
Our survey focused only on the damaged part of the road located near the Lokanthali area (Fig. 21), covering a length of about 400 m. The state of the road before and after the earthquake is shown in Fig. 22. The various locations, types and extent of damage of the surveyed area are shown in Fig. 23. On the Kathmandu side, heaving and subsidence of the road, slope failures in the main road and access road, ground fissuring, retaining wall damage and damage to the residential buildings close to the access road were observed. Similarly, on the Bhaktapur side, heaving and subsidence of the main road, slope failures in the access road and ground fissuring were observed.

Fig. 22. State of the road before and after the earthquake. (a) Before the Eq. (b) After the Eq.

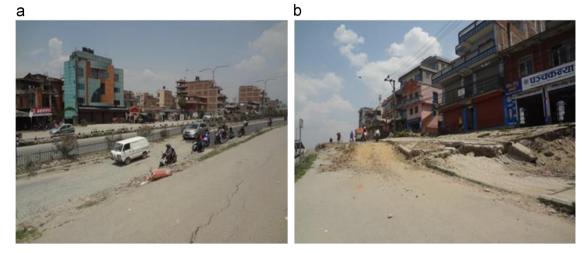
Fig. 25. Slope failure and subsidence (Bhaktapur side). (a) Sinking of the main road and (b) slope failure in the access road.

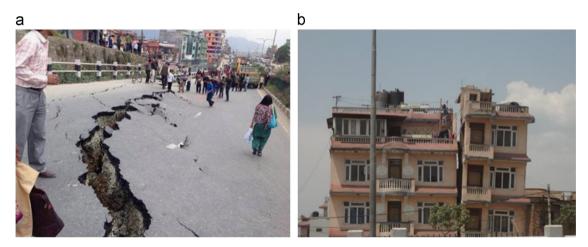
Fig. 26. Access road and building damage (Kathmandu side). (a) Subsidence of the access road and (b) tilted building.

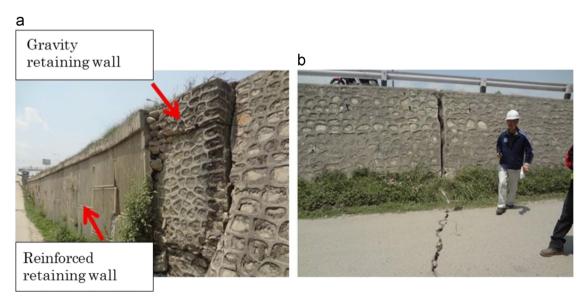
Fig. 27. Retaining wall damage and ground fissuring. (a) Damage to gravity retaining wall and (b) ground cracks.
