# Damage statistics (Summary of the 2011 off the Pacific Coast of Tohoku Earthquake damage)

Motoki Kazama<sup>a</sup>, Toshihiro Noda<sup>b,\*</sup>

<sup>a</sup>Department of Civil and Environmental Engineering, Tohoku University, Japan

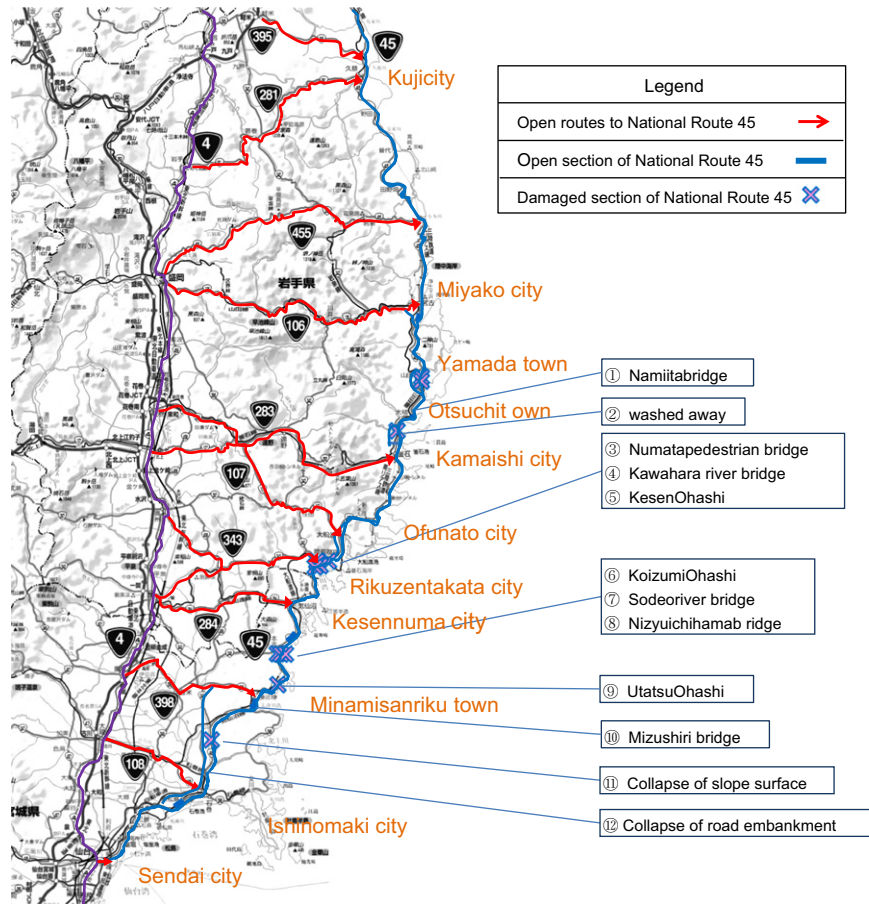
Fig. 7. Damage to National Route 45 (MLIT Tohoku Regional Development Bureau, 2011b).

Figs. 7 and 8 show the damaged parts of the road facilities on National Route 45 and National Routes 4 and 6, respectively. The main forms of damage were the erosion of embankments at bridges ((1) Namiita Bridge: Otsuchicho, Iwate Prefecture), road embankments washed away by the tsunami ((2) Kamaishi City, Iwate Prefecture), bridge decks washed away ((3) pedestrian bridge over a

railway in Numata, (4) Kawahara River bridge, (5) Kesen Ohashi ((3)–(5) in Rikuzen-Takada, Iwate Prefecture), (6) Koizumi Ohashi, (7) Sodeogawa Bridge, (8) Nijuichihama Bridge ((6)–(7) in Kesennuma City, Miyagi Prefecture), (9)

Utatsu Ohashi, and (10) Mizushiri Bridge ((9)–(10) in Minamisanrikucho, Miyagi Prefecture)), the collapse of slope surfaces ((11) Ishinomaki City, Miyagi Prefecture), the collapse of road embankments and slopes ((12) Ishinomaki City,

Miyagi Prefecture, (13) Fukushima City, Fukushima Prefecture, and (14) Hirono Town, Fukushima Prefecture), etc.

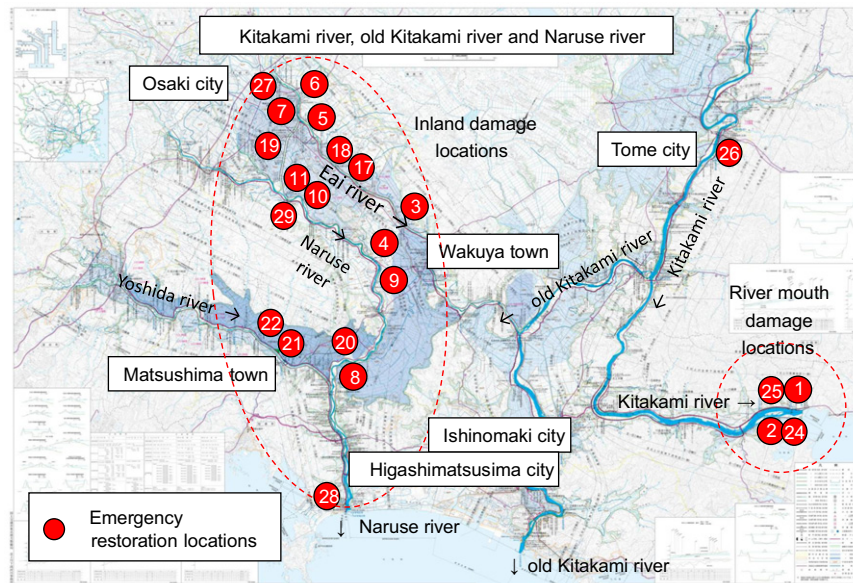
Fig. 9. Major damage locations along the Kitakami and Naruse River drainage systems (MLIT Tohoku Regional Development Bureau, 2011b).

The causes of the damage in almost all cases were the tsunami at the mouths of the rivers and liquefaction in the inland areas. Fig. 9 shows the positions of the major damage along the Kitakami River drainage system and the Naruse River drainage system in the Tohoku Region. Also, almost all the damage in the Kanto Region was

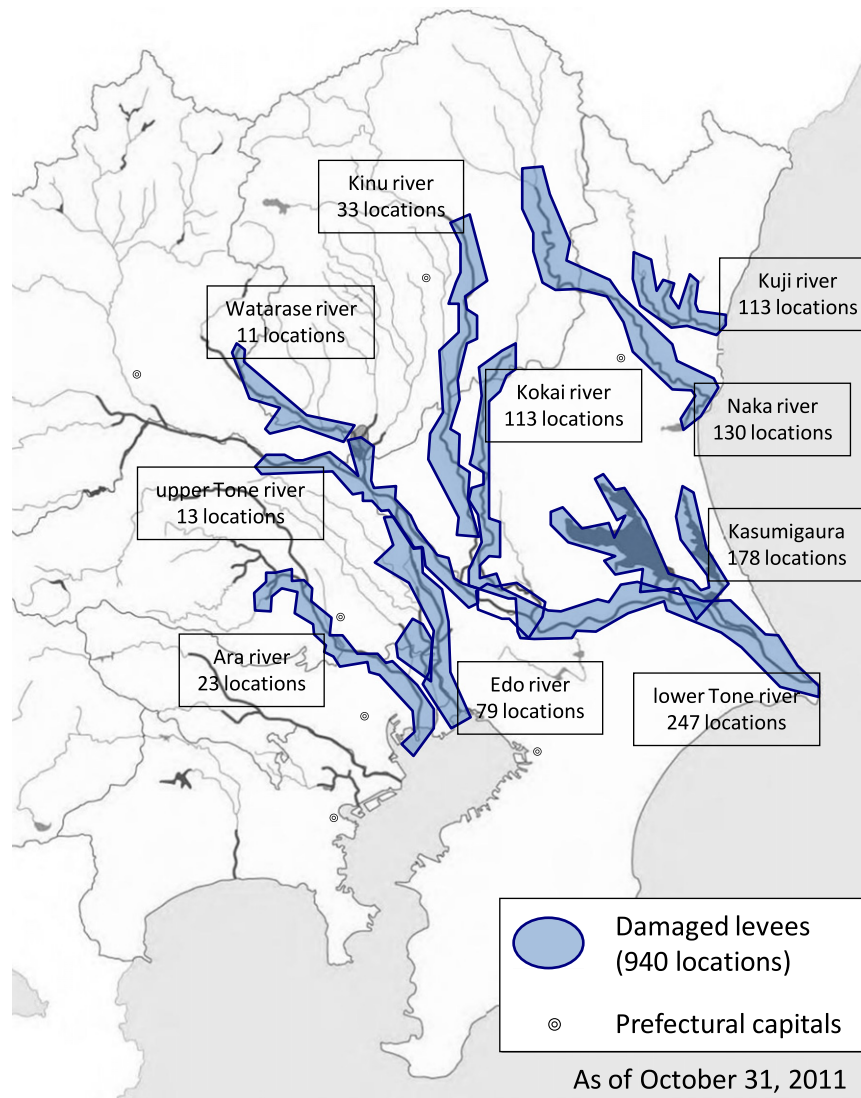
Fig. 10. Locations of damage to river levees in Kanto Region (MLIT Kanto Regional Development Bureau, 2011).

caused by liquefaction (see Fig. 10). On the other hand, it was reported that in areas where countermeasures had been taken against liquefaction, there was either no damage or the damage was slight.
