## Case Studies in Engineering Failure Analysis

## In vivo shell-like fractures of veneered-ZrO<sub>2</sub> fixed dental prostheses

Fractographic analyses are performed in two fixed dental prosthetic reconstructions made of ZrO<sub>2</sub> frameworks covered by a veneering ceramic that fractured during function in the mouth. Processing histories, material properties, recovered broken parts and replicas of the fracture surface were used, along with fractographic markings to determine fracture origins and cause of failure. A shell-like fracture pattern was found common for both cases, although different factors were identified to be involved in each fracture event. Internal thermal residual stresses and occlusal surface defects from localized contact overloading were found to precipitate the fracture in Case 1, whereas extreme occlusal surface damage from sliding chewing contact was determinant in the fracture of Case 2. The interface between the veneering ceramic and the ZrO<sub>2</sub> framework was unaffected by the fractures.

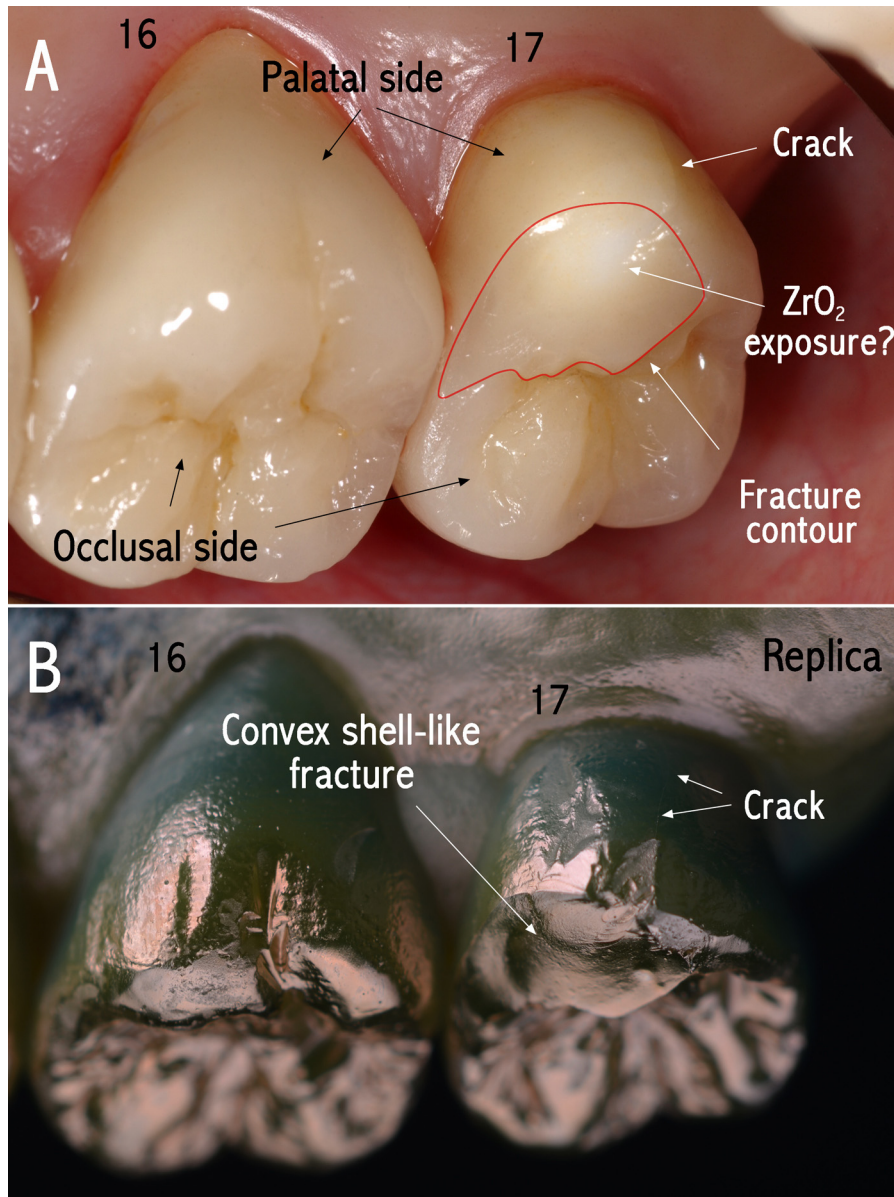
**Fig. 1.** (A) Palatal view of the clinical situation of Case 1. A fracture of the veneer material of the veneer-ZrO<sub>2</sub> crown of element 17 is outlined in red. A whitish area on the fracture surface indicates that the underlying ZrO<sub>2</sub> framework might have been exposed. A crack can be seen running through the palatal surface connecting the to the cervical margin of the crown. (B) Palatal view of the gold-sputtered replica from an *in situ* impression (A). With a lateral illumination reflections allow for the convex fracture surface to be distinguished. A crack (A) can be seen running from broken surface and connecting with the palatal (cervical) margin. Images (A) and (B) are oriented as in reality, following the position of teeth in the upper arch. The following SEM images are presented in particular orientations for a better understanding of the fractographic analysis.

The clinical appearance of the first case is shown in Fig. 1a. Both shown elements are single veneered- $ZrO_2$  crowns from the first and second upper right molars (FDI numbering system: #16, #17). In crown #17, the fracture of the veneering ceramic can be observed involving the palatal cusp and extending towards the approximal mesial ridge. The fragment was not recovered. A crack is visible emanating from the palatal periphery of the fracture surface and running towards the cervical margin. On the fractured surface the whitish appearance is the underlying zirconia framework, but SEM is needed to determine if zirconia is exposed. The convexity of the fracture surface is better seen from the optical images of the gold-sputtered replica (Fig. 1b).

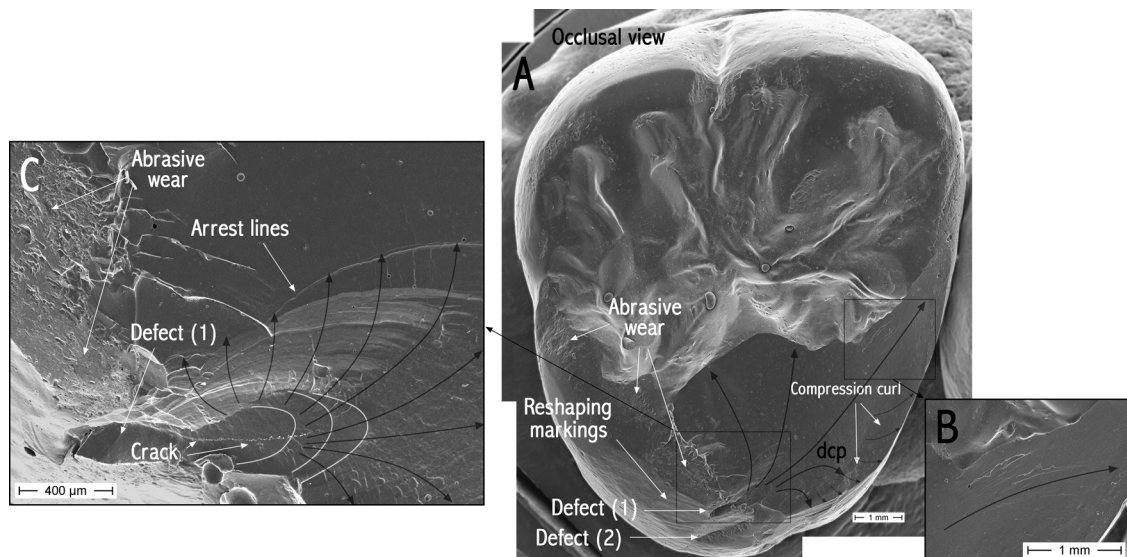
Fig. 2. (A) SEM image of the occlusal view of the fractured crown. Boxes B and C are magnifications. Defect 1 located at the periphery of the occlusal surface and the palatal wall represents the fracture origin (C). Hackle lines (B) indicate that the fracture propagated from the left to the right. Concentric arrest lines on the opposite side reveal that the failure origin is located in the region of the Defect 1. A magnification of this area (C) reveals that the arrest lines are connected to Defect 1, the failure origin. An arrested thin crack can be observed on the base of Defect 1. Nearby this site, reshaping markings and substantial surface damage from abrasive occlusal wear are seen. "dcp" stands for "direction of crack propagation".

the direction of crack propagation and were used to locate the origin of the fracture at the midline of the palatal surface where two major surface damages (Defects 1 and 2) were found (Figs. 2 and 3). Working backwards from the occlusal and approximal fracture borders, a zone of concentric arrest lines (Fig. 2) delimitates an elliptical region connected to Defect 1 which was the site of fracture origin. The fracture propagated along the occlusal surface along the black arrows (Fig. 2). A compression curl (e.g. a compression lip) visible on the occlusal palato-mesial surface (Fig. 2a) is a result of flexural stress and indicates the end of the fracture event. Adjacent to Defect 1, distinctive signs of contact abrasion can be distinguished, which suggests that the fracture origin was circumscribed within a zone of active occlusal contact loading. A scan of Defect 1 was made using a non-contact white-light optical profilometer (CyberSCAN CT 100, Cyber Technologies, Ingolstadt, Germany) and measured to have a depth of 158  $\mu\text{m}$  (Fig. 3). At the deepest region of Defect 1 a thin crack is observed (Fig. 3), which extended tortuously along the palatal surface (Fig. 4), where it got wider (10  $\mu\text{m}$ ) towards the cervical region of the crown. There, a surface scan revealed a 20  $\mu\text{m}$  surface step (unevenness). The presence of fracture markings, pores and microstructural features over the whole fracture surface indicates that no exposure of the  $\text{ZrO}_2$  framework had taken place, and a thin layer of the veneering material remained bonded to its surface.

Residual stresses may have accelerated the fracture in Case 1, but the cause of fracture initiation was the deep sharp surface damage (Defect 1) located within an occlusal contact area. The concentration of wear damage around the fracture origin and absent in other regions also point to a possible overloading of the fractured cusp. Using the measured crack size  $a$  ( $158 \mu\text{m}$ ), and the fracture toughness  $K_c$  value ( $\sim 1.0 \text{ MPa}\sqrt{\text{m}}$  for a typical dental veneering ceramic), the stress at fracture  $\sigma_f$  can be estimated using the basic fracture mechanics relation:

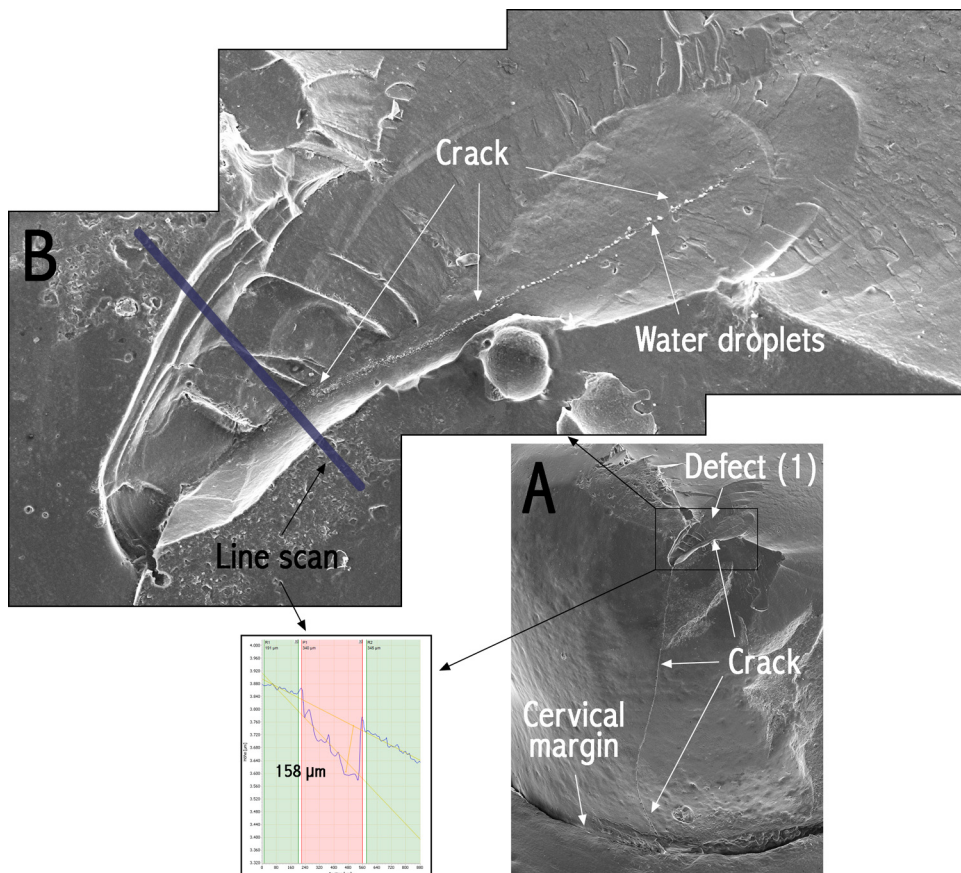
**Fig. 3.** (A) SEM image of the palatal view of the crown. (B) A magnification of Defect 1 shows that the crack at its base has been arrested in the direction of the fracture surface but also propagated in the opposite direction towards the cervical margin of the crown. Water droplets emerging from this crack are seen. These droplets could be replicated due to the low polymerization rate of the polyvinylsiloxane impression material. A line scan of the crack origin was made using an optical profilometer and measured to 158 μm in depth.

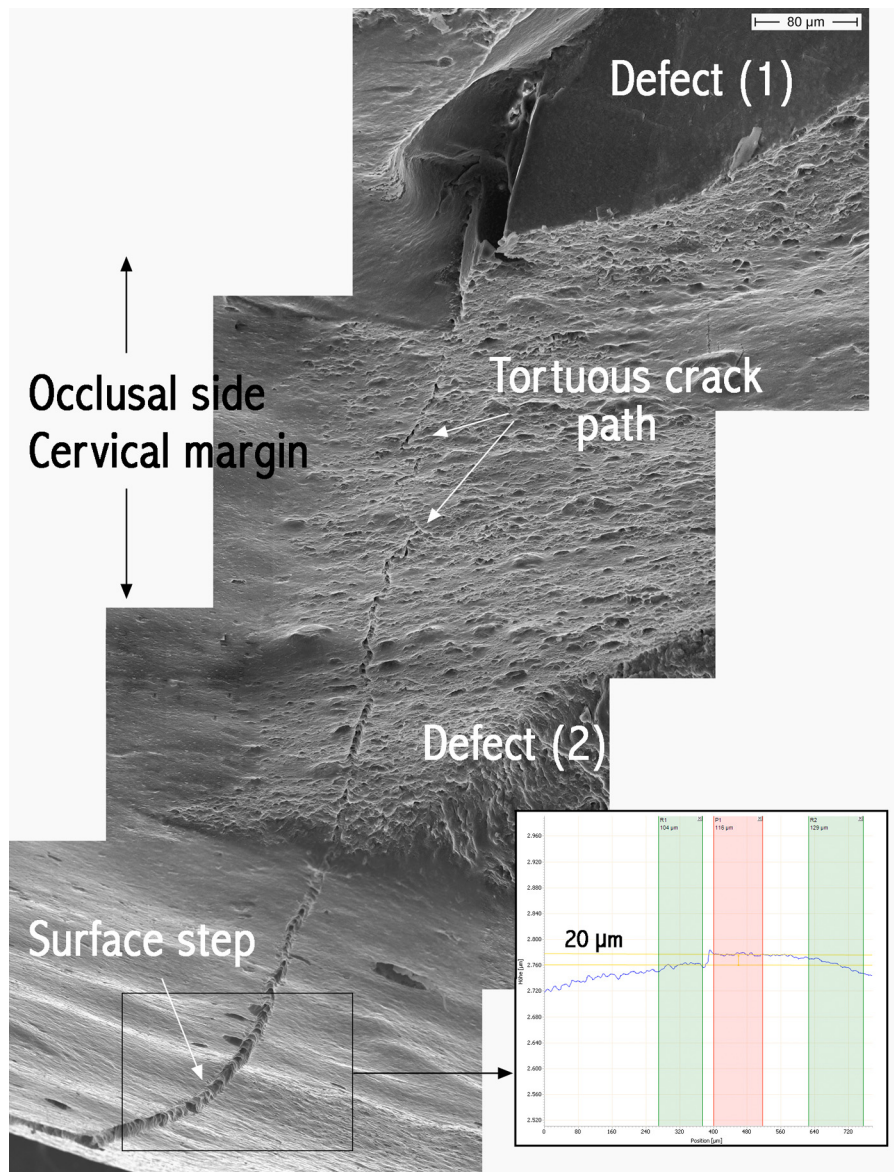
Fig. 4. SEM image of the crack on the palatal surface. The crack connects the origin to the cervical margin. The tortuous crack path suggests that the crack originally grew from inside-out at the palatal side. Towards the cervical margin the crack generates a vertical surface step (unevenness) measured to 20  $\mu\text{m}$  height and a horizontal width opening of 10  $\mu\text{m}$ .

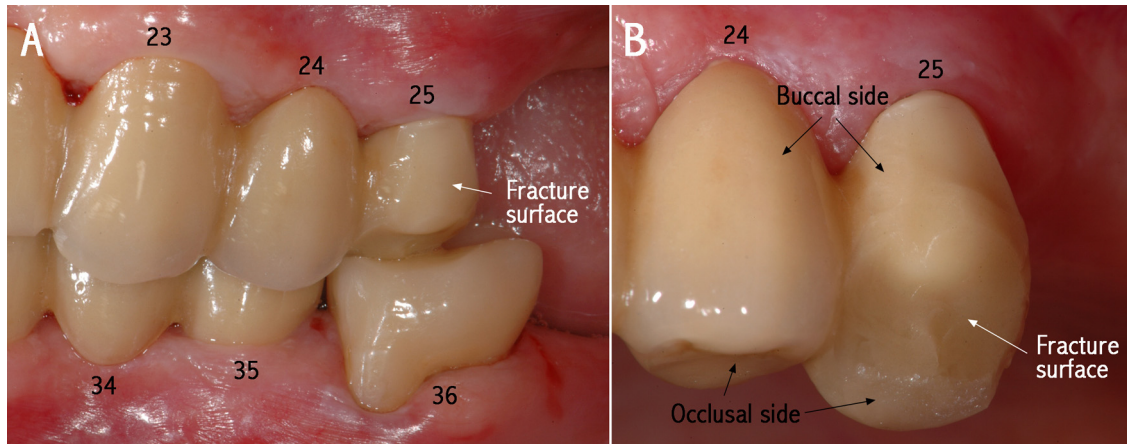
The second case deals also with a shell-like fracture of the veneering ceramic of the last abutment tooth (#25) of a ZrO<sub>2</sub>-based 5-unit Fixed Dental Prosthesis (FDP) (*i.e.* bridge) that extended from the left first incisor (#21) to the second premolar (#25) (elements #22 and #24 are pontics). Fig. 5 shows the clinical situation of crown #25, where the entire veneering ceramic of the buccal cusp has been lost, along with additional fracture of the ceramic from the buccal surface up to the cervical margin of the restoration.

**Fig. 5.** (A) Buccal view of the clinical condition of Case 2 in occlusion. The fixed prosthesis in the maxilla is a veneered-ZrO<sub>2</sub> 5-unit bridge with elements 21, 23 and 25 as abutments, and elements 22 and 24 as pontics (unsupported elements). The fracture occurred in element 25 and involved its buccal cusp and the entire buccal surface reaching the cervical margin. (B) Magnification of elements 24 and 25. The impressions were taken to produce a replica of the fracture surface.

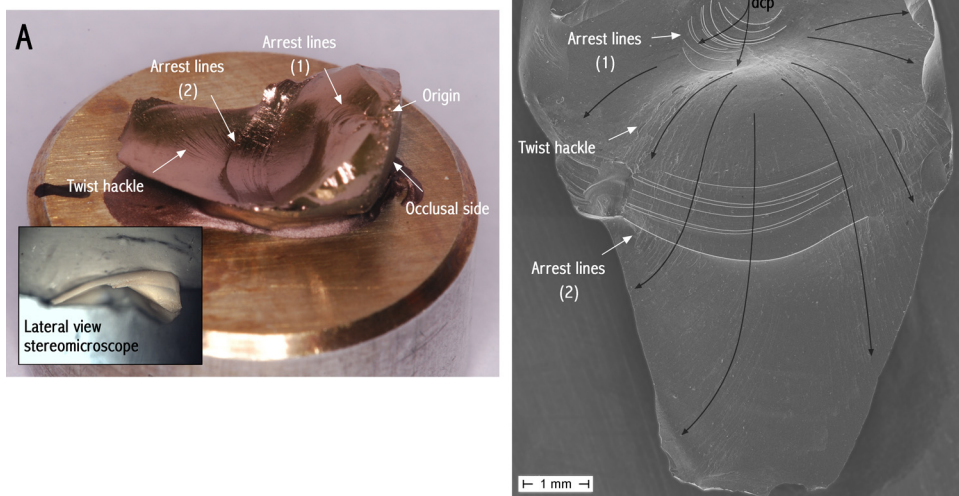
The fracture origin was simple to determine from the semi-circular arrest lines that converged to a contact area at the occlusal surface of the recovered fragment (Fig. 6). In this occlusal surface sector a great deal of abrasion is evident (Figs. 7 and 8) showing surface microcracking, with substantial ceramic loss and cracking around the origin (Figs. 7c,d and 8b). Sintering defects were also found on the abraded surface (Fig. 7). At the distal edge of the fragment, partial cone cracks were found on the abraded occlusal surface (Fig. 7), a distinct feature of sliding contact damage. A cross-section of the fragment (not shown) revealed numerous competing cracks extending up to 200  $\mu\text{m}$  from the surface into the bulk of the veneer. The array of arrest lines that developed close to the origin and later after the crack went past the occlusal buccal outer surface of the ZrO<sub>2</sub> framework, could be indicative of fatigue fracture. The arrest lines that developed inwards from the origin point showed a change in orientation (from the normal loading direction) at around  $\sim 1.5$  mm in depth (arrest lines (1) in Figs. 6

**Fig. 6.** (A) The recovered fragment was gold-sputtered for SEM analysis. Arrest lines and hackle lines can be distinguished on the fracture surface. Inset shows a lateral view of the fragment under the stereomicroscope before sputtering. (B) SEM image of the fracture surface of the fragment. Two sets of arrest lines are outlined in white. Arrest lines (1) developed under the fracture origin towards the veneering ceramic bulk and show the change in crack orientation due to an oblique loading component. Arrest lines (2) were formed as the crack grew around the convexity of the ZrO<sub>2</sub> framework structure. “dcp” stands for “direction of crack propagation”.

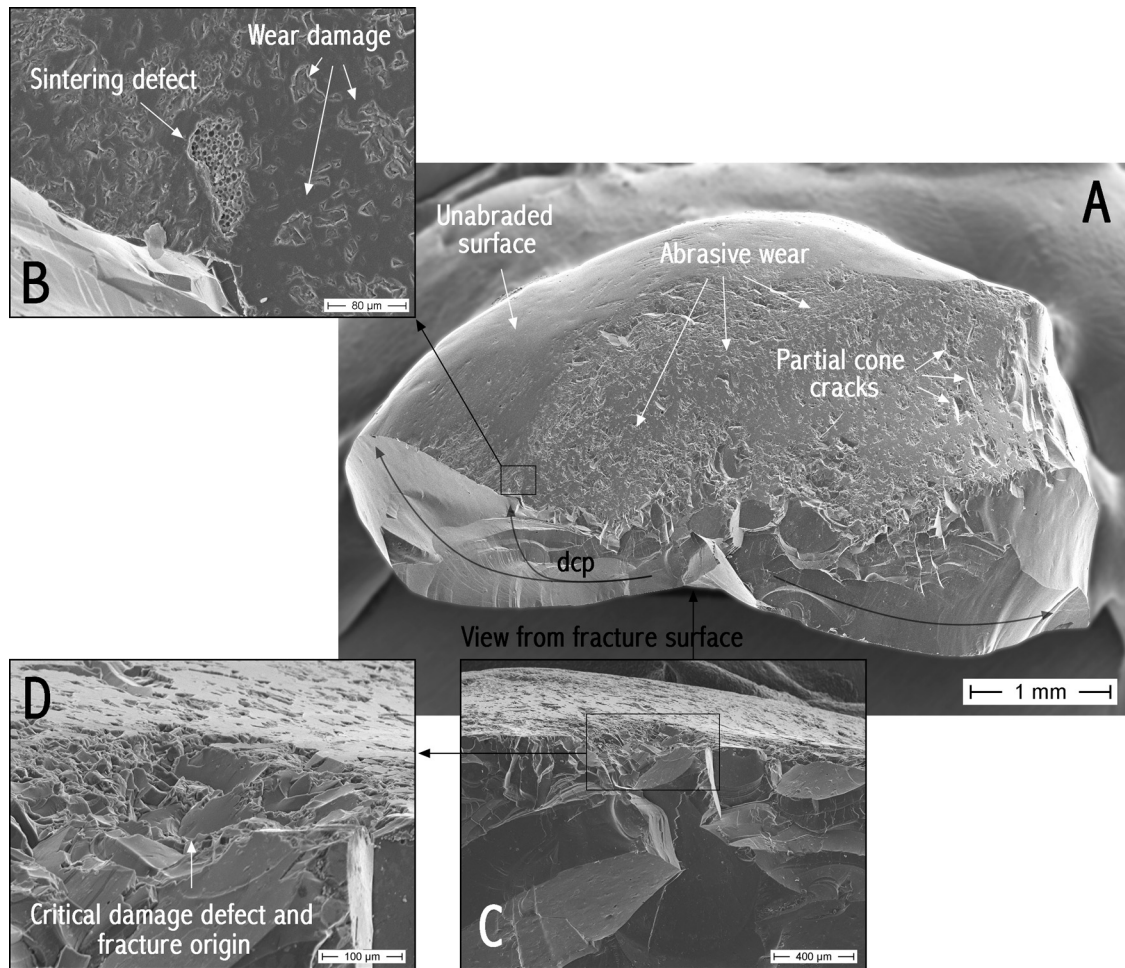
Fig. 7. (A) SEM image of the occlusal view of the veneering ceramic recovered fragment. On the occlusal surface a large area of abrasive contact wear covers the surface. On the right-hand side of the image cracking of the edge and partial cone cracks are visible as part of a contact damage that included sliding and friction. (B) Magnification of an area of the abraded occlusal surface, showing severe wear damage and a sintering defect. (C and D) View from the fracture surface where the fracture origin is located. A large surface contact damage defect is associated with the fracture origin. “dcp” stands for “direction of crack propagation”.

In Case 2, a pre-existent defect was not identified (although sintering defects were found on the surface), and the critical crack leading to failure was a result of extensive surface contact damage and high contact pressure. On the occlusal surface the wear pattern and the partial cone cracks indicate that severe sliding contact loading took place. This gives rise to a tangential loading component and shear stresses acting at the advancing crack. According to the dentist, the patient

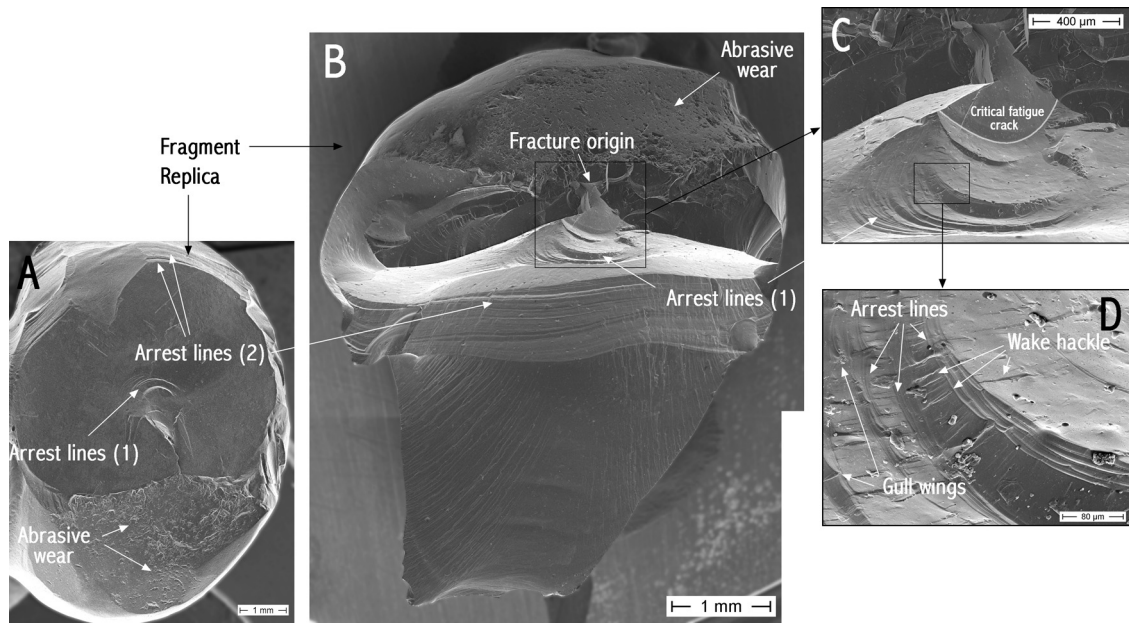
and 8a,b), indicating an oblique occlusal loading component. Wake hackle formed from pores often connected subsequent arrest lines (Fig. 8). These markings suggest that a thin layer of the veneering ceramic remained attached to the ZrO<sub>2</sub> surface as seen from the replicated surface (Fig. 8a).

Fig. 8. (A) SEM image of the occlusal side of the replica, showing the two sets of arrest lines that can be matched to the fragment in (B). A substantial area of abrasion is also present on the occlusal surface of the replica. (B) Occlusal and fracture surface view of the fragment. (C and D) Magnifications show the Arrest lines (1) in detail, where wake hackle and other fractographic markings can be seen.
