Post mortem analysis of a tungsten coated tile from the outer divertor strike point region of ASDEX upgrade

E. Fortuna-Zalesna^{a,*}, M. Andrzejczuk^a, L. Ciupinski^a, K. Rozniatowski^a, K. Sugiyama^b, M. Mayer^b, K.J. Kurzydowski^a, ASDEX Upgrade. Team

In the present study, the structure and the composition of co-deposited layers developed at the outer divertor strike point tile 1 in ASDEX Upgrade during three campaigns from 2009 to 2013 were examined. The samples were cut from representative locations which differed in received flux: private flux, strike point, the highest plasma fluence and “moderate” flux regions. High resolution scanning (SEM) and transmission electron microscopy (HRSTEM) combined with energy-dispersive X-ray spectroscopy (EDS) and optical profilometry have been used to identify deposits composition and morphology as well as to assess coating degradation. The aim of the post-mortem analyses was the evaluation of materials mixing and evidence of plasma-induced damage.

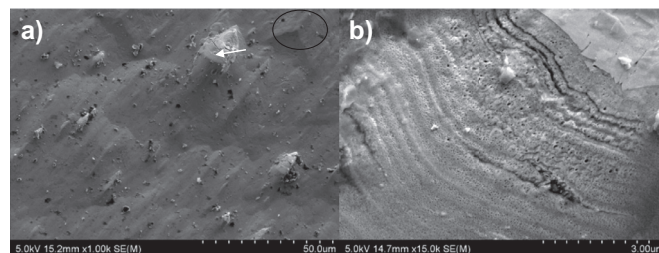
Fig. 3. SEM images of the coating and deposit morphology: a) sample 1-4A, b) sample 1-10A. Deposit is encircled in the oval.

The surface morphology of the three other samples is different. They exhibit a more pronounced surface smoothing, as evidenced by the SEM images in Figs. 2b and 3a. Their surface is also covered by deposit, however, of a different character, with a tungsten-based, sponge like structure shown in Fig. 3b. Solid layers, rich in boron were also found. The thickness of the deposit is inhomogeneous and higher in the shadowed areas, as indicated in Figs. 2b and 3a. Particles rich in boron were also found and elongated artefacts as observed already before by M. Balden [11] – see Fig. 3a.

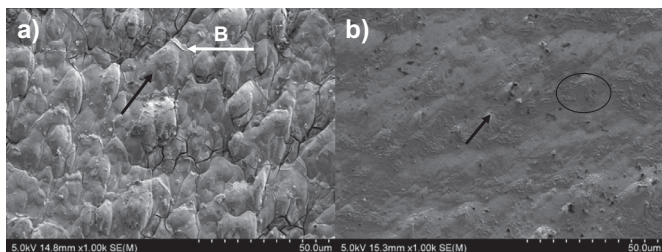
Fig. 2. SEM images of the coating morphology of sample 1-1A, (a), and 1-3A, (b). Black arrows indicate the direction of the erosion, whereas the white arrow in (a) indicates the direction of the lines of the toroidal magnetic field. Deposit is encircled in the oval – see the stratified, wavy area, where re-deposited material was sequentially accumulated (b).

SEM examinations revealed that the surface of all examined samples was modified due to exposure to the conditions of the 2009–2013 campaigns as evidenced by the images in Fig. 2. The investigated samples have distinctly smoother surfaces in comparison to their initial morphology, which has been described in [6]. The surface shows a specific erosion/deposition patterns in the form of: (i) elongated remains of the initial grain structure, which are at an angle of approximately 45° to the lines of the toroidal magnetic field and (ii) deposits in the shadowed areas.

The highest roughness has been measured for the sample 1-1A shown in Fig. 2a. The surface is covered by a thick, cracked, stratified deposit of good adhesion to the coating. Small fragments of deposit are chipped off, very likely contributing to the dust production.

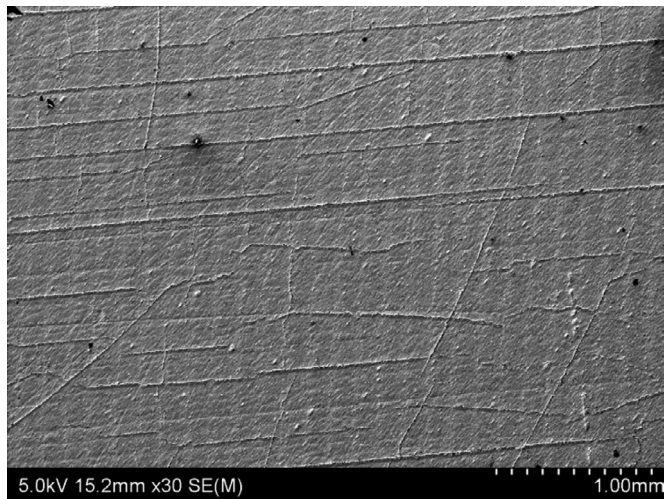
It should be noted that the surfaces of samples 1-3A and 1-4A, which were from the strike point and the highest plasma fluence region respectively, revealed a network of cracks shown in Fig. 4. The examinations of coating cross-sections revealed that these cracks go through the entire CMSII-W and Mo (inter)-layers down to the graphite substrate. It is worth noting that cracks and other defects have also been revealed underneath the surface of the tungsten layers (see Fig 5). Thus, it can be concluded that the cracks observed are very likely to initiate at the graphite/molybdenum interface.

Fig. 4. SEM image of cracks on the surface of 1-4A sample.

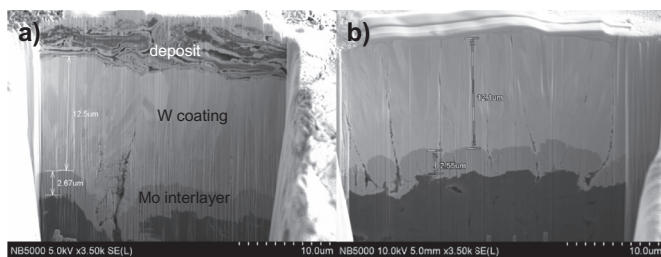
The observations on cross-sections of the coatings, prepared by FIB – see Fig. 5 – showed the same thickness of the tungsten and molybdenum layers, ~ 12.5 and ~ 2.5 μm , respectively. The thickest deposit, up to 6.5 μm , was found in sample 1-1A. The deposit on sample 1-10A was the thinnest and not covering the entire surface.

Fig. 5. SEM images of the coating cross-sections: a) sample 1-1A and b) sample 1-10A.

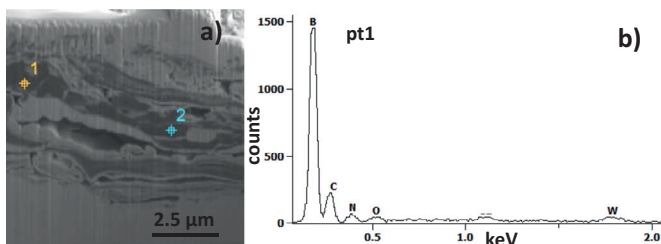
Fig. 6. SEM image of the deposit present at the sample 1-1A cross-section (a) and the corresponding EDS spectrum (b).

The EDS measurements showed that the components of the deposit are tungsten, oxygen and boron – Figs. 6 and 7. Nitrogen, carbon and iron were also detected. The EDS measurements performed both at the FIB cross-sections and thin foils indicated the higher boron content in the deposit cut from the private flux region (Figs. 6, 7, 9).

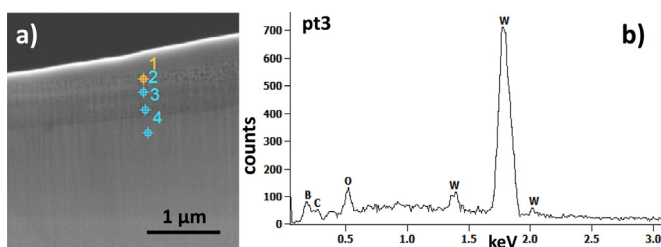
Fig. 7. SEM image of the deposit present at the sample 1-3A cross-section (a) and the corresponding EDS spectrum (b).

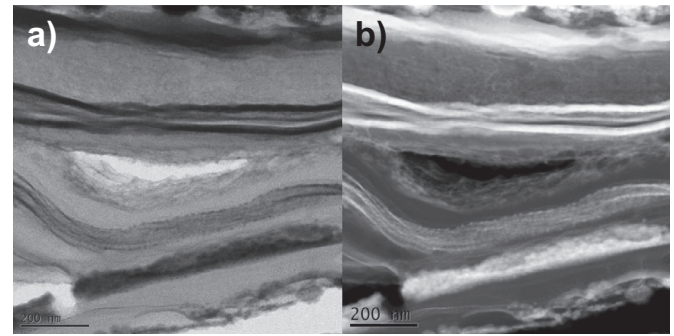
Fig. 8. STEM images of the deposit on sample 1-1A: a) bright field (BF) mode and b) HAADF mode.

The structure of the deposit was investigated by STEM observations of thin lamellas cut by FIB. In the case of sample 1-1A in the lamella cut from the “flat” region, a stratified structure of deposited material has been revealed with sub-layers having thicknesses up to 200 nm – see Fig. 8. Observations using a high angle annular dark field (HAADF) mode, also called Z-contrast, proved differences in their chemical composition. The bright stripes visible in Fig. 8b are enriched in heavy elements i.e. tungsten, whereas the dark ones are rich in light elements - boron and carbon. The EDS spectra from the deposit region are presented in Fig. 9. The signal from copper comes from the copper grid the FIB lamella is mounted on.

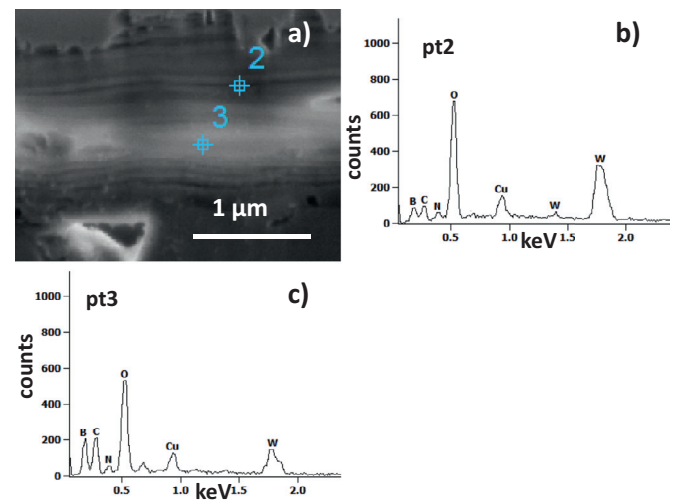
Fig. 9. SEM image of the deposit present at the sample 1-1A cross-section (a) and the corresponding EDS spectra (b-c).

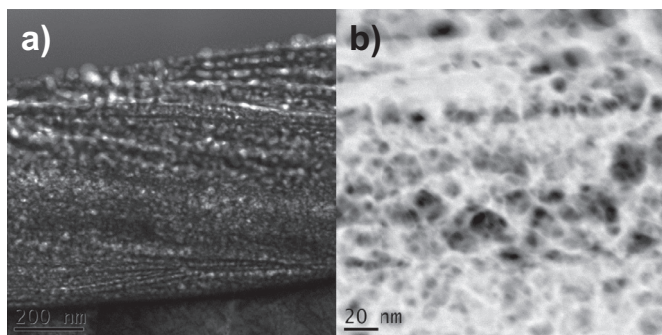
The deposit on the samples designated as 1-3A, 1-4A and 1-10A is similar and reveals re-deposited tungsten in the form of a three dimensional sponge-like structure illustrated in Fig. 10. The structure is inhomogeneous with “sponge cells” sizes varying from a few to several tens of nm. It contains re-deposited tungsten together with boron and carbon, Fig. 7. Diffraction patterns from the deposit area proved the presence of both amorphous and crystalline matter, as shown in Fig. 11.

Fig. 10. STEM images of deposit present at sample 1-3A: a) BF mode, b) HAADF mode.

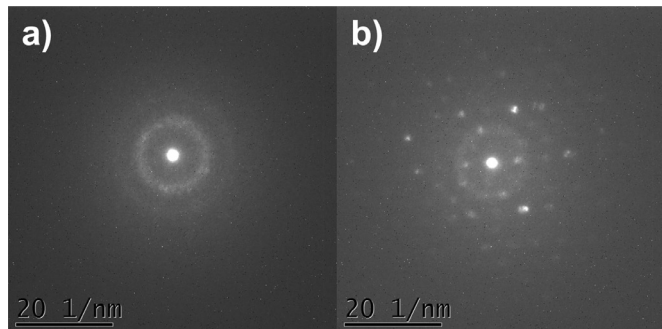
Fig. 11. Diffraction patterns from deposit present in Fig. 9a.
