Energy Procedia 69 (2015) 1519 – 1528

ProcediaInternational Conference on Concentrating Solar Power and Chemical Energy Systems,
SolarPACES 2014

Critical constraints responsible to solar glass mirror degradation

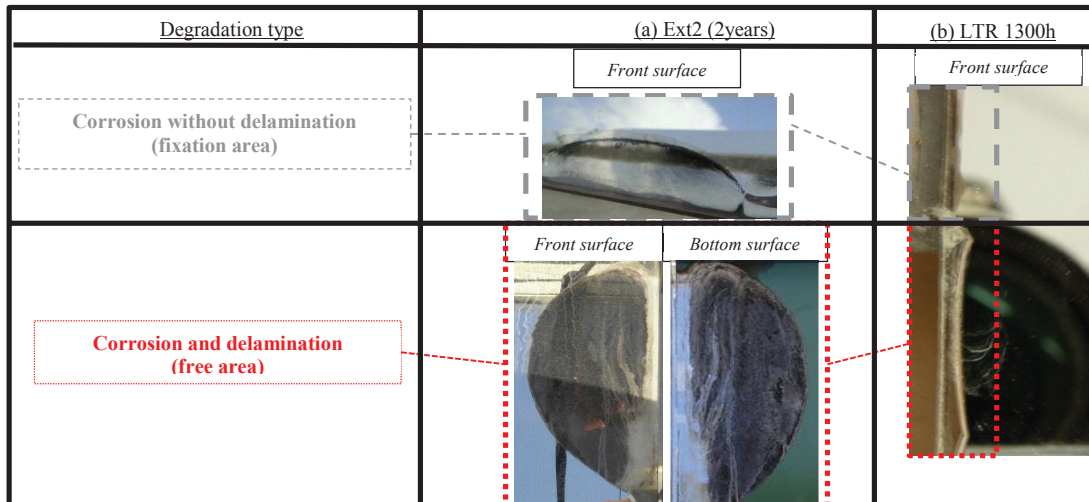
Silver corrosion starts from the edges of the mirrors and may go along with delamination of the paint system. These phenomena were firstly observed in natural ageing Ext2 (Fig. 5a). Two kinds of degradation were observed depending on the fixation system of the mirrors. Under the fixation of the mirror there is corrosion from the edge but no delamination. On the other hand, the corrosion from the edge goes along with delamination. These phenomena happen only with water retention on the paint and when ageing induces temperature and wetting/drying cycles. From this fact observed in Ext2 site (Fig. 5a), we develop a new artificial test with alternation of dry phase and rain phase. This test called LTR in this study is based on the standard ISO 11341.

Optical micrographs Fig. 5b and 6 after LTR ageing for mirror #1 evidence the silver corrosion and the delamination of the paints system. The degradations are in really good agreement with what occurs in outdoor ageing Ext2. This confirms assumptions that water retention associated with temperature cycle are the critical constraints responsible to silver corrosion and paint delamination. Mirror #2 is also subject to these phenomena (Fig. 7). Silver corrosion is observed in Ext2 ageing whereas silver corrosion and delamination is already observed on LTR after 1300h of ageing. Mirror #3 is not corroded at all in Ext2 and in LTR test. This is another fact which confirms the relevance of the LTR test. All the mirrors do not have edge protection by paint, polymer or scotch because samples are cut from larger mirror. The well edge resistance of mirror #3 shows that a better edge protection can be guarantee by the mirror technology itself without applying an edge protection system.

Results show that the degradation mechanism from the mirror edge starts with the silver corrosion due to water retention. This corrosion decreases the adhesion between the metallic layer and the paints system. The paint degradation (Fig. 2) induces modifications of chemical properties of paints such as wettability and water absorption. Physical properties like coefficient of thermal extension or tensile and compression strength may also be affected. Temperature changes and cycle of humid and dry phases induce strains which cause delamination of the paint when corrosion of metallic has already begun.

Fig. 5: Photographs of the mirror #1 degradation after 2 years Outdoor (Ext 2) and after artificial ageing (LTR).

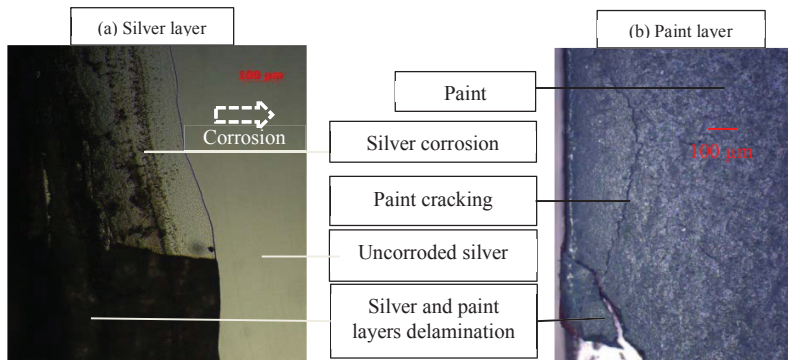
Fig. 6: Optical micrograph of corrosion of the silver layer and delamination of paint system after 450h of artificial ageing LTR.

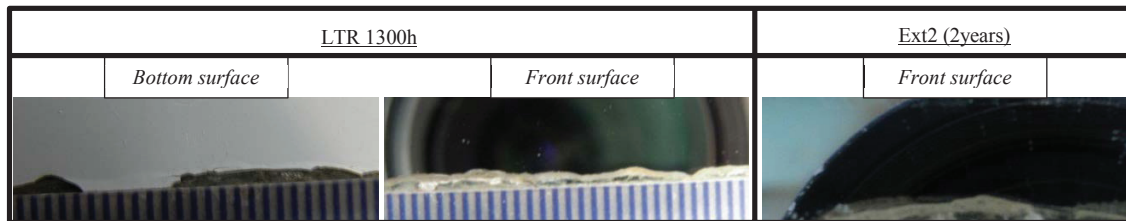
Fig. 7: Photographs of the mirror #2 degradation after Outdoor (Ext 2) and artificial ageing (LTR).
