Metallurgical analysis of SA-106 Gr. B pipe failure during hot bending

A.H.V. Pavan^{a,*}, K.S.N. Vikrant^a, G. Vimalan^b, Kulvir Singh^a^a Metallurgy Department, BHEL, Corporate R&D Division, Vikasnagar, Hyderabad 500 093, India^b Welding Research Institute, BHEL, Tiruchirappalli 620 014, India

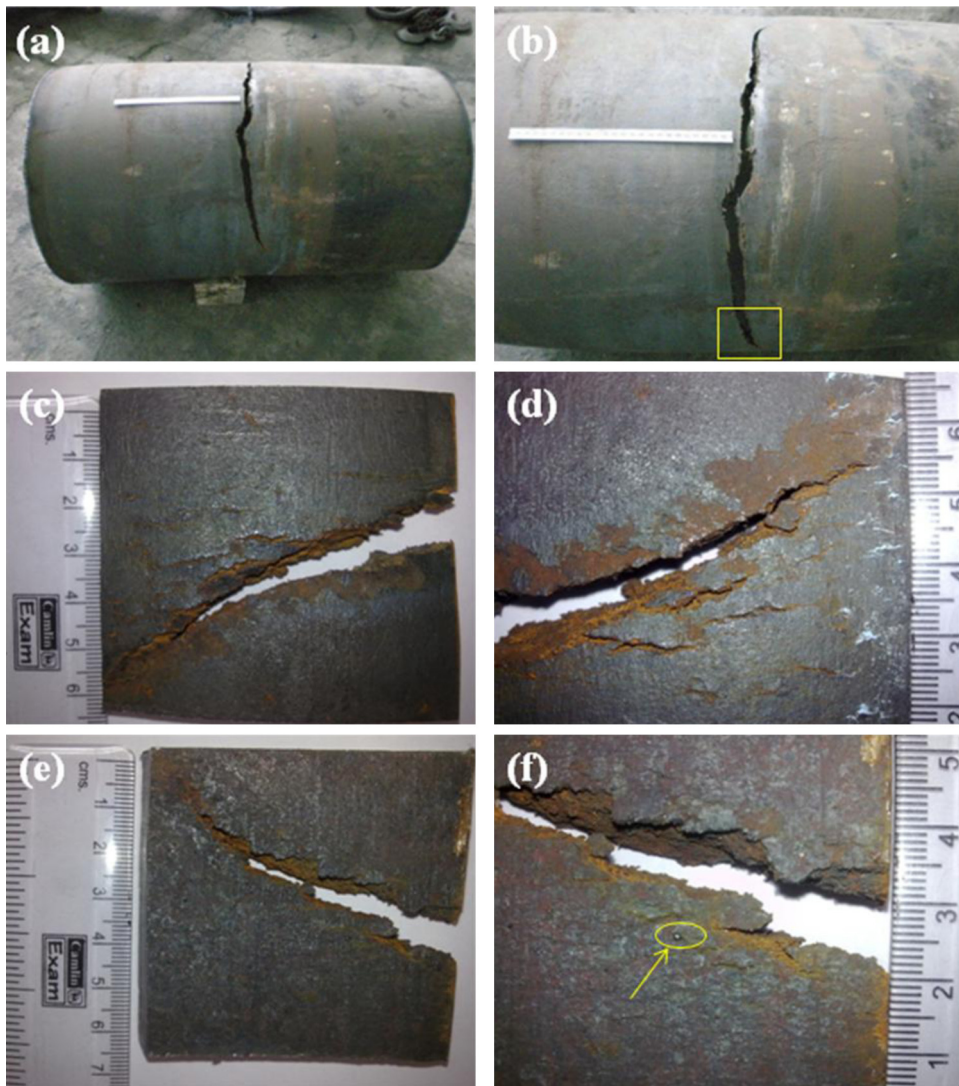
Fig. 2. (a) Actual pipe after removing it from the hot bending machine, (b) pipe indicating the portion cut for further investigations, (c and d) outer surface and (e and f) inner surface of the portion indicating the presence of globules on the surface.

The pipe which had failed was inspected and a large transverse/circumferential crack was observed. A small portion towards an end of the crack (Fig. 2(b)) was cut and observed with naked eye. The extrados and intrados surfaces had an oxide scale over it with branching of fine cracks. In addition to these observations, the intrados surface had a number of globules over it (a large globule is indicated in Fig. 2(f)), all of which had metallic appearance. Similar kinds of globules were observed on the crack surface towards the intrados surface. In case of good pipe, there was only oxide scale which was observed over the surfaces of the pipe after hot bending operation.

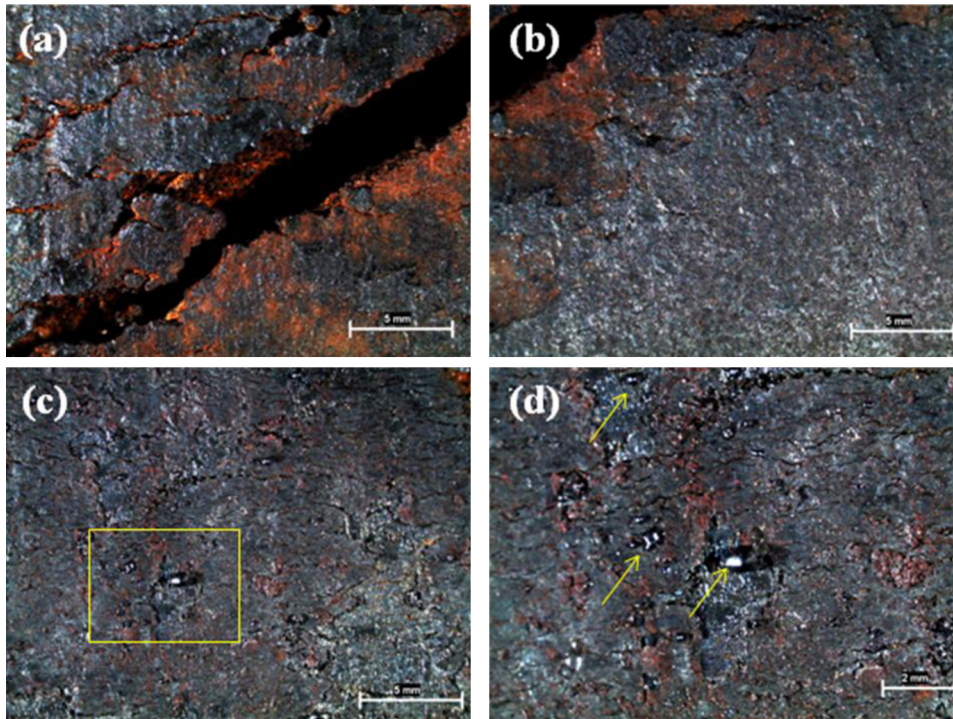
Fig. 3. (a and b) Outer surface of the pipe indicating thick oxide scale, (c and d) inner surface of the pipe indicating the presence of globules having metallic appearance and (d) magnified view of the region indicated in (c).

crack on the extrados surface while the intrados surface clearly indicated the presence of globules having metallic appearance (Figs. 3 and 4). These globules had formed on the inner surface of the crack as well as over the interior surface of the pipe (Fig. 5).

SA-106 Gr. B is a plain carbon steel. Plain carbon steels oxidize and form a thick oxide layer when they are heated to higher (beyond red-hot) temperatures. Therefore, the thick oxide scales observed on the extrados and the intrados surfaces formed when the pipe was heated to 900–950 °C in air by induction heating during hot bending.

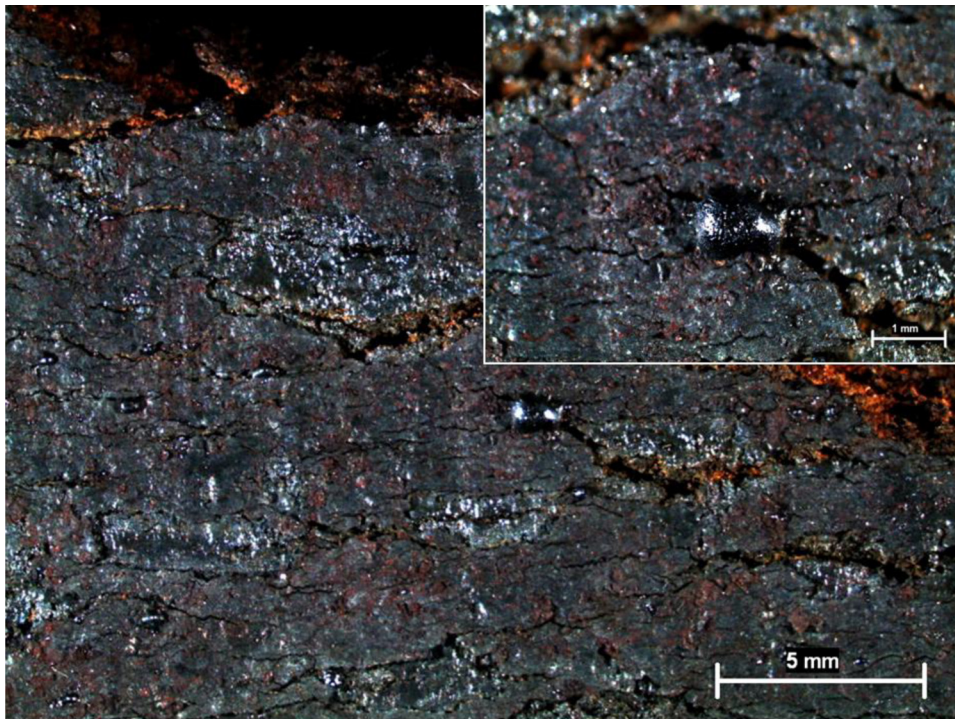
Fig. 4. Inner surface close to the crack indicating globules (inset: higher magnification of the globule).

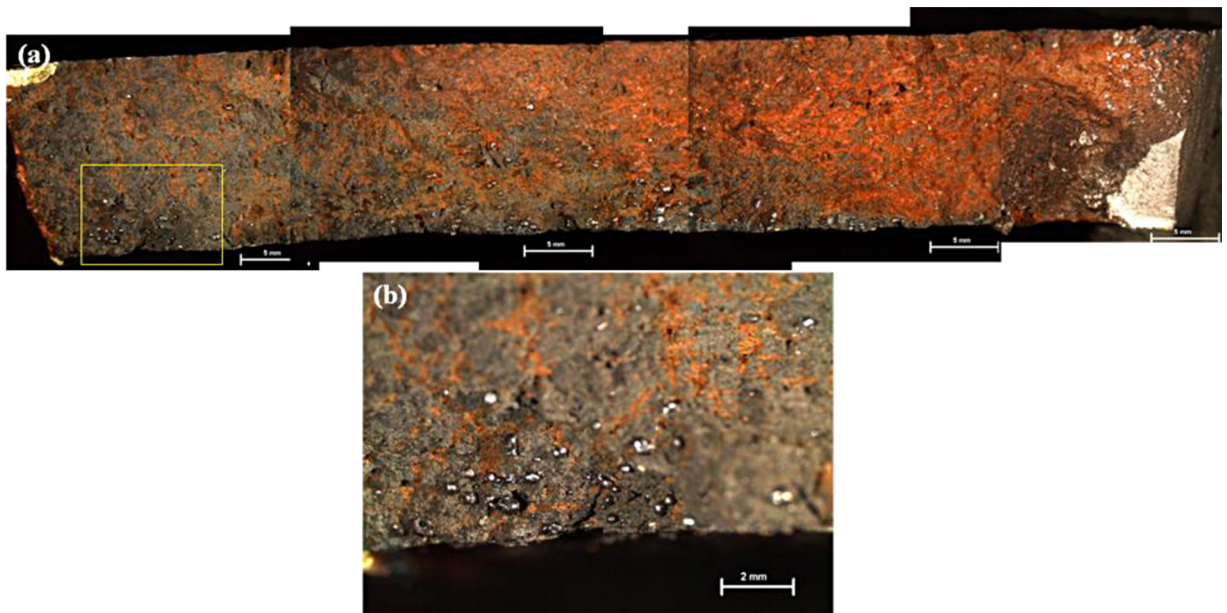
Fig. 5. Stereomicroscopic images of surface of the crack. (a) Fractured surface of the pipe clearly indicating the presence of globules towards the inner side of the pipe and (b) magnified view of the globules.

Visual inspection and stereomicroscopic studies clearly indicated the presence of the globules on the intrados surface. Also, stereomicroscopic studies of the surface of the crack revealed the presence of similar kinds of globules on the surface towards the intrados surface. Fractography of these globules indicated presence of distinct dendritic morphology over their surface. EDS results on the surface of these globules indicated composition similar to that of base metal while base of these

The intrados and extrados surfaces of the pipe located away from the bend angle, experience compressive and tensile stresses, respectively during bending as indicated in Fig. 1. Therefore, the temperature hike which led to localized melting of base metal, seeped out through the cracks developed from the inclusions, into the intrados surface due to compressive stress, thus, forming metallic globules.

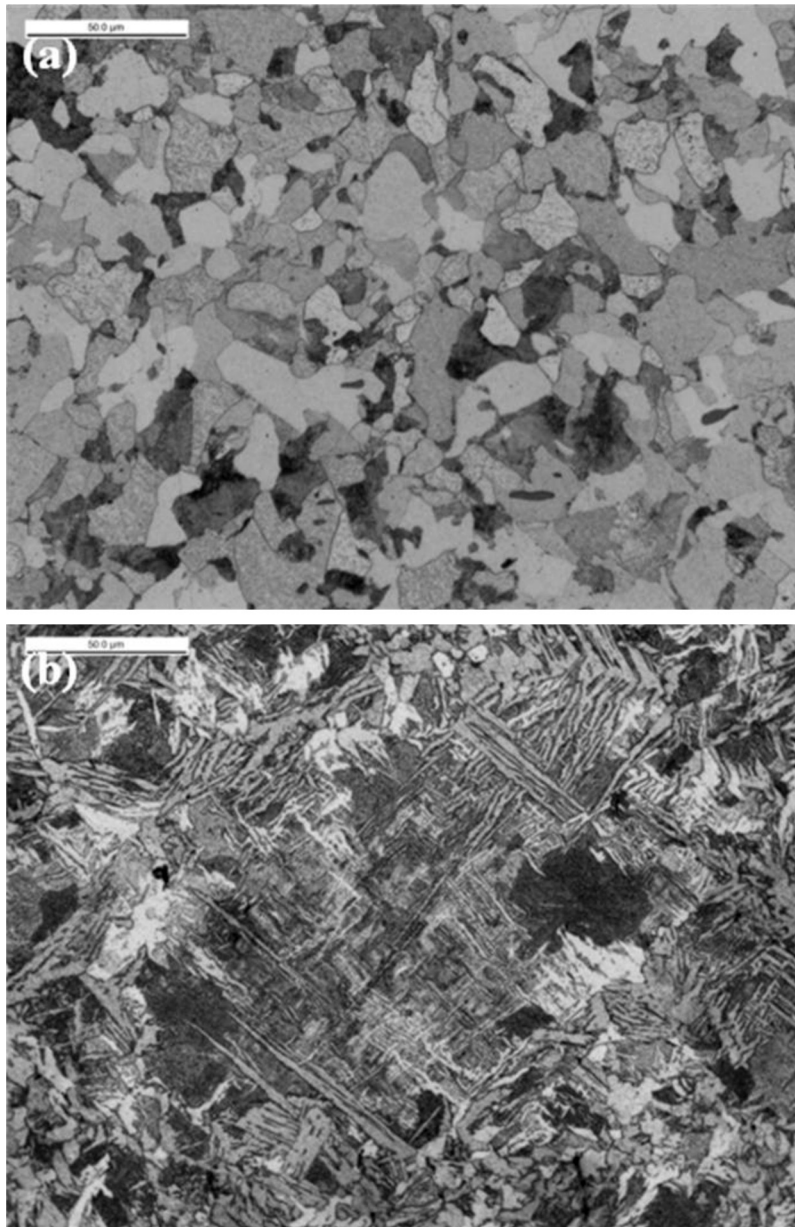
Optical microscopic and FESEM studies of the good pipe and the failed pipe specimens were conducted. There was change in microstructure of the pipe from ferrite–pearlite (Figs. 6(a) and 7(a)) in case of good pipe specimen to Widmanstätten ferrite–pearlite (Figs. 6(b) and 7(b)) kind of morphology in case of failed pipe specimen. Cracks were also observed in the latter microstructure. Electron micrographs also indicate the presence of groups of inclusions (Fig. 8). The inclusions were identified as Sulfides having distinct regions one rich in Al while the other rich in Mn (Fig. 9).

Fig. 6. Optical micrographs of (a) good SA-106 Gr. B sample and (b) failed pipe.

globules had higher Al, Si content. This confirmed melting and solidification of the base metal suggesting that higher temperature was attained during operation. Also, optical micrographs indicated the presence of Widmanstätten ferrite–pearlite in the failed pipe which was complimented by higher hardness results. This morphology of ferrite appears when there is sudden increase of temperature followed by moderate cooling rate.

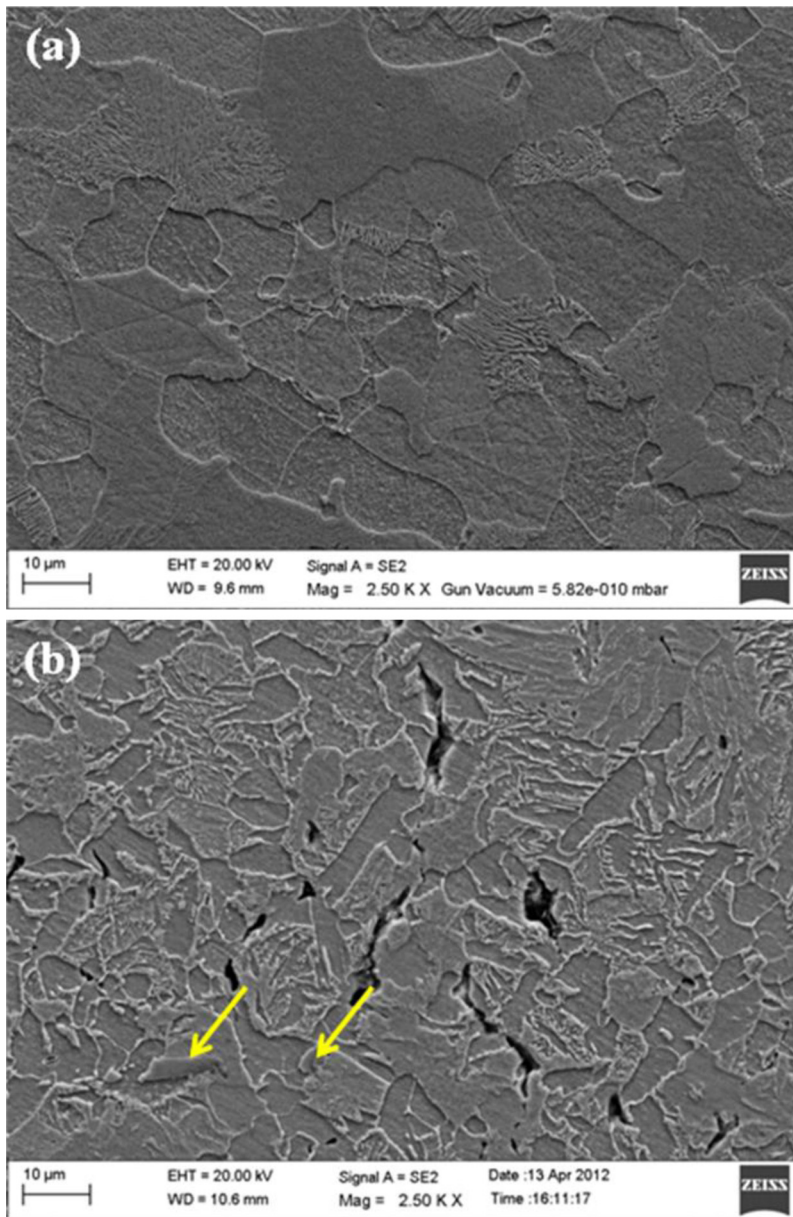
Fig. 7. Electron micrographs of (a) good SA-106 Gr. B sample and (b) failed pipe indicating MnS inclusions.

From the electron micrographs, presence of groups of inclusions was observed. The presence of these inclusions led to significantly lower ductility and impact toughness of the failed material which could have bolstered the crack formation. This explains the presence of cracks originating from the inclusions due to excessive deformation during bending process. This may have occurred by sudden thermal expansion of pipe during induction heating of the pipe.

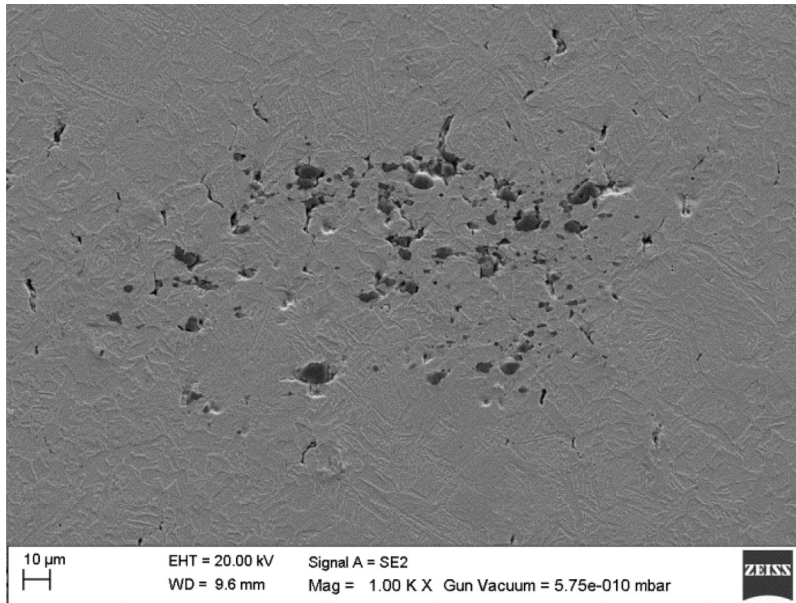
Fig. 8. Groups of inclusions observed in the failed pipe.

This could possibly be avoided by stringent quality control of the pipe material for pipes as well as maintaining the operation parameters within the limits during hot bending process.

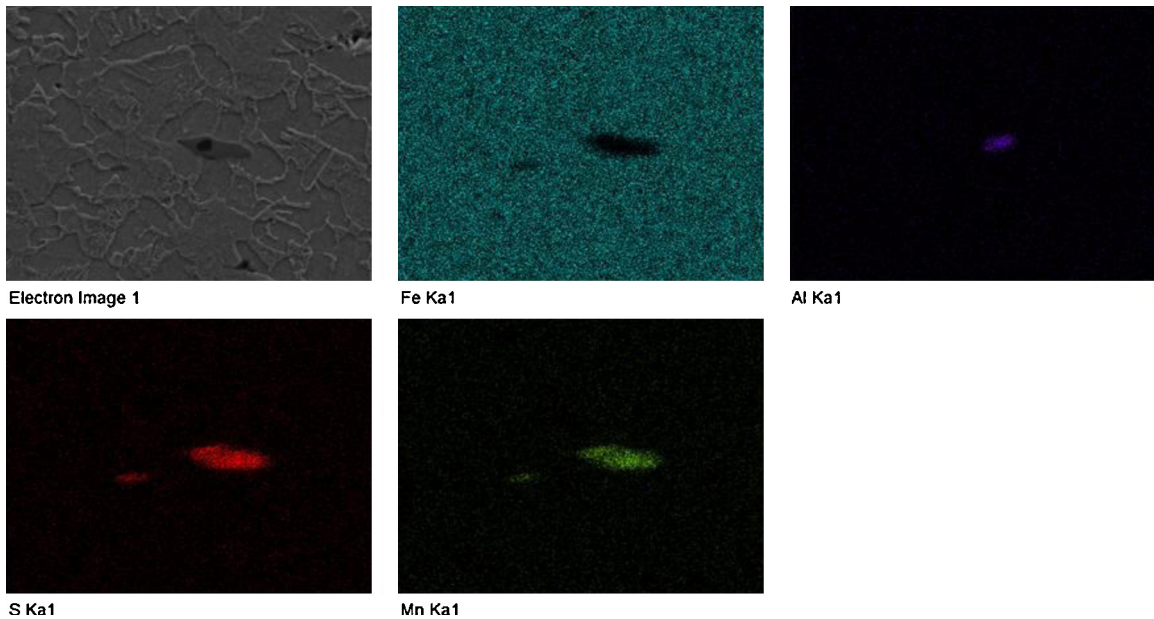
Fig. 9. Elemental mapping of the inclusion revealed the sulfide inclusion indicating distinct regions rich in Al and Mn.

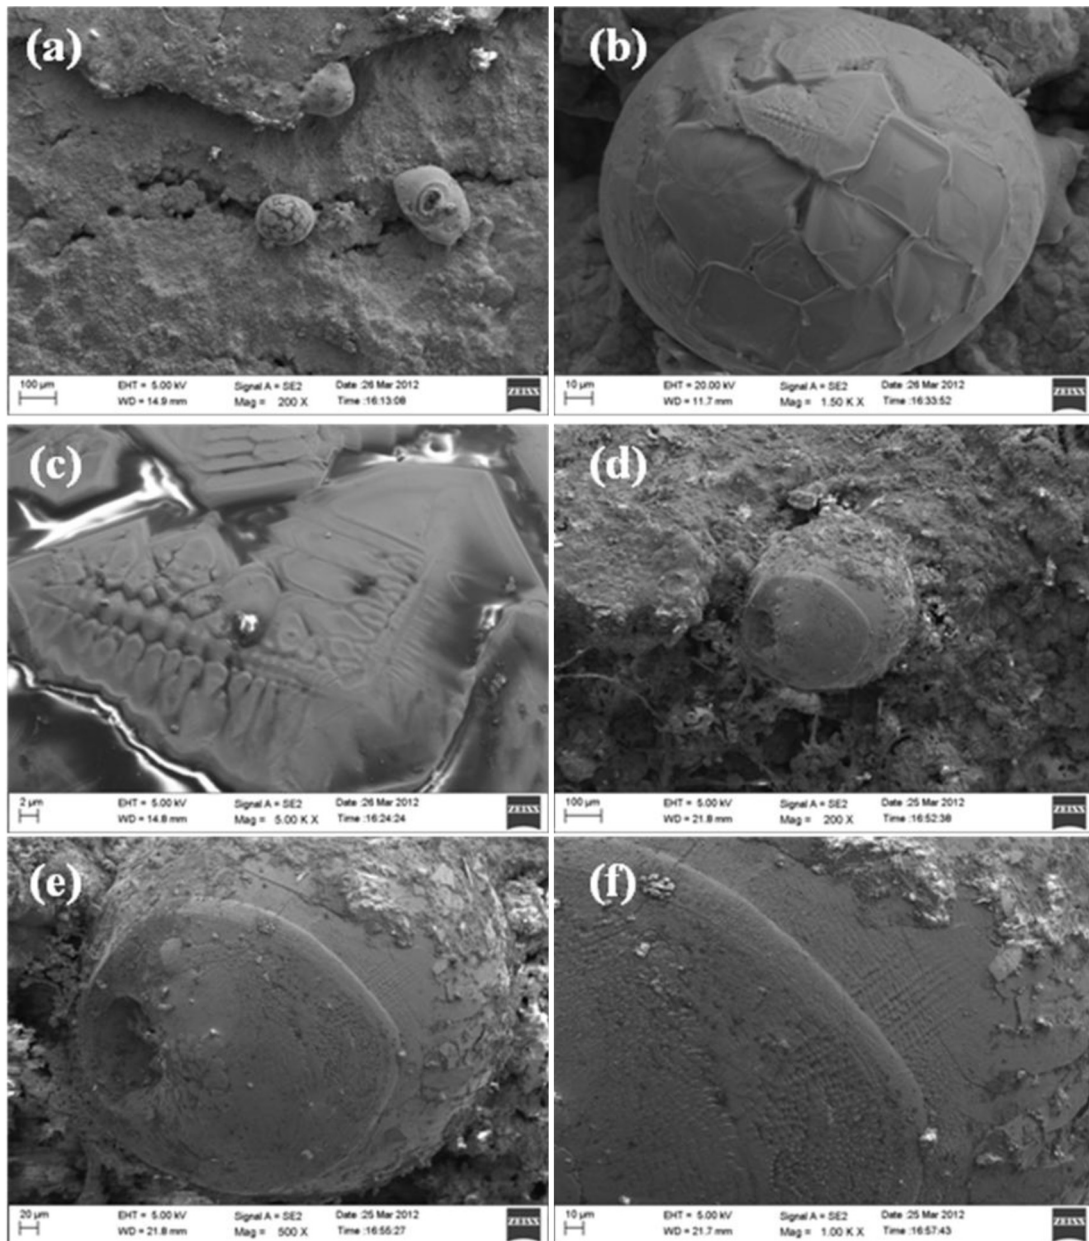
Fractography was carried out on the surface of the crack towards the interior edge especially on the globules present. Dendritic morphology was clearly observed on the surface of these globules (Fig. 10(c) and (f)). These observations indicated that there has been melting and solidification of liquid metal. EDS analysis on these globules clearly indicates that the qualitative chemical composition of these are similar to the base metal as obtained during microstructural examination. In addition to the existing results, it was observed that the base of these globules which was attached to the surface of the crack contained Al, Si in significant quantities (as shown in Fig. 11, spot 1 and Table 2). The portion which was observed to be non-conducting in Fig. 10(c) was due to the fact that the sample was cleaned in acetone and it led to the formation of a layer rich in carbon.

Fig. 10. (a and b) Fractographs clearly indicating the presence of globules on the surface of the crack, (c) higher magnification fractograph clearly depicting dendritic structure and (d–f) fractographs indicating another yet similar metal-like globule.

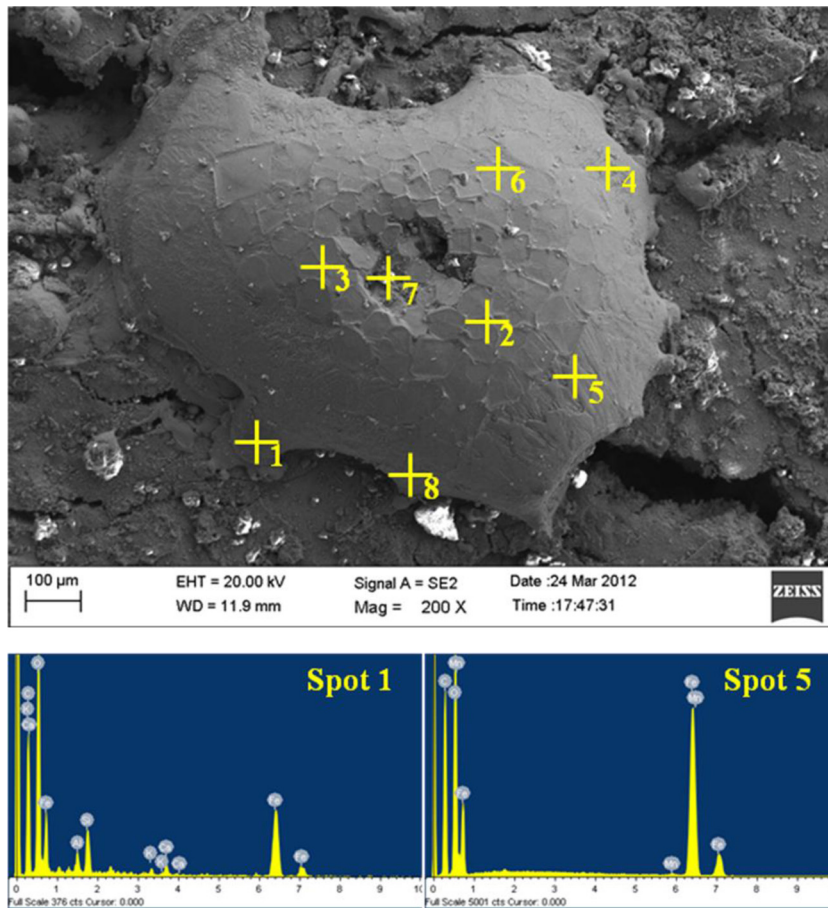
Table 2
EDS results (in wt.%) of the spots as shown in Fig. 11.

Spot/element	K	O	Al	Si	Ca	Ti	Fe	C	Mn	S	Cl	Na	Mg
Spot 1	0.67	50.78	1.50	3.68	1.08	–	23.22	19.05	–	–	–	–	–
Spot 2	–	35.34	–	–	–	–	50.95	13.26	0.45	–	–	–	–
Spot 3	–	35.57	–	–	–	–	50.59	13.35	0.49	–	–	–	–
Spot 4	0.17	38.35	0.88	1.40	0.95	0.44	41.49	14.41	0.40	0.74	0.20	0.56	–
Spot 5	–	35.02	–	–	–	–	51.37	13.14	0.46	–	–	–	–
Spot 6	–	45.09	–	–	–	–	37.69	16.92	0.30	–	–	–	–
Spot 7	1.03	37.84	2.39	5.06	2.73	0.39	30.64	14.35	–	1.78	1.76	1.28	0.74
Spot 8	0.67	50.78	1.50	3.68	1.08	–	23.22	19.05	–	–	–	–	–

Fig. 11. EDS spots on the micrograph and their respective spectra on a globule.

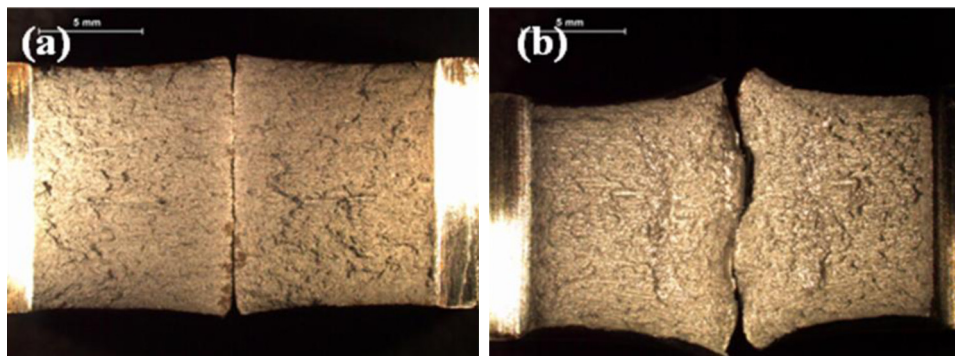
Impact testing by Charpy method was carried out on the specimens prepared from failed pipe material as well as good pipe material. The results (as indicated in Table 3) clearly show that the impact strength (toughness) of failed pipe specimen was significantly low leading to lesser reduction in area as compared to that of the good pipe specimen which was reflected in the stereomicroscopy images of the respective impact specimen (Fig. 12).

Fig. 12. Stereomicrographs of (a) failed pipe and (b) good pipe impact specimen.
