CASE REPORT

Severe corrosion after malpositioning of a metallic head over the Morse taper of a cementless hip arthroplasty. A case report

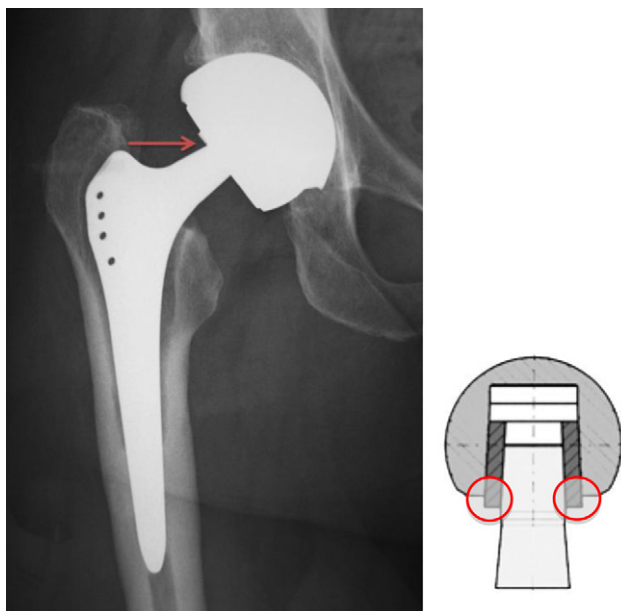
Figure 1 Antero-posterior (AP) X-ray just before implant replacement, showing defective fitting of the head-adaptor assembly onto the Morse taper of the pivot. The arrow points to the projection of the ring, which should not be asymmetrical. The diagram shows that the medium-sized ring should not project asymmetrically (circles).

A year after the THR, the patient complained of inguinal and trochanteric pain; distal iliopsoas release was performed and the cerclage wires removed, without changing any implant component. Pain failed to improve, and onset of crural pain led to referral to our center. The patient had a Postel-Merle-d'Aubigné (PMA) score of 9, and presented with 5 mm shortening of the left lower limb. Soft-tissue ultrasound found periprosthetic liquid effusion, but without any solid formation suggestive of pseudotumor. Joint puncture and bacteriological analysis ruled out infection. Antero-posterior X-ray found 5 mm subsidence of the femoral pivot with distal pedestal. Above all, the juncture between the Morse taper and the adaptor was abnormally visible, with an inadequate connection angle (Fig. 1), suggestive of

an adaptation defect between the Morse taper and the head/adaptor assembly.

The present observation stands as a reminder that Morse tapers, however widespread, may lead to THR failure. Implant adaptation onto the taper requires not only painstaking drying but also great attention to secure the mechanical connection. Whatever the material of the head, we recommend tightening it onto the Morse taper with a screwing movement, then completing fixation by strong impaction.

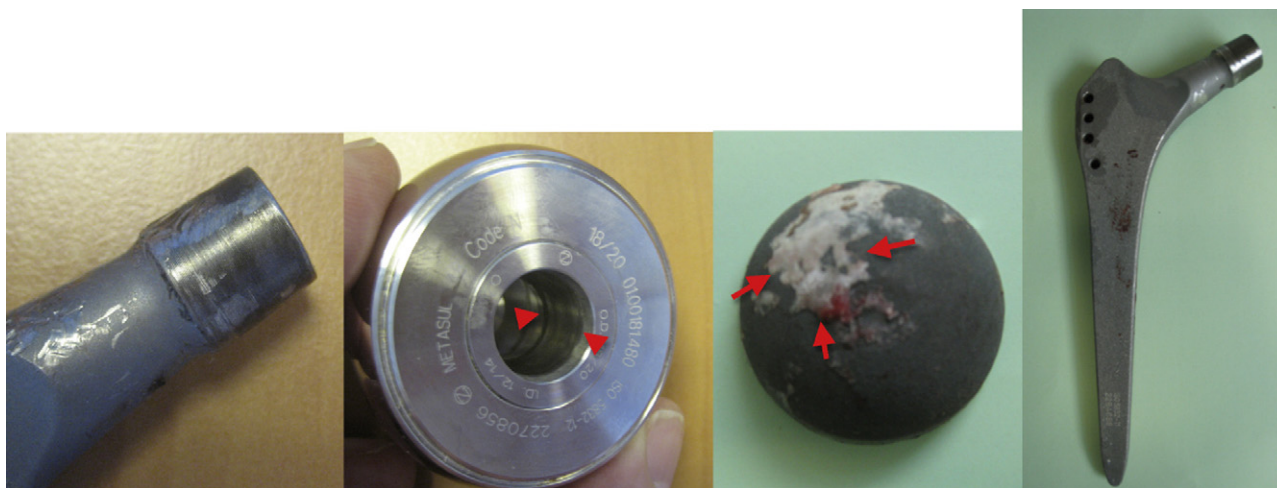
- if the femoral loosening was primary, it could have induced metallosis by micromobility of the titanium alloy pivot; however, the femoral pivot surface did not in fact show significant damage (Fig. 2);
- contact between the metal wires and the pivot may have induced a galvanic effect; however, the pain persisted and the lesions continued to develop even after removal of the wire;

Figure 2 Retrieval photos, showing abnormal Morse taper wear. There was corrosion, but without serious damage to the inner surface of the adaptor (triangles). The presence of bone (arrows) on the rehabitable surface of the cup confirmed fixation. The femoral pivot surface showed no damage, but also no significant new bone growth.

- defective Morse taper adaptation would thus seem to have been the main factor inducing metallosis, as there was no pain-free interval and the very early damage sustained by the taper (Fig. 2) suggests intense early metal debris release.

present case confirms this hypothesis: radiography showed an asymmetric aspect of the adaptor, and the retrieval study showed major damage to the Morse taper. The asymmetric locking onto the taper resembled what is found with drawers in old furniture, with a misleading impression of what in fact is precarious fixation. To prevent this phenomenon, we, like Callaway et al. [13] recommend screwing the head onto the cone during positioning, to avoid any adaptation defect, then impacting strongly. The adaptation rings used in the large-head DuromTM system and the open geometry of certain head sizes have been implicated in elevated metal ion production due to increased modularity [18]. We did not assay blood ions in the present case, which is an important study limitation, as it seems likely that titanium assay would have definitively confirmed the origin of the metallosis and THR failure. Even so, the severe early Morse taper damage bears out the hypothesis that defective locking of the head onto the taper was the cause of the failure here observed.

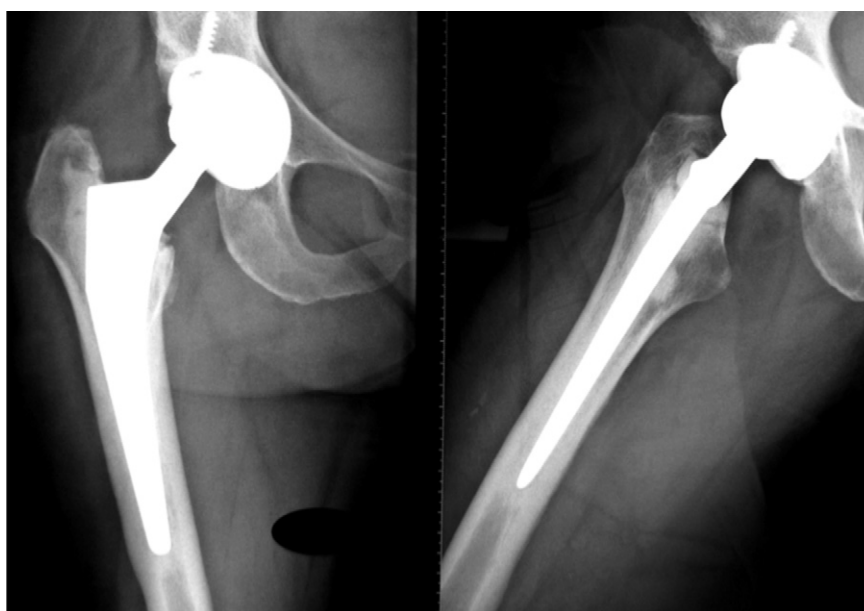
Three years post-revision, the patient's PMA score was 17 and control X-ray showed neither osteolysis nor any implant component migration (Fig. 3).

Figure 3 Antero-posterior (AP) and lateral X-rays 3 years after revision, showing no loosening or recurrence of osteolysis.
