Case Studies in Construction Materials

Renovation of an alkali–aggregate reaction damaged swimming pool

Jukka Lahdensivu*, Jussi Aromaa

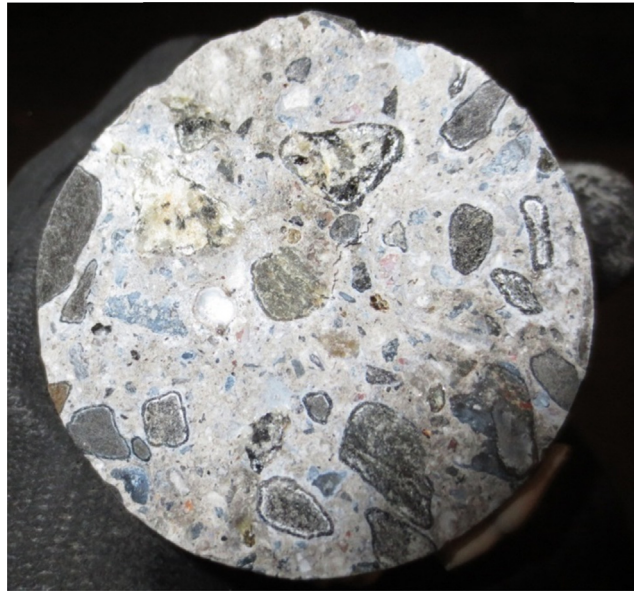
White void fillings were found in the sheared surfaces of concrete samples, see Fig. 2. SEM examination revealed that the white void filling material was alkali–silica gel. The white filling was typically discovered at a depth of 80–120 mm from the

Fig. 2. Alkali-silica gel in voids.

surface of a concrete sample. The cracking detected in 11 samples was considered to have been caused by drying shrinkage after casting. No cracks or disintegration were detected in any of the 17 samples.

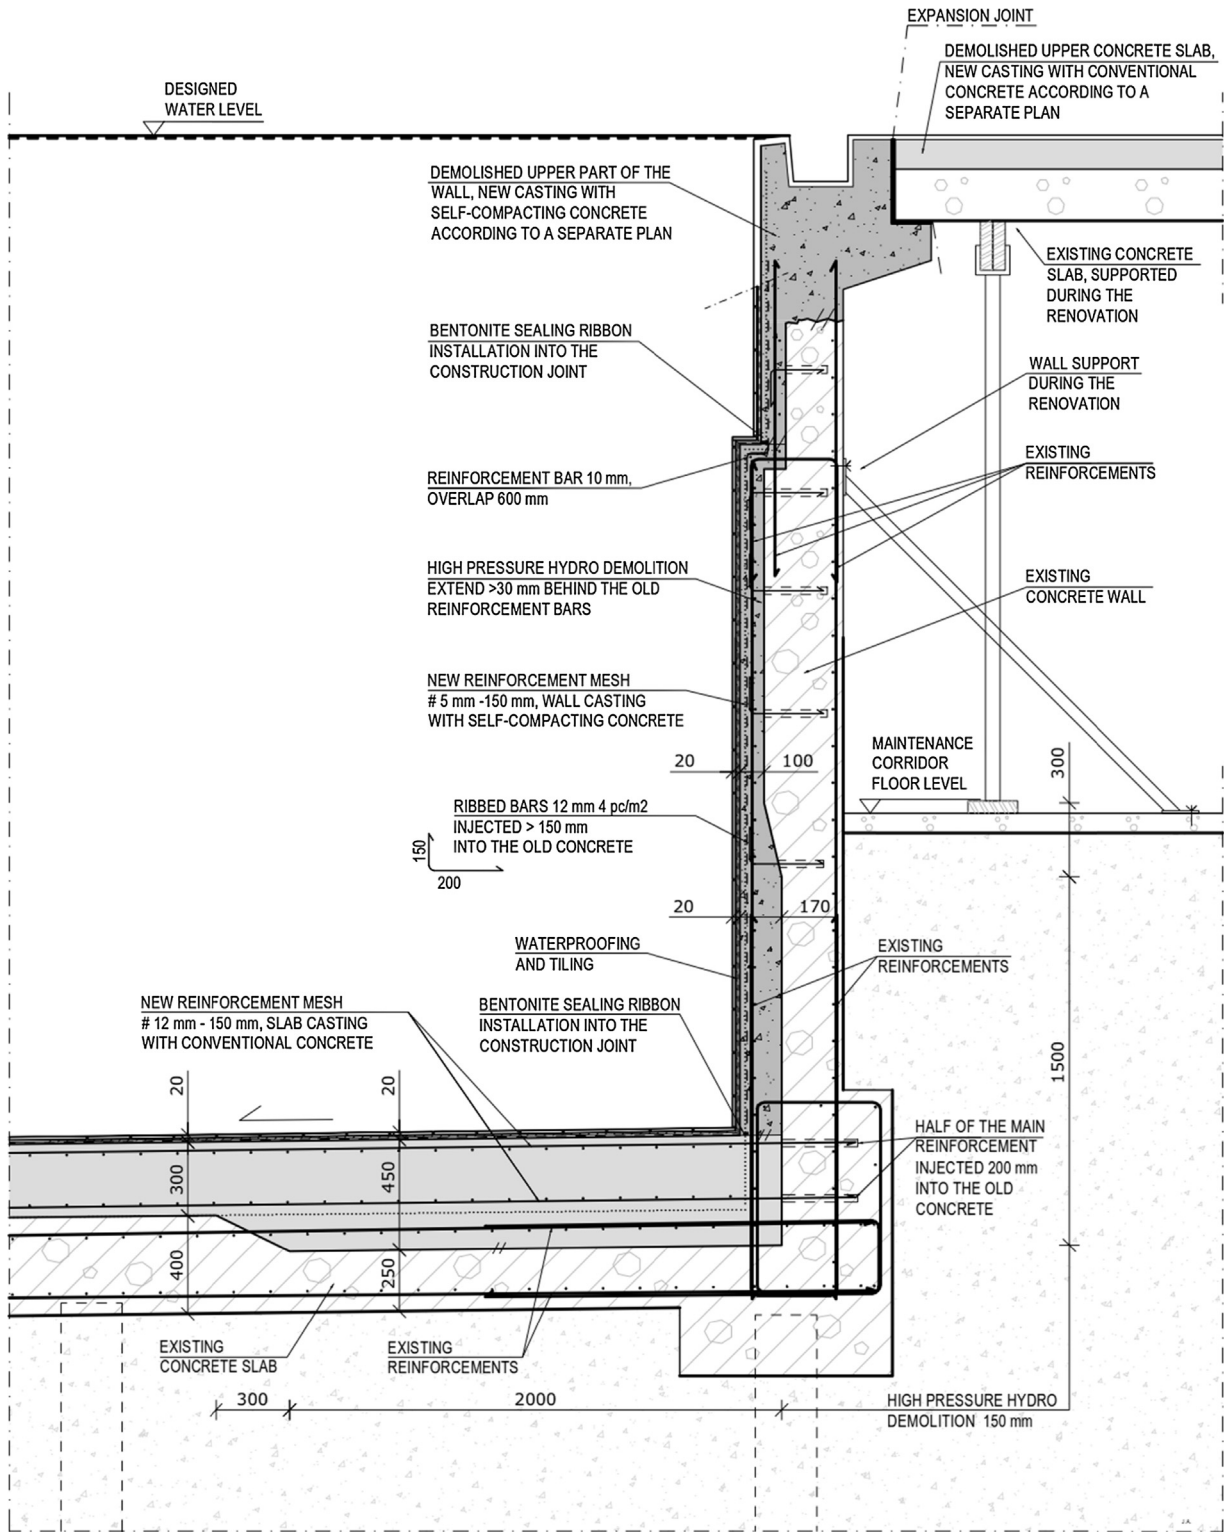
Fig. 3. Cross section of the pool. The grey parts are new concrete.

At the deep end of the pool, new water treatment pipes were installed on the old ground slab and a new reinforced slab 300 mm thick was cast on top of it, see Fig. 2. At the shallow end of the pool a new layer approx. 70 mm thick was cast of C32/40 concrete.

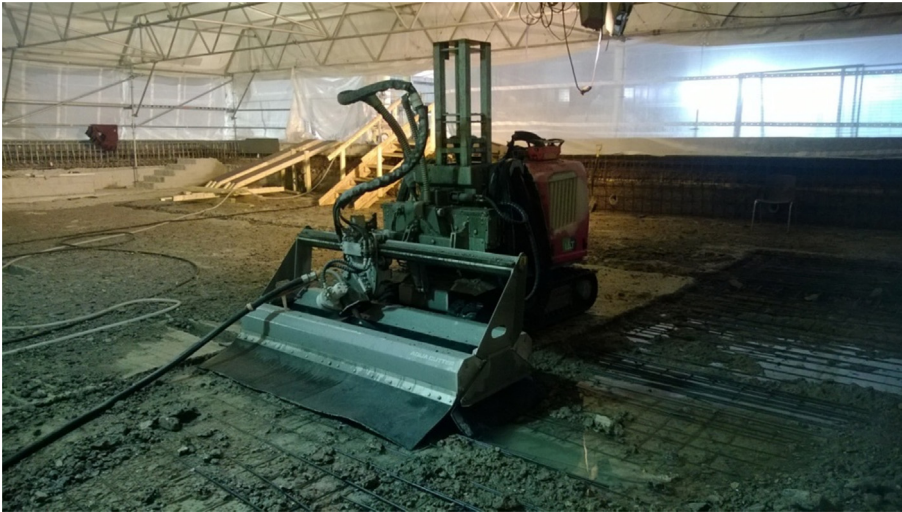
Fig. 4. The working width of the high-pressure water-jet cutter was 2 m. Concrete was removed under a temporary shield.

Approx. 70 mm of deteriorated concrete was removed from the upper parts of the walls using a high-pressure water-jet or a hydro-demolition robot, see Fig. 4. The aim was to penetrate 20–25 mm behind the existing vertical reinforcement and thereby ensure the durability of the old pool and the new concrete. Approx. 150 mm of deteriorated concrete was removed from the lower parts of the walls up to a height of 1500 mm from the ground slab. New and old concrete were joined with ribbed bars (\varnothing 12 mm, 4 pc/m²). At the deep end of the pool, a 2000 mm layer of the ground slab concrete was removed along the walls. At the shallow end of the pool, an approx. 70 mm layer of concrete was removed off the top of the entire ground slab to the level of the existing reinforcement.

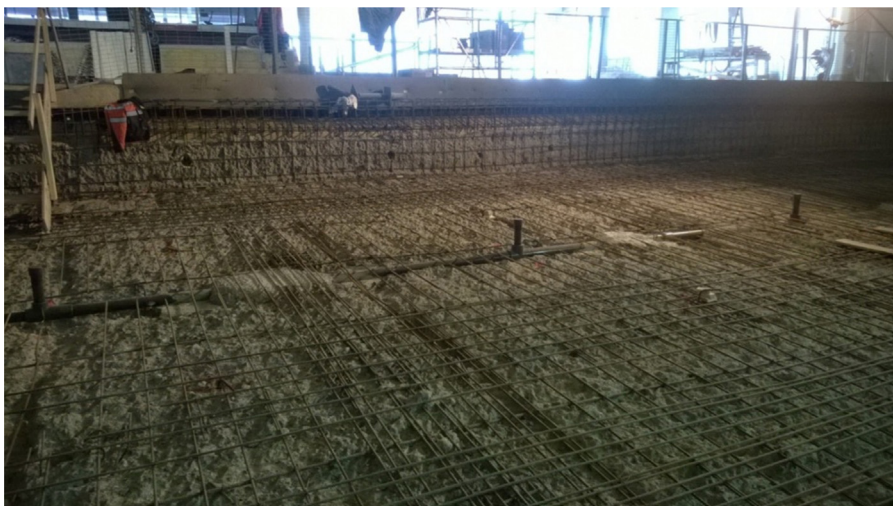
Fig. 5. Upper reinforcement of ground slab. New water treatment pipes were installed before reinforcement.

A temporary shield was built for using the high-pressure water jetting equipment and a hydro-demolition robot on the pool to keep splash water, moisture and removed pieces of concrete within a limited area. The working width of the hydro-demolition robot was 2000 mm both on the wall and the slab. In the corners which were inaccessible to the robot or spots demanding higher accuracy, concrete was removed with high-pressure water jetting equipment operated by a worker. When the concrete had been removed and washed out of all solutes, the condition and location of existing reinforcement was checked, and necessary auxiliary reinforcement was installed on top of new water treatment pipes, see Fig. 5.

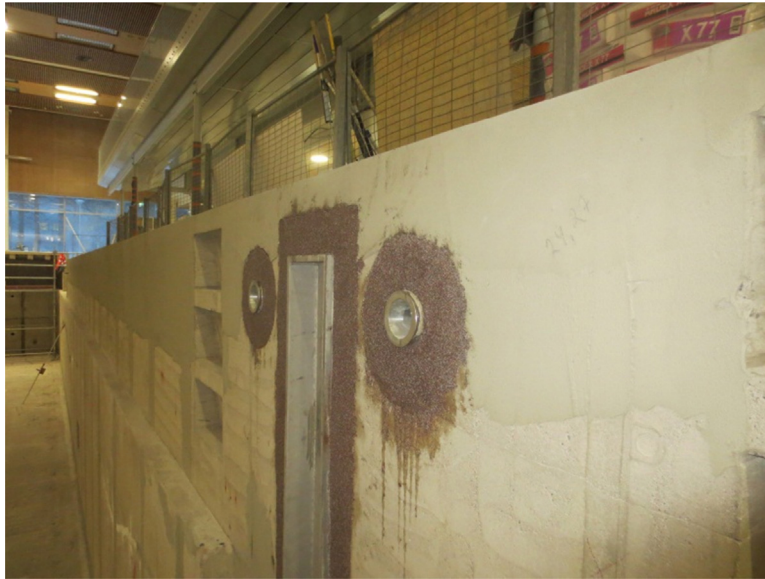
Fig. 6. Epoxy-based materials were used to seal all penetrations.

Waterproofing was installed on the concrete surface after the concrete had dried to RH 92% at a depth of 50 mm. The waterproofing was strengthened with buckram at the corners. Pipe penetrations, etc. were sealed with epoxy-based materials, see Fig. 6.
