# Case Studies in Engineering Failure Analysis

# Fracture of a veneered-ZrO<sub>2</sub> dental prosthesis from an inner thermal crack

Here we describe the fractographic analysis of a veneer-ZrO<sub>2</sub> single-unit dental prosthesis that fractured in a shell-like manner. Analysis of the retrieved fragment revealed that the crack originated in the bulk of the veneer from a thermal flaw located between two layers of the veneering material. Using the measured flaw plane we showed that the conditions of loading at fracture were complex and probably involved important tangential components.

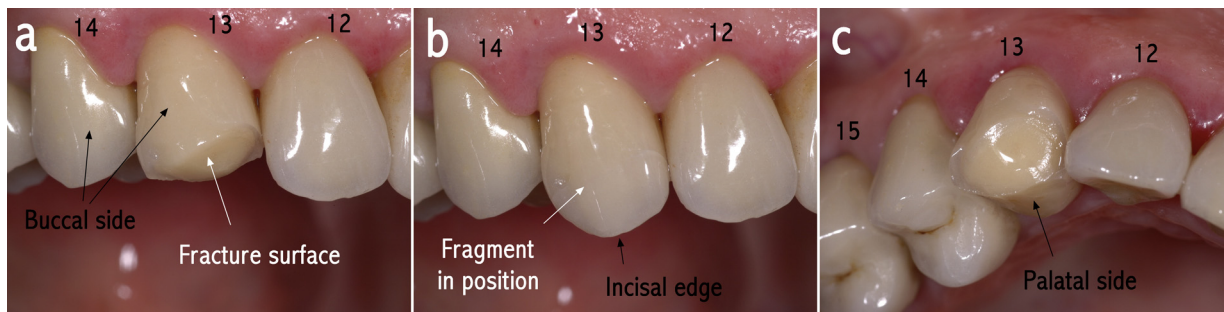
Fig. 1. (a) Buccal view of the clinical situation. The incisal third of the zirconia-veneered crown has fractured off. (b) Buccal view with the fragment in position. (c) Incisal view of the clinical situation. The fracture extended from palatal to buccal involving the whole circumference of the crown.

The presented case deals with a fracture of a veneered-ZrO<sub>2</sub> single crown that took place during normal mastication (Fig. 1). The fracture event was reported to have occurred on May 24, 2011; the fragment was retrieved by the patient and brought to the dentist. The patient's record dated the installation to March 08, 2010, making it a 14 months and 16 days lifespan. The counterpart of the fragment remained attached to the tooth and had to be removed for purposes of restoration replacement and could not be further analyzed. The original fragment was received for analysis, along with the available material and processing information. According to the dentist, the affected tooth was an upper-right canine (FDI number system: #13) that had been restored with a veneered-ZrO<sub>2</sub> single crown. The framework material was a ZrO<sub>2</sub> (Yttria-stabilized Tetragonal Zirconia Polycrystals, 3Y-TZP) machined in a presintered state from a Zenotec Zr Disc (Wieland Dental, Pforzheim, Germany) having a coefficient of thermal expansion (CTE) of 10.5 ppm/°C. The overlaying veneering material was applied following the layering technique, in that successive layers of the veneering slurry are built-up anatomically over each other and sintered separately until the final anatomic form is reached. Usually between 2 and 5 layers can be needed for a single-unit dental FDP. The veneering material of the same manufacturer was an unreinforced porcelain (Zirot NR) of CTE = 9.3 ppm/°C. The antagonist was a natural tooth. This case was initially analyzed in June 2011 at the American Dental Association/NIST 2 day course on Dental Materials Fractography. It was more fully analyzed later in June 2012 and April 2014. A preliminary analysis of this case was published in [10].

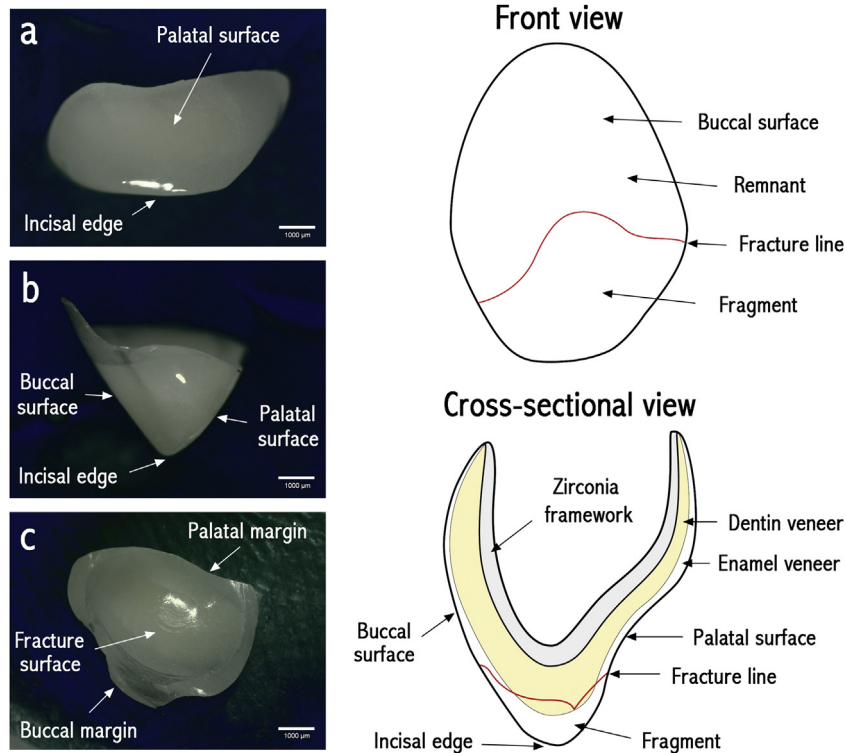
Optical and scanning electron microscopy (SEM-EDX) were used to analyze the piece. Optical images of the fragment are shown in different angles in Fig. 2. For better orientation, readers are referred to the diagram of an original structure (canine single-unit FDP) and the outline of the fracture edges and the internal fracture surface. On the fracture surface a distinct feature is observed some ~1 mm into the bulk (Fig. 3). This region in optical magnification reveals a circular convex plane that differs from the other planes on the fracture surface (note the variations in light reflection), and is delimited at the upper part by an angular border. An elongated flaw is located at the midline of this border and appears flat, smooth and shiny. By tilting the fragment the “outer veneer”, the “inner veneer” and the flaw seem to have distinct surface planes. The “outer veneer” formed a sharp angle with the external surface, whereas the plane of the flaw deviated from the “outer veneer” plane toward the y-axis (see Fig. 6 for coordinates). The fracture surface was scanned using a non-contact white-light optical profilometer (CyberSCAN CT 100, Cyber Technologies, Ingolstadt, Germany) to measure these angles (Fig. 5). The angle between the “outer veneer” and the external palatal surface was 55°, and the angle between the “outer veneer” and the flaw plane was 131°. This results in an angle of 76° between the flaw plane and the contact surface. The angle between the flaw plane and plane of crack propagation (“inner veneer” in Fig. 3) was 156°. Using the scan data the depth of the flaw into the bulk was determined to be 820 μm.

Fig. 2. Images (a–c) show optical microscopy images of the recovered fragment from different views. The reader is referred to the diagram on the right-hand side and to the legends for better understanding.

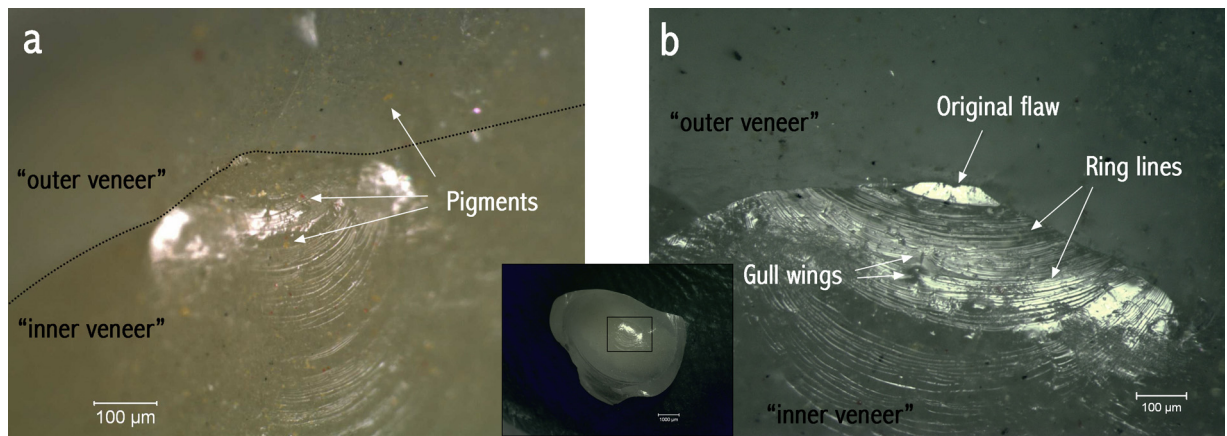
From the elongated flaw, concentric “ringing” lines developed inward to an extension of 1–1.5 mm (Fig. 3). These are *Wallner lines*, which form as ripples from the crack propagation event and indicate the primary direction of crack propagation. Figure 4 consists of a composite of several images from the gold-coated fragment to form a single focused image. The better contrast highlights the outer edges of the fragment and reveals a ~0.8 mm-thick flat margin around most of the fragment in a ~90° angle with the external surface. The inner edge of this margin circumscribes the concave region on the fracture surface. Further, Fig. 4 shows a composition of SEM images showing the palatal and the fracture surfaces of the fragment. On the palatal surface a track of occlusal wear is clearly distinguishable from the unworn surface, indicating the activity of antagonistic contact on the region of fracture. Moving down in the image, a hackle line connects the fracture originating flaw to the outer edge of the fracture. This is a resulting intersection line that formed in a second stage of fracture, when the crack path went around the origin site to complete the fracture (Fig. 6). The backscattered mode in the SEM revealed no difference between the “outer veneer” and the “inner veneer”. A close-up of the fracture initiating flaw is seen in Fig. 5b, and shows no particular material irregularity, but a flat surface measuring 48 μm in the short axis and 180 μm in the

Fig. 3. Optical microscopy images of the fracture surface showing the fracture origin site in magnification. Note the convex plane at the center. In (a) two regions are delimited above and below the upper border of the convex plane and designated “outer veneer” and “inner veneer”. Shade and translucency can be distinguished between these two regions. Yellow and red crystal pigments can be seen through the porcelain. In (b) the light source is made perpendicular to the plane of the origin flaw, which shows a flat and reflective surface. From the flaw downward, ring “Wallner” lines formed concentrically at the first stages of crack growth. (For interpretation of the references to color in this figure legend, the reader is referred to the web version of this article.)

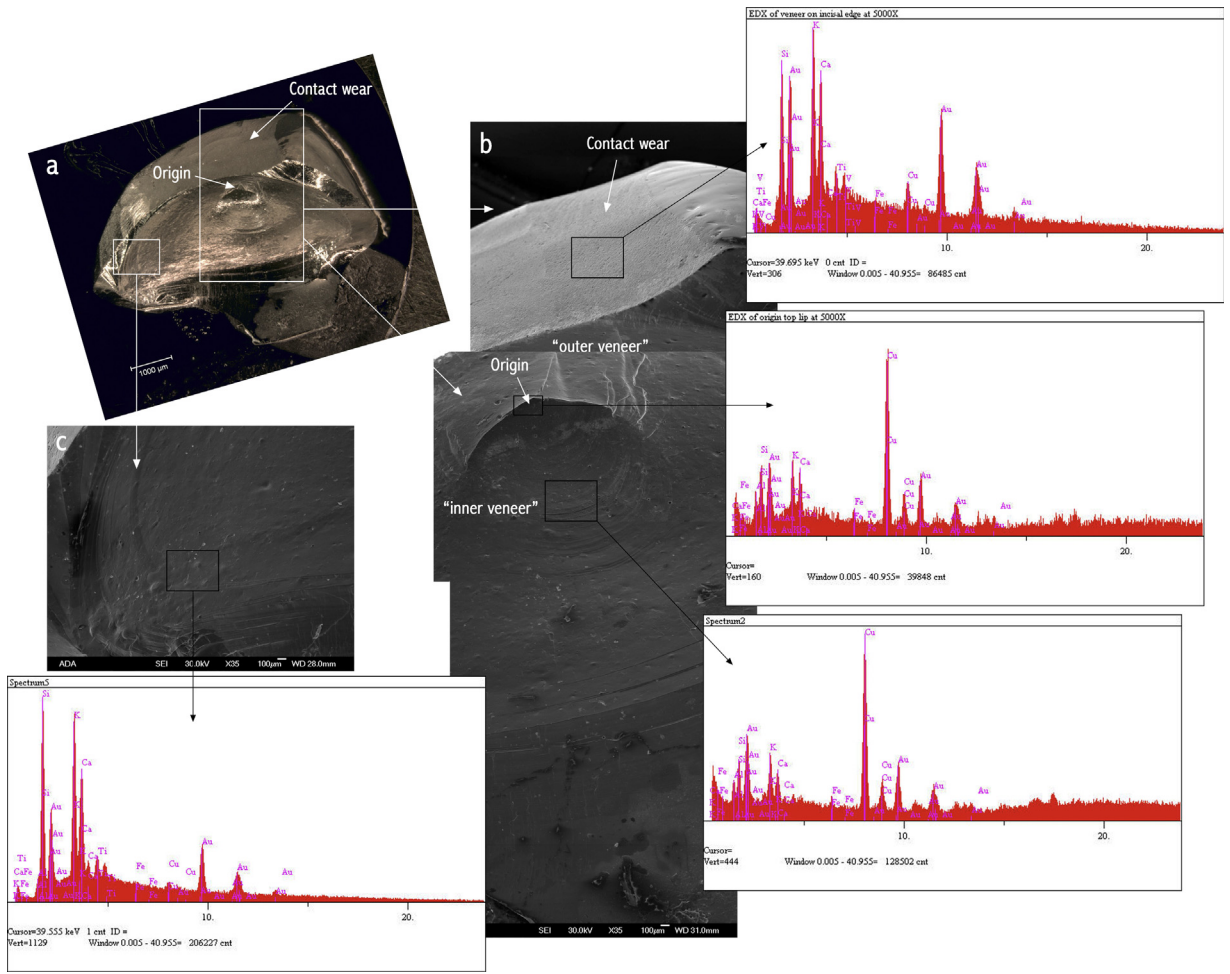
long axis, with sharp extremities. An EDX analysis was conducted on different regions of the piece, as seen in Fig. 4. Common elements for all areas were those typical for porcelain materials, such as Al, K, Si, and Ca. On the fracture surface in the “inner veneer” high amounts of Cu and Fe were found, elements that were scarce on the external surface of the piece, where additional traces of Ti were found.

Fig. 4. SEM images of the palatal and fracture surfaces of the fragment. EDX maps from different regions of the fragment are indicated accordingly. Note the presence of Cu on the “inner veneer” and its absence on the “outer veneer”.

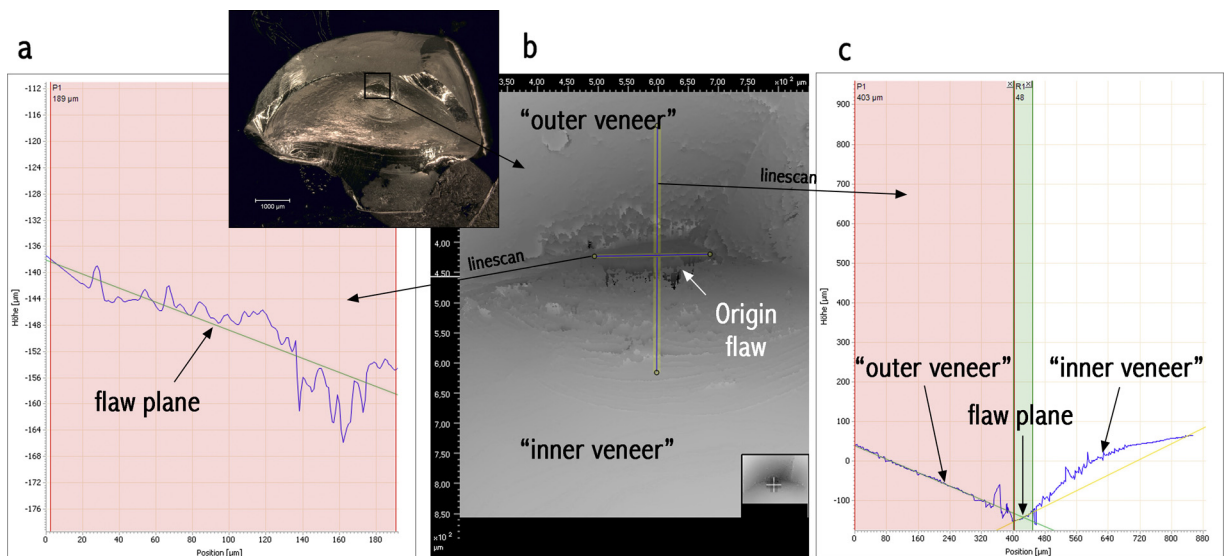
Fig. 5. Optical profilometry of the fracture origin site (b). Linescans through the origin flaw show the inclination planes in its long axis (a) and short axis (c). In (c) the angle between the “outer veneer” plane and the flaw plane is measured. Note the steep plane of the “inner veneer” in comparison to the flaw plane.

Hamilton [12]. The crack tip under mixed mode loading feels the tensile and the shear components of the stress, and deflects to a more favorable orientation from its original plane. According to some available fracture criteria for mixed mode loading, the crack propagates onto the direction perpendicular to the maximum tensile normal stress (maximum normal stress criterion [13]) or to the plane of the maximum energy release rate (maximum energy release rate criterion [14]), where the mode-II stress intensity factor disappears. From our measurements this plane formed a  $52^\circ$  angle to the palatal contact surface (Fig. 5).

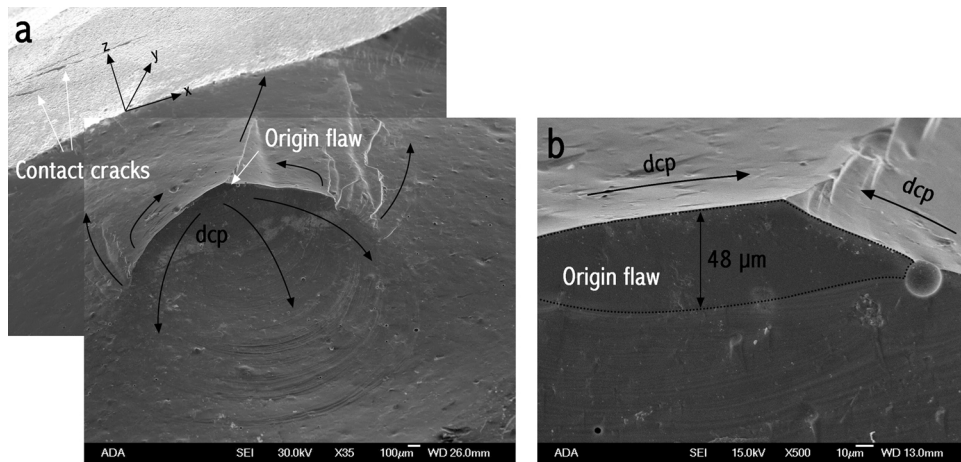
**Fig. 6.** SEM magnification images of the origin site (a) and the flaw triggering fracture (b). In (a) the direction of crack propagation (dcp) shows how the crack first propagated inward and only later outward to complete the fracture. In (b) the flaw morphology is to be observed. Note in (a) the spacial coordinates that help to put fracture planes in perspective. The “y” plane is the plane of the palatal surface, whereas the “z” plane characterizes the depth into the bulk.

FDPs? contact surfaces and triggering failure, but rather a thermally created flaw. Thermal cracks are usually very smooth and reflective. The fracture originating from this flaw first developed inward (into the bulk), and only outward (toward the palatal surface) in the last moments of fracture, when the crack completed a full-circle around itself. The location depth and the surface plane of the flaw in relation to the external palatal surface suggests that it may have been located between two layers of veneering material that were built-up and fired separately. Thermal stresses probably developed at the interface during this process. The fact that the EDX readings on the external surface and on the “inner veneer” resulted in slightly different compositions supports this hypothesis. The “inner veneer” contained high amounts of copper, which in the oxide form  $\text{Cu}_2\text{O}$  is a red pigment used in dental porcelains along with  $\text{Fe}_2\text{O}_3$ , for recreating the saturated yellow-brownish shade of the dentin tissue. In the optical image in Fig. 3a, a multitude of red and yellow spots are seen dispersed in the porcelain, probably the crystals of  $\text{Cu}_2\text{O}$  (red) and  $\text{Fe}_2\text{O}_3$  (yellow). The outer surface gave less readings of these elements, characterizing a more translucent material, usually used to mimic the milky opalescent dental enamel ( $\text{TiO}_2$  confers a whitish appearance). It is very unusual to find a fracture origin located at the interface between veneer layers. If our hypothesis is true, the flaw triggering the fracture originated during the laboratorial manufacturing of the piece as a result of the layering procedure.

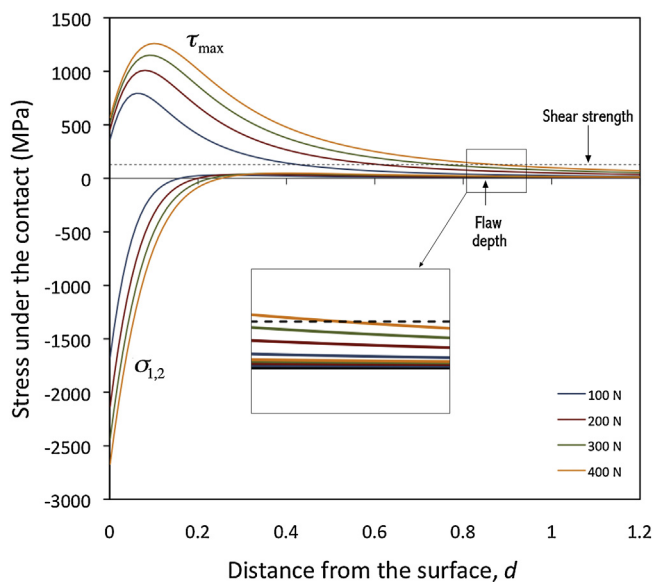
For a 100 N normal load, immediately under the indenter the principal stresses are compressive up to  $-1670$  MPa. At around  $160 \mu\text{m}$  from the surface  $\sigma_1$  and  $\sigma_2$  become tensile, and reach their maximum value of  $29$  MPa at around  $z = 250 \mu\text{m}$ . At the flaw depth ( $z = 820 \mu\text{m}$ )  $\sigma_1$  and  $\sigma_2$  decrease to  $6.3$  MPa, and  $\tau_{\max} = 37.5$  MPa. The maximum value of the shear stresses  $\tau_{12}$  and  $\tau_{23}$  are located at circa  $0.5a$  and reach  $794$  MPa.

Fig. 7. Plot of the unnormalized values (in respect to  $p_0$ ) of the Hertzian principal stresses  $\sigma_{1,2}$  and the shear stress  $\tau_{\max}$  along the z axis under the contact for different loads. Note at the flaw depth how the principal stresses are tensile approaching zero. The dashed line is the ultimate shear strength of the material.
