## Case Studies in Engineering Failure Analysis

## Metallurgical investigation of cracked Al–5.5Zn–2.5Mg–1.5Cu aluminium alloy valve

The high strength aluminium alloy Al–5.5Zn–2.5Mg–1.5Cu (AA7075) is being widely used in realisation of aerospace components. A component ‘fill and vent valve’ used in liquid propulsion system was fabricated from AA 7075 forgings in T7352 temper condition, and subsequently undergone various functional tests, four years back. Recently, during dye penetrant test after proof pressure test at 525 bar, a valve indicated presence of a crack. Detailed metallurgical investigation indicated that failure was caused by stress corrosion cracking.

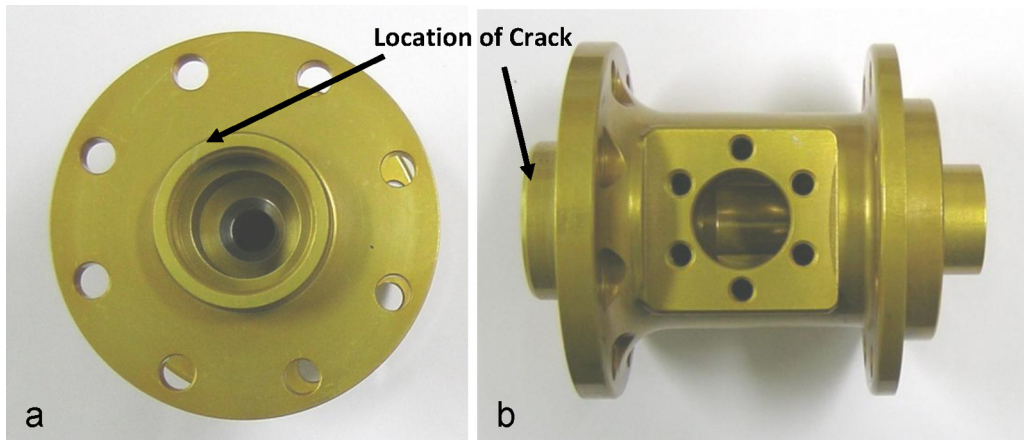
Fig. 1. Photograph showing the component (a) radial plane and (b) axial plane.

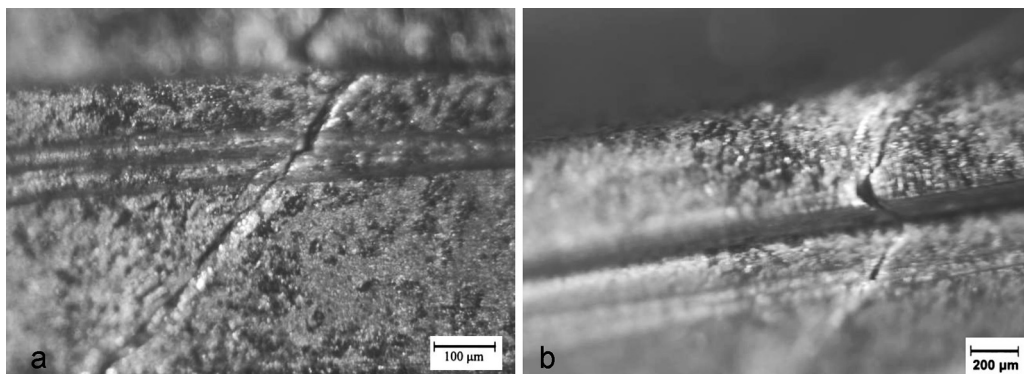
The crack was seen on a radial plane of component, coincided with short transverse plane of the forged stock used to realise the component. Crack propagation was confirmed to its axial plane. The cracked valve was observed under optical microscope with stereographic facility. Numerous corrosion pits were seen on radial as well as axial plane at the vicinity of the crack (Fig. 2).

Fig. 2. Stereo photomicrographs showing cracks on (a) radial and (b) axial plane with numerous corrosion pits surrounding the crack.

The component was anodised more than five years ago and after qualification kept in store. The presence of numerous pits on the valve face, especially nearby cracked region was indicative of anodised layer inability to prevent corrosion. The anodised layer was not intact throughout. There were many locations all along the crack, indicating devoid of anodised layer. It seems as if the anodised layer was mechanically damaged/or deteriorated due to long storage period, which facilitated corrosion to take place. In fact, under such condition the anode to cathode area ratio will be drastically low, resulting in very high anodic current density and in order to balance during the electro chemical reactions, the corrosion will be severe. Once anodised layer is broken, and corrosion initiated with high current density, its penetration through anodic Cu-depleted zones surrounding the precipitates at grain boundaries goes uncontrolled. Evidence of anodic dissolution at crack tip (Figs. 7b and 9b) and presence of dried mud pattern of corrosion product on fracture surface support this conclusion. Further, resistance of this alloy to SCC is inferior, when conductivity is on lower side of the band 38–40% IACS, that too with 0.2% PS on higher side. It is always preferred to use AA 7075-T7352 material with conductivity more than 40% IACS. In the present case, little modification in ageing temperature/time may yield conductivity more than 40% IACS with strength marginally above minimum required value. Further the time gap between final machining and anodising must be kept as low as possible.

1. It is desirable to use material in T7352 condition with conductivity more than 40% IACS. The ageing cycles may be modified accordingly.
2. Time gap between the machining and anodising should be kept bare minimum.
3. Components, if stored for longer period, adequacy of anodised layer should be ensured.

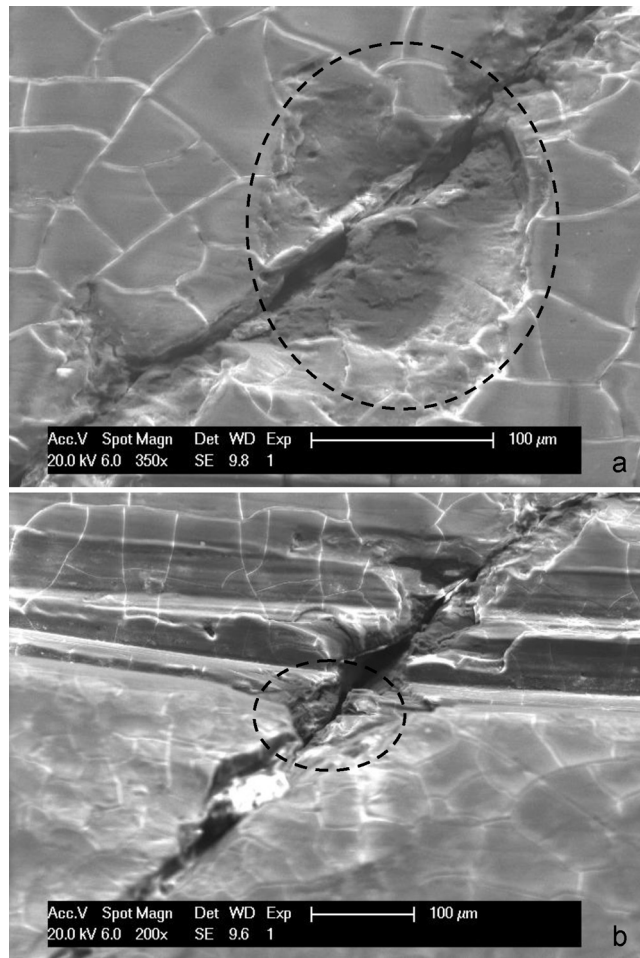
The cut pieces from the cracked valve were removed with utmost care and subjected to metallurgical investigation using optical and scanning electron microscopy to elucidate the cause of failure. All along the crack traverse at many locations on radial as well as axial plane, spalling of anodised layer was noticed (Fig. 3). Feature of corrosion underneath of loosely held anodised layer was also noticed as shown by arrow (Fig. 3a).

It was understood during the investigation that there were reasonable delay between final machining of component and their anodising.

Fig. 3. SEM photomicrographs showing (a) crack on radial plane and devoid of anodized layer, (b) crack on axial plane.

Further time gap between the machining and anodising was found to be reasonably high. Keeping machined component unprotected for such longer duration of 11–14 months is not desirable, as it may have deleterious effect and cause corrosion.

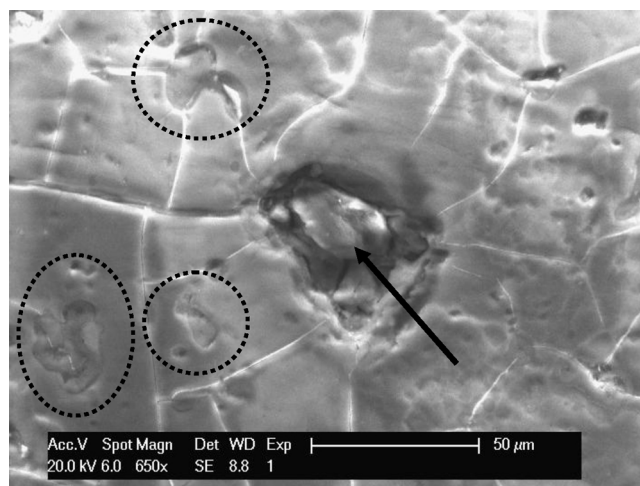
Pits nearby cracked region and the corrosion product within the cavity was seen (Fig. 4) on radial plane of component. There were few more additional locations, where corrosion initiated and resulted in minor pits, encircled with dotted line (Fig. 4). Similar was the observation at crack traverse on axial plane (Fig. 5). The axial plane of cut pieces removed from failed valve and consisted of main crack was polished using conventional metallurgical techniques. The polished specimen was viewed under SEM to study crack tip morphology. Few fine additional cracks running parallel to the primary crack was noticed (Fig. 6). At some locations such fine cracks had shown crack branching. The crack branching was confined to grain

Fig. 4. SEM photomicrograph showing the corrosion pits (shown by arrow) adjacent to the crack on radial plane and locations of corrosion initiation (dotted encircled).

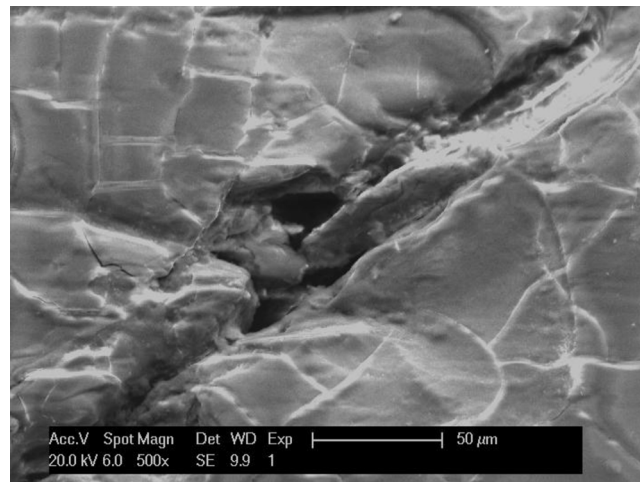
Fig. 5. SEM photomicrograph showing crack on radial plane with feature of grain dissolution.

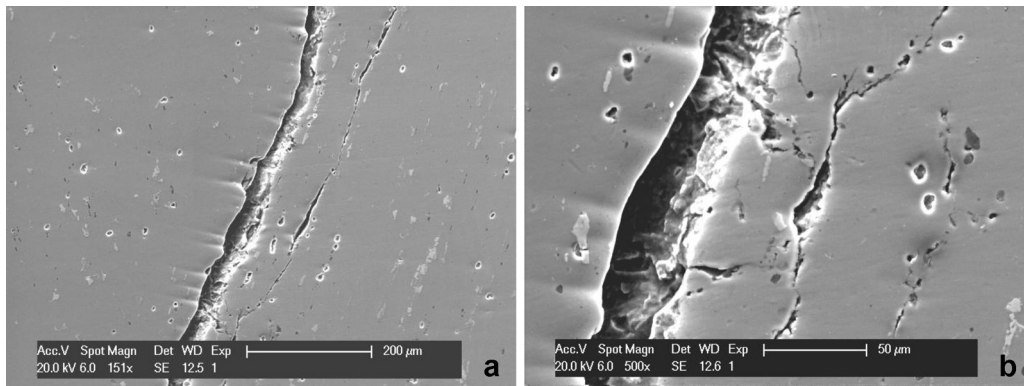
Fig. 6. SEM photomicrographs showing (a and b) multiple cracks running parallel to primary crack.

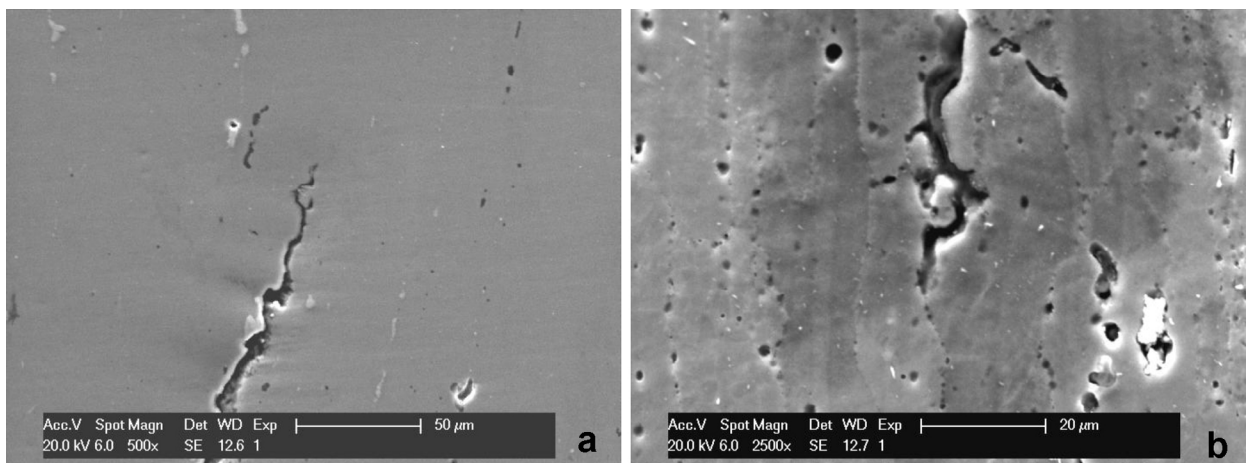
boundaries of recrystallised grains. There were spots (isolated) of preferential anodic dissolution sites. Crack tip was sharp and resembled features of as seen for traverse direction along grain boundaries (Fig. 7). The polished specimen, duly etched with Keller's reagent [2 ml HF + 3 ml HCl + 5 ml HNO<sub>3</sub> + 190 ml H<sub>2</sub>O] revealed crack propagation along grain boundaries. Features of crack branching were also seen (Figs. 8 and 9). Traverse of crack tip all along the grain boundaries was confirmed as shown in Fig. 9b.

Fig. 7. SEM photomicrograph showing crack tip, confirming dissolution product within crack opening.

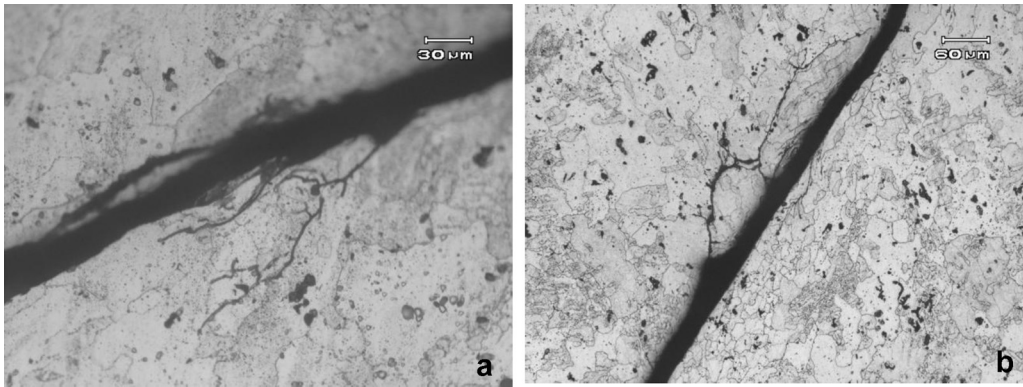
Fig. 8. Optical photomicrographs showing (a and b) crack branching along grain boundaries.

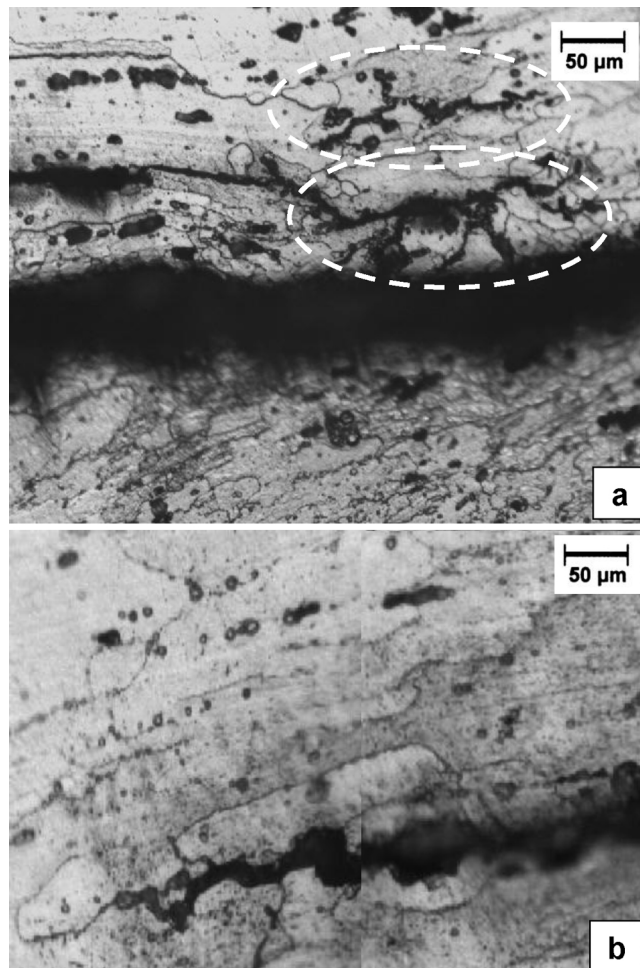
Fig. 9. Optical photomicrographs showing (a) multiple cracks running along parallel to primary crack and (b) crack tip traverse along grain boundaries.

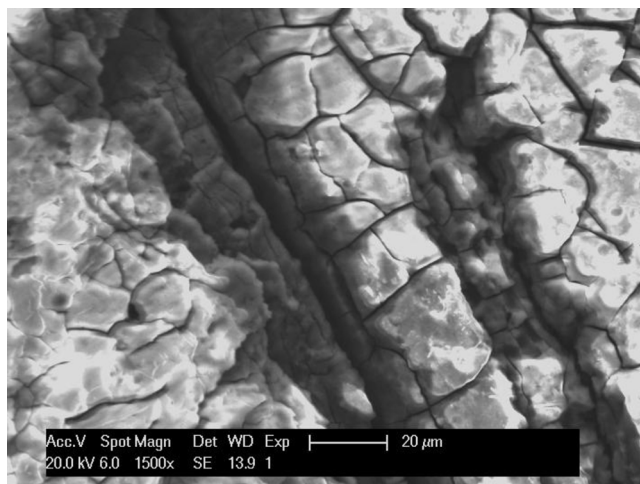
The fracture surface was opened carefully and observed under SEM. Fracture surface was fully covered with corrosion product, however presence of secondary cracks running parallel to each other was seen (Fig. 10) and was consistent with boundaries of elongated grains. Microstructure of region away from cracked region was seen on radial and axial plane. Longitudinal plane had elongated grains with grain aspect ratio of 12 and above. At many locations dried mud pattern of corrosion product (Fig. 10), typical of SCC [1] was seen at fracture surface. Electrical conductivity measurements were also carried out on the samples taken from the cracked component to ascertain whether the compression after solution treatment

Fig. 10. SEM fractograph showing dried mud pattern of corrosion product on fracture surface.

Cracking occurred on radial plane of component, which was short transverse plane of forged block used to realise the component. Crack penetrated in axial plane with its path along the grain boundaries and had its branching at many locations, leaving behind the dried mud pattern of the corrosion product on the fracture surface. Such evidences were confirmative for the cause as stress corrosion cracking (SCC).
