Physics Procedia 69 (2015) 636 – 645

10 World Conference on Neutron Radiography 5-10 October 2014

Non-destructive investigation of “The Violinist” a lead sculpture by Pablo Gargallo, using the neutron imaging facility NEUTRA in the Paul Scherrer Institute

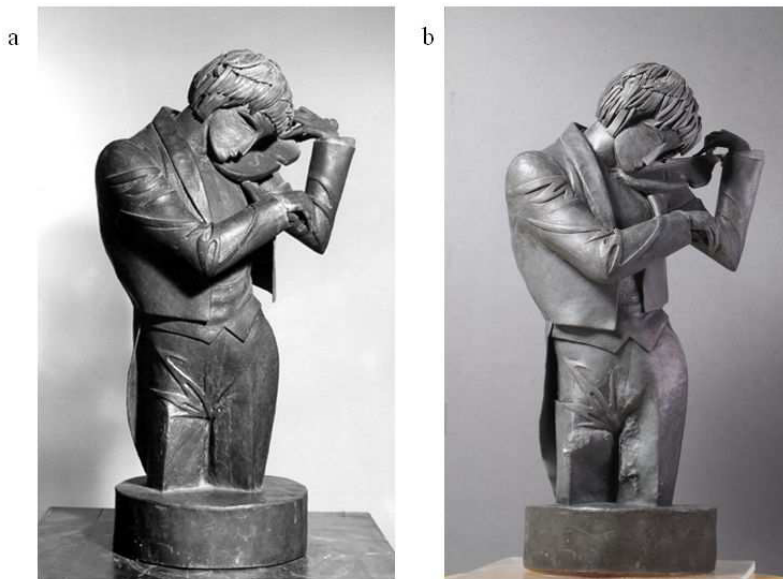
Fig. 1. Frontal views of The Violinist, by Pablo Gargallo: (a) picture taken between 1920-1924; (b) present state.

Due to its fragility, there have been some plastic deformations of the lead sheets together with splitting or broken solders caused by mishandling or shocks. These changes in the shape and position of different parts, noticeable by superimposing an old picture of The Violinist (Fig. 1a) to a recent one (Fig. 1b), affect the position of both hands and that of the locks of hair on the head, some of which are also broken or showing fatigue cracking caused by repeated bending. The tails of the swallow tailed suit which were originally stiff are now completely folded and adapted to the shape of the buttocks and legs.

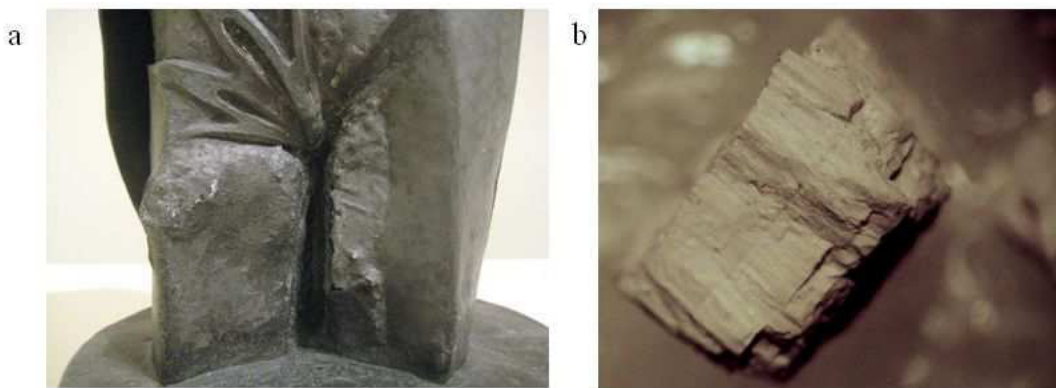
On the other hand, some years ago different swollen areas on both legs of The Violinist were noticed for the first time (Fig. 2a). With time these areas grew larger and higher, and began to open up while a white substance began to show through. In order to identify its composition different samples were taken from the swollen areas on both legs (Fig. 2b), filling with synthetic stucco the hole left by sampling. The results from the chemical analysis confirmed the presence of basic lead carbonate hydrocerussite. During the last two years there appeared more areas swelling up and the process seems to be speeding up. New blisters can also be found at the back of the neck, on the right shoulder, on the left hip and between both legs. The sculpture, which had been on show in the permanent

Lead and wood are two non compatible materials. Lead is often affected by corrosion when used in combination with wood (Graedel, 1994; Hallebeek, 1994; Tetreault et al., 1998). Lead can be attacked by emitted volatile organic compounds (VOCs) such as formaldehyde, formic and acetic acids coming from some timbers, polyvinyl acetate (PVA) wood-glue and medium density fibreboard (MDF) binders. These organic compounds, and specially acetic acid, transform lead into lead carbonate which is the white, granular powder we see showing through the blisters on the legs (Fig. 2b).

Fig. 2. (a) Plastic deformation on both legs due to advanced lead carbonate corrosion; (b) macrophotography of sample of lead carbonate taken from the blister in the left leg. The fine parallel lines grow with every new layer of lead carbonate formed most probably due to an increase in relative humidity.

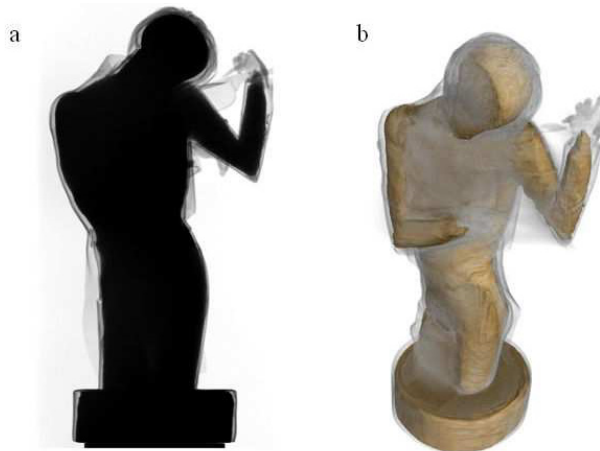
High resolution projections have been obtained showing quite a sharp image of the sculpture (Fig. 4a). The wooden core, visible for the first time as it is, appeared like a dark blob in the middle of the figure allowing the lead sheets to be seen only on the silhouette. It is along this silhouette where the features of The Violinist's lead suit could be studied.

Fig.3. (a) frontal view of The Violinist seen in a neutron radiography; (b) 3D reconstruction of the sculpture with inner wood core.

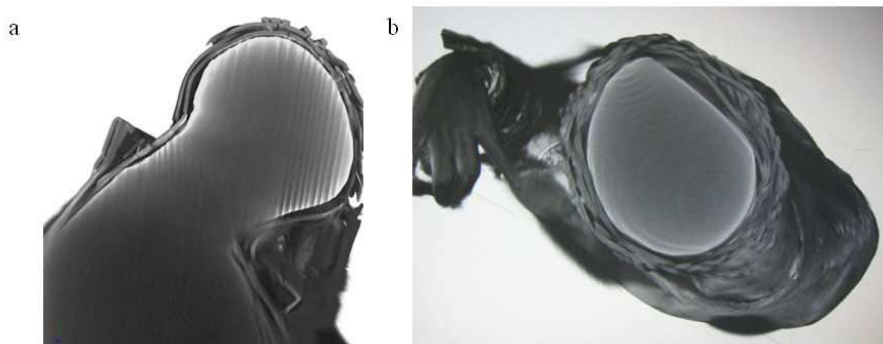
Fig. 4. (a) detail of the head and upper part of body cross sectioned in the 3D reconstruction; (b) the different lead sheets, nails and some wood grain can be identified.

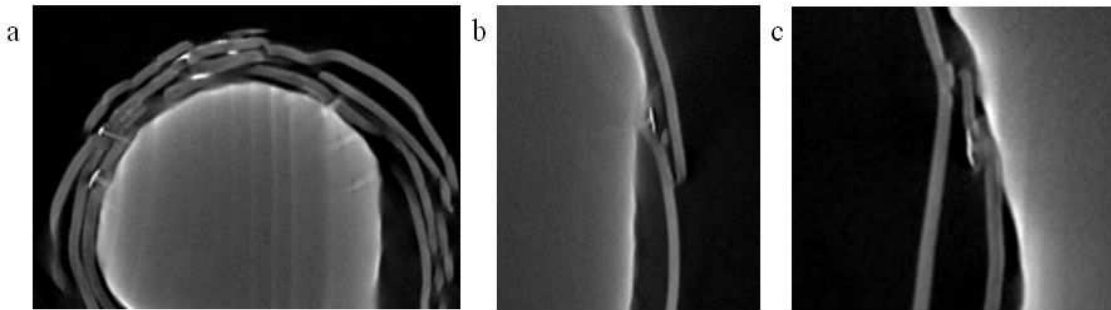
The high quality of images together with their good contrast have shown iron elements in the sculpture in a brighter grey tone, allowing them to be counted and even to recognize their shape. A total of 34 iron nails and tacks were hammered into the wood core to fix the main sheets of the sculpture in specific chosen spots that were covered by the following layer of lead (Fig. 5). These nails can be seen in the radiographs, the tomograms (Fig. 5) and in the 3D reconstructions. There are 21 nails and tacks and possibly one screw in the head (Fig. 5a). These nails can fix one to three layers of lead. In some cases it is possible to measure the length of the nail inside the wood core (Fig. 5a).

Fig.5. Details of fixing nails in tomograms: (a) in head; (b) in left hip; (c) on the back.

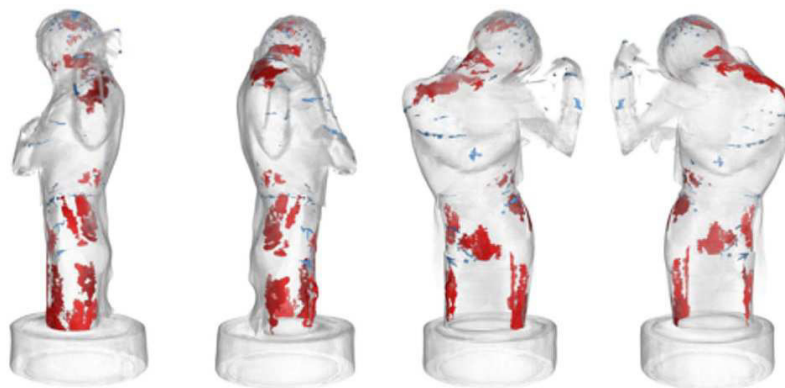
Fig. 7. Mapping showing corroded areas (in red) inside the lead sheet, remains of flux and nails (blue) according to the information given by the tomograms.

In tomography the lead carbonate layers appear as a fine white band attached to the inside of the lead sheets. They can sometimes be confused with the remains of flux in the soldering. The accurate and thorough analysis of the tomographic images can help us obtain quite an accurate mapping of the areas affected by carbonation (Fig. 7) and thus estimate the percentage of the total internal lead surface affected which is about 10 to 15%.

Thanks to the good resolution of the tomography images the thicknesses of both the sound lead and the thicker lead carbonate layers have been measured. The thickness of the lead sheets varies from 2,5 mm to 1,5 mm depending on the degree of hammering. Carbonation reduces the section of sound lead as the white lead carbonate crust builds up. Measurements of the lead carbonate layers range from 4×10^{-1} mm to nearly 2 cm in the blister on the right leg where no sound lead is preserved.

It is clear in the images that the lead sheets begin to show symptoms of plastic deformation only when the growth of the carbonate layer has reduced the thickness of the sound lead to approximately 25% which has happened now. Corrosion has been going on behind the lead sculpture from the very moment it was created in 1920 and with every rise of relative humidity a new fine layer has grown just on the interface with the sound lead. Today there are several areas on the sculpture beginning to swell and that means it will show more blisters in a relatively near future.

Thanks to the results obtained in this study, an appropriate strategy can be set in order to minimize the risks during the dismantling of the sculpture. Having information in advance about the condition inside the sculpture will also enable conservators to foresee the steps for future treatment.
