## Case Studies in Engineering Failure Analysis

## Case study

Failure analysis of a motor-car coil spring<sup>☆</sup>

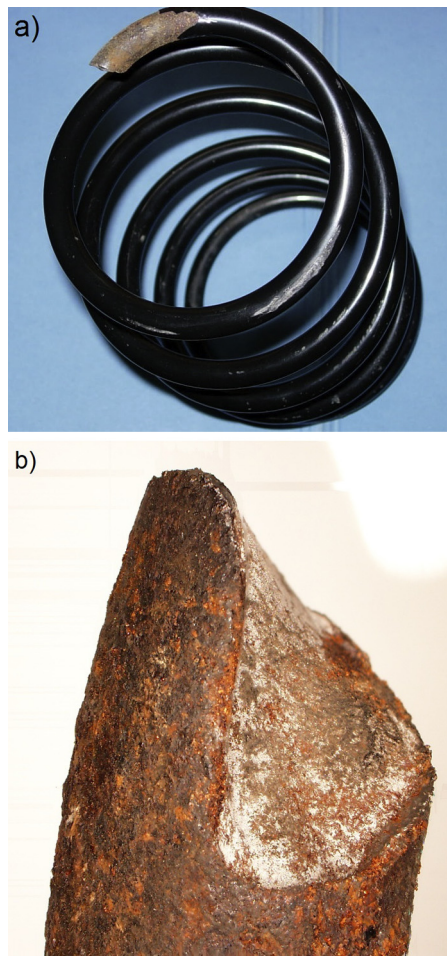
A motor car coil spring of a rear shock absorber has been ruptured during car operation. The surface of a spring was protected against corrosion with a thick layer of paint on polymer basis. Around the fracture surface, a protective layer was damaged and removed over a length of several centimeters. In this area, spring has long been exposed to corrosion attack and thus surface heavily corroded and wrinkled (Fig. 1).

Fig. 1. Damaged motor-car coil surface (a) and corroded fracture surface (b).

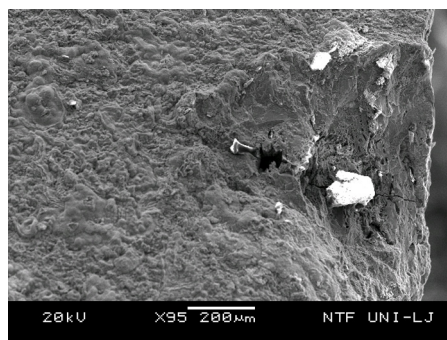
The fracture surface of a spring is discontinuous and in major part of it covered with fresh rust. On a minor portion of a fracture surface, a compact, dark brown rust (like on the circumference of the spring) is visible, which was formed substantially (months) before the final rupture of the spring (Fig. 2). From this part of the fracture surface, crack gradually propagated (the “arrest lines” are clearly visible), due to the combination of corrosion attack and cyclic loading during the car operation (Fig. 3), until the length of the crack reached its critical value, and the spring broke instantly (Fig. 4).

Rupture of the coil spring is considered as a failure due to corrosion induced fatigue. Corrosion fatigue caused simultaneous action of corrosion, due to damaged protective layer, and cyclic loading [1,2]. From one of the corrosion induced indentations, crack propagated through the material and led to the final rupture of the spring [3].

Fig. 2. The fracture initiation surface of a coil spring, covered with corrosion products and secondary cracks.

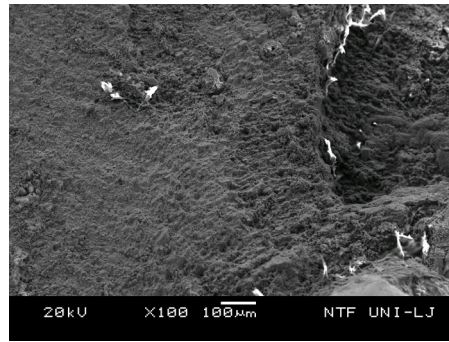
Fig. 3. Part of the fracture surface with a gradual crack propagation (corrosion induced fatigue).

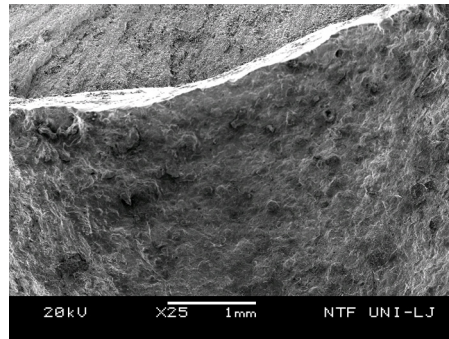
Fig. 4. Upper part of a fracture surface represents a termination stage of a fatigue where spring broke instantly and lower area corroded surface of the spring.

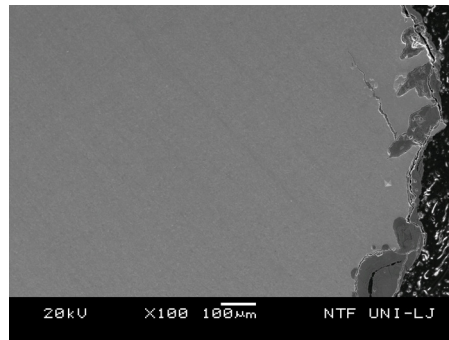
Part of the fracture surface, covered with thick, compact and dark rust is the primary crack, which was exposed to corrosion attack for months. Part of the fracture surface (Fig. 5), where a layer of compact surface rust and indentations of rust into the material are clearly visible represents a propagating stage of a fatigue and part of a surface (Fig. 6), which is covered with thin fresh rust (formed in a few days after final rupture) the terminating stage of the fatigue.

Fig. 5. Axial cross-section through fracture surface. Corrosion products are at the circumference and the fracture surface as in the indentations (secondary cracks).

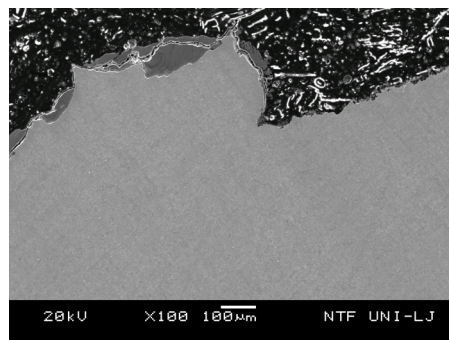
Fig. 6. The micrograph shows the boundary between propagating stage, with visible corrosion products and terminating stage of the fatigue fracture. Opposite side of the primary crack.

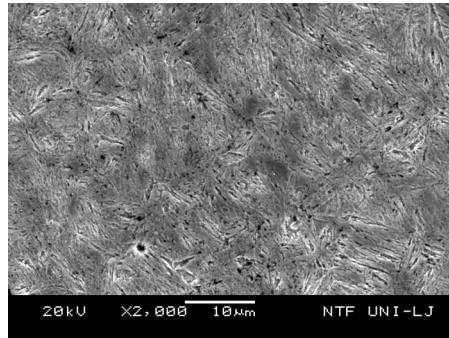
Fig. 7. Martensitic microstructure of the spring.

Steel was quenched and tempered to obtain martensitic microstructure with hardness of 520 HV–560 HV (49 HRC–51 HRC). There was found no evidence of any imperfection in the steel, which could be the cause of failure of the spring (Fig. 7).
