Case Studies in Engineering Failure Analysis

Analysis of internal corrosion in subsea oil pipeline

M.N. Ilman*, Kusmono

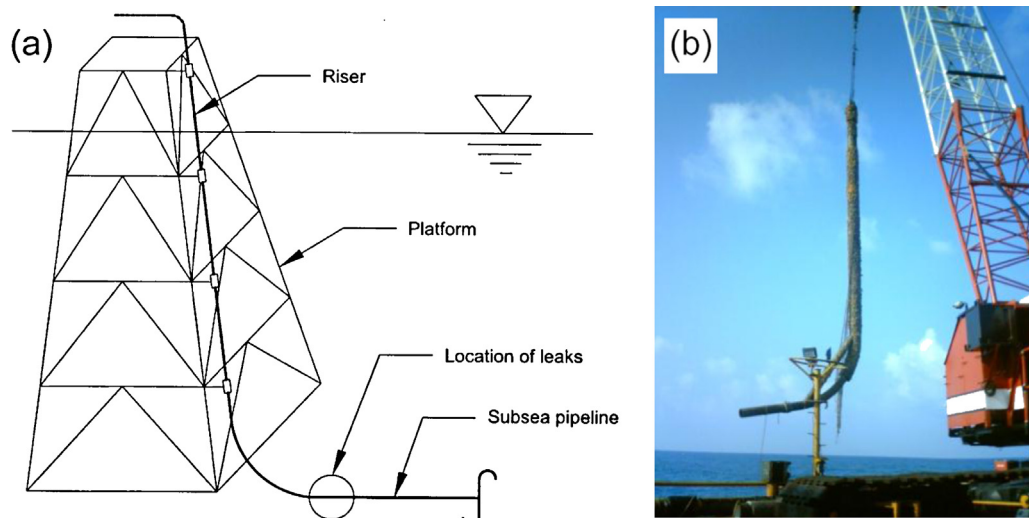
Recently, oil leaks have been reported to occur at a horizontal crude oil subsea pipeline after 27 years in service. A schematic diagram of the crude oil flow and the actual picture of the failed crude oil pipeline under investigation are shown in Fig. 1. During operation, crude oil was pumped from subsea wells into the horizontal pipeline. The crude oil then flowed out the pipeline directly into a long radius elbow section which turned the crude oil flow vertically allowing the flow to pass through a riser for further processing in platform.

Some oil leaks were observed at the bottom of the horizontal pipeline just before the flow entered the elbow section. No other areas of damage were identified during inspection. Details of the failed pipeline and its operating data are as follows.

Fig. 1. (a) A schematic diagram of subsea pipeline-riser configuration, (b) a view of the failed subsea pipeline.

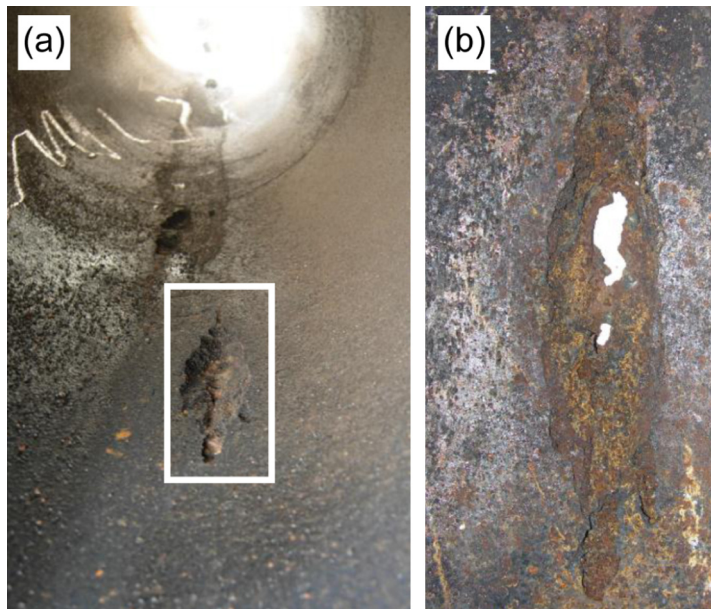
Fig. 2 shows visual examination results of leaks found in the pipeline. As is seen, the leaks were mainly observed at the inner surface of the pipeline. These leaks were nucleated locally at the bottom of pipeline (6 o'clock position) in the form of teardrop-shaped pits or grooves which elongated parallel to the fluid flow direction. This type of failure leads to hypothesis that the leaks are resulted from combined effect of electrochemical corrosion and fluid flow. However, this preliminary analysis needs to be verified by more detailed characterizations as shown later.

Fig. 2. (a) Leaks found at the inner surface of pipeline at 6 o'clock position, (b) magnified area outlined by square in (a).

Based on visual analysis, it can be seen that the leaks are in the form of teardrop shaped pits or grooves at the bottom of the pipeline (6 o'clock position) where water layers preferentially form. The absence of scales or deposits around the grooves suggest that the pipeline is locally attacked by flow-induced corrosion. Such corrosion initially produces brittle scales or rusts on the pipe surface exposed to the fluid. These scales act as barrier between the metal surface and the fluid so that further corrosion penetration is inhibited. Subsequently, the fluid flow causes the erosion process and the scales or corrosion products are periodically scoured from the exposed surface hence increasing corrosion rate along the flow direction.

Ferric hydroxide [$\text{Fe}(\text{OH})_3$] appears to be reddish-brown in color as shown in Fig. 2b. It seems that the $\text{Fe}(\text{OH})_2$ or $\text{Fe}(\text{OH})_3$ deposits resulted from corrosion reaction are then scoured from the exposed surface by the fluid flow hence increasing corrosion rate along the flow direction. As a result, the corrosion rate at the spread of corrosion downstream is higher than that of penetration and sideways. Such corrosion attack changes from pinhole shape, typical of purely corrosive attack to become teardrop-shaped pits or grooves.

1. Flow induced corrosion seems to be the main cause of leakages that occur locally at the horizontal subsea pipeline near an elbow section.
2. Combined effect of pitting corrosion and erosive flow increases corrosion rate along the flow direction resulting in teardrop-shaped pits.
3. The damage prevention options are suggested: first, prevent water separation by increasing oil flow sufficiently so that the pipeline surfaces are maintained oil wetted and secondly, give inhibitor injection into an oil pipeline fluid stream.

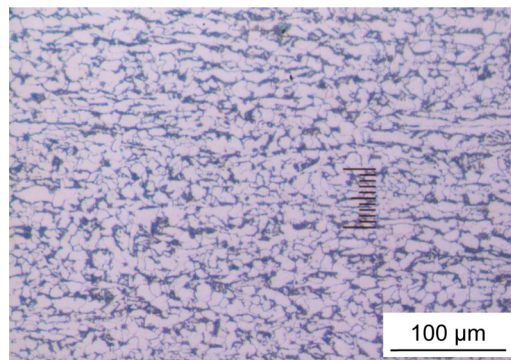
Fig. 3 shows an optical photomicrograph of the pipeline under study. It can be seen that microstructure of the pipeline is composed of ferrite and pearlite as commonly seen in low carbon steels. These fine grained ferrite and pearlite are elongated along rolling direction known as texture. Such microstructure can give high strength in steels via grain refinement according to Hall–Petch relationship and good impact toughness to meet stringent requirements of pipeline material.

Fig. 3. Microstructure of the pipeline under investigation.

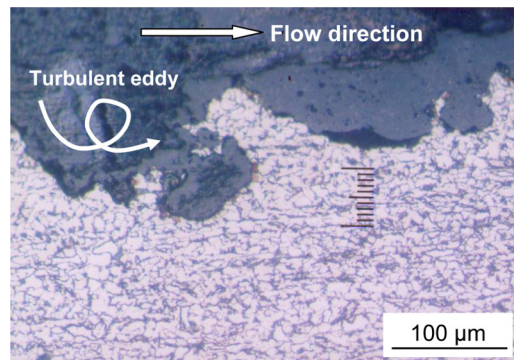
Fig. 4 shows a surface profile taken from longitudinal section of the teardrop-shaped pits. Based on the surface profile, it seemed that the crude oil flow produced undercutting in the downstream direction probably due to the presence of turbulence. The interpreted turbulent eddy is indicated by an arrow in Fig. 4.

Fig. 4. Surface profile of the pipeline along the flow direction.

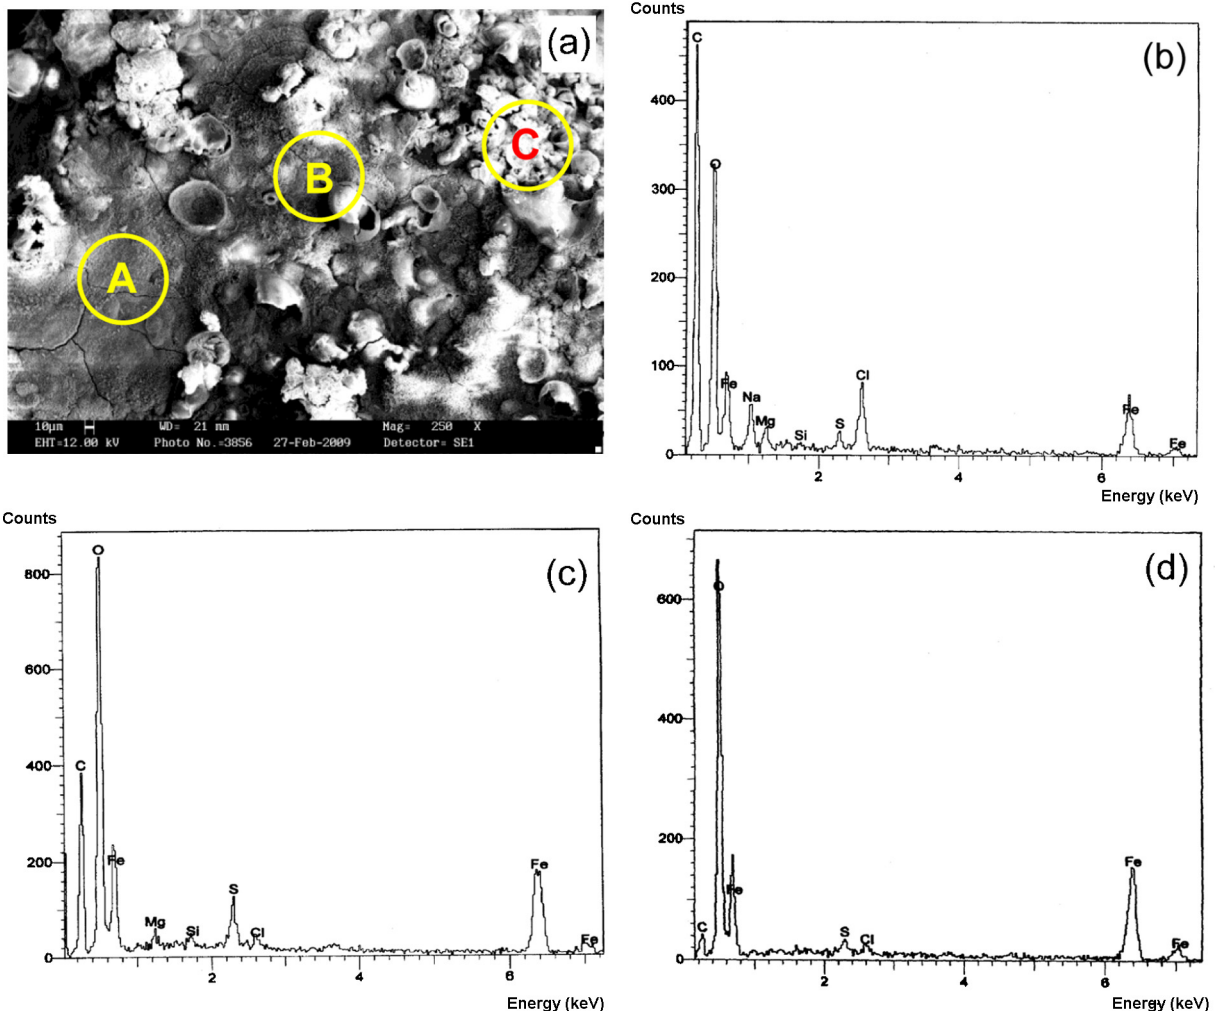
Results of SEM microanalysis on the corroded surface near corrosion pits are shown in Fig. 5a with the EDX-spectra are shown in Fig. 5b–d. It can be seen that the region marked A in Fig. 5a is the inner layer of corrosion product where this layer is directly in contact with the steel pipeline surface. EDX-microanalysis taken from this region reveals elements such as Fe, O, C, Cl with low levels of Na, Mg, Si and S (Fig. 5b) suggesting that this inner layer is in the form of FeOCl as a result of chloride attack on hydrated passive film (FeOOH). Region marked B in Fig. 5a seems to be intermediate layer and it is composed of mainly Fe and O with a considerable amount of S as shown in Fig. 5c. At outer deposit, i.e. the region marked C in Fig. 5a, oxygen easily comes into contact with the deposit and as expected, this deposit consists of mainly Fe and O (Fig. 5d), probably in the form of hydrous ferrous oxide $\text{Fe}_2\text{O}_3 \cdot n\text{H}_2\text{O}$ or ferrous hydroxide $\text{FeO}(\text{OH})_2$.

It seems that the chemistry of oxides change from metal-rich to oxygen-rich as the distance moves from metal-oxide interface (Fig. 5b) to outer deposits (Fig. 5c and d). These various corrosion products are consistent with the works reported by some researchers [4,5]. Of note is that C present in corrosion products probably comes from hydrocarbon and/or bicarbonate (HCO_3^-) whereas Cl is resulted from chloride ions (Cl^-) dissolved in water. The presence of S in corrosion deposits is likely associated with SO_4^{2-} in the water. Sulfate, SO_4^{2-} is anionic sulfur species in which S is fully oxidized state with the oxidation number of +6 and it is relatively unreactive.

Fig. 5. (a) Corrosion products at the region near leaks. (b–d) EDX-spectra taken from regions marked A–C, respectively, in (a).

The presence of Cl in corrosion product as shown in EDX-spectra in Fig. 5b suggests that the mechanism in which chloride ions destroy passive film is operative.

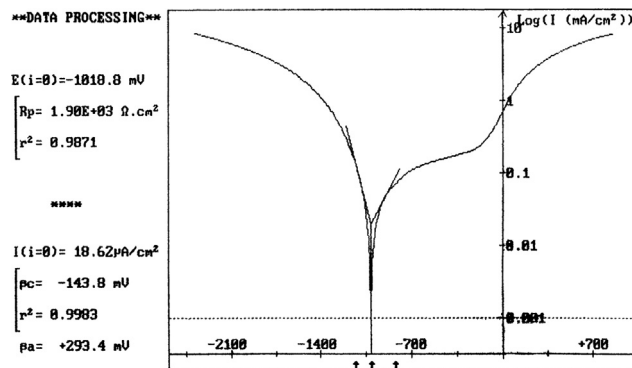
Fig. 6 shows polarization diagram (Tafel plot) for the pipeline from which the corrosion rate, given in steady state current density i_{corr} ($\mu\text{A}/\text{cm}^2$), can be determined. In engineering practice, corrosion rate (r) expressed in the form of penetration per

Fig. 6. Tafel plot for the pipeline in the water phase extracted from the crude oil.

where f is mass fraction of element in alloys. Results of corrosion rate calculation are given in Table 4. As it is demonstrated, the corrosion rate of the steel pipeline is $18.62 \mu\text{A/cm}^2$ or equivalent to 8.616 mpy (0.2184 mm/year) suggesting that the pipeline material has a good corrosion resistance. Of note is that the corrosion rate measured in the laboratory test would not be the same as that obtained from on-site observation due to the facts that in the laboratory test, the surface of corrosion specimen was polished with no fluid flow during the test and test temperature was lower than the actual operating temperature. However, from the view point of passivity behavior, the polarization test may give useful information on active-passive behavior of steel pipeline in aqueous environment.

Referring to Fig. 6, it can be seen that at the potential range of -700 to -175 mV SCE , the pipeline exhibits passivity presumably due to the formation of passive film [6,7].

Breakdown of passivity starts to occur at the potential of -175 mV SCE or higher suggesting that the steel pipeline has susceptibility to pitting corrosion. This type of corrosion could be linked to aggressive agents such as chloride which destroy the passive film locally and catalyze the liberation of Fe^{3+} according to [8]:
