The Finite Element Analysis and The Optimization Design of The Yj3128-type Dump Truck's Sub-Frames Based on ANSYS

Chen Yanhong, Zhu Feng

Mechanical and Electrical Engineering Institute of Kaifeng University, Kai Feng 475004, China

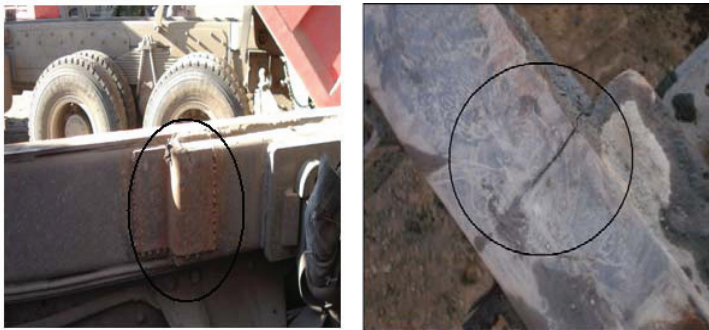
As the state's infrastructure investment increased year by year, the demand for heavy-duty trucks are also multiplying, China's annual demand of heavy-duty trucks is 95 million or more, and its annual growth rate is 15% or 20%. YJ3128-type dump truck is a Transport vehicles designed and manufactured by Inner Mongolia First Machinery Group Corporation and China North Mercedes-Benz Co., Ltd. It is formed by the main-frame, sub-frame, Cab, cargo box, the hydraulic lifting mechanism, engine, and gears. The sub-frame connected the main frame and the container, and increased strength and stiffness of the main frame, and lead to the main frame 's distributed load force. Therefore, the designing of the sub-frame has the important influence to the main frame's quality and service life. YJ3128-type dump truck's sub-frame is researched by the Co. itself, but after been used for 3-5 months, there will be cracking at the right side of the square beams and the turning point of the left stringer.

Figure 1 the fatigue crack of the sub-frame

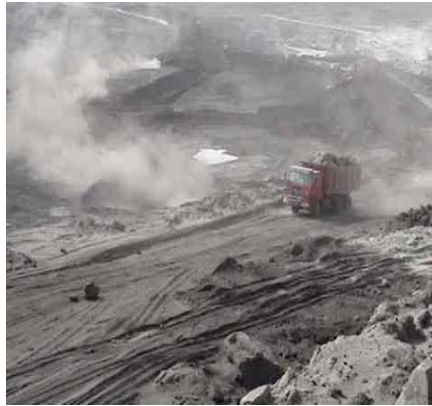
The YJ3128-type dump truck is the transport vehicle using in the field operation place such as mining etc., and Figure 3 shows the actual situation. The road is uneven, and there are many big stone on it. This will result in vehicles' one or more tires driving up and down. That is the main cause of the sub-frames' fatigue failure. So the lifting height of the frame is set for 20mm and 50mm, and the Analysis of bending moment and torque are conducted^{[1][2]}.

Figure 3 the conditions of the mining road

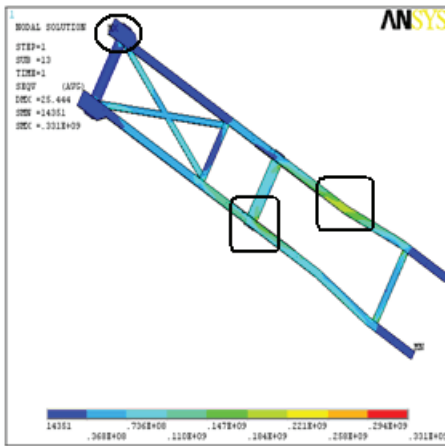
As is shown in figure 4, in this case, there were three relatively large stress: firstly, the maximum Von-Mises stress occurs in the final end of frame, it is 331MPa, exceeding the allowable stress of the material. So cracks would appear, and especially it may break at the welding place. Secondly, the stress is about 184MPa, at the right side of the square beams which is near the elevated rear wheel. Thirdly, the stress is about 184MPa, at the turning point of the left stringer. These two stress values are less than the allowable stress^[4].

Figure 4 the equivalent stress contours for 20mm

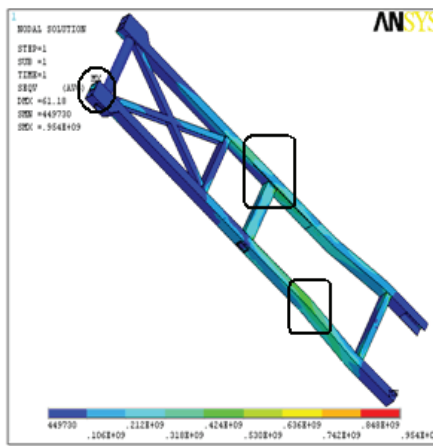
Figure 5 the equivalent stress contours for 50mm

As is shown in figure 5, in this case, there were three relatively large stress: firstly, the maximum Von-Mises stress occurs in the final end of frame, it is 954MPa, exceeding the allowable tensile strength of the material. The cause shall be the frames' irrational structures. Secondly, the stress is about 424MPa, at the right side of the square beams which is near the elevated rear wheel, and the value is also excessive. Thirdly, the stress is about 530MPa, at the turning point of the left stringer. There are also prone to be crack and even break, especially in the welds, the welding is prone to be open, leading to frame's failure.

Based on the above results of the sub-frames' analysis, under the joint load, the stress concentration is the greatest at the right side of the square beams and the turning point of the left stringer, and that is the main cause of the frames' fatigue failure. By analyzing, the following conclusions are drawn: The number of the beams the in front of the frames is small, and the one of the beams at end of the frames is large. The

large torsional stiffness causes the uncoordinated deformation. And the stress concentration appeared in the middle frame, and the two key points obtained by the above analysis are just in the neighborhood. They impede the generation of deformation, so the stress concentration deteriorate further. In short, the above mainly due to the frames' lack of torsional.

For the main reason of the crack is the lack of the sub-frame's torsional stiffness, a beam is added to the front of the sub-frame, as is shown in figure 6. And the upper surface of the block slope on both sides of the circular beam is turned into inclined plane, then it and the upper surface of the longitudinal are not in the same plane^[5].

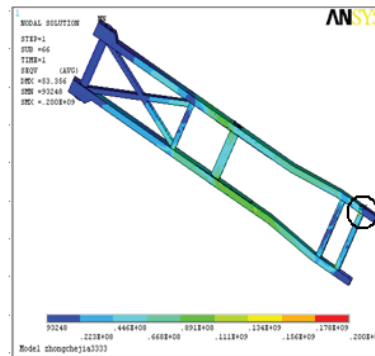
Figure 6 the equivalent stress contours for improved one

For the frame is damaged in the condition that it is raised 50mm, the analyzing results for the improved frame working in this condition are provided, as is shown in figure 7. Then the max Von-Mises stress is 200MPa, which is under the allowable stress of the material, and it occurs at the front beams. The stress at the right side of the square beams and the turning point of the left stringer is also reduced greatly, and it is only 50% of allowable stress. Therefore, there is no big turning transform in the improved frames, and the torsional stiffness is enhanced. No excessive stress concentration exists, and the bearing capacity is greatly improved. Thus it meet the design and use requirements.
