Case Studies in Engineering Failure Analysis

Root cause analysis (RCA) of fractured ASTM A53 carbon steel pipe at oil & gas company

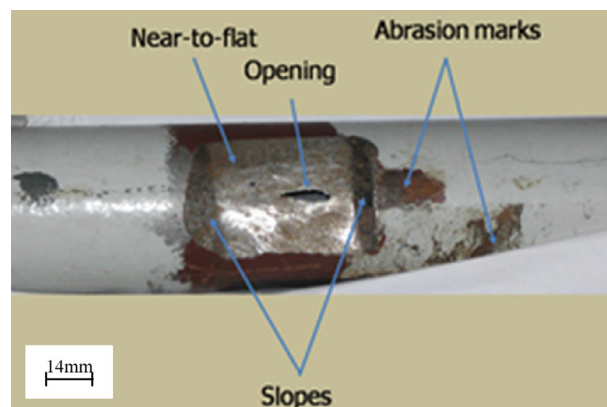
Visual inspections were carried out using photos and on the physical pipe specimen provided (Fig. 3). This pipe section was resting on the lower C-support. Failure areas marked on the failed specimen were cracked opening, abrasion marks, near-to-flat area and visible slopes on both ends.

Fig. 3. Portion of the pipe showing the failure area.

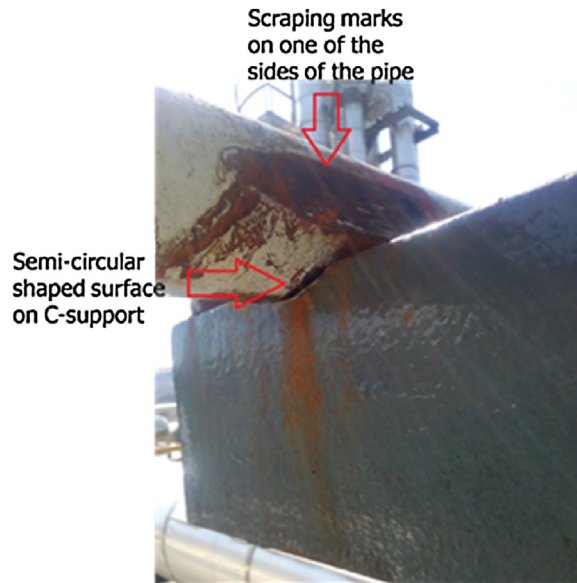
Fig. 4 shows actual location of the pipe portion that is resting on the C-support. The semi-circular shaped surface on this support is visible and indicates a material loss for both the pipe and the C-support.

In addition, minor corrosion and excessive scrapping marks on the sides of the pipe can also be seen. This situation further deteriorates the condition of the resting pipe.

Fig. 4. Actual pipe portion resting on C-support.

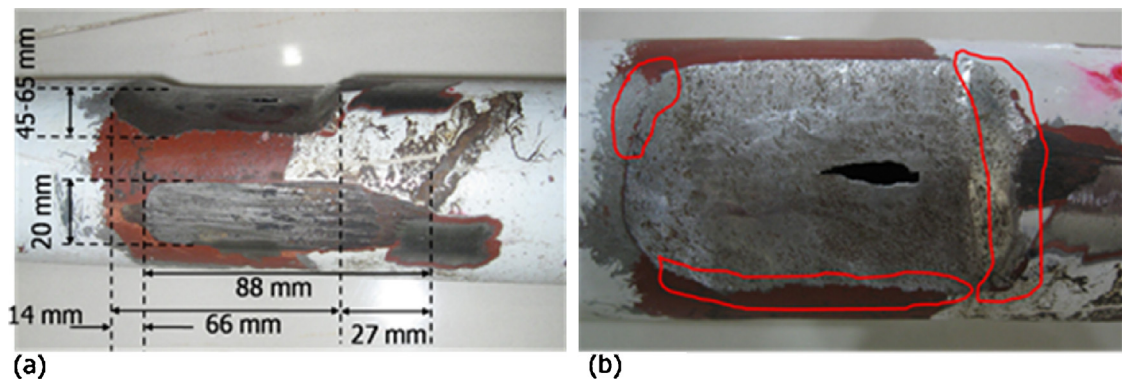
The carbon steel gas pipe was inspected externally and internally and photo-documented. Dimensional mapping was conducted and shown in Fig. 5a. The major failure area consists of approximately 45–50 mm in length of reduced section of pipe along with tapered edges on both sides of the cut. The depth of the reduced thickness portion varies from 3.1 mm to 4.3 mm on various locations, whereby, occurrence of the maximum thickness loss has led to the gas leakage from the opening. Moreover, it is also clear from Fig. 5a that the abrasion marks facing lower C-support and side support are not in line. Fig. 5b shows the presence of metal flakes around the boundary of the failure area. The direction of these flakes is towards outside with reference to the opening.

Fig. 5. (a) Approximate dimensions of the failure area resting on lower support and side abrasion region (Note: the smooth surface marks on right side are due to post failure lab work) and (b) metal flakes on boundary of the failure area.

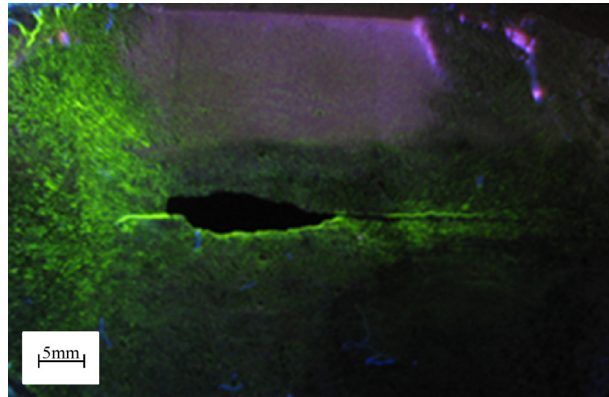
Fluorescent penetrant inspection (FPI) and magnetic particle testing (MPT) were performed on the fractured area of the pipe section. Fig. 6 shows the damaged pipe section under UV light during MPT. This proved that cracks have only initiated from the failed portion area due to the thickness loss and there are no further inherent defects.

Fig. 6. Fractured pipe area through UV light after magnetic particle testing (MT).

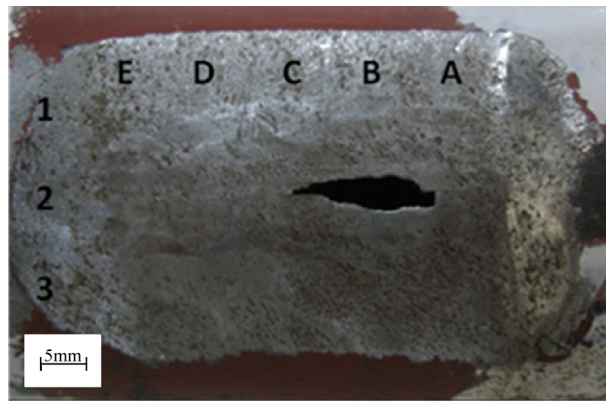
Ultrasonic thickness measurement (UTM) was performed for the fractured pipe section. The UTM results have shown marked variation in the thickness values at the vicinity of the fractured area. The thickness values vary from 1.48 mm to 2.91 mm. Marking plan and thickness variation are shown in Fig. 7 and Table 1 accordingly.

Hardness is affected by the levels of heat input and preheat used during welding. Table 2 shows hardness values (HRB) at selected locations of the failure region of the pipe. Apparently the unaffected portion has the highest hardness, 90 HRB, while it reduced to the minimum value of 64 HRB at failure location. Scatter of the measured hardness data is primarily attributed to the roughness of the eroded surface.

Fig. 7. Marking plan for UTM.

Table 1
Ultrasonic thickness measurement (mm) for fractured pipe section.

A	B	C	D	E
1	2.86	1.67	1.88	1.65	2.07
2	–	–	–	1.87	2.88
3	2.91	1.69	1.48	1.87	2.38

Table 2
Hardness numbers (HRB) at different locations of the failure region (cf. Fig. 7).

A	B	C	D	E
1	76	64	74	82	78
2	76	–	–	60	90
3	70	81	71	90	90

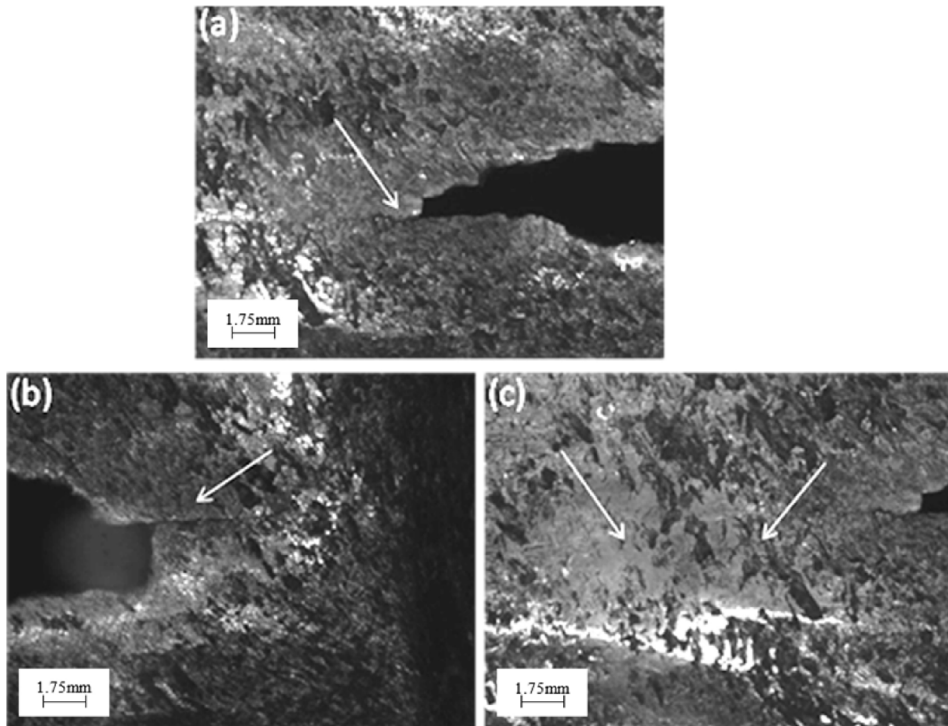
This task was carried out by examining the fractured area with stereo microscope. Fig. 8a and b shows that cracks nucleated from the edges of the opening due to post wall thinning nominal vibrations. Additionally, it can be seen that the surface texture of the failure area is a blend of shiny and uneven profile (Fig. 8c). Prepared specimen was also then examined with 200 \times magnification using Nikon optical metallographic microscope.

Fig. 8. Fracture surface analysis by stereo microscope.

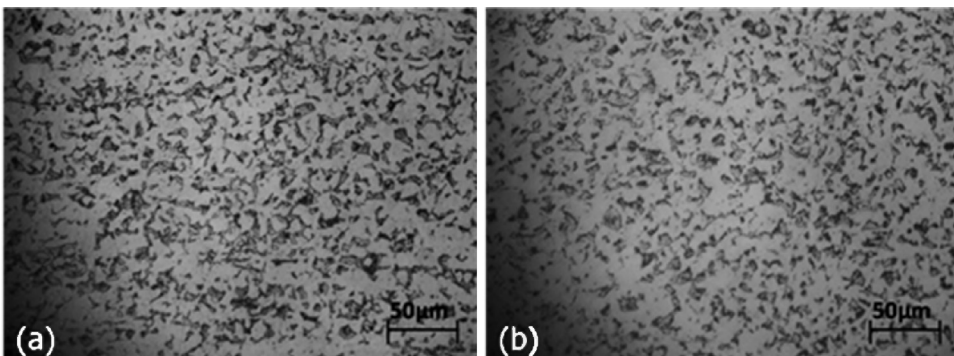
Examination of the microstructure at the failure region and the base metal location clearly indicate close similarity between both specimens that consist the typical ferrite and pearlite structure observed in carbon steels. There is also no evidence of micro fractures (Fig. 9a and b). These findings fully support the hypothesis that the pipe failed due to the increased turbulence caused by abrasive grindings and its adjacent regions and erosion-corrosion phenomenon was aggravated due to faulty workmanship erosion instead of corrosion.

Fig. 9. Optical micrograph of (a) fractured area and (b) base metal at 200 \times .

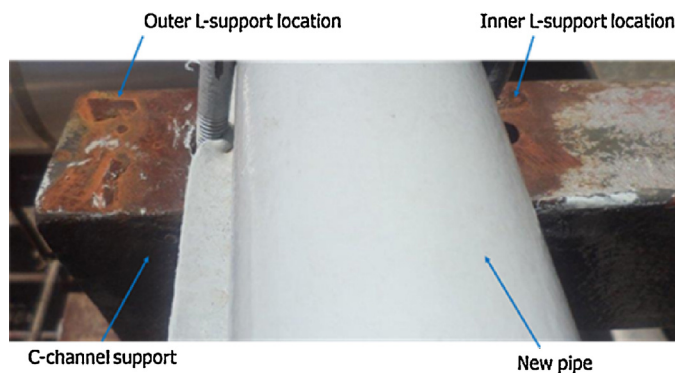
- i. In addition to pipe contact with the C-support, Figs. 10 and 11 show that the pipe was also in contact with inner L-support. This leads to a hypothesis that there may be significant amount of axial movement during the service. However, this theory was nullified by our earlier observed scrapping marks (Fig. 5a) on the pipe which indicates that the abrasion marks on lower and side facings on the pipe are not inline. This shows that any linear movement along the length of the piping during the service could not be the cause of failure. The reason is both motions should have been taken simultaneously.

Fig. 10. Actual location of the L-supports on C-support.

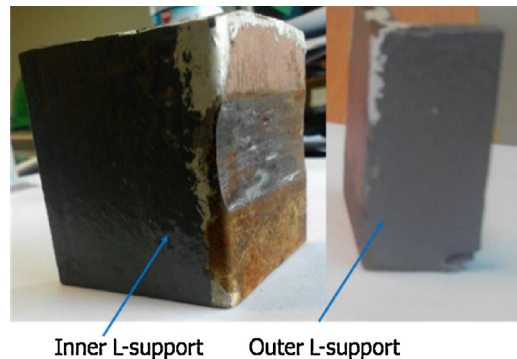
- ii. Based on the inspection results, it was observed that the failed surface does not indicate any metallurgical failure, and hence could be a foremost basis of failure. The surface texture on the main failure area shows grinding marks (Fig. 11). This leads to a conclusion that the main failure area on the piping could be due to manual grinding.

Fig. 11. Inner and outer L-supports.

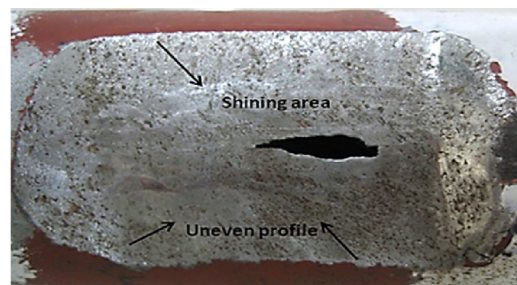
Fig. 12. Shining and uneven profile of failure area.

Shining and uneven profile of failure area can be seen in Fig. 12. It is also observed that pipe surface adjacent to the failure region was also excessively grinded, as shown in Fig. 13.

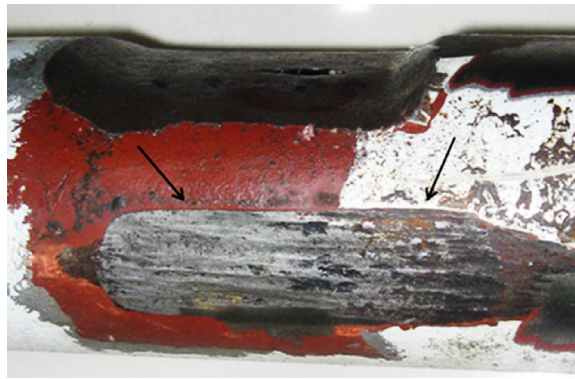
Fig. 13. Grinding marks on side surface of pipe.

- iv. The geometry and location of the excessive grinding at the failure and its adjacent regions of the pipe, base area of the C-channel and L-shaped side supports, clearly indicate that these grindings might have been performed to accommodate the pre-installed piping spool to avoid the alteration in pipe position to sit properly on support.

Based on the above, it is recommended that during installation/fabrication of piping system, proper procedures may be implemented, followed by visual inspection through qualified inspector(s) including pre-service and in-service inspection.
