Case Studies in Construction Materials

Diagnosis of the surface layer damage in a 1960s reinforced concrete building

This work aimed to determine the degradation causes of the Palace of Public Works located in S. Giovanni square in Turin (Piedmont, Italy). The samples collected from the surface layer were characterized by means of scanning electron microscopy (SEM), X-ray diffraction (XRD), thermogravimetric coupled with differential thermal analysis (TG-DTA), mercury intrusion porosimetry measurements (MIP) and phenolphthalein test. Metallographic and elemental analyses were also carried out on the steel reinforcing bars. An exhaustive picture of the main causes of deterioration was drawn in order to design the intervention of rehabilitation.

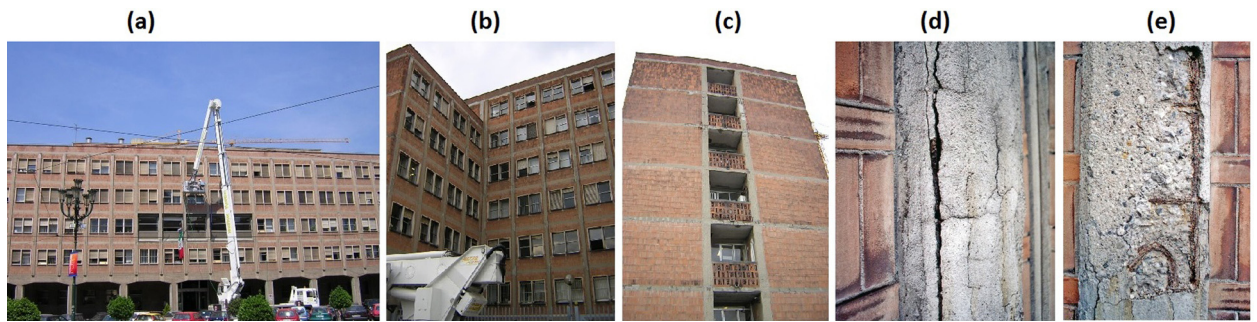
Direct exposure to weathering and air pollutants involved soon damage to concrete pilasters and facing bricks. During 42 years, numerous patches and repairs were carried out, without never facing the problem in depth. In 2004, the state of degradation of the Palace of Public Works was widespread throughout the building: it was considerable in the eastern and western façades and very marked in the northern elevation (Fig. 1, suppl. mat.), but was minor in the southern façade. Sometimes, concrete covers were easily removed manually (Fig. 1d and e) (sample 11 – Table 1). Steel reinforcing bars showed a variable state of corrosion, sometimes very pronounced, with a certain loss of structural integrity, while in other areas they were not corroded at all. Regarding facing bricks and brick laying mortar, the most diffuse degradations were lacunas, pulverization, delamination, cracking, presence of efflorescences, patina and black crusts, dissolution and leaching of mortar between brick courses and the presence of salts inside the masonry (Fig. 2, suppl. mat.).

Fig. 1. Palace of Public Works in S. Giovanni square (Turin-Italy): eastern (a) and northern façades (b–e).

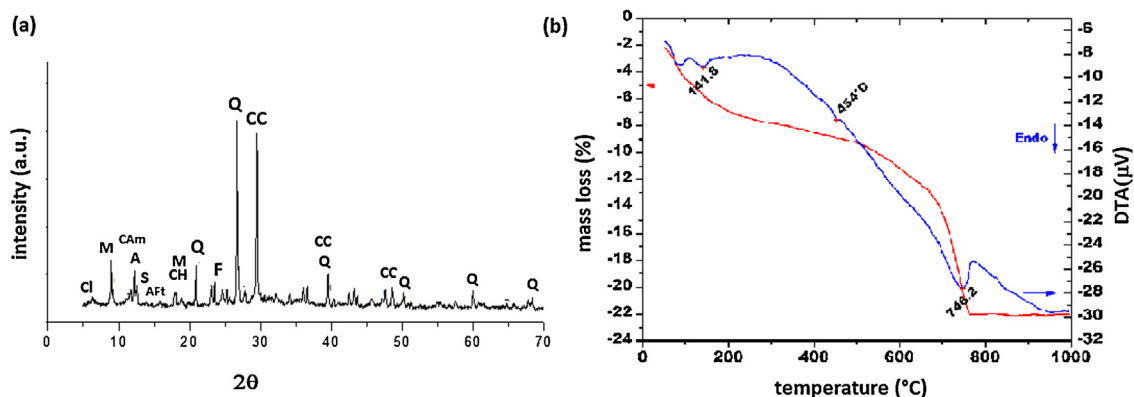
DTA analysis performed on core 7 indicated the presence of ettringite (endothermic peak at 141.8°C), of calcium hydroxide (CH) (endothermic peak at 450°C) and of calcite (endothermic peak at 746.2°C) (Fig. 2(b)). The mass loss relative to the endothermic peak at 141.8°C was relatively low (1.16%). These results confirmed XRD data.

Fig. 2. Sample 7: (a) powder diffraction pattern: A = antigorite, AFt = ettringite, CAm = calcium mono-carboaluminate hydrate, CC = calcium carbonate (calcite), CH = calcium hydroxide, Cl = chlorite, F = feldspar, M = mica, Q = quartz, S = serpentine; (b) TG-DTA curves.

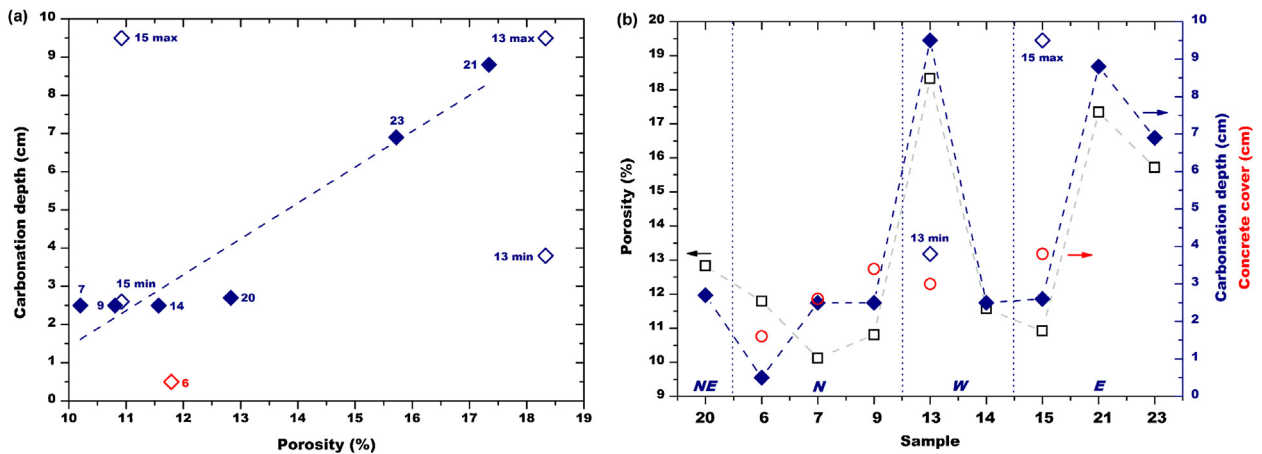
Fig. 3. (a) Carbonation depth versus total open porosity; (b) total open porosity, concrete cover thickness and depth of carbonation versus sampling point orientation.

A variable carbonation depth was observed, depending on sampling points, on the presence of plastered coating made during maintenance operations (core 6) and of macro bubbles and cavities (cores 13 and 15) (Fig. 3, suppl. mat.). A maximum carbonation depth of 95–100 mm was recorded for samples, 13, 15 and 28 collected from western and eastern façades, respectively, while a minimum carbonation depth (5 mm) was recorded for sample 6, presumably due to the presence of a protective plastered coating of about 2 cm made during maintenance operations (Fig. 3c, suppl. mat.). A comparison between the trends of the carbonation depth and of the total intruded porosity pointed out a correlation between these parameters (Fig. 3(a)), except for core 6. Cores 15 and 13 showed a non-uniform depth of carbonation, for this reason the minimum and maximum values of carbonation depth were reported separately in Fig. 3(a) and (b), without calculating the average value. The measured thickness of concrete cover ranged between 2 and 4 cm (Fig. 3b). Some of these values are below the minimum value (3 cm) required by the current Eurocode N2 (EN, 2004), but this standard is more recent (1992) than the construction of the building.
