Procedia Engineering 156 (2016) 219 – 226

9th International Conference „Bridges in Danube Basin 2016“, BDB 2016

The road steel bridge over Bosut river in Serbia Part 1: The assessment of the bridge

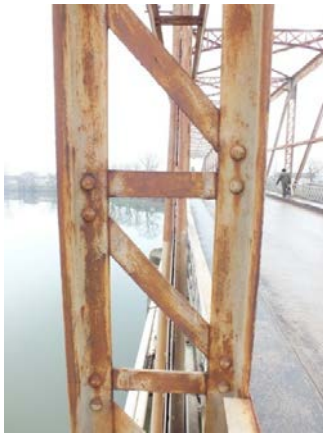
Fig. 2. Surface corrosion

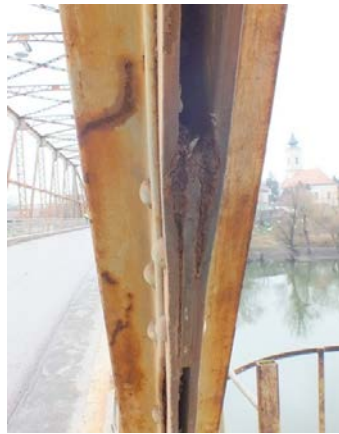
Fig. 3. Delamination and spalling of steel due to corrosion, swelling and expansion of steel profiles

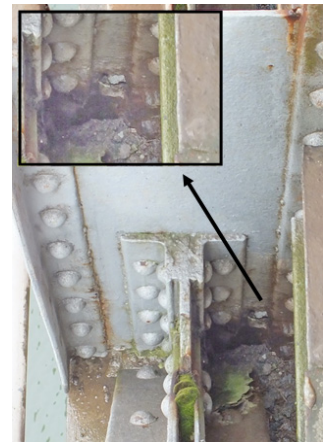
Fig. 4. Corrosion in the lower parts of the elements due to water retention and a layer of moss between the steel sheets, hole on the steel sheet

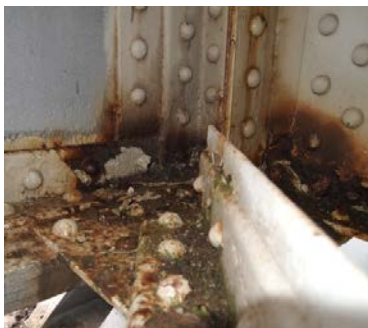
Fig. 5. Corrosion at the junction of main longitudinal and main transverse girder, reduction of cross section of steel profiles

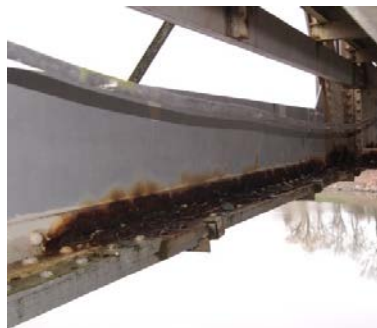
Fig. 6. Appearance of transverse girder, corrosion in lower part of vertical steel sheet

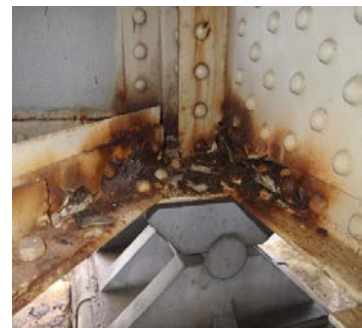
Fig. 7. Appearance of the supporting zone, corrosion

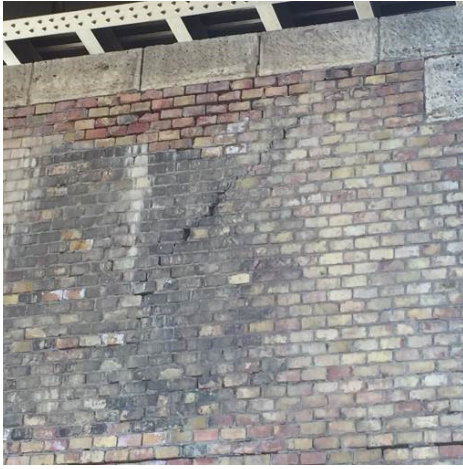
- Aslope cracks and horizontal crack (Figure 8),
- Rinsing of the mortar from the horizontal and vertical joints (Figure 8),
- Falling of brick parts (Figure 9),
- Salt crystallization (Figure 9),
- Biological corrosion – moss.

Fig. 8. River pier, cracks, mortar rinsing

It is necessary to immediately take appropriate measures, in order to bring the load bearing structure in a technically correct and functional condition, with satisfactory durability during future exploitation. Works on the rehabilitation and revitalization of the bridge structure include replacement of all parts of steel load bearing structure affected by severe corrosion processes, complete cleansing of the bridge structure from surface corrosion and protective coatings applications. Also, it is necessary to restore the function of bearings in the zones of coastal supports, to repair cracks formed in the river pier, and to eliminate cracked wing walls and to executed new ones.

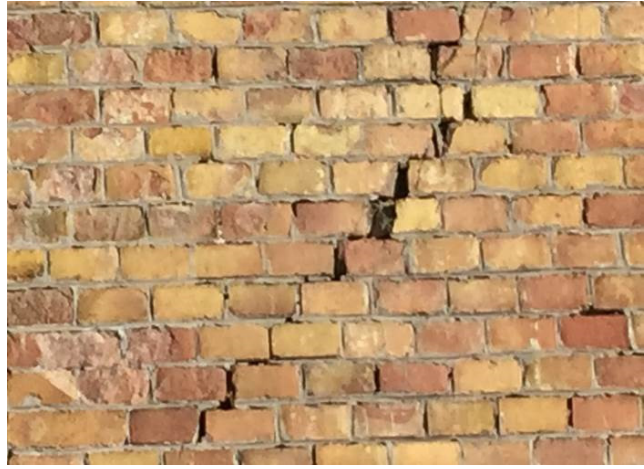
Fig. 9. River pier, aslope crack, crushing and cracking of brick elements

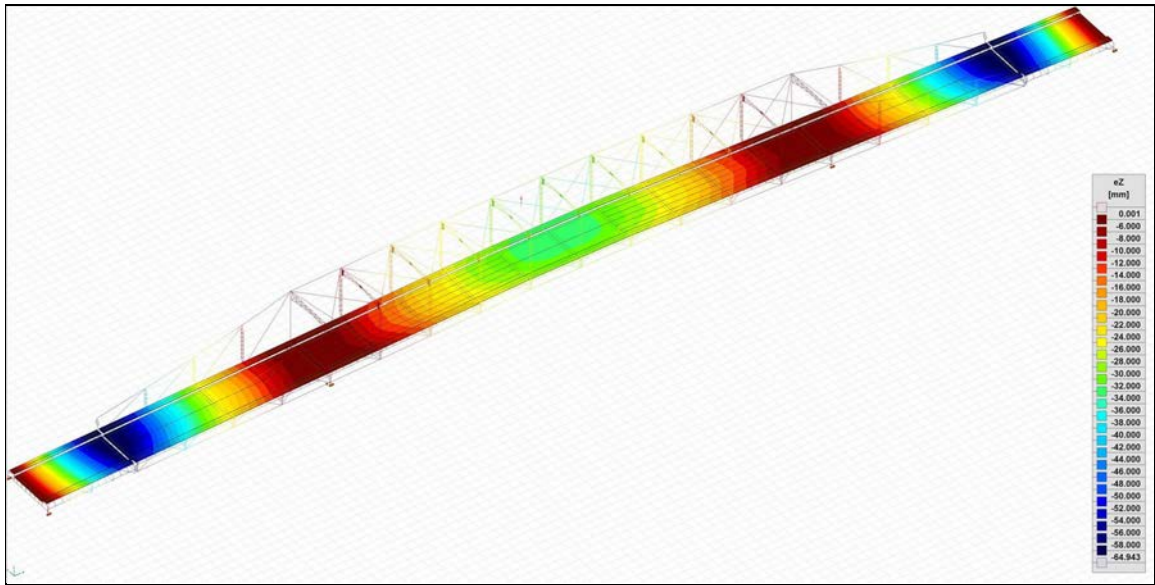
From the span/deflections ratio (Figure 14), it can be concluded that deflections are in the proper limits if spans are considered as distance from support zones. But if spans are treated as distance between discontinuities points of the deflections lines/areas, parts of the bridge which consist approach and cantilever structures don't satisfied requests of needed serviceability state.

Fig. 14. Vertical displacements envelope ($\delta_{\max}=-64.9\text{mm}$)

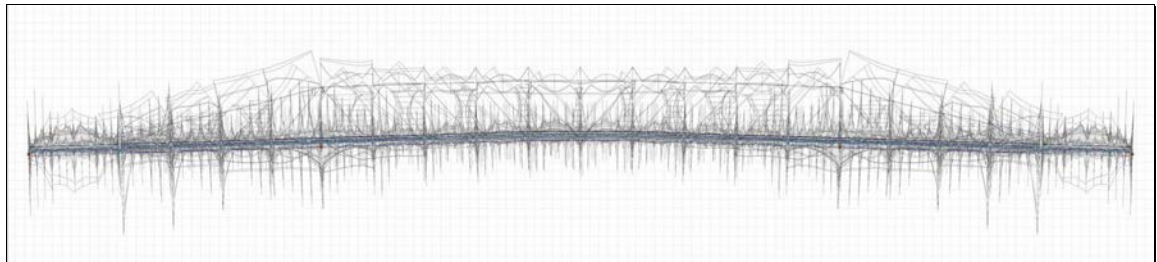
Significant excess of stress limits as well as distribution of zones with these excess ($\sigma_{\max/\min} = -247.9\text{ MPa}/192.2\text{ MPa}$) are indicative (Figure 15). These zones, between hinged joint of approach/cantilever connection and nearby column in the river, can be treated as critical according to criterion of need for rehabilitation or reconstruction. As this level of stress excess refers to permanent and traffic loads only (50 %), it is not necessary to check bearing capacity for other possible loads. In the next phase of project (rehabilitation and/or reconstruction) numerical analysis will be performed for these additional actions. Top and bottom chord members and web members (vertical and diagonal) of in the main span as well as deck plate had acceptable stress values.

Fig. 15. Envelope of compression/tension axial stresses ($\sigma_{\min/\max}=-247.9\text{MPa}/192.2\text{MPa}$)

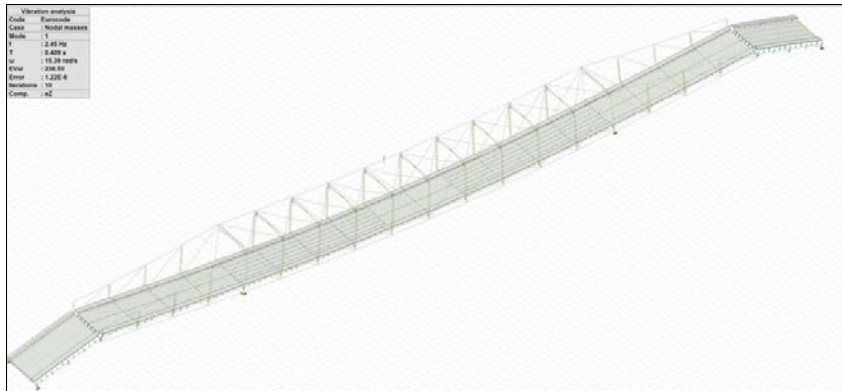
Range of frequency for the first six form of free vibrations (from 2.5 Hz to 5.5 Hz) designates to possibility of appearance of vibration beating which is unpleasant phenomenon for the fulfillment of a serviceability state especially in the case of pedestrian traffic (Figures 16-17).

Namely, hinged connection between approach and cantilever parts causes discontinuity in the angle of structural elements jointed in the hinge what could be cause of dynamical excitations (shock vibration) in the transition of heavy vehicles from the approach to cantilever. Also, this disagreeable phenomenon can be resolved by proper structural repair in the rehabilitation/reconstruction phase of this project.

Fig. 16. First form of free vibrations ($f_1=2.45\text{Hz}$, $T_1=0.41\text{s}$)

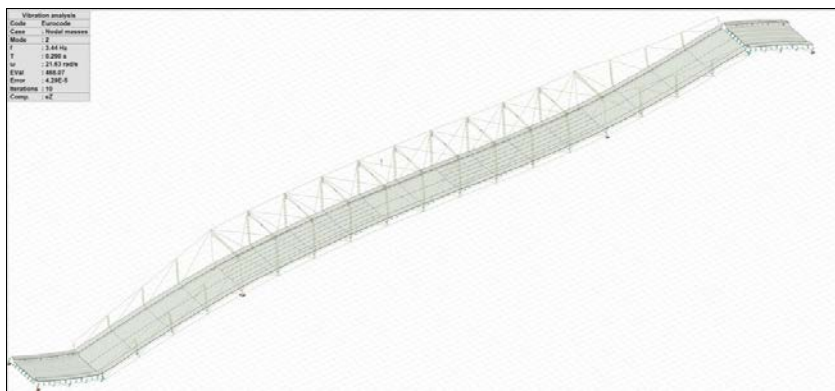
Fig. 17. Second form of free vibrations ($f_1=3.44\text{Hz}$, $T_1=0.29\text{s}$)
