Case study

Analysis of cracks generated in the spinning-mandrel teeth

M. Haghshenas*, R.J. Klassen

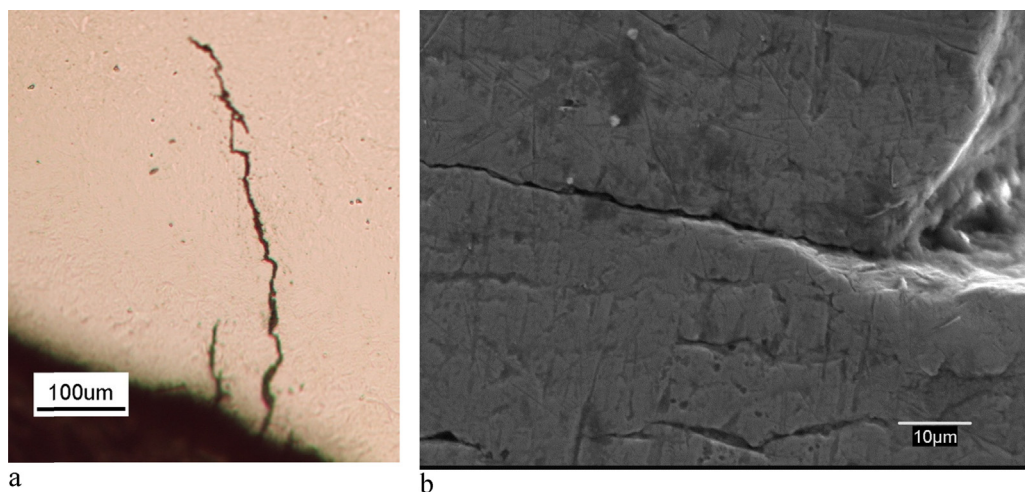
microscopy and SEM has been shown in Fig. 4. The crack initiates at the rolling contact surface, caused by the accumulation of shear deformation due to repeated rolling–sliding contact loading and then propagates into the interior of the spline.

Fig. 4. Crack propagation in the spinning mandrel (a) optical microscopy, (b) SEM image; cracks emanate from the surface and propagate toward the center of the mandrel spline.

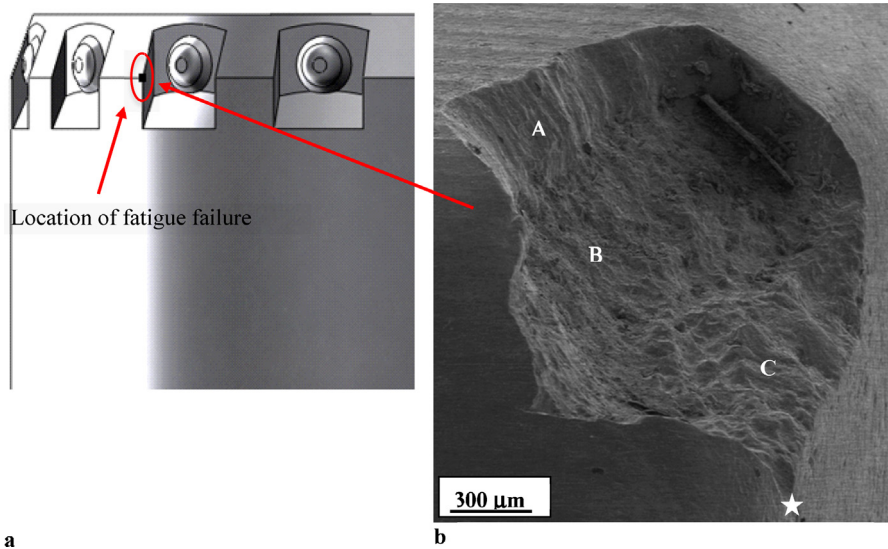
Fig. 5 shows the macro-scale contact fatigue fracture surface using SEM which includes the whole area of the damage. As seen the fracture surface include three distinct regions (shown in Fig. 5 as zones “A”, “B” and “C”). Fracture surface in the zone “A” consists of arranged lamellas (Fig. 6). The appearance of such a fracture is often called “platy” or “laminated”. Zone “C” (Fig. 7) consists of a wavy appearance (rising (hills) and falling (valleys)) and zone “B” is a transition area between wavy and lamellae regions with irregular feature.

Fig. 5. (a) The location where mandrel typically fails. Mandrel fails by cracking or chipping which produces unacceptable defects on the formed parts. Cracking and chipping typically takes place on the corners of the slots either at the head of the spline/slot or at the base. (b) the scanning electron microscopy image taken of the fracture surface of the failed spline which consists of three distinct zones of (A) lamellar, (B) transition and (C) wavy.

An important feature revealed in Fig. 5 is a transition from one type of fracture surface to another from the leading edge to the trailing edge. The fracture features of the two zones, A and C, differed markedly. The leading edge area appeared to contain a number of hills and valleys. Such a failure mechanism in the leading edge has been shown to be the characteristic fracture process in bearing steels [9,10]. The presence of cyclic stresses along the front corner of the spall could cause the fracture surfaces to rub together and thus might alter their appearance somewhat. There were indications that the ductile growth (hills and valleys) in the leading-edge area is a fatigue failure (*i.e.* relatively slow crack propagation due to alternating stress). This is confirmed with the presence of particles and globules of debris which suggest the fairly slow nature of the propagation process/stage. Spherical debris is often the product of high metal-to-metal contact, heavy fatigue loading and high frictional temperature. These are in consistent with previously reported results in the literature [11,12].

It is suggested that contact fatigue failures are initiated in the leading edge area near the surface (shown with white star in Fig. 5). The fatigue crack then results in very rapid crack propagation which completes the failure and produces the different fracture surface appearance of the trailing-edge area (zone C contained fracture tongues or lamellas surrounded by smooth regions).

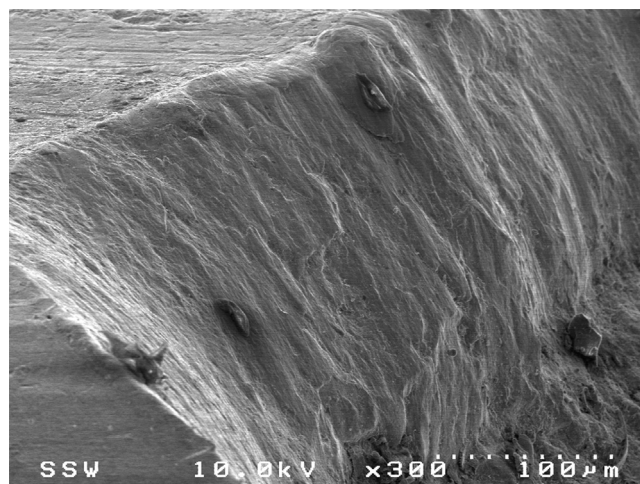
Fig. 6. SEM image of zone A (lamellar structure). These lamellar structures are attributed to the crack propagation stage.

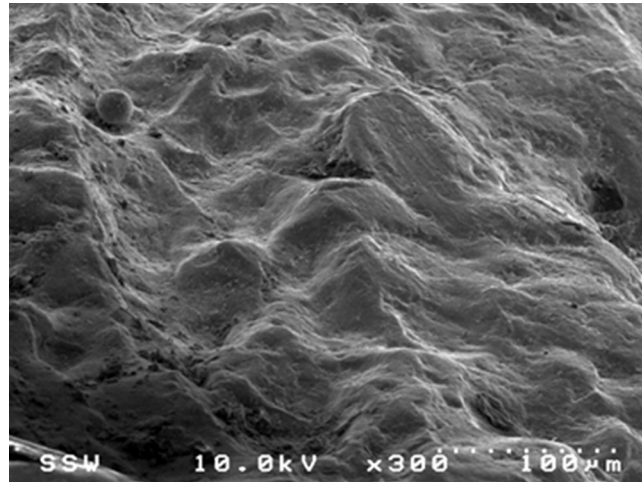
Fig. 7. SEM image of zone C (wavy structure). The presence of globules of debris and uneven structures are observed. The presence of debris confirms that the wavy structure progress slowly and therefore this region represents the crack propagation stage.

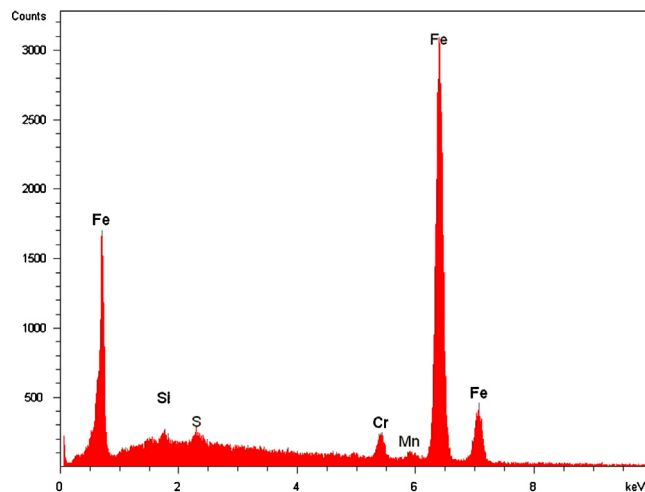
The energy-dispersive spectroscopy (EDS) elemental analyses in the crack path and in a region away from the crack path are shown in Figs. 8 and 9 and Table 1. As seen, the amount of sulfur (S), as being the most detrimental element in the steel, is significantly higher near the crack path than in regions away from the crack path. Table 2 indicates that the specific grade of tool steel, S7 in this study, possess a fairly low fatigue resistance compared with other tool steels and is therefore susceptible to fatigue fracture.

Fig. 8. The EDS analysis of the crack path showing significant amount of sulfur in the structure.

The EDS analyses show that the quality of the S7 tool steel is poor. The amount of oxygen and sulfur as two main harmful elements in steel is quite high (Figs. 10–12 and Table 2). It is suggested to use a higher quality (clean) steel for the splined mandrels. The steel shall contain lower oxygen and sulfur content and thus less oxide/sulfide inclusions. Our assessment of the fracture surface of failed splines on the mandrel indicates that oxide/sulfide contribute to the pre-mature fatigue failure.

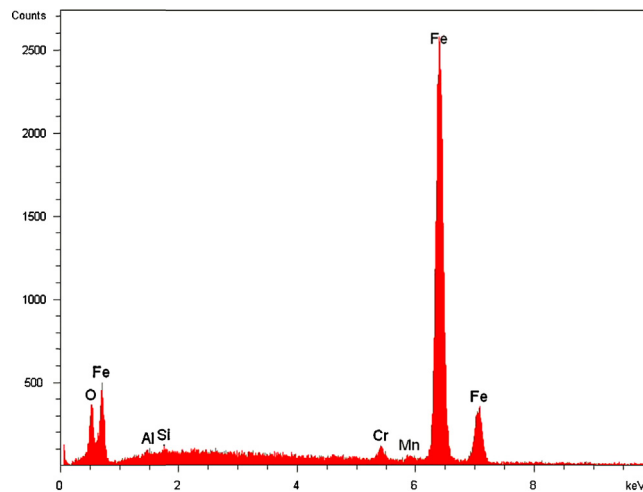
Fig. 9. The EDS analysis of base metal (away from crack path; reference area).

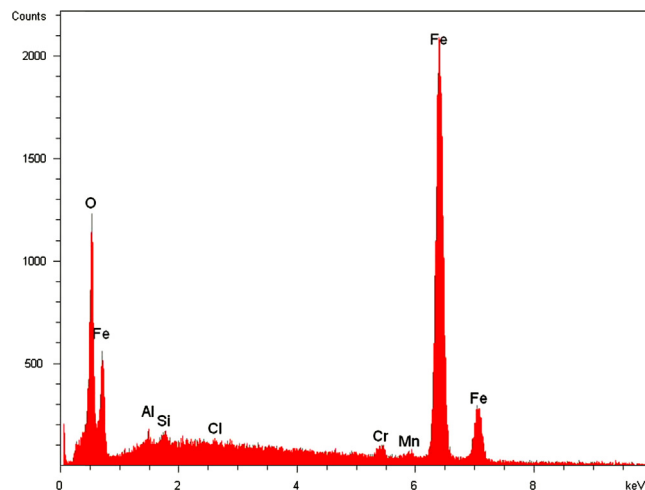
- 3.3. Employing EDM to make the teeth on the mandrel which makes the teeth corner locally harder (and more brittle) than other regions.
- 3.4. High amounts of sulfur and oxygen in local regions of the mandrel. These regions may be sites for easy fatigue crack initiation and propagation. Fig. 10 shows the elemental composition of iron oxides which are distributed in the base metal.

Fig. 10. The EDS analysis of iron oxide in the mandrel steel.

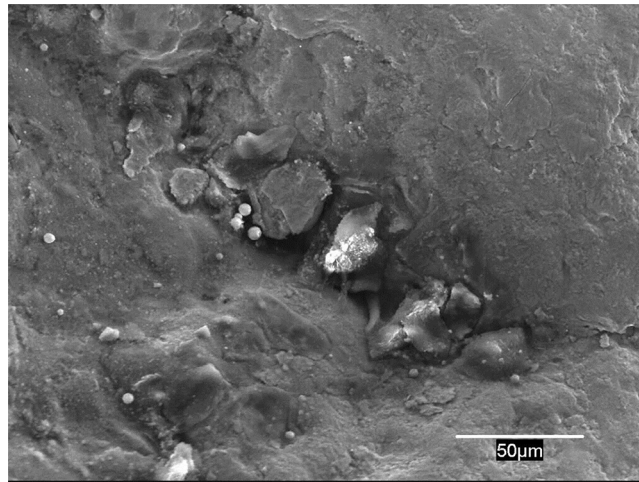
Fig. 11. Coarse inclusions and debris in the flaw surface.

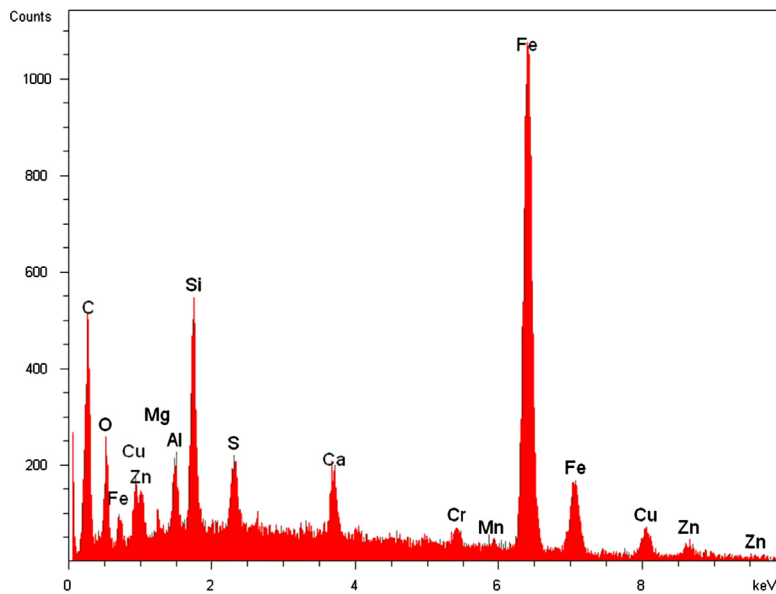
Fig. 12. The EDS analysis of inclusions in Fig. 11.
