## Earthquake-resistant performance investigation for rural buildings in Zhongxiang area, China

**Abstract:** We carried out a census of the rural residential buildings of Zhongxiang area's 17 towns. Next, we conducted a sample survey in four townships: Huji, Shipai, Zhangji, and Jiuli. According to the census and sample survey data of the rural residence buildings, we evaluated the quality and earthquake-resistant performance of the rural buildings for the various local rural residential structural types. The results showed that there are four main factors affecting the seismic performance of the local rural residences: (1) Foundations are not made appropriately (such as by compaction or some other fill) but are built directly in the farming soil. (2) Seismic measures are not completely implemented. Structure construction measures are not in place at the junction of the vertical and horizontal wall. The vertical wall joints are not the result of the same masonry techniques as the horizontal joints. There are no lintels above the door and window openings, or if there are any, the length of the lintels is less than 240 mm. (3) The brick masonry wall has low strength. The greatest h

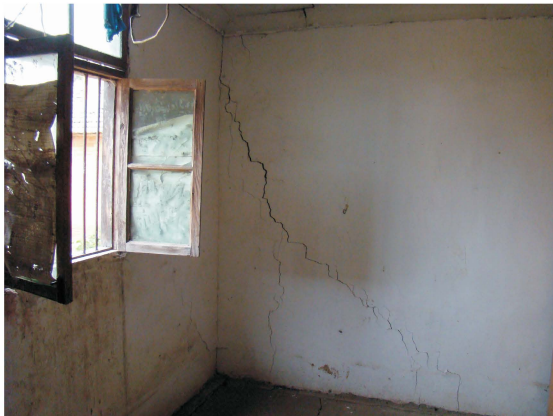
According to the survey results, most of the farmhouses built before 2000 have no ring beams or structural columns. There are vertical cracks in the vertical and horizontal wall junctions. The mortar strength is low, and the weak seismic capacity needs to be strengthened to meet seismic requirements.

Figure 5 Wall junction vertical crack

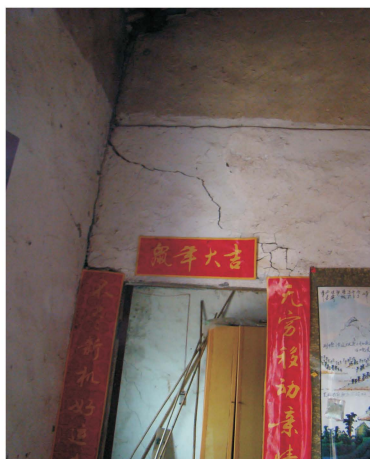
The wall of the house, floor (house) cover, and the various structural elements between the anchor and the foundation constitute the whole house. They contribute to the structure as a whole, quickly strengthening the stiffness of the space during an earthquake to prevent any structural damage from spreading. Therefore, it is reasonable to take structural construction measures to strengthen the areas between the walls and the floor node connections between the various parts of the building's components. This is very important for improving seismic performance. In this investigation, we found that the structural construction measures of many rural residences are not in place in the junction of the vertical and horizontal walls. The vertical wall joints are not the result of the same masonry technique as the horizontal joints. Therefore, there are large vertical cracks, even through the seams (Fig. 5). There are no lintels above the door and window openings, or if there are any, the length of the lintels is less than 240 mm. Because of this, there are 45-degree cracks in the top of the door and window openings (Fig. 6).

Figure 6 Wall tilt crack

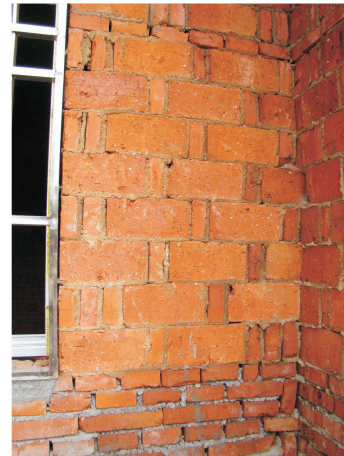
For shear strength, frictional sliding, crisp crush resistance and compressive strength of multi-story brick houses to improve, they must rely on the quality of construction<sup>[9]</sup>. Survey results show that the building construction quality is poor. The quality of the mortar masonry wall is poor. The cracks between the bricks are uneven, even in the seams (Fig. 7).

Figure 7 Poor quality of a masonry wall
