Energy Procedia 78 (2015) 1269 – 1274

6th International Building Physics Conference, IBPC 2015

Conservation climate analysis of a church containing valuable artworks

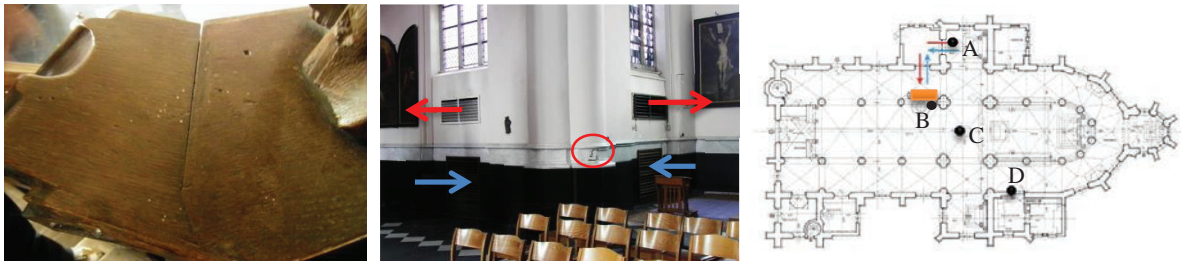
The parish church in Watervliet deals with major moisture problems, caused by the bad condition of the building envelope. The ground water rises up into the walls and rain penetrates through the façades. The church also suffers from clogged roof-gutters, causing major rain water flows across the walls. There are also traces of frost damage and salt formations. Despite these problems, some valuable artworks are exposed in the church. E.g. Panel paintings dating back from the 16th century and baroque wooden artworks can be seen [1]. Figure 1a shows white spots caused by fungus on the baroque wooden pulpit. This reveals that high levels of relative humidity occur very often. Besides that, figure 1a also shows a broadened joint, proving that these artworks suffer from re-occurring low relative humidity levels in the indoor climate. This is also revealed by the stucco layer on the walls and the surface of the panel paintings. Pieces of the top layers are crumbled off or show cracks. Previous research in other churches showed that these damages are often caused by an old air heating system [2].

The church is heated once every two weeks with an old air heating system. The supply and extraction grilles are positioned in a chapel, at the north side of the church (Fig. 1b and c). This system causes major fluctuations in temperature and relative humidity, which give rise to damage to the artworks in the church. Furthermore, due to the positioning of the grilles, the system causes draught and stratification throughout the church. The supply grilles are positioned above the extraction grilles, causing a short circuit of warm air close to the north chapel. On top of that, at one side the warm air is blocked by the wooden pulpit (Fig 1c). The system is controlled by a thermostat that is positioned on the outer corner, in between the grilles (Fig. 1b). The air heating system is only turned on when events are organized in the church. From January 2014 until March 2014, an attempt was made to keep the indoor climate permanently at a high temperature. Unfortunately, the measurements showed that the air temperature at the supply grille fluctuated constantly between 25°C and 50°C [1].

Fig. 1: (a) White spots and broadened joint at the pulpit. (b) Extraction and supply grille air heating system. The red arrow is warm air blown into the church, from the supply grille. The blue arrows symbolise the extracted air, coming through the extraction grille. The thermostat controlling the system is encircled on the figure. (c) Ground plan of the church. The red and blue arrows show the location of the supply- and extraction grilles. The orange block is the pulpit, obstructing the warm air to flow to the middle of the church. The black spots show the location of the loggers discussed in this paper. (A: Logger at supply grilles. B: Logger at the pulpit. C: Logger in the middle of the church. D: Logger behind a panel painting, at the south wall [1])

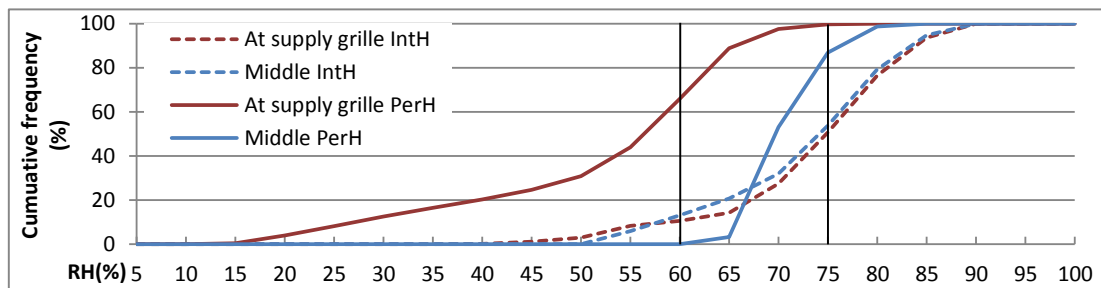
During the period of intermittent heating, RH-levels higher than 75% were registered more than 50% of the time in the middle of the church and at the supply grille (Fig 2). During permanent heating, the percentage RH-values above 75% decreased to 17% in the middle of the church. At locations closer to the supply grille, only 4% of the measurements showed a RH > 75%. In this way, permanent heating had a positive influence on the indoor climate. However, when compared with the amount of data that contained a RH > 60%, it was found that the RH-level remained almost constantly between 60% and 75% during permanent heating. In contrast, during intermittent heating, a RH-level of 55% and lower occurred between 5 and 10% of the time in the middle of the church hall. Only at the supply and extraction grills, values beneath 55% RH were registered during 60% of the time.

Fig. 2: Cumulative frequency of the measured RH at the supply grille and the middle of the church. Periods with intermittent heating (IntH, dashed line) and permanent heating (PerH, full line) were analysed separately. When the church was permanently heated, the RH in the middle stabilized. Values above 75% RH and beneath 60% RH appeared less often [1].

Consequently, permanent heating caused a certain stabilization of the RH in the middle of the church. Extreme high and low values of RH were less common. An explanation probably lies in the walls of the church, which acted as a constant moisture source during heating and thus low RH levels [5]. In the analysis of the heating effects (§4), it was found that the absolute humidity levels rose simultaneously with the temperature. This revealed that the moisture in the walls started to vaporize when higher temperatures occurred in the church, making low RH-levels occur less frequently during permanent heating.

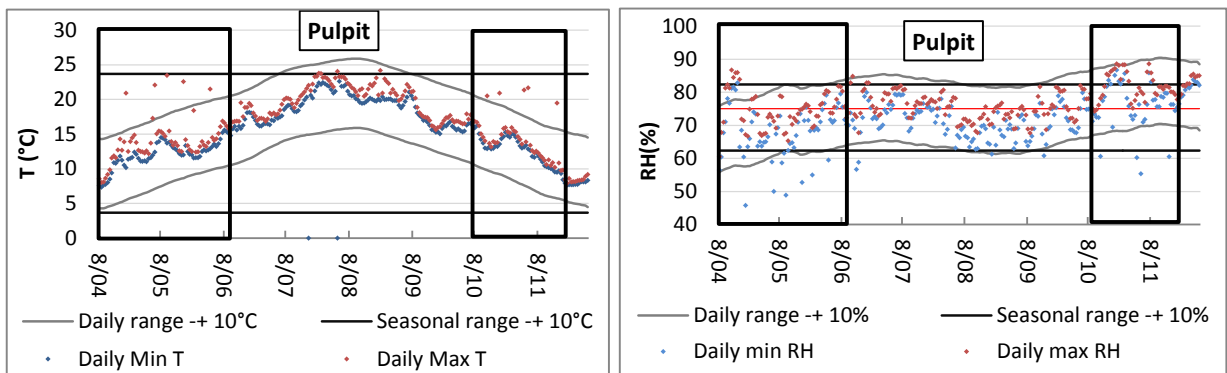
When the church was occasionally heated, the indoor climate did not meet the requirements for class B during 55% of the days. This was mostly due to a high RH level above 75%, as can be seen on figure 3b for the logger near the pulpit. The allowed limits were also exceeded when a high T and low RH occurred. These situations appeared mainly during winter, when the air heating system was switched on during services, e.g. between 8/04 and 8/06 and 8/10 and 8/11, marked on figure 3. Figure 3b also shows that high RH-levels above 75% could not be avoided during days with heating.

Fig.3: (a) Temperatures during intermittent heating from the logger near the pulpit. The daily ranges were only exceeded when the heating system was switched on. (b) RH during intermittent heating from the logger near the pulpit. Lower RH values appeared when the air heating system was switched on. High RH values above 75% (red line) appeared almost every day. The seasonal ranges were based on the total average measured T and RH, which was respectively 13.7 °C and 72.3%. The rectangles mark the period in which the church was heated [1].

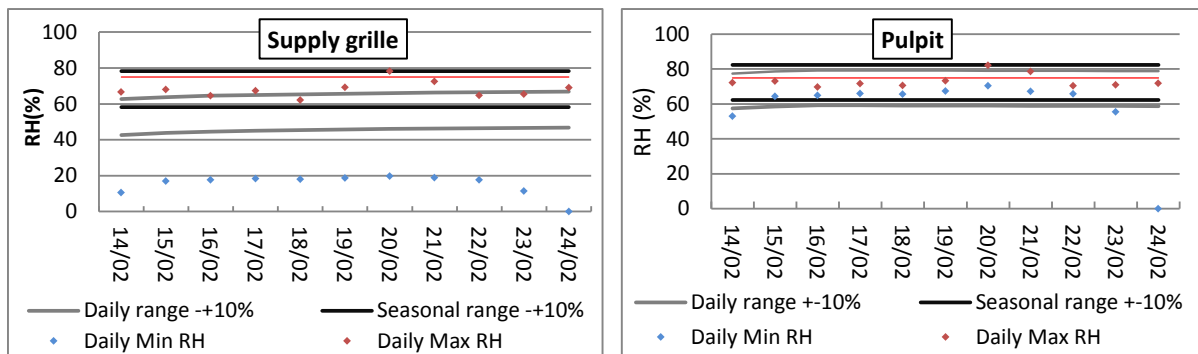
With permanent heating, the percentage of days during which the RH requirements were not met, increased at the supply grille. This was caused by an unstable air temperature of the heating system itself. On the other hand, the RH became more stable in the middle of the church. While the RH at the supply grille varied constantly between 20% and 70%, the RH in the middle of the church remained between 60% and 80%. (Figure 4a and 4b). This means that locations further away from the supply grille, experienced less influence from the heating system. Thus, permanently heating the church was not sufficient to obtain a uniform T and RH-level throughout the indoor climate church, but the climate stabilized in the center of the church.

Despite the stabilization of the indoor climate in the middle of the church with permanent heating, values above 75% RH still occurred at all measurement locations in the church. So, permanent heating did stabilize the indoor

Fig. 4: (a) RH-values during permanent heating near the supply grille. (b) RH-values during permanent heating near the altar. Despite of the permanent heating, high values above 75% RH (red line) kept appearing in the middle of the church (altar) [1].

The same conclusion was drawn when comparing the measured daily maximum and minimum T and RH to the allowed seasonal T and RH fluctuations. Locations closer to the supply grille, had fewer days where the seasonal requirements for class B were fulfilled (Figure 4). At these locations more low RH-values were measured. This was true for both the period with intermittent and permanent heating. At the supply grille itself, during almost none of the days with permanent heating the requirements for a conservation climate were met. The temperature reached levels up to 50 °C daily (§4, Figure 5). This caused RH drops to approx. 20%, while the allowed seasonal fluctuations were $68,3\% \pm 10\%$. The latter value was the average measured RH from March 2013 until April 2014, including both intermittent and permanent heating (Figure 4a).

climate, but the old air heating system was still not sufficient to avoid high RH levels. On top of that, the temperature of the heated air fluctuated constantly between 17 °C and 50 °C during permanent heating (§4, figure 5), which resulted in intolerable T and RH fluctuations at the various measurement locations. In order to stabilize the indoor climate, the installation of a new reliable heating system is advised.

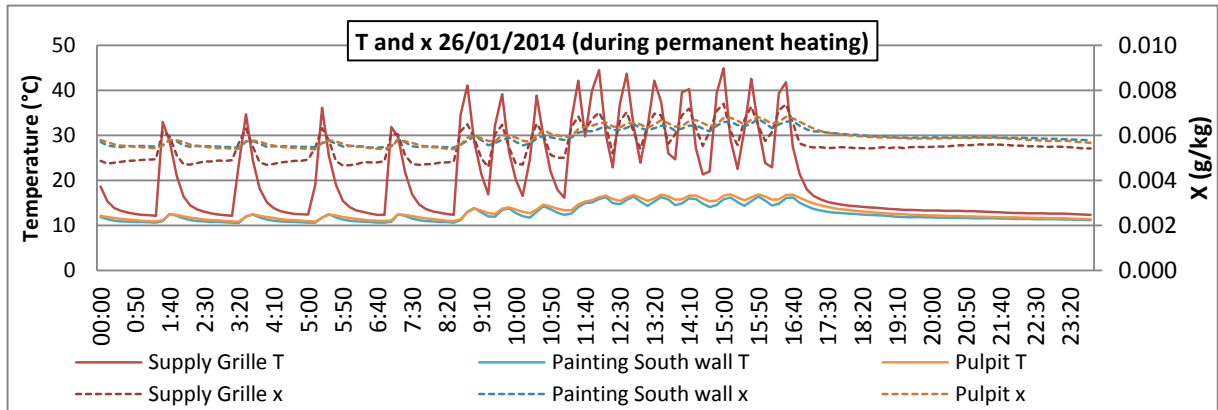
In this analysis, it was also found that permanent heating caused smaller fluctuations in T and RH in the middle of the church and at the south wall. But, as the heating system was continuously in operation, these small cycles occurred constantly (figure 5). So, according to ASHRAE requirements, the climate was indeed more stable. But one can ask if smaller but continuous cycles are less damaging for panel paintings than a major fluctuation of ± 20 °C appearing once a while. Both regimes should be avoided for the conservation of materials susceptible to fatigue.

Fig. 5: Temperature (T, full lines) and humidity level (x, dashed lines) on 26 January 2014. The heating system was permanently in operation, but during the service (at 10:00), the temperature was set to a higher value. It can be seen that the humidity level followed the fluctuations of the temperature, on various locations throughout the church, e.g. at the pulpit and at a panel painting on the south wall [1].
