## Case Studies in Engineering Failure Analysis

## Case study

## A failure study of the railway rail serviced for heavy cargo trains

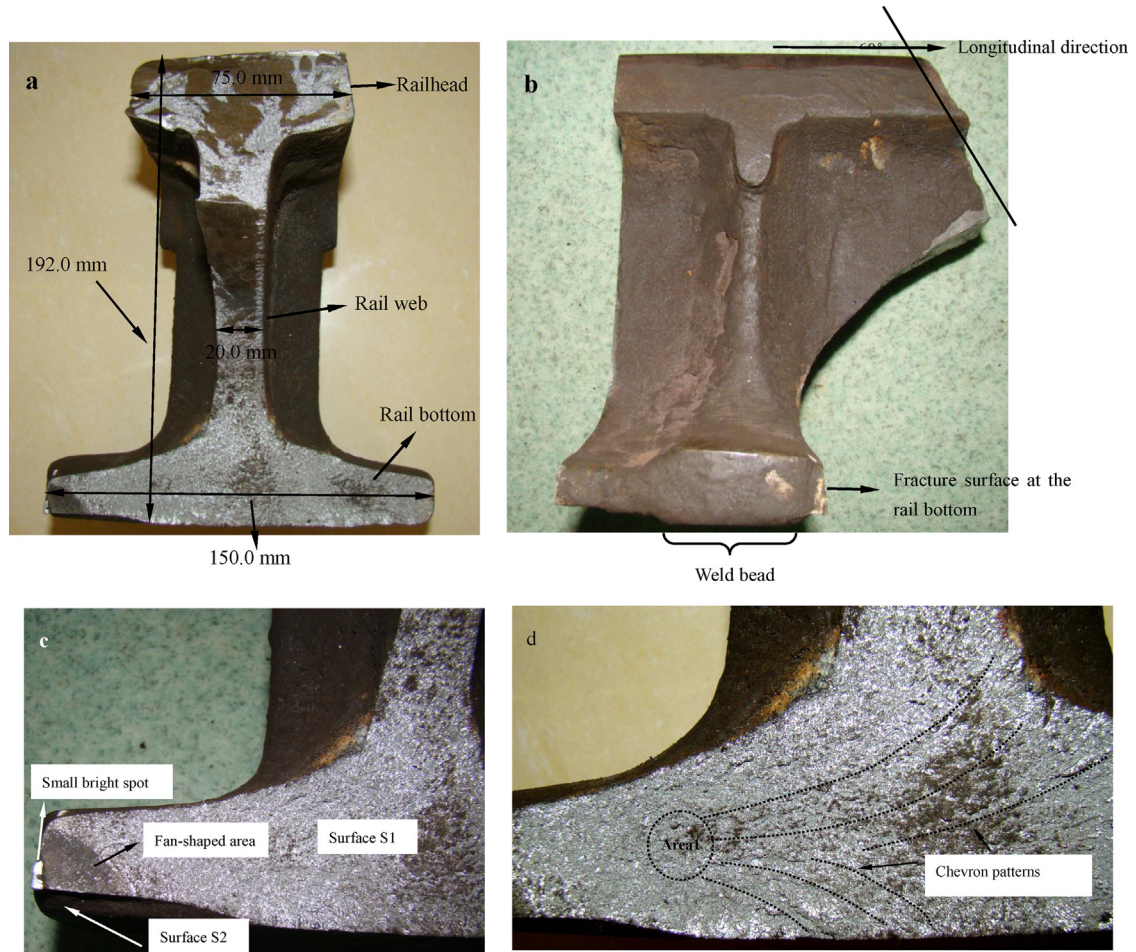
The macroscopic fracture morphology of the fractured railway rail was shown in Fig. 2. The dimensions of the railway rail which were provided by the client were shown in Fig. 2(a). It was found that the fracture surface was basically clean and fresh, which demonstrated that the corrosion of the fracture surface was not heavy. The top in Fig. 2(a) was the railhead contacted with wheel rim, the bottom was the rail bottom contacted with the ballast, the middle part between railhead and rail bottom was the rail web. We could also found that the fracture surface at the rail bottom was close to the weld bead and relatively flat (Fig. 2(b)), and that the fracture surface was approximately perpendicular to the longitudinal direction of the railway rail. The fracture surface at the rail web was approximately arched when observed from the profile (Fig. 2(b)). The fracture surface at the railhead was inclined at about  $60^\circ$  to the longitudinal direction of the railway rail. The fracture surface at the railhead was very rough; therefore, it was deduced that this part might be caused by the final instant fracture instead of the fracture origin. There was a darkly fan-shaped area at the left bottom of Fig. 2(c). A small bright spot was observed next to the darkly fan-shaped area (Fig. 2(c)). As introduced by the railway administration staff, the bright spot was not separated yet when the railway rail failed.

Fig. 2. The macroscopic morphologies of the failed railway rail. (a) The front view, (b) the lateral view, (c) the macroscopic morphology of the rail bottom, and (d) the chevron patterns and crack origin at the fracture surface of rail bottom.

Since the railway rail was subjected to cyclic loading and served about 6 years, it is rational to consider that this railway rail might be failed due to fatigue, even in giga cycle fatigue regime [5–7]. The arc boundary of fan-shaped area looks like a beach mark when observed macroscopically, as seen in Fig. 2(c). Then it can be deduced that the crack origin might be at the corner of darkly fan-shaped area (viz., the small bright spot as shown in Fig. 2(c)). However, taking into account that the small bright spot was next to darkly fan-shaped area, it is obviously to deduce that the small bright spot would not be the crack origin. The beach marks which were the classical features of metal fatigue were not observed from the macroscopic observations (the arc boundary of fan-shaped area is actually not a beach mark, we will discuss that hereinafter). However, the chevron patterns can be clearly observed at the fracture surface of rail bottom (Fig. 2(d)). Therefore, we can deduce that the crack origin should be at the tip of chevron patterns (area 1), and the crack growth direction is along the diverging direction of river patterns, as shown in Fig. 2(d). It can be deduced from the flat fractography and chevron patterns that the macro fracture feature is brittle fracture.

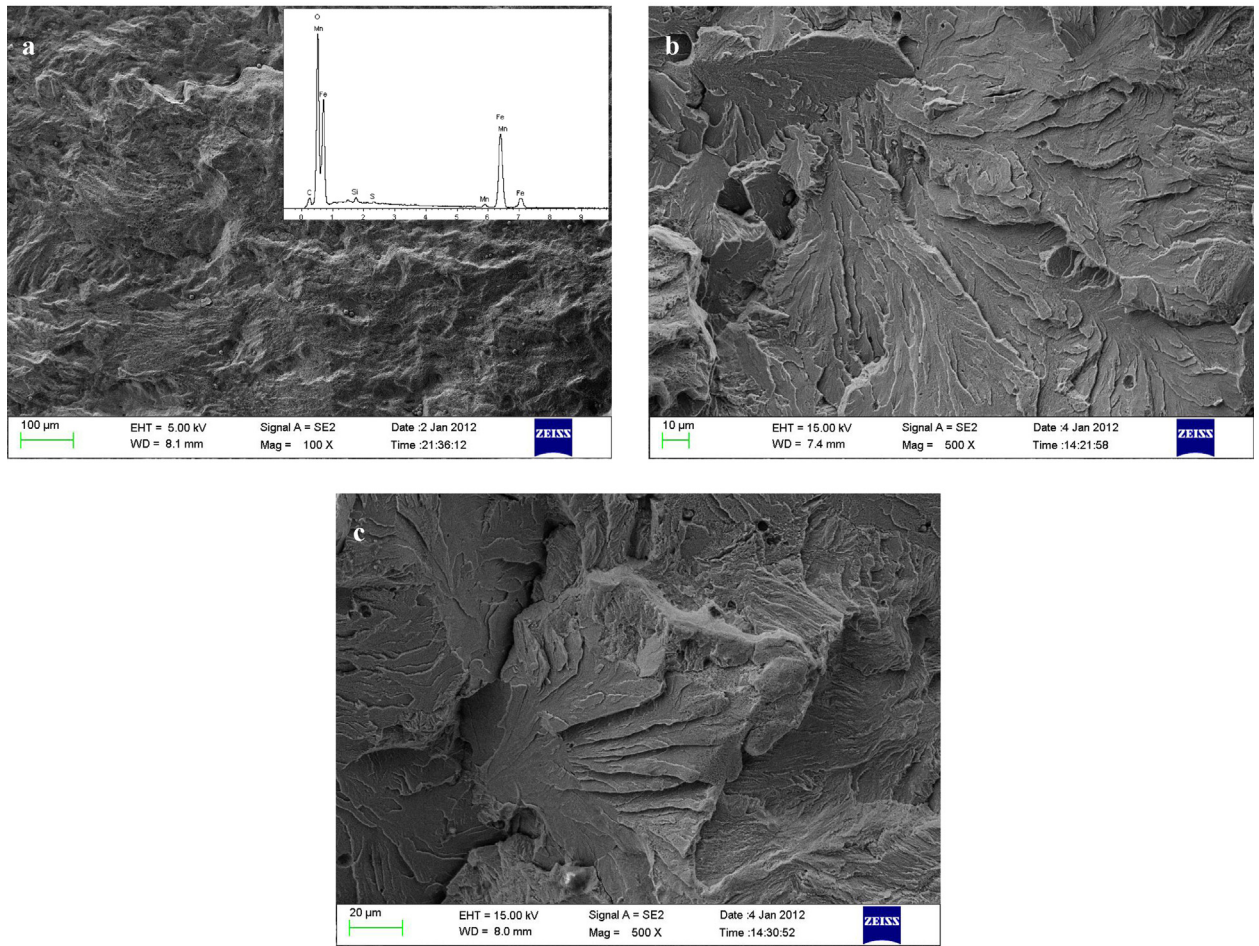
Fig. 3. The microscopic morphologies of the fracture surface. (a) Inside fan-shaped area, (b) area 1, and (c) the area of chevron patterns.

The fracture surface at the rail bottom, viz. surface S1 (as shown in Fig. 2(c)), was cut from the failed railway rail, and then cleaned by alcohol and dichloroethane. After that, surface S1 was observed by ZEISS-SUPRA 55 field emission scanning electron microscope (FESEM) in detail. The morphology inside the darkly fan-shaped area is shown in Fig. 3(a) which shows a relatively flat surface. The qualitative chemical compositions of this area are analyzed by EDX, also shown in Fig. 3(a). Higher oxygen contents were detected, which demonstrates that this area was oxidized heavily. The typical morphology in area 1 is shown in Fig. 3(b) which shows the typical feature of cleavage fracture. The fan-shaped patterns, cleavage step and river patterns which are the typical feature of cleavage fracture are observed in this figure. Fatigue striations which were the typical microscopic features of metal fatigue were not observed in the fracture surface. The micro fractography of the chevron patterns area is shown in Fig. 3(c) which is similar to Fig. 3(b). The fracture surface outside the darkly fan-shaped area is clean and fresh, almost no oxygen is detected. Combined with the experimental results outside and inside the darkly fan-shaped area, it can be deduced that the darkly fan-shaped area might be an incomplete fusion area during welding.

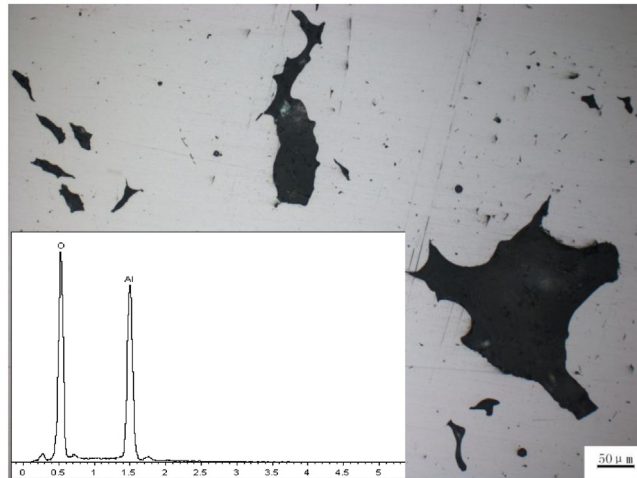
Firstly, surface S2 (as shown in Fig. 2(c)) was polished to observe the distribution of inclusions. It was shown in Fig. 4 that some bigger slag inclusions with sharp angular shape were observed at surface S2 close to the fracture surface at the rail bottom. The size of these slag inclusions was about at least 126  $\mu\text{m}$  defined by Murakami's effective projective area model [9]. EDX demonstrated that the composition of these slag inclusions was alumina. After etched by 3% nital the metallurgical structure of surface S2 close to the fracture surface was observed by optically metallurgical microscope (OMM). Continuous

Fig. 4. The morphologies of the slag inclusions and EDX results.

The failed railway rail was caused by overload. The crack origin was the ferrite net induced by inadequate welding technology. Therefore, in order to prevent similar failures in future, the welding process must be improved. For example, pre and postweld heat treatments should be conducted to eliminate the bigger slag inclusions and ferrite networks along the grain boundaries. On the other hand, it is of great importance to control the load of train.

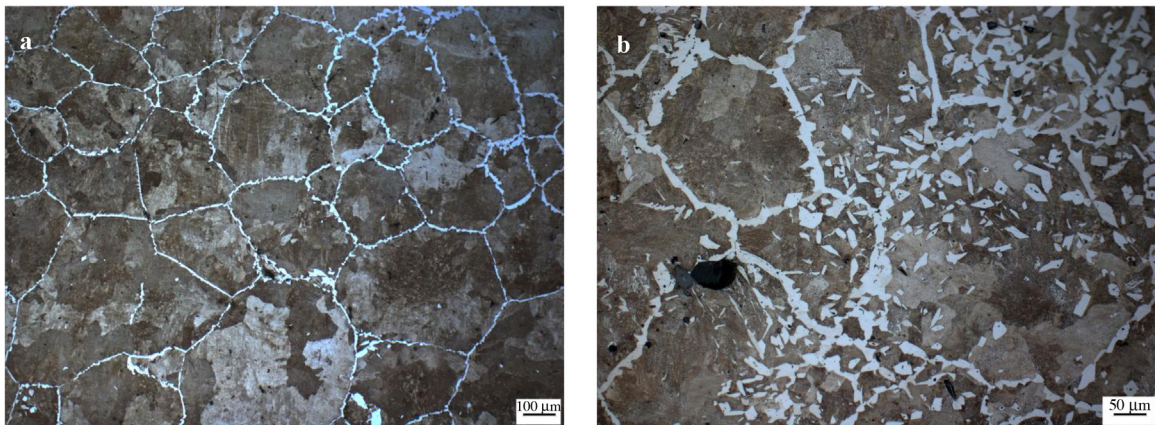
Fig. 5. (a) The metallurgical structures of surface S2 close to the fracture surface and (b) the metallurgical structures in area 1.

ferrite networks and pearlite colonies were observed, as shown in Fig. 5(a). It was also demonstrated from Fig. 5(a) that the size of pearlite colony, viz. the area surrounded by continuous ferrite networks, was rather heterogeneous. The biggest size of the pearlite colony was about 726  $\mu\text{m}$  in diameter, the smallest size 68  $\mu\text{m}$ . After making an obvious mark at the crack origin site (area 1) on surface S1, surface S1 was polished and etched by 3% nital in order to observe the metallurgical structures. The metallurgical structures in area 1 were pearlite, continuous ferrite networks and a mass of ferrite fragments distributed inside the pearlite colonies, as shown in Fig. 5(b). Considering the weaker strength of ferrite distributed like nets compared with pearlite; it can be deduced that the crack might be initiated from the ferrite networks.

As introduced in Section 1, the railway rail was mainly subjected to cyclic loading. In this case study, the macroscopic beach marks and microscopic fatigue striations were not observed at the fracture surface. In addition, the typical chevron patterns were observed. And the feature of cleavage fracture was observed at the tip of chevron patterns. Given all of that, we can draw a conclusion that the railway rail is mainly caused by overload even though it is subjected to cyclic loading. Considering the abnormal metallurgical structures (ferrite networks distributed along the grain boundaries) at the crack origin, the crack is supposed to be initiated from the weaker ferrite networks which are caused by welding. Therefore, it is much needed to eliminate the ferrite networks by improving the welding technology.
