1st International Conference on Structural Integrity, ICONS-2014

Flow Accelerated Corrosion: Forms, Mechanisms and Case Studies

Vivekanand Kain

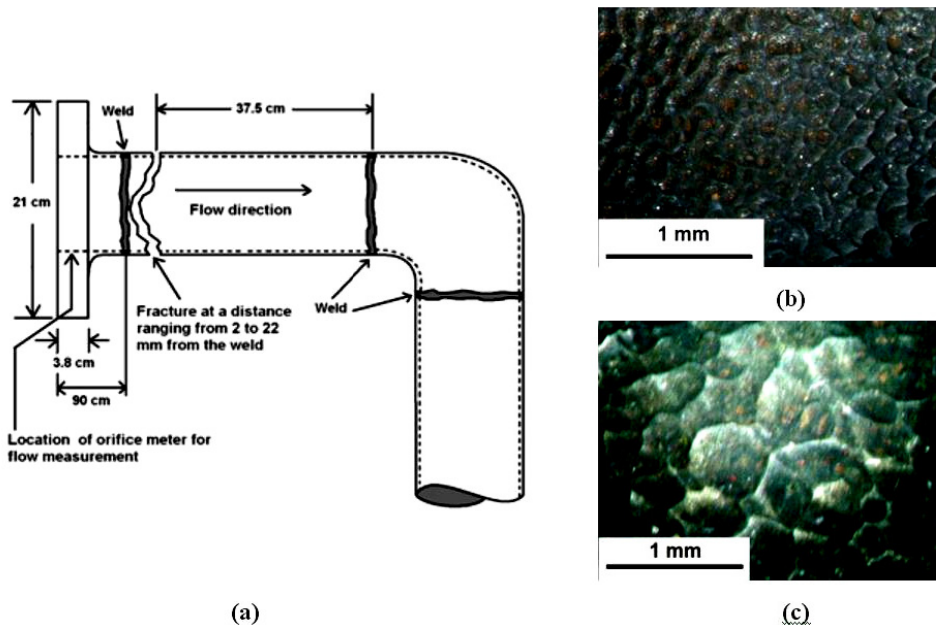
A pipe segment in the 10% feed line, immediately downstream of flow element (orifice meter) ruptured releasing steam in boiler room on February 9, 2006, in Kakrapar Atomic Power Station unit-2 (KAPS # 2). The process details and other specifications of the ruptured pipe segment were: Process fluid - feed water (liquid), operating temp. - 171 °C, design pressure - 72 kg/cm², flow and velocity - 35 m³/hr (2.33 m/sec), material - A 106 Grade B, size and thickness - 80 NB (7.62 mm). This pipeline carries 10% of the feed water to the steam generator and the failure occurred after approximately 10 years of operation. Fig. 3 (a) gives the schematic of the failed piece of the pipeline showing the location of the fracture with respect to the welds and the location of the orifice meter used for flow measurement [13]. The failure had occurred on the pipeline side of the weld between the flange reducer and the pipeline and it was all along the circumference but was not at a uniform distance from the weld. The observations clearly indicate that the failure is not in the heat-affected zone (HAZ) due to welding. The fracture surface is at varying distances from the weld (at a distance ranging from 2 to 22 mm). Fracture in the HAZ region would approximately be equidistant from the weld all around unlike what is seen here. There is an orifice meter located in the flange for flow measurement and the fracture is downstream the orifice meter. The inner surface that had undergone FAC shows a distinct pattern. This pattern is much finer in the regions severely affected by FAC while it is quite coarse at other locations as shown in the stereomicroscope image in Fig. 7 (b, c). The thickness of the pipeline had reduced from the original (measured) value of 7.11 mm to a minimum of < 2.5 mm at the location of the failure.

Chemical analysis of chips taken from the failed pipeline was done. Except for silicon content, the chemical composition of the material used corresponds to A 106 Grade B of ASTM. The Cr (wt% - 0.032) and Mo (wt% - 0.001) contents of the material was found to be very low (and are typical of A 106 Grade B) in the pipeline material. The fracture surface was examined under the scanning electron microscope and clear ductile failure was observed with no indication of any cleavage facets indicating an overload failure. Since there was excessive thinning observed at this region, the overload failure is due to the pipeline thickness reducing to a level at which it can not withstand the operating load. Similar observations have been reported earlier [1,6]. XRD analysis was done on two samples. The sample taken from regions far away from the failed regions showed presence of magnetite at the ID surfaces. Haematite was not detected in this sample. The sample from the failed region showed peaks due to base metal only. The absence of magnetite (or any other oxide) confirmed that the oxide (magnetite) was getting dissolved at the regions of failure [7-8]. Thickness of the pipe was mapped by ultrasonic method as well as the surface morphology was recorded using a stereo microscope at 11 equidistant locations along the circumference and at an interval of one inch along the length. The thinning was maximum near the flange (at a distance of 1.5 times diameter – this is considered a thumb rule) and it gradually reduced away from it but the reduction in thickness had occurred over a long distance [7-8]. The size of the scallops also changed depending on the extent of degradation. At regions near the fractured regions the size of scallops was smaller as compared to the size of scallops in regions far away from the failed region.

Fig. 3 (a) Schematic of the failed pipeline indicating the location of the fracture surface, welds and the orifice meter for flow measurement. Typical patterns on the ID surfaces as observed by stereomicroscope [7], (b) showing fine pattern near the fracture surfaces (at locations most affected by FAC) [7] and (c) a much coarser pattern at a location that is least affected by FAC [7].

Based on this investigation of this failure, a periodic inspection program for UT thickness measurements of components which are most vulnerable to FAC pertaining to high energy systems of secondary cycle has been prepared and issued for all stations/projects. Decision was also taken to replace the existing carbon steel pipe and fittings of the systems/portion of piping which are prone for FAC with low alloy steel A 333 Gr. 6 (Cr: 0.25-0.40%). ASTM, A-335 Gr. P22 (2¼% Cr, 1% Mo) [18] could also be a possible choice. Studies have shown [14] that for feeders operating at ~ 310°C, the increased chromium content (to the permissible limit in A106 Gr. B itself) results in a 50% reduction in the FAC rates. For A106 carbon steel, there is an allowable range in specified chromium

content of upto 0.4%, and thus increased FAC resistance can be obtained within the A106 Gr. B specification [14]. It has been decided to use of pipes and fittings of one schedule higher than required schedule for FAC prone areas and to analyze and systematically study FAC phenomena from the cut and removed (degraded) pipes and fittings from the secondary cycle piping. Results from some such analysis are given in this paper. The layout of piping system and its configuration is also understood to be a contributing factor for FAC. Efforts are being made to study these aspects in existing stations. In the future projects special efforts shall be made to design the piping system layout so as to minimize turbulent flow, direct pipe wall impingement, vortex flows which are the perceptible causes to increase FAC.

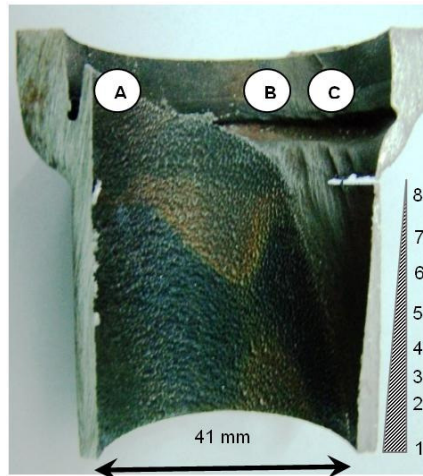
The microstructure of the pipe and NRV portion was ferrite + pearlite, typical of carbon-steel A106 Gr. B. The ID side of the downstream pipe showed substantial degradation. The ID surface was severely corroded. The 40 NB downstream pipe above the weld region, towards NRV side, was severely corroded and in some regions had totally dissolved. It corresponds to Regions C6 - C8 in Fig. 4. Substantial thickness reduction was observed on the pipe portion and thickness reduction was very large near the socket weld (Region C8). Some portion of the downstream pipe had totally corroded, as indicated in Fig. 4 at Region C8 & Region B8 to a distance of 15 mm above it. The socket weld was also affected by corrosion (indicated by surface pattern observed on all the affected regions). A region near the leak (at the downstream pipeline) that showed maximum thickness reduction had shown surface appearance typical of the FAC affected surface patterns and is shown in Fig. 5. It is corresponding to Region A8 in the Fig.4 [8,17].

Fig. 4 Heavy thickness reduction near the socket weld (at location 8). Lower thickness reduction is seen at a distance 40 mm away from the socket weld (location 1) [8,17].

Thickness measurements were carried out at different locations in the region where the maximum thickness reduction was noticed. A maximum thickness reduction was noticed in the region where a leak was detected (at location C8 in Fig.9). At the NRV location the geometry of the downstream pipeline (especially the part above the socket weld location) or the returning water stream created very high local velocity regions. This led to FAC to such an extent that a part of the downstream pipe had totally dissolved (Fig. 4). This led to development of a perforation as the FAC rate on the weld was not as high as on the base material, leading to leakage from the socket weld region. The thickness had decreased to 0.78 mm at location C8 (Fig. 4) from 3.82 mm at location C1 (Fig. 4). Signature surface patterns of single phase FAC were observed at these surfaces (Fig. 5) [17].

Changes in design of the weld, especially its geometry and protruding part after the socket weld of the downstream pipe has to be improved upon to reduce FAC. The use of a better material (containing $> 0.3\%$ Cr or Cr-Mo type steel – e.g. ASTM A333 P22) was also identified as helpful to increase the resistance to FAC.

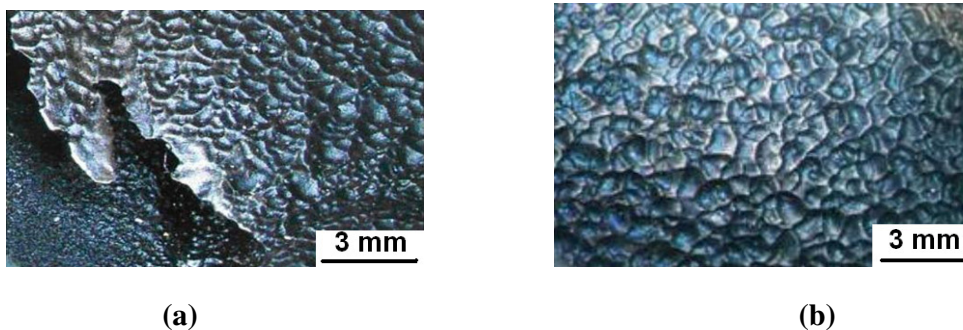
Fig. 5 a) Surface pattern typical of the FAC at the location most affected by corrosion (Downstream pipeline, C8 in Fig. 10), b) A typical FAC pattern in the region of downstream pipe, corresponding to Region A in Fig. 10 [8,17].
