# Failure Analysis of Heavy-Ion-Irradiated Schottky Diodes

Megan C. Casey<sup>1</sup>, Jean-Marie Lauenstein<sup>1</sup>, Edward P. Wilcox<sup>2</sup>, Alyson D. Topper<sup>2</sup>, Michael J. Campola<sup>1</sup>, and Kenneth A. LaBel<sup>1</sup>

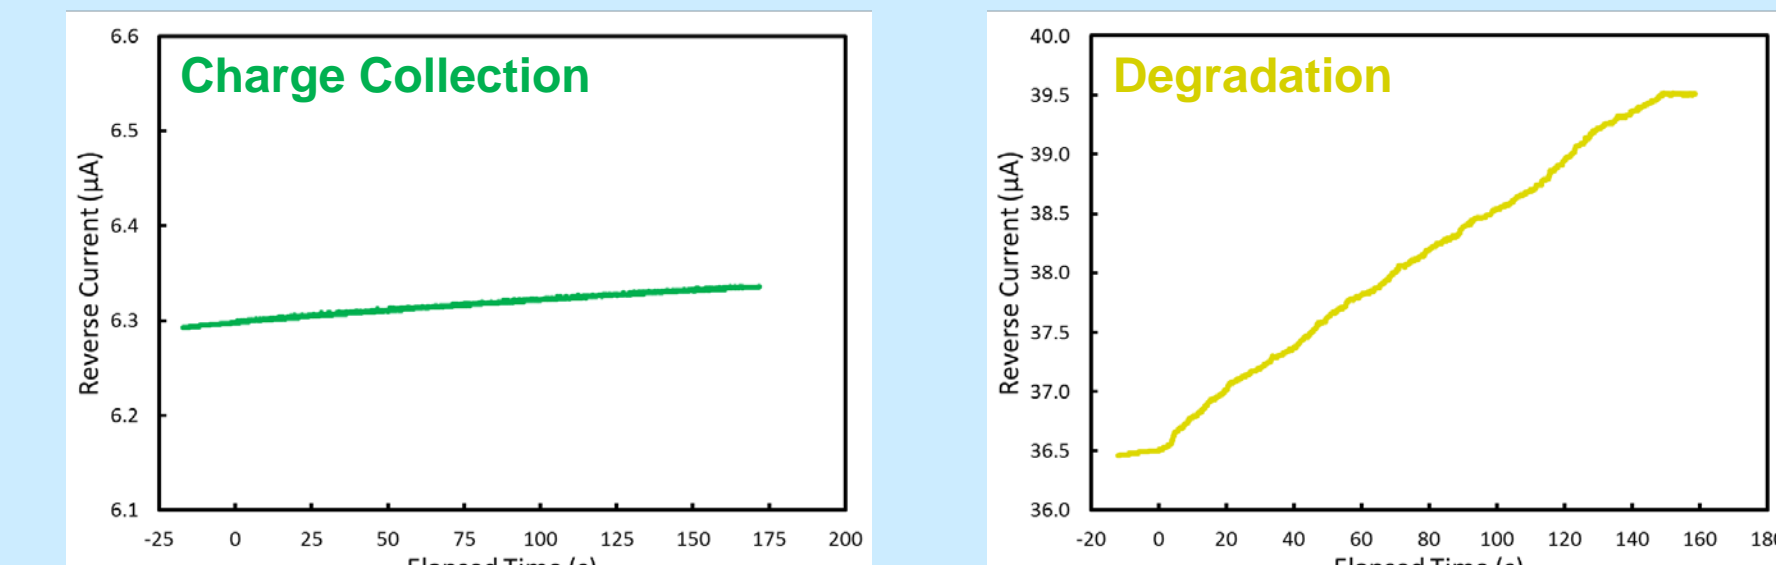
Fig. 1a. Charge collection is observed during the beam run. All post-irradiation parameters were within specification, and this was considered a passing condition. Fig. 1b. Degradation is observed in the reverse current during the beam run. All post-irradiation parameters were within specification, and this was considered a passing condition.

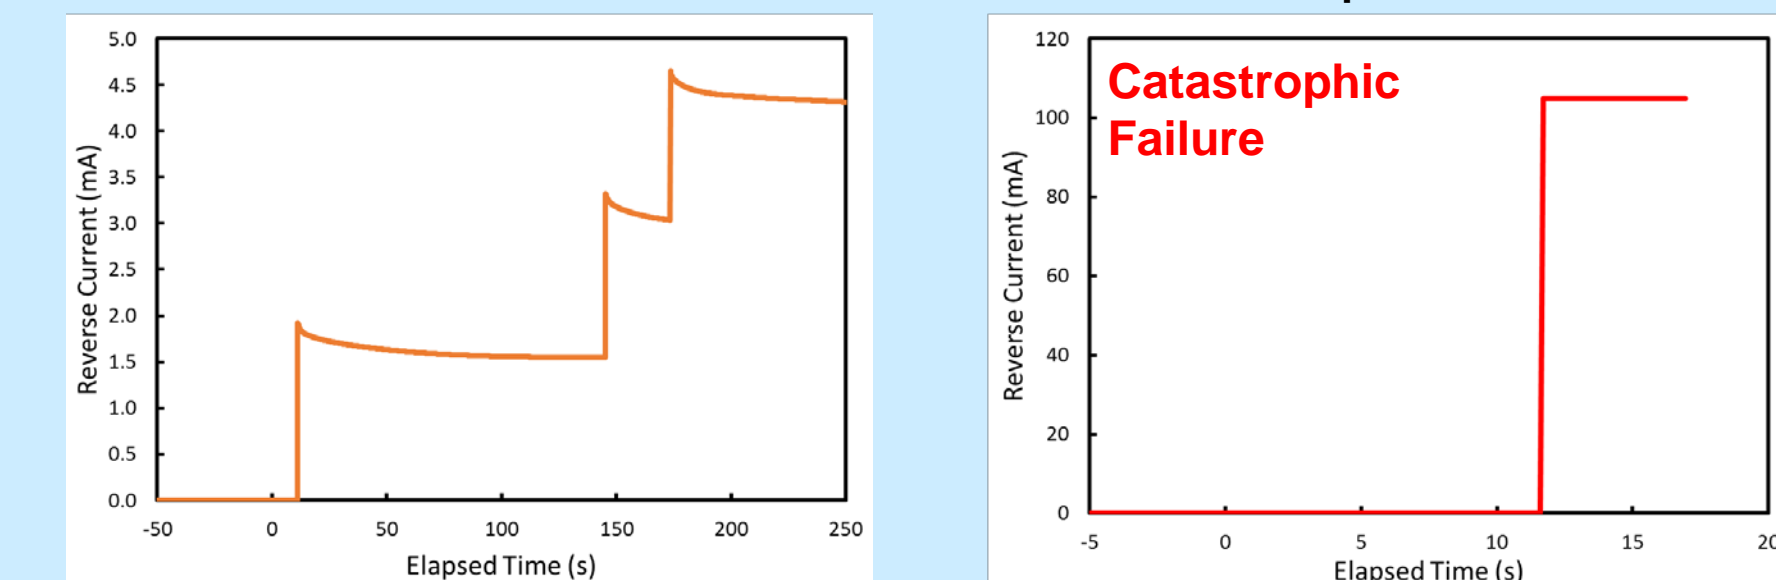
Fig. 1c. Degradation is observed in the reverse current during the beam run. Some or all of the post-irradiation parameters were outside of their specification, and this was considered a failing condition. Fig. 1d. Some time after the beam is turned on, the anode and cathode short causing catastrophic failure. Some or all of the post-irradiation parameters were outside of their specification, and this was considered a failing condition.

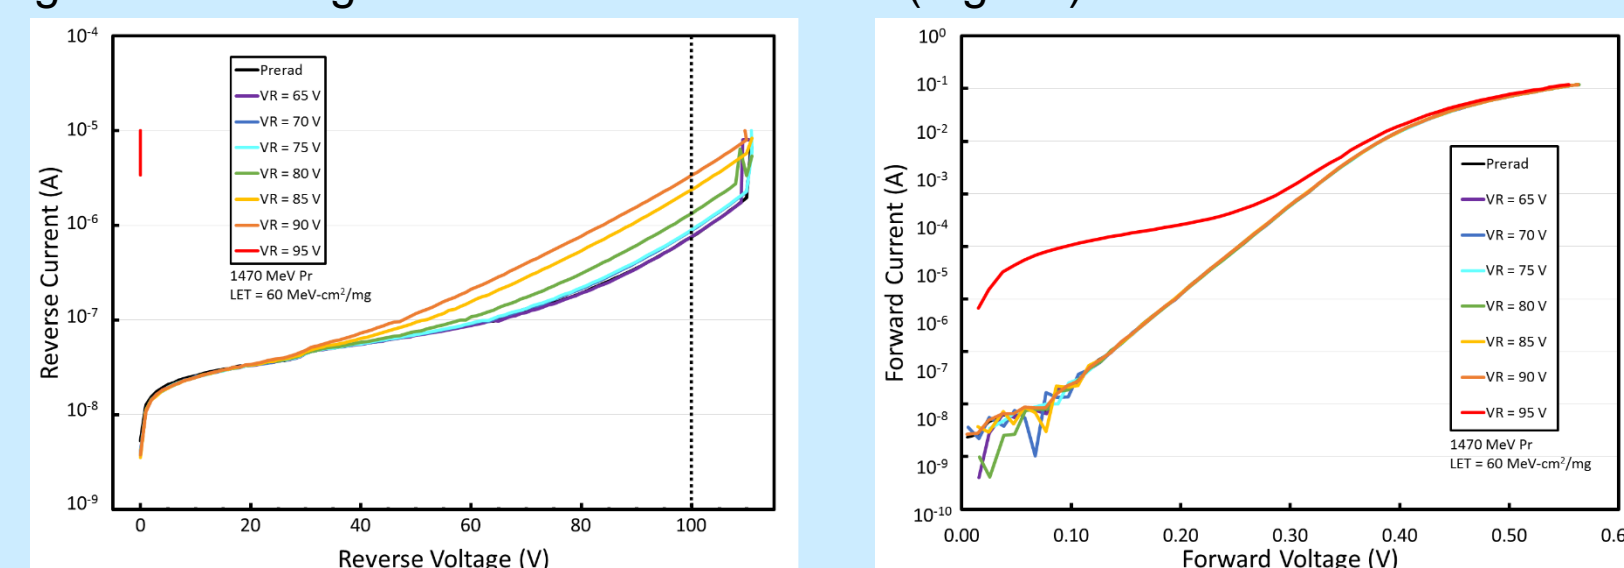
Fig. 2. Reverse currents from the power supply during each run. The reverse voltage at which the DUT was biased is shown in the legend. Fig. 3a. The post-irradiation reverse current as a function of the reverse voltage is shown for each beam run. Fig. 3b. The post-irradiation forward current as a function of the forward voltage is shown for each beam run.

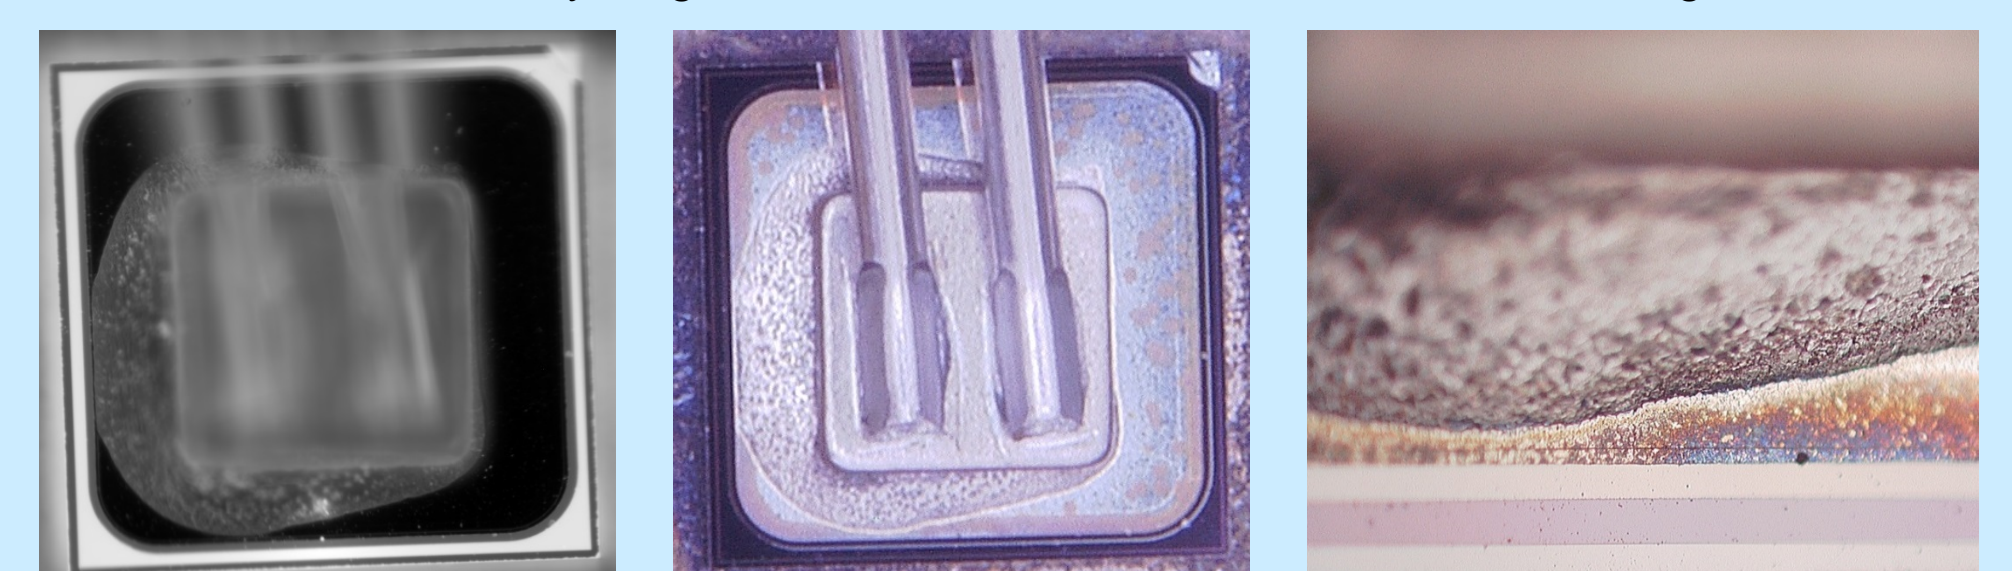
Fig. 4a. Thermal image of the irradiated DUT identifies location of failure. Fig. 4b. The failure location is not visible in the low-magnification optical image of SN5. Fig. 4c. The failure location is not visible in the high-magnification optical image of the DUT.

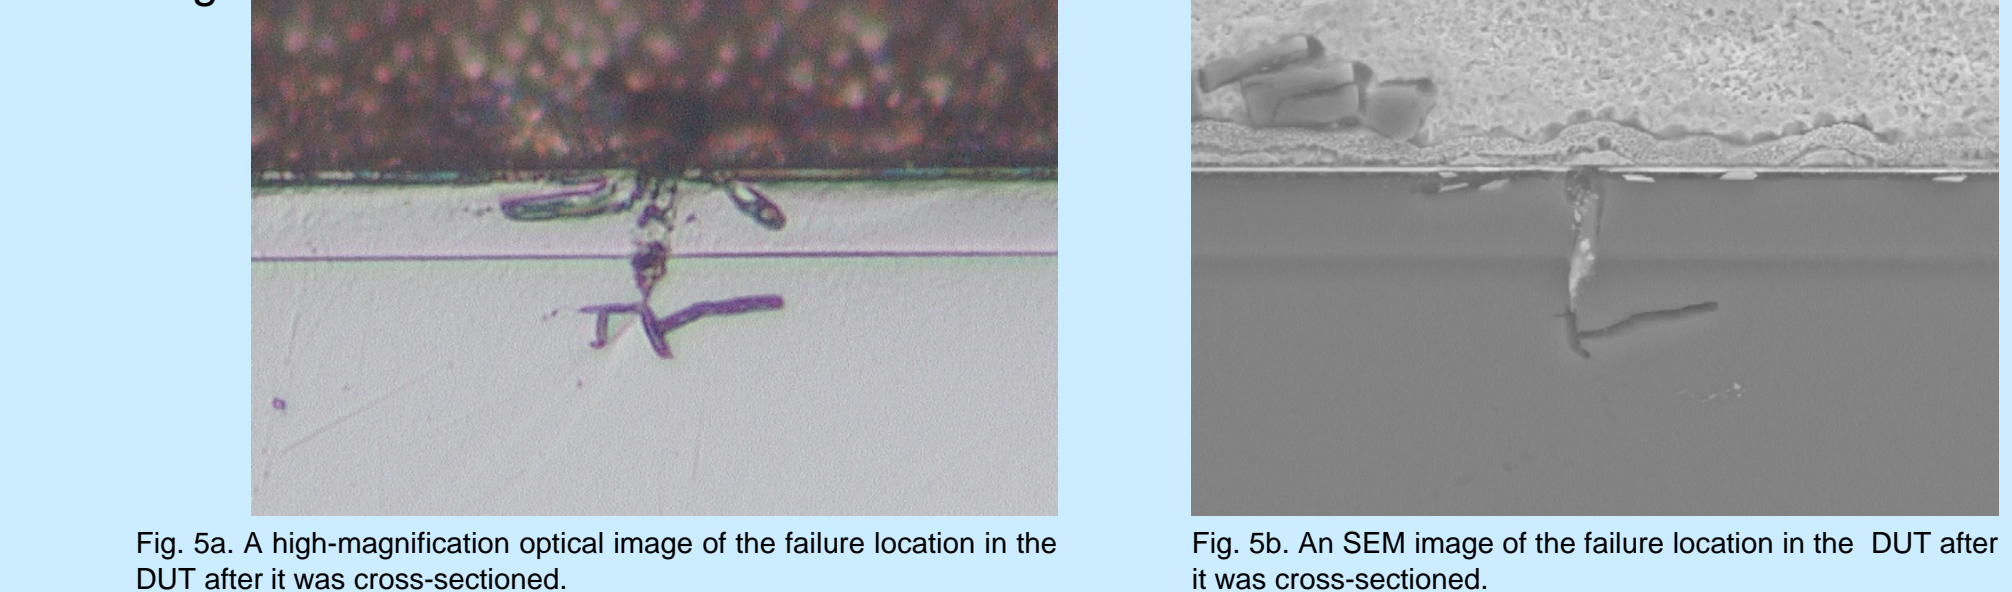
Fig. 5a. A high-magnification optical image of the failure location in the DUT after it was cross-sectioned. Fig. 5b. An SEM image of the failure location in the DUT after it was cross-sectioned.

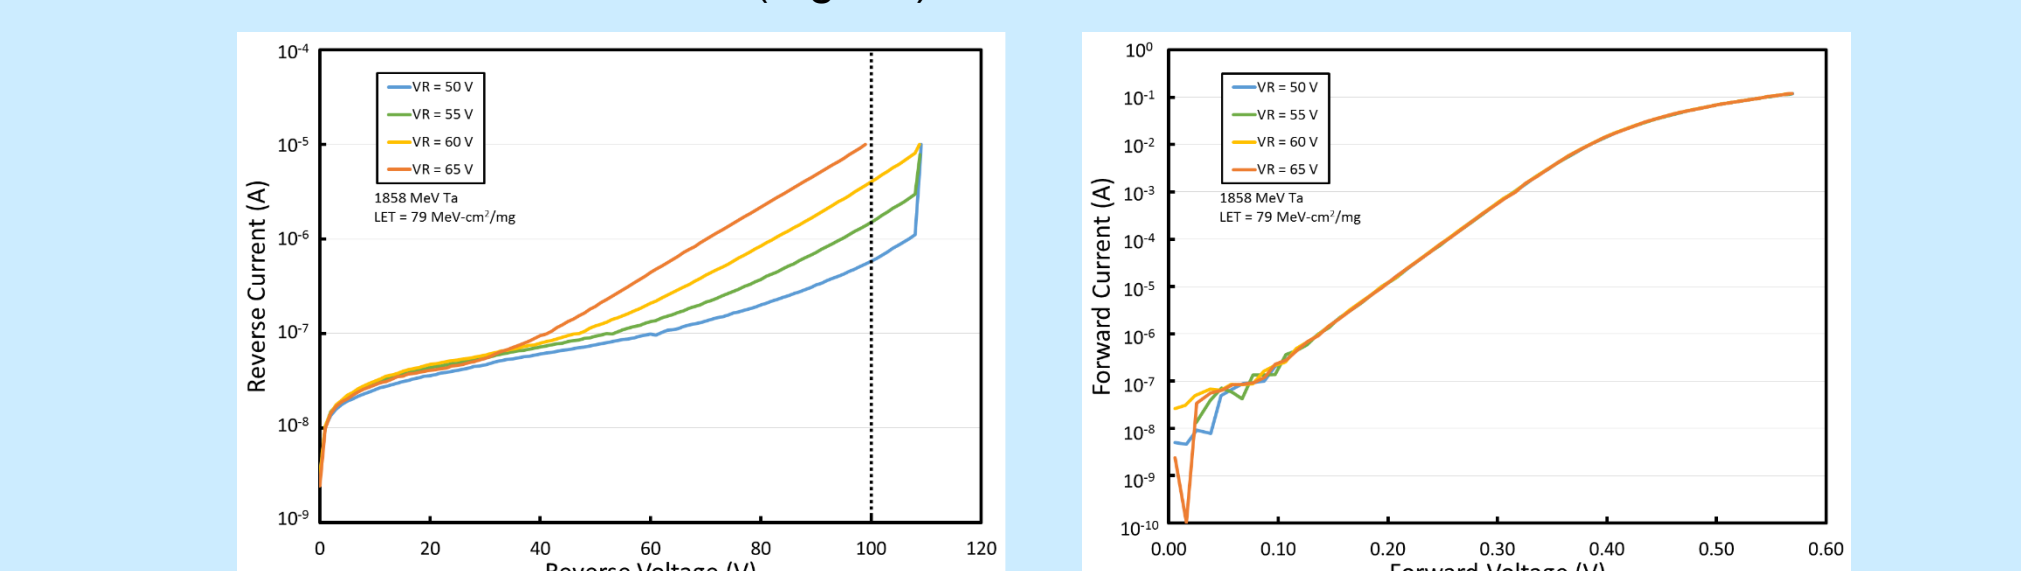
Fig. 7. Reverse currents from the power supply for SN2 during each run. The reverse voltage at which the DUT was biased is shown in the legend. Fig. 8a. The post-irradiation reverse current as a function of the reverse voltage is shown for each beam run. Fig. 8b. The post-irradiation forward current as a function of the forward voltage is shown for each beam run.

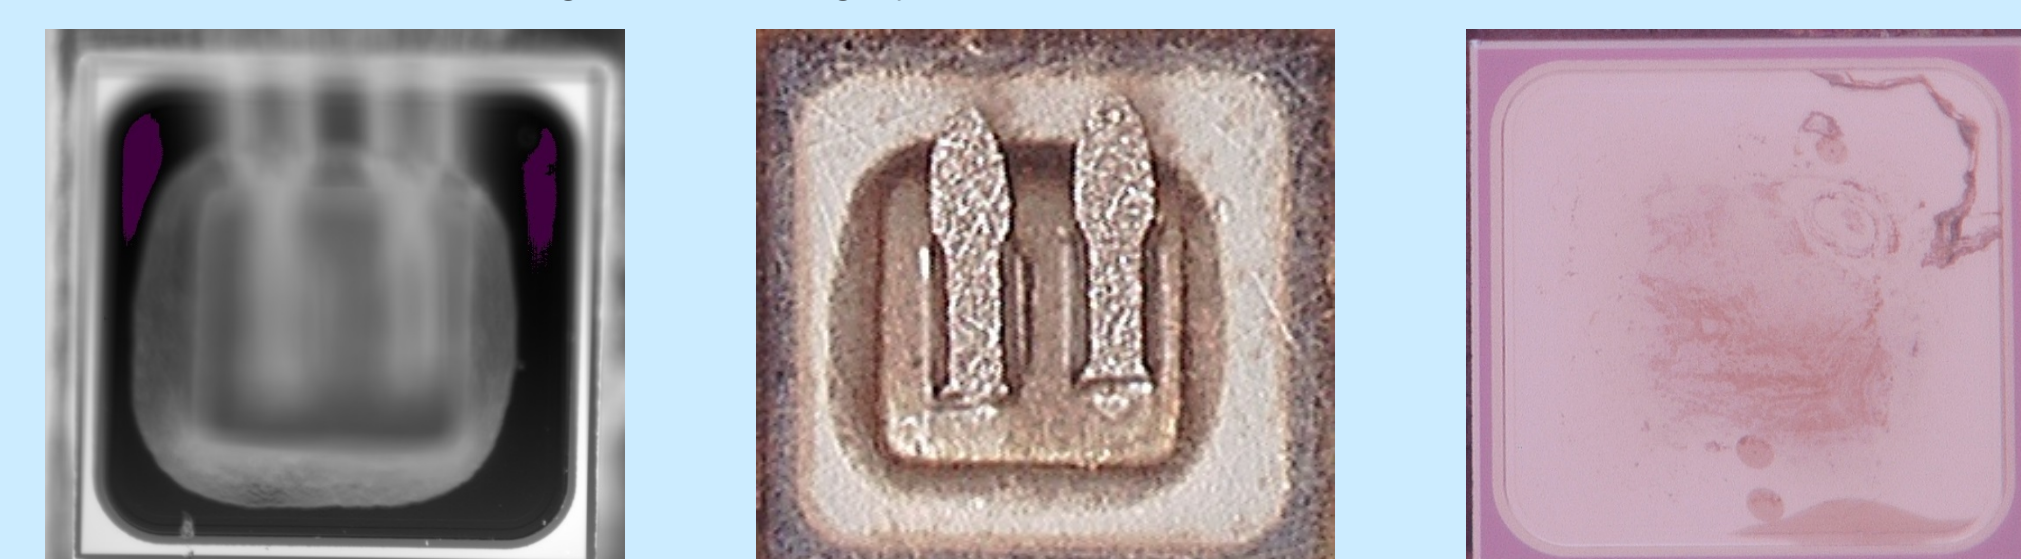
Fig. 9a. Thermal image of the irradiated SN2 does not identify any failure locations. Fig. 9b. No failure location is visible in the low-magnification optical image of the DUT. Fig. 9c. These discolorations are observed in the silicon of SN2 after the Schottky barrier metal, bond pad, and bond wires were removed.

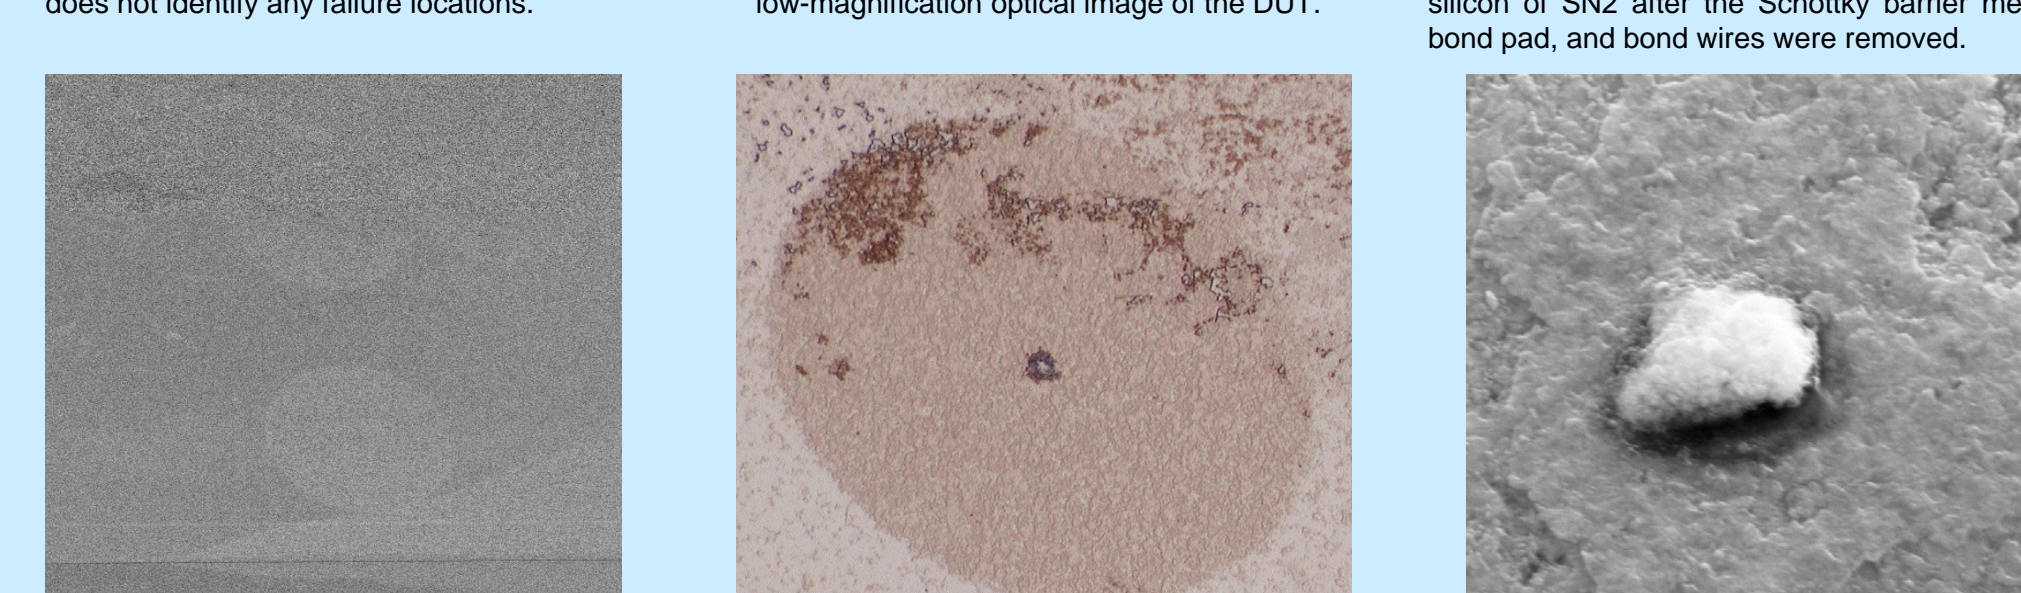
Fig. 9d. SEM image of two of the discolorations observed on the surface of SN2. Fig. 9e. High-magnification optical image of one of the discolorations observed on the surface of SN2. Fig. 9f. SEM image of displaced silicon particle located at center of discoloration.

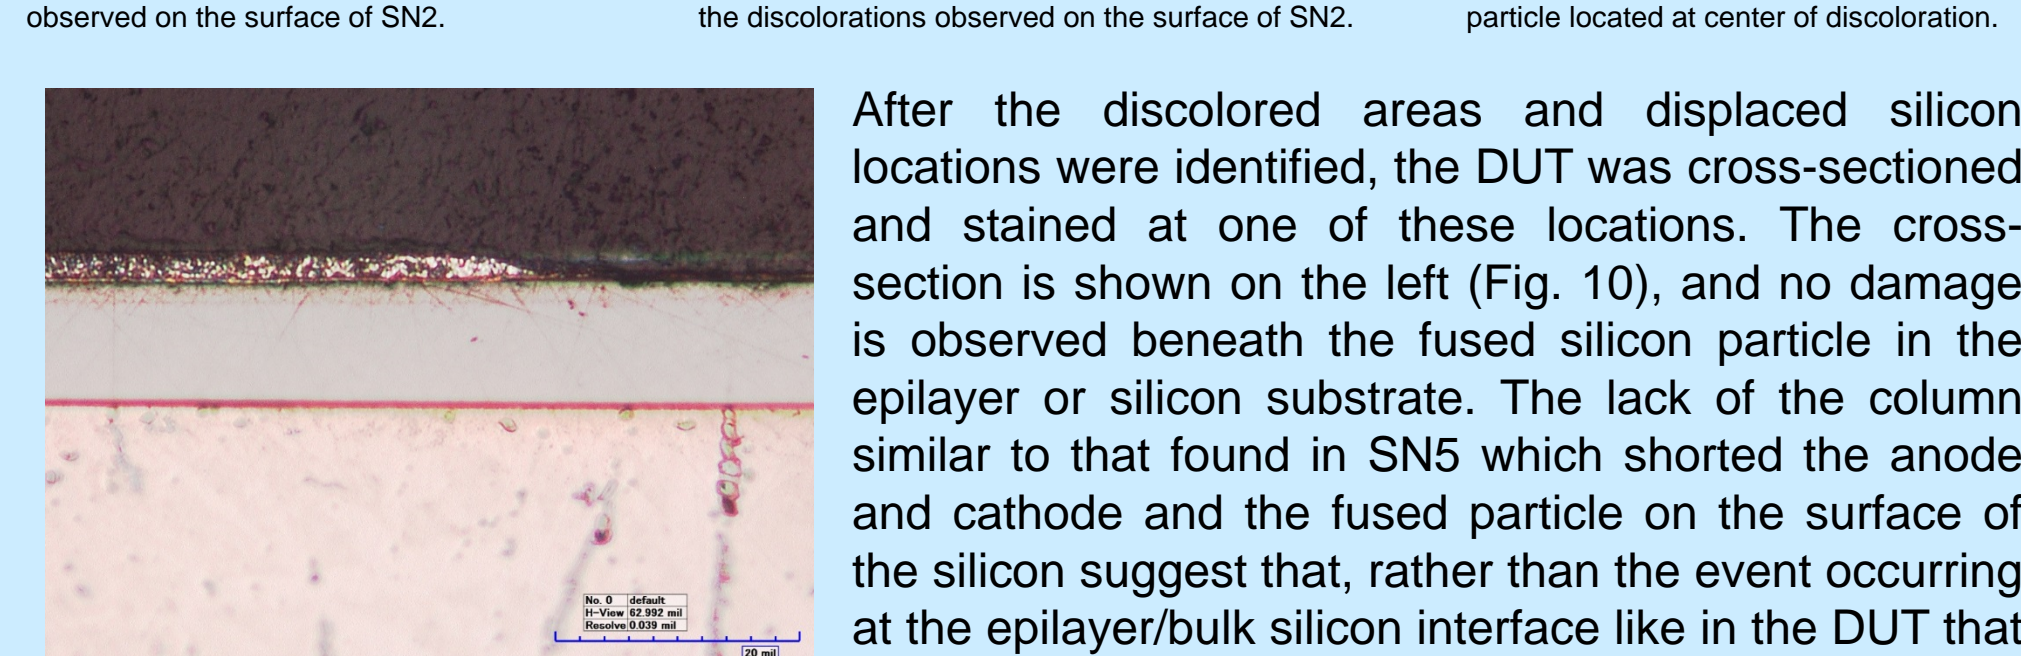
Fig. 10. The DUT was cross-sectioned through one of the displaced silicon particles at the center of the discolorated areas. No damage structure is present into the epilayer or bulk silicon.

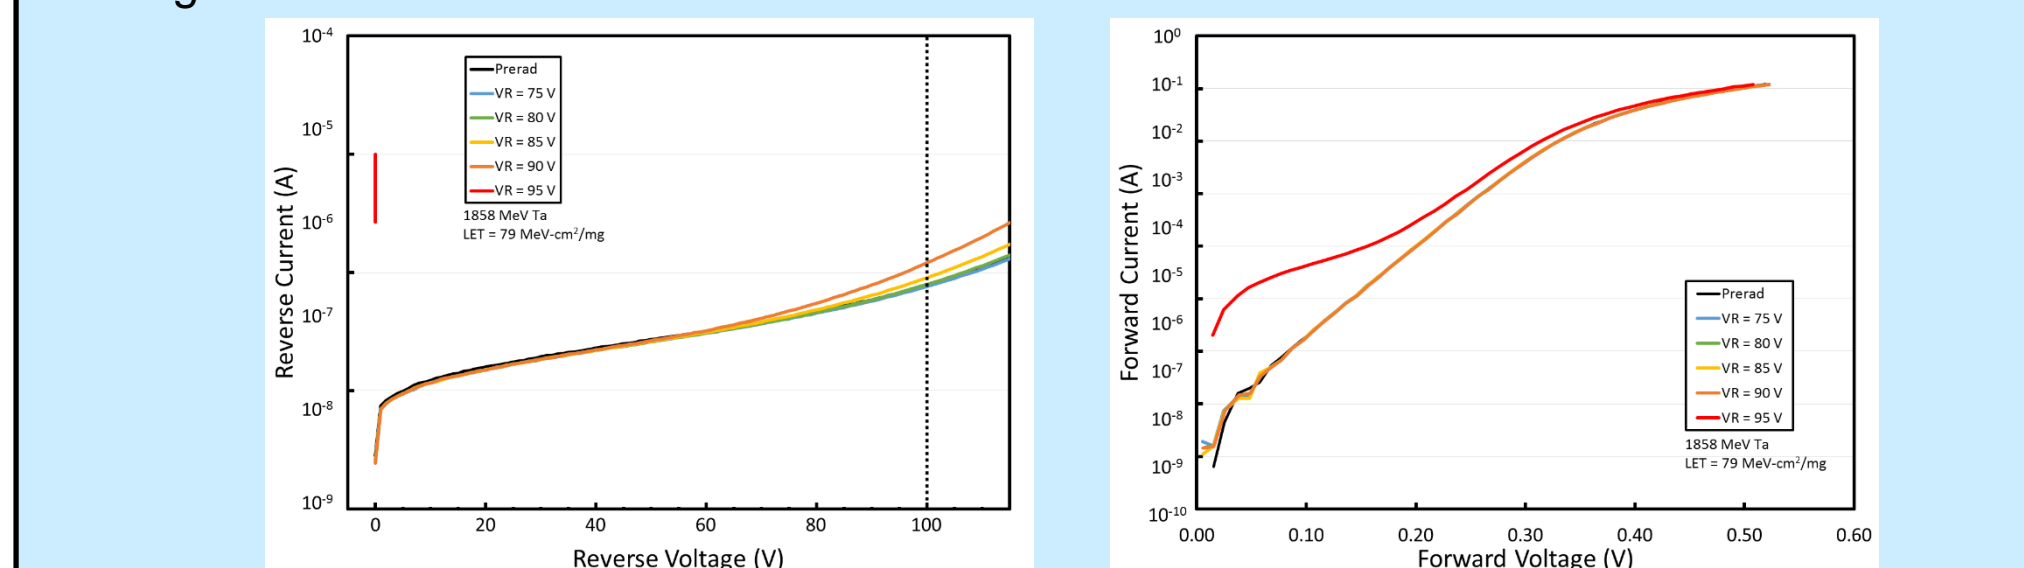
Fig. 11. Reverse currents from the power supply for SN7 during each beam run. The reverse voltage at which the DUT was biased is shown in the legend. Fig. 12a. The post-irradiation reverse current as a function of the reverse voltage is shown for each beam run. Fig. 12b. The post-irradiation forward current as a function of the forward voltage is shown for each beam run.

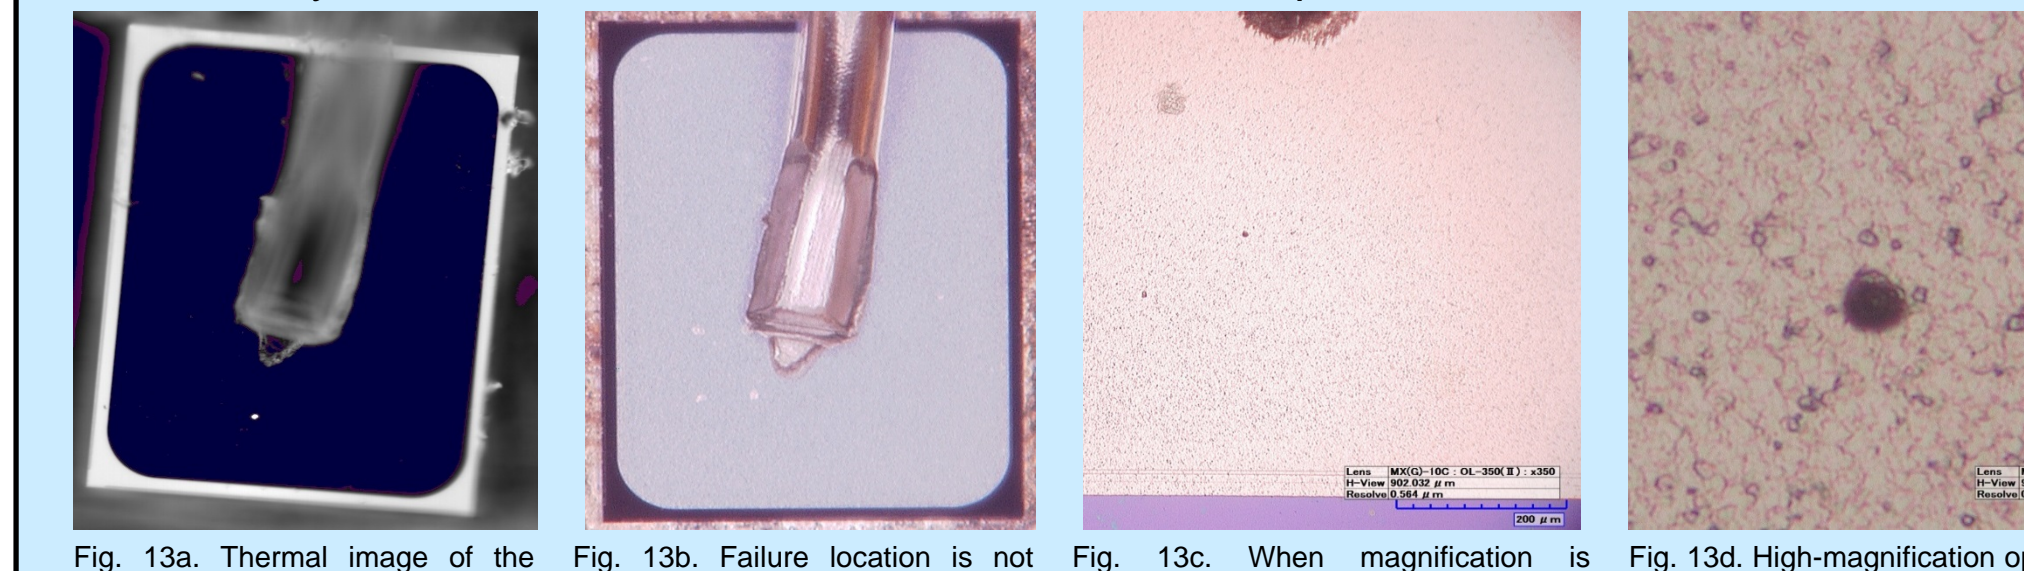
Fig. 13a. Thermal image of the irradiated DUT identifies location of failure. Fig. 13b. Failure location is not visible in low-magnification optical image. Fig. 13c. When magnification is increased, failure location is visible as a dark spot in optical images. Fig. 13d. High-magnification optical image of the failure location observed in the IR image.

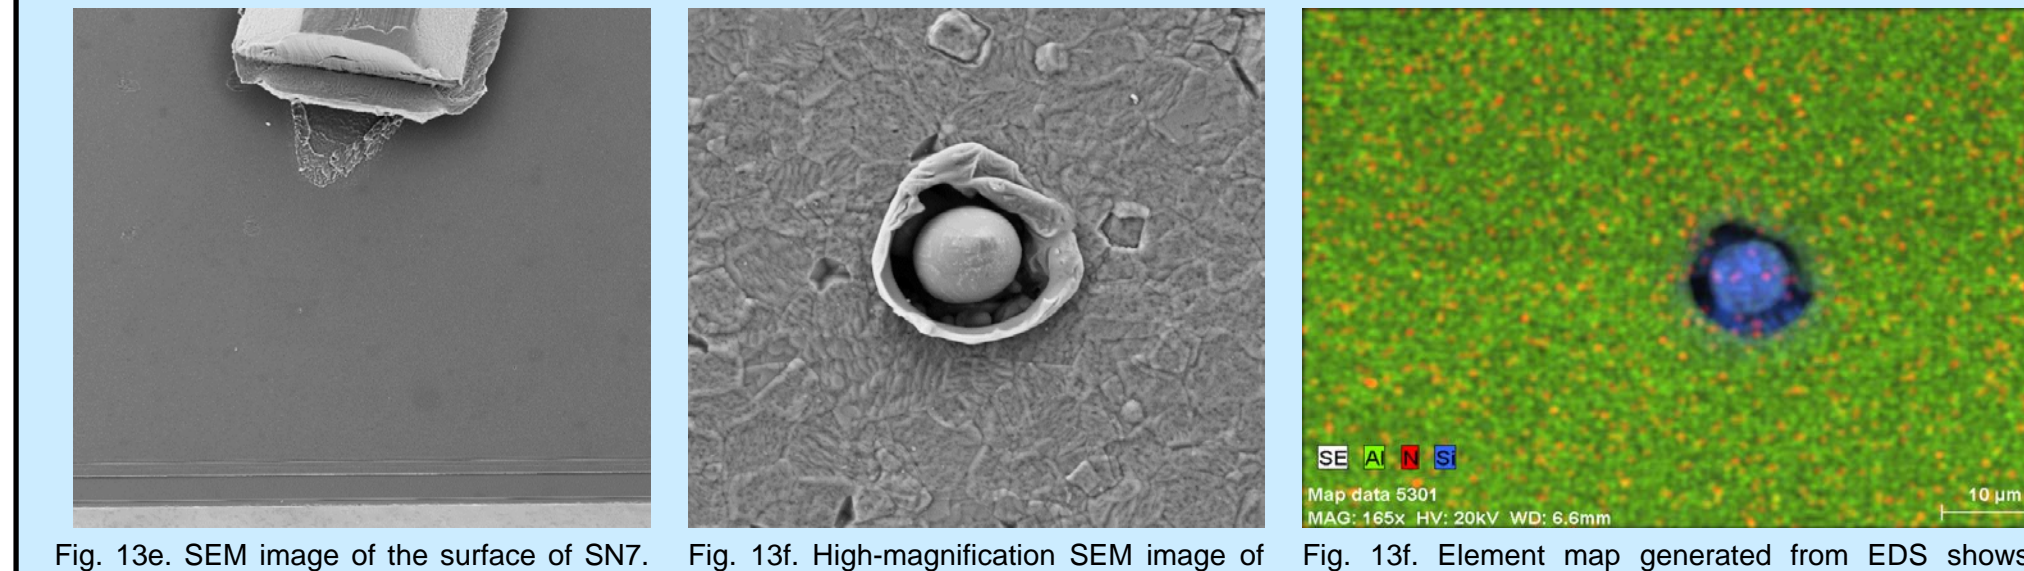
Fig. 13e. SEM image of the surface of SN7. Failure location is visible below the bondwires. Fig. 13f. High-magnification SEM image of failure location. Fig. 13g. Element map generated from EDS shows the Schottky barrier metal had melted away and silicon ball became displaced to the surface.

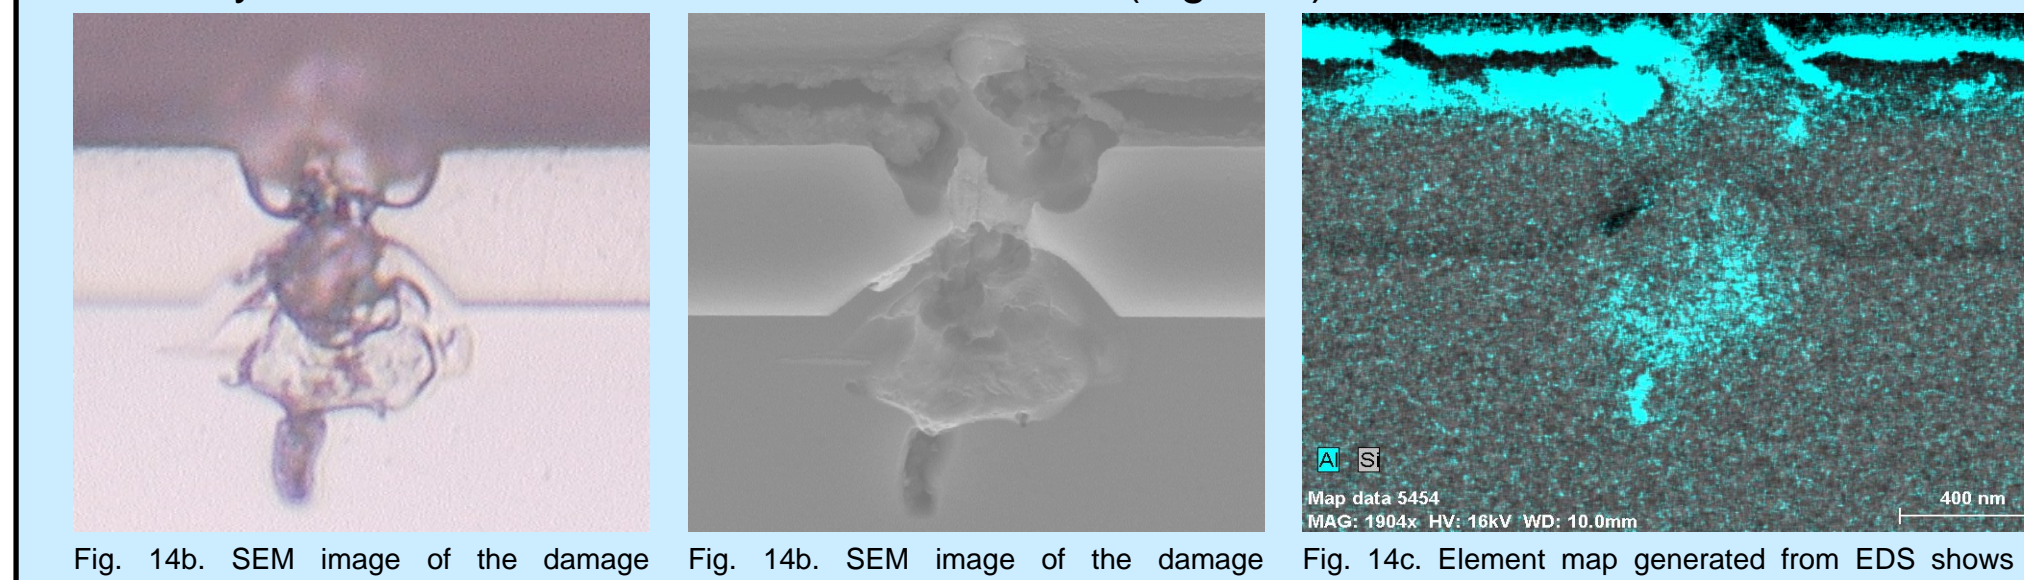
Fig. 14a. SEM image of the damage structure after the failure location in SN7 was cross-sectioned. Fig. 14b. SEM image of the damage structure after the failure location in SN7 was cross-sectioned. Fig. 14c. Element map generated from EDS shows the Schottky barrier metal migrated into the bulk silicon.
