NASA CR-1897

DESIGN AND APPLICATION OF POLYCARBONATE CAPACITORS IN AEROSPACE AC POWER SYSTEMS

by J. F. Gosda, A. C. Elles, and R. R. Bailey

TRW

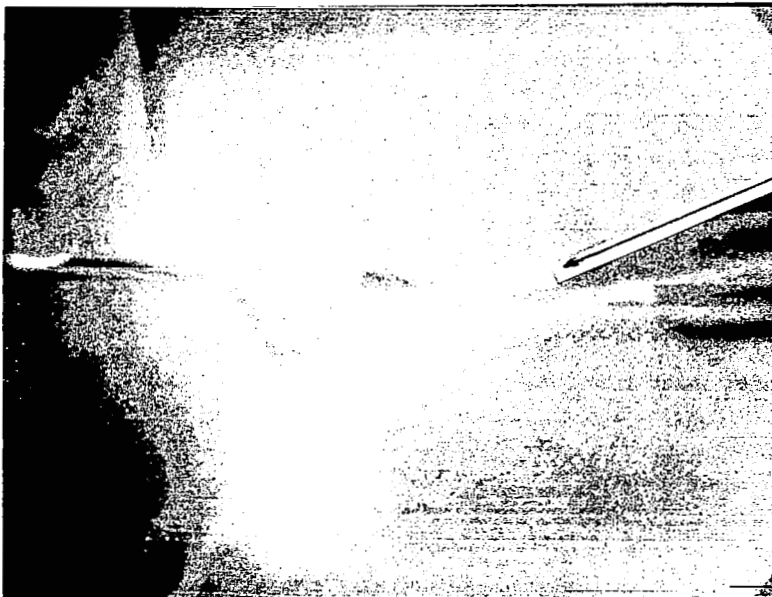
Ser. No. 47XA02

Note: Notice the deposit of metallizing on the layer of plain polycarbonate film.

FIGURE 47. Weakened dielectric due to the presence of corona is the cause for part failure (Design A-3). Refer to Failure Analysis #7. Magnification is 5.25X.
