THREE-STAGE POTASSIUM VAPOR TURBINE TEST

by B. L. Moor and E. Schnetzer

Prepared by
GENERAL ELECTRIC COMPANY
Cincinnati, Ohio 45215
for Lewis Research Center

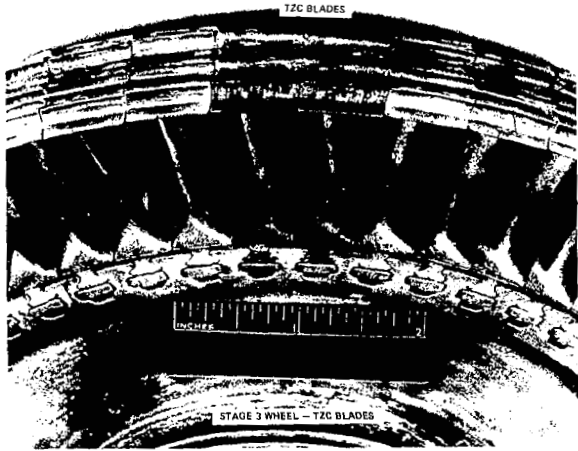
A 1400-hour test, carried out in 1968, ended with inconclusive results. The turbine was shut down as a result of excessive and inexplicable output torque reduction. Upon opening the turbine, it was discovered that the four Mo-TZM third-stage blades had lost substantial portions of their tip shrouds. In addition, many of the blade retainer clips of all stages had strain age hardened and fractured at the non-annealed aft assembly bend. Mechanical damage due to the retainer clip fragments was noted generally on rotor and stator blades. The damage to the leading edges of the third-stage rotor blades was such as to preclude separation of mechanical and erosive effects, Figure 2. The tip shroud fragments could have contributed to this leading edge damage.

Figure 2. Third Stage Turbine Wheel Showing Combined Mechanical and Erosion Damage After 1400 Test Hours in 1968. (P68-9-8J)

To eliminate the previous source of mechanical damage, new spring type bucket retainers, Figure 7, were developed and incorporated in the turbine. The tip shrouds of the third-stage rotor blades were removed to eliminate another potential for damage, Figure 8. This permitted direct visual blade tip inspection.

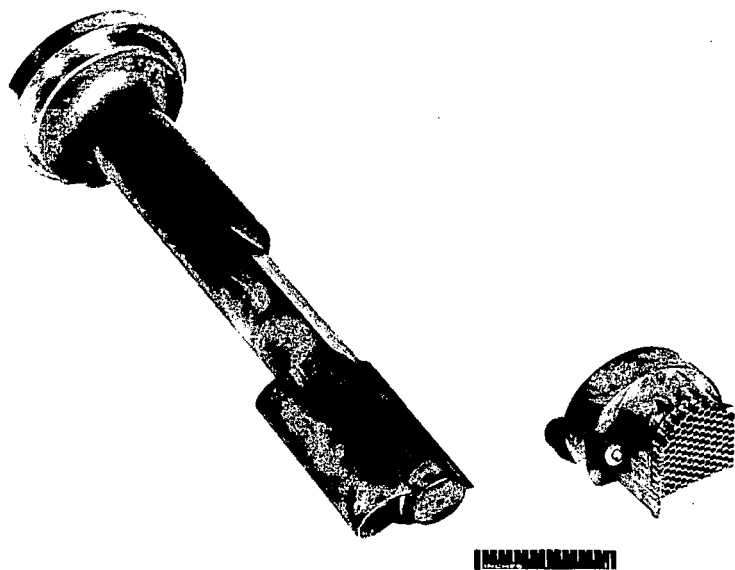
Figure 5. Stage 3 Removable Nozzle Vane and Tip Seal Insert After 405 Hr of Testing. (P69-9-25A)

Test Time	Stage 3 Mo and Rene' 77 Blades Washing Corrosion Comments	Stage 3 Mo and Rene' 77 Blades Impact Erosion Comments	Deposit Comments	Other Comments
405 Hr.	Serious corrosion grooves along lower leading edges and top of dovetail platform of Mo blades, roughly parallel to the direction of vapor flow. Leading edges were thinned and sharp. 33-50% of Rene' 77 blades showed minor flat at leading edge tips.	No evidence.	Deposits on all components appeared to be potassium oxides or hydroxides, probably formed when the viewport was opened.	Dial indicator measurements through viewport showed some leading edge loss from all types of blades.
1000 Hr.	Corrosion apparently continued in previous patterns at a reduced rate. Light corrosion pitting of convex surfaces appeared, but observations were somewhat obscured by the presence of a potassium film.	First indications appeared as pits on the convex tip leading edge corners of a few Rene' 77 buckets.	One mil thick Fe/Ni deposits were flaking off the blades, and Fe/Ni and potassium dizirconate deposits were present on the removable nozzle vane.	Increased leading edge material loss measurements.

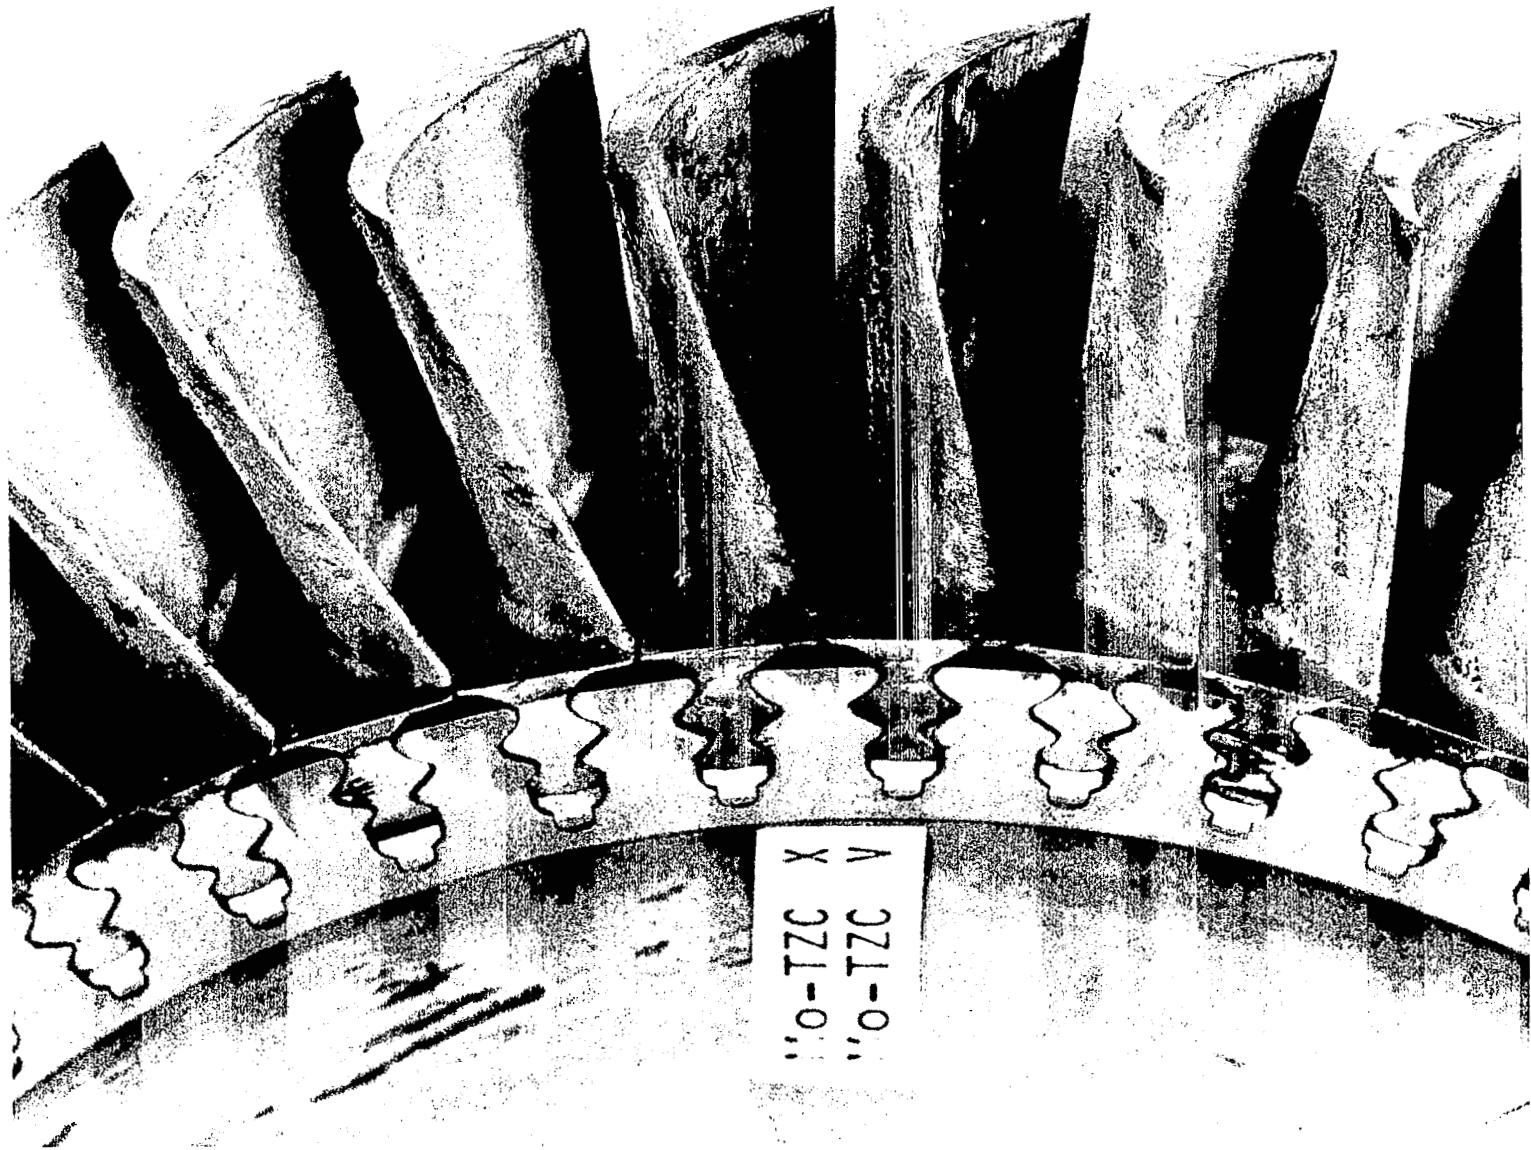
Washing corrosion was concentrated on the blades, with some minor evidence of its presence on tip seal honeycombs and the forward faces of the wheels, where the potassium vapor flowed through the interstage labyrinth seals. Oxygen ingestion through the efflux tube leaks washed grooves through the tip seal honeycombs and into their supporting structure at a few discrete locations adjacent to the leaks.

Figure 11. Forward Surface of Stage 3 Rotor Bucket and Wheel After 5000 Hour Test. Mo-TZC Buckets X and V in Center. (P70-6-19AE)

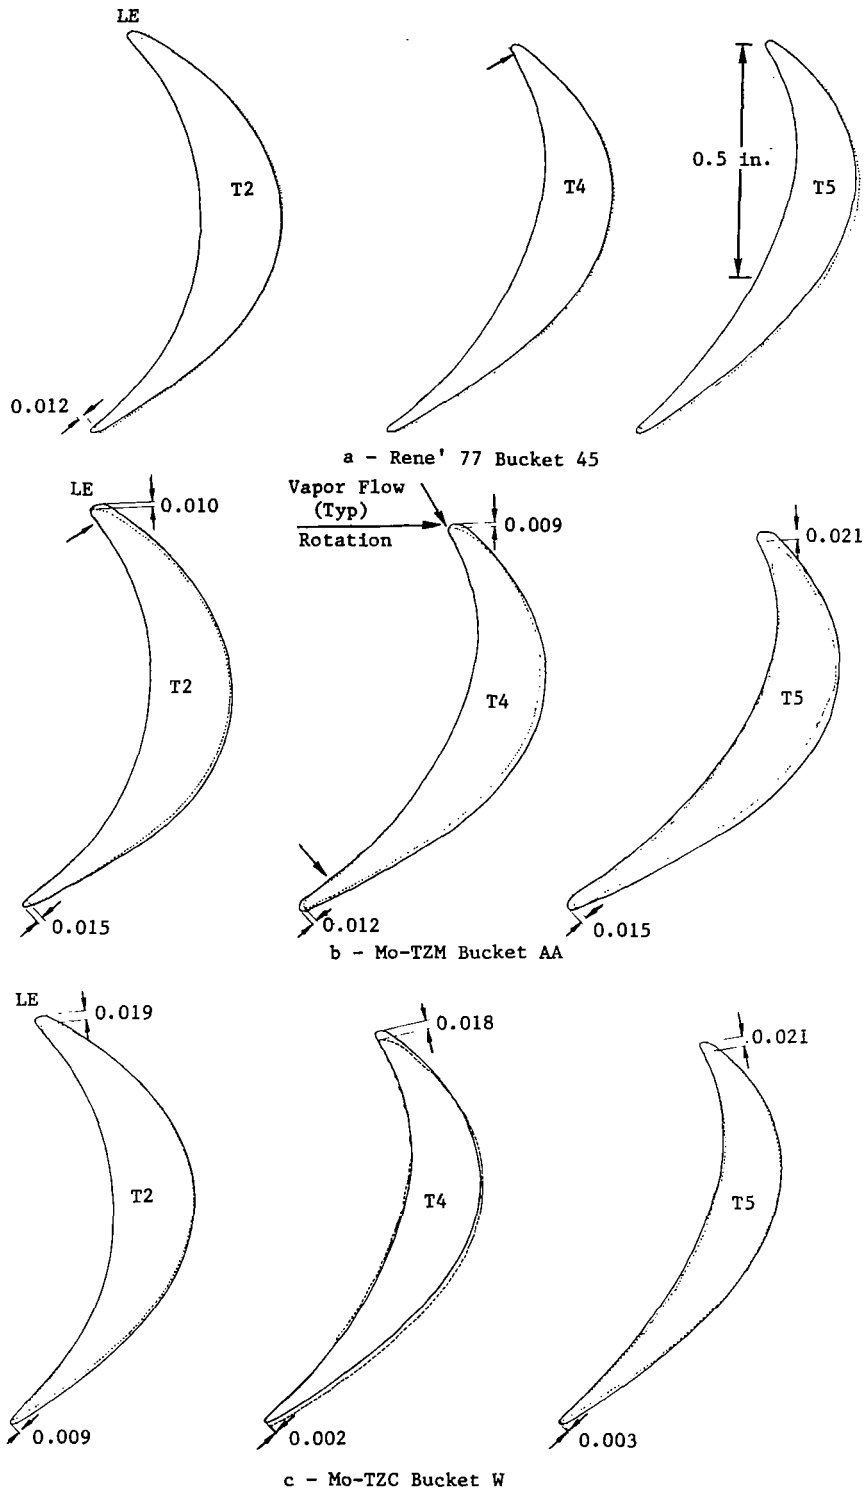
Rene' 77 bucket 45, Figure 12a, showed no loss of leading edge material except for a 5 mil deep x 10 mil wide corrosion groove on the T4 concave surface (see arrow). The 0-12 mil deposits not penetrated by the stylus were primarily potassium dizirconate. The trailing edge lost 12 mils at section T4, which is the approximate location where the concave and convex surface radial corrosion grooves intersect.

Mo-TZM bucket AA, Figure 12b, showed substantial leading edge and trailing edge material losses. The T2 and T4 concave surfaces were unchanged except for 0-5 mil deep radial grooves near the leading edge and trailing edge. The T5 concave surface lost material generally, up to 10 mils depth. All convex surfaces lost material generally, up to 20 mils depth, an indication of washing corrosion.

Mo-TZC bucket W, Figure 12c, showed wear patterns similar to those of Mo-TZM bucket AA. Both Mo-TZC and Mo-TZM are similarly susceptible to corrosion by potassium which contains oxygen. The difference in material loss at comparable positions is a function of the ability of the stylus to penetrate the deposits on the buckets and of the observer to accurately match the pretest and post-test airfoil contours.

Figure 12. Pantascrobe Measurements of Three Stage 3 Rotor Buckets Before and After 5000 Hour Test With Potassium Dizirconate Deposits Present.
(All Dimensions in Inches)

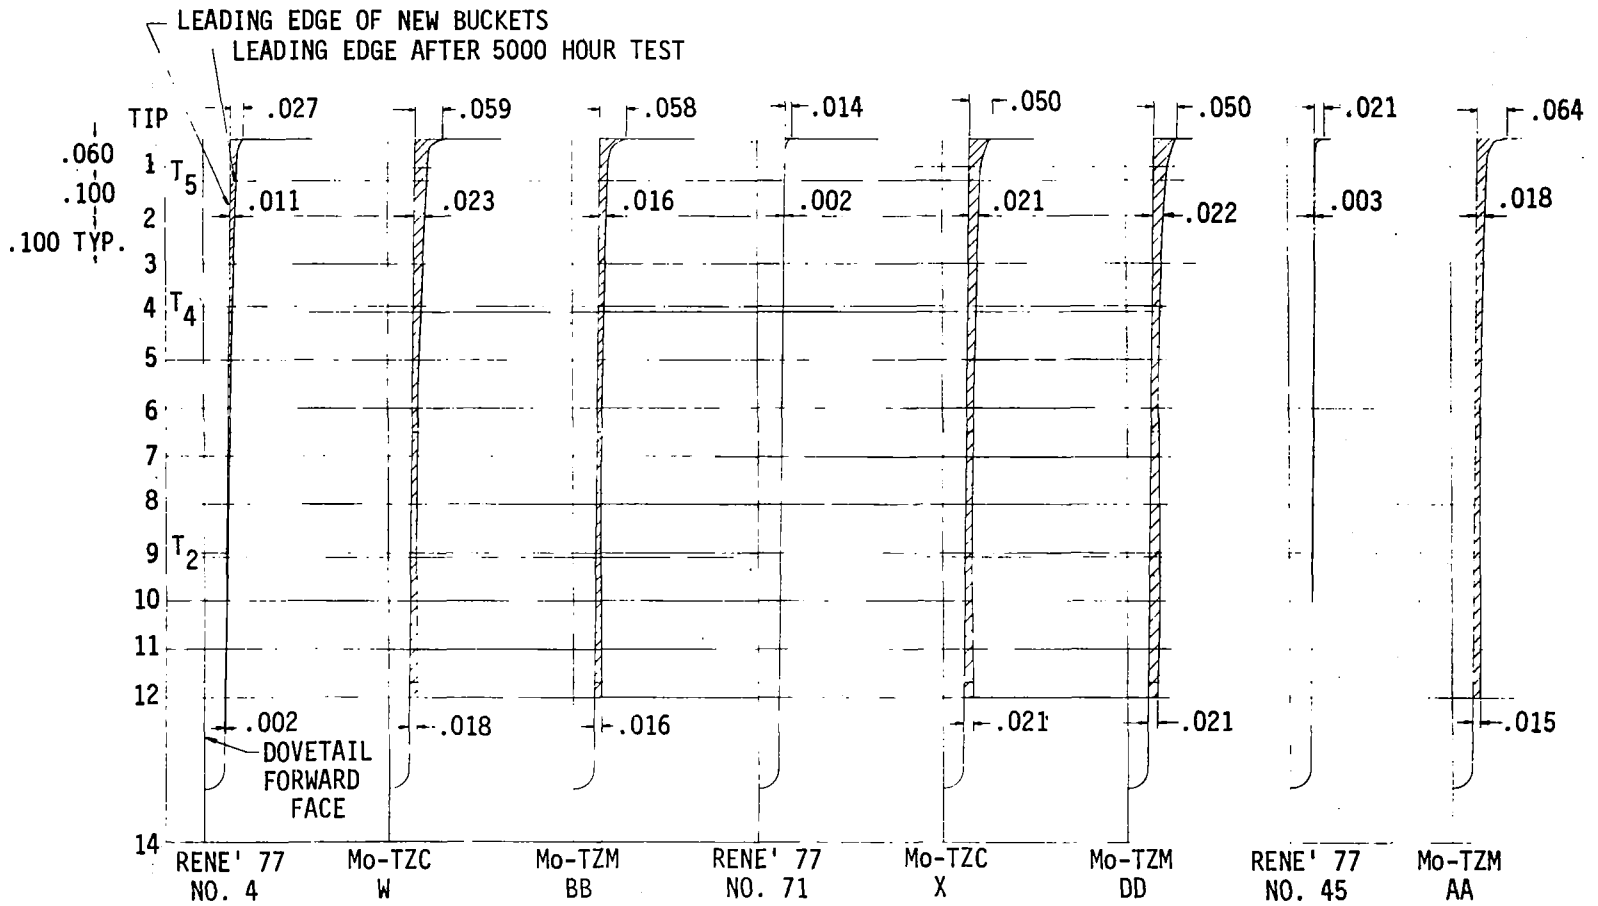
Figure 13. Surface Plate Measurements of Stage 3 Bucket Leading Edges.
(All dimensions in inches)

at 0.1 inch increments. The dovetail forward faces were used as a reference since shallow pretest identification marks and machining grooves could be seen when not covered by the metallic film. The differences between pretest and post-test configurations correlate well with the Pantascribe measurements of Figure 12.

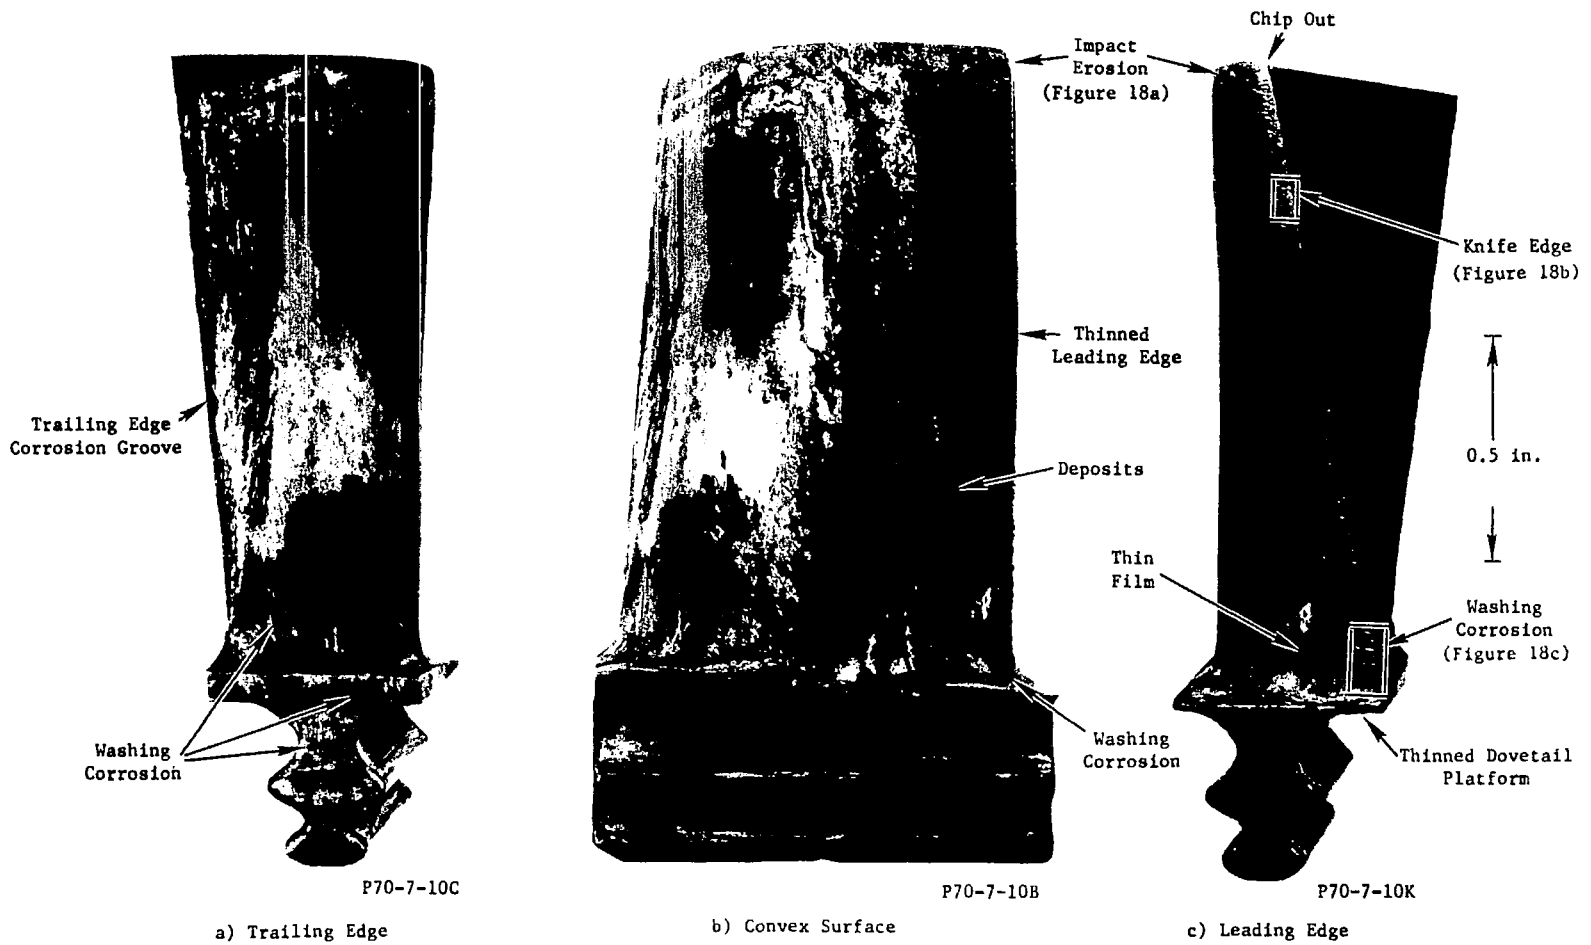
To characterize the third stage buckets and the thin films found on them, metallographic and chemical analysis techniques were employed. Figure 17c shows the leading edge of a Stage 3 Mo-TZM bucket. The heaviest washing corrosion occurred at the root of the blade. On top of the dovetail platform, where undercutting can be noted, the upper portion of the airfoil has been worn to a knife edge. A small amount of

Figure 17. Mo-TZM CC Third Stage Rotor Bucket Following 5000 Hours Exposure to Potassium - Inlet Vapor Temperature 1250°F, Vapor Quality 90-93%, Tip Speed 845 ft/sec.

impact erosion damage is evident at the tip of the blade despite the washing corrosion which also occurred at the tip.

Figure 17b shows a deep corrosion groove that starts on the pressure surface and extends radially upward on the suction surface. These observations are typical for both Mo-TZM and Mo-TZC buckets.

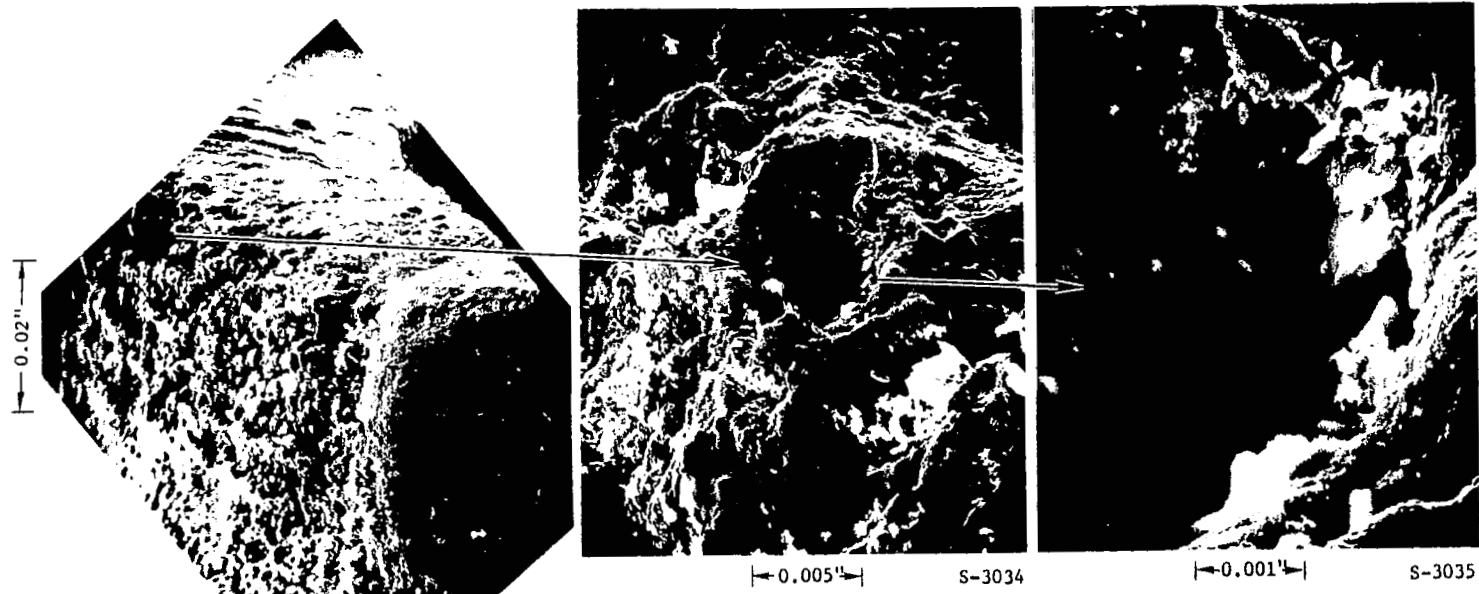
Figure 18a is a scanning electron micrograph of the impact erosion at the tip of a Mo-TZM bucket. Great similarity is seen between this surface and impingement erosion surfaces reported in the literature;⁽¹²⁾ however, no cracks were noted at the base of the pits. The evidence of corrosion products, seen as white particles in Figure 18a,* indicated the surface has been altered by washing corrosion.

a) Impact Erosion at Convex Surface Tip

b) Washing Corrosion Grooves and Pits in Upper Leading Edge Convex Surface

c) Washing Corrosion Grooves and Pits in Root of Airfoil Leading Edge Convex Surface. (Area of Extensive Washing Corrosion)

Figure 18. Magnified Views of Damage on Stage 3 Mo-TZM Bucket No. CC.

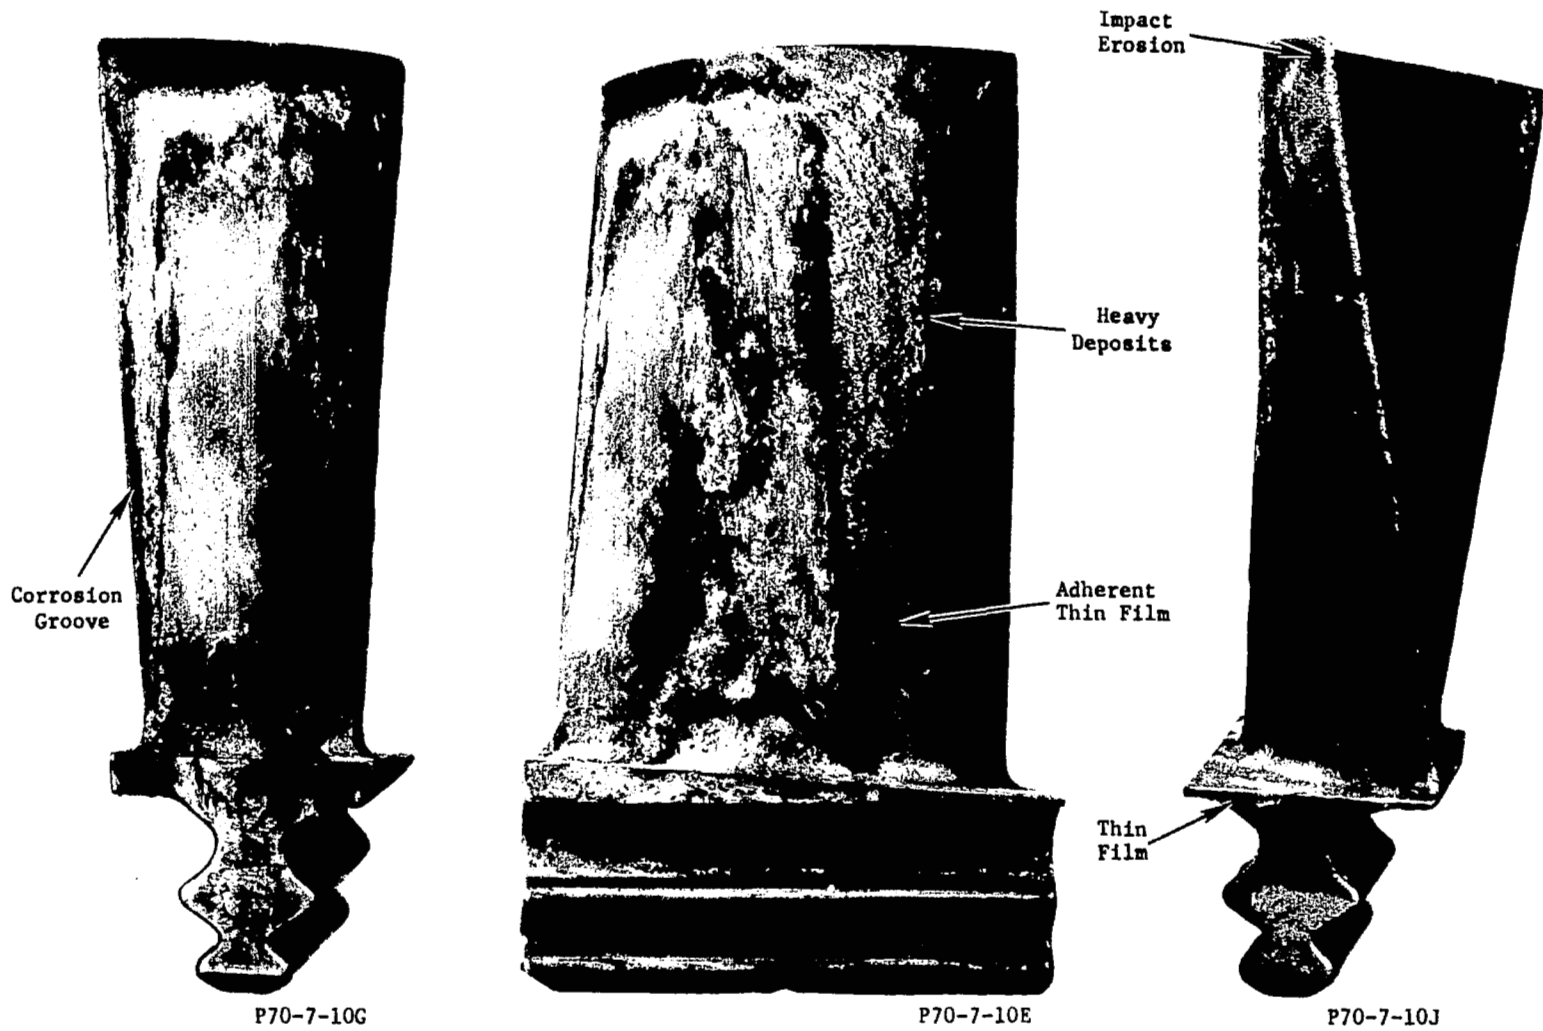
Figure 20 shows a Stage 3 Rene' 77 bucket. Except for signs of impact erosion at the tip of the bucket and the presence of the thin films and deposits, the Rene' 77 buckets show very few signs of deterioration.

Apparently the differences in appearance between the molybdenum alloy and nickel alloy buckets can be attributed to oxygen effects.

Figure 20. Rene' 77 No. 19 Third Stage Rotor Bucket Following 5000 Hours Exposure to Potassium-Vapor Temperature 1250°F, Vapor Quality 90-93%, Tip Speed 845 ft/sec.

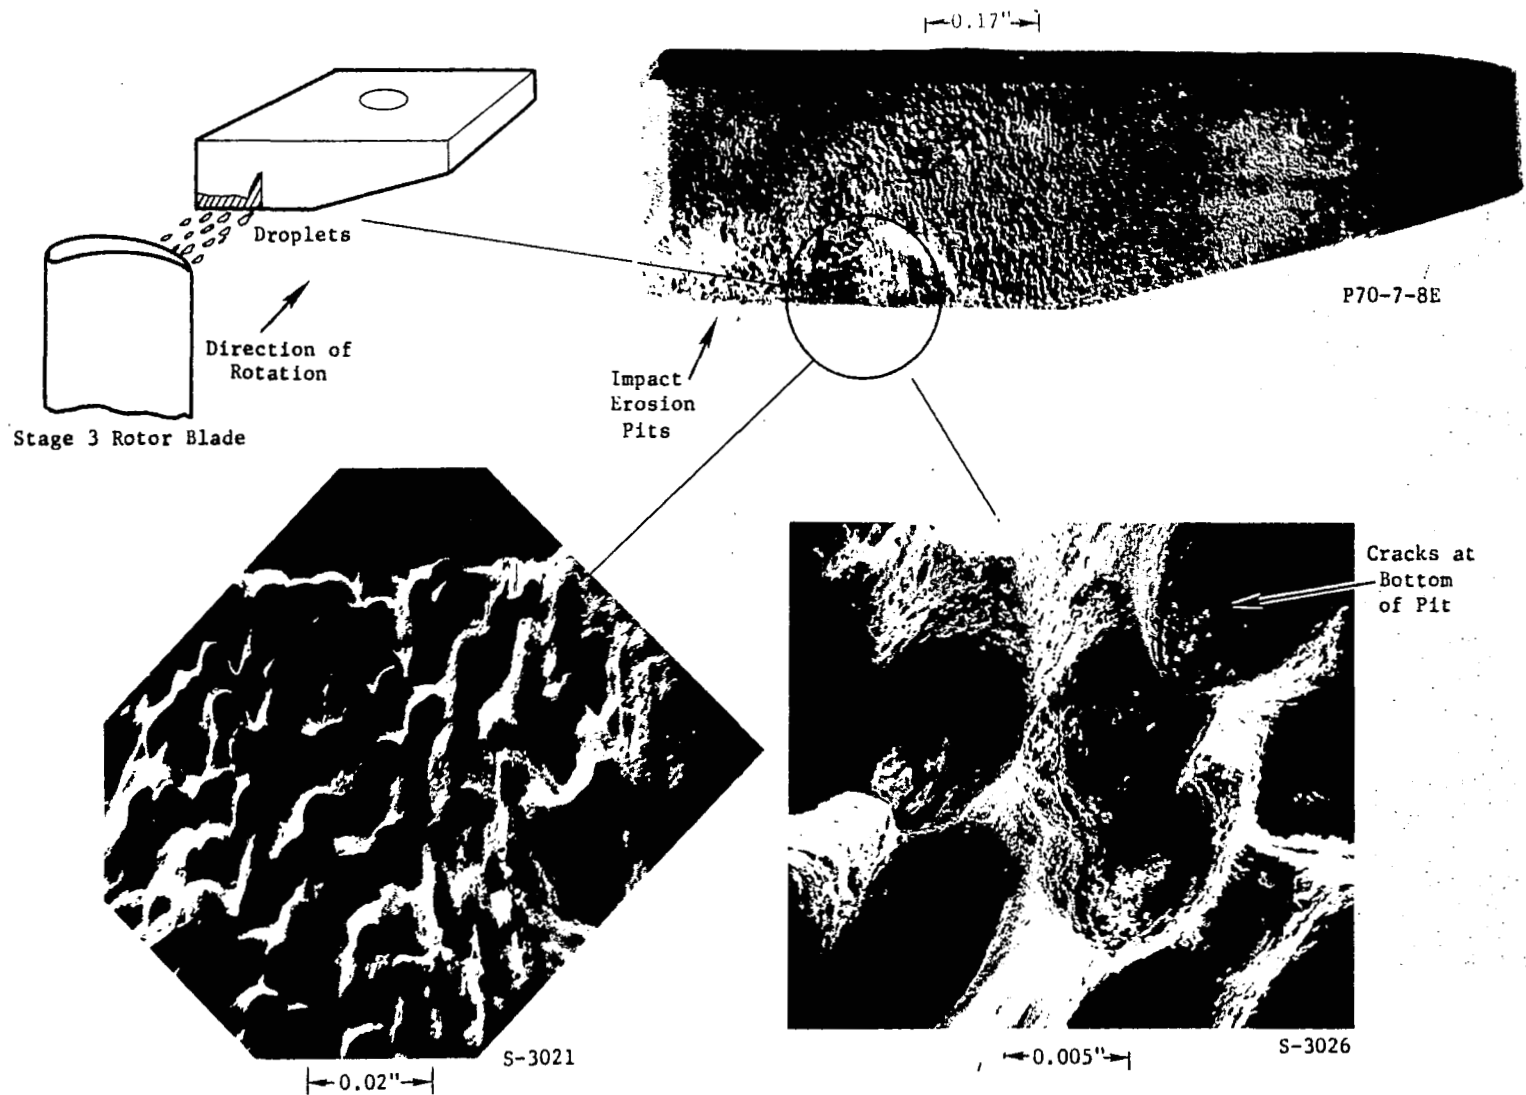
Table V contains the summary of erosion insert volume loss which indicates that the molybdenum alloys lost about 0.1 cubic centimeter, sixteen times that of Rene' 77 and eight times that of the U-700. However, the material loss of the molybdenum inserts by washing corrosion is part of the total volume loss.

Figure 21. Impact Surface of Mo-TZM No. 1 Erosion Insert and Magnifications of Damage After 5000 Hours of Test.

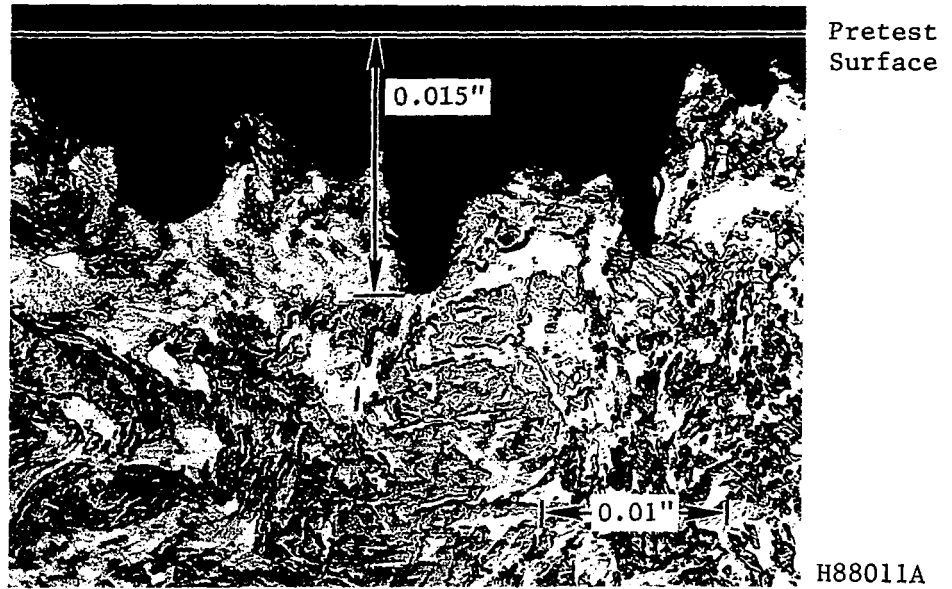
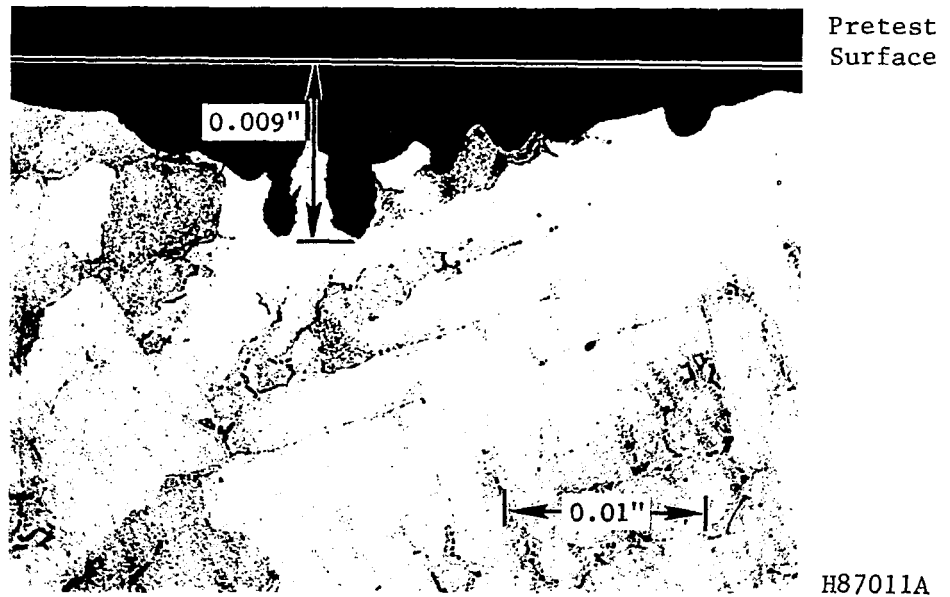
a) Mo-TZC - Maximum Pit Diameter = 0.0090 In.

b) Rene' 77 - Maximum Pit Diameter = 0.0025 In.

Figure 22. Magnified Cross-Sections of Mo-TZM and Rene' 77 Erosion Inserts.
