CR-72690  
MDC G0729

# SPACE-STORABLE OXIDIZER VALVE

FINAL REPORT  
NOVEMBER 1970

McDonnell Douglas Astronautics Company—West  
McDonnell Douglas Corporation  
5301 Bolsa Avenue  
Huntington Beach, California 92647

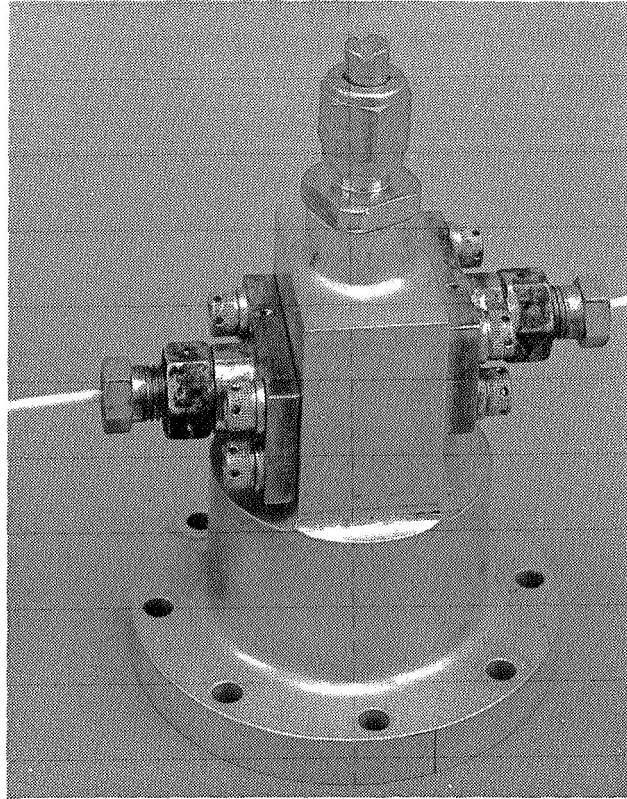
Figure 3-14. -1 Valve Actuator Cap After Task III Testing

A preliminary visual inspection of the valve exterior showed some black deposits on the position indicator bosses and lock nuts (Figure 3-14). Otherwise, the valve's appearance was normal. The appearance of the valve's inlet and outlet flanges, internal cavities, and static seals after removal of the test adapters was also normal. The valve was disassembled, noting the tightening torque of each bolt or screw before removal. All torque values were found to be within specification. Removal of the actuator cap revealed black soot deposits around the entire circumference of the piston seal and the seal recess in the actuator cap (Figures 3-15 and 3-16). Also, two grooves were burned in the teflon seal where it contacted the piston (Figure 3-17). Later removal of the position indicator bosses and seals showed no evidence of damage or leakage. From this it is concluded that all external  $\text{GF}_2$  leakage was through the actuator vent port. Next, the indicator nut, actuator piston, inner and outer springs, piston shims, and the actuator housing were removed. All of these parts were in good condition, showing no signs of fire damage. Minor impact marks on the actuator piston face, and spring scratches inside the actuator housing were the result of operation at the proof-pressure condition (Figures 3-18 and 3-19). At this time, the valve inlet was pressurized with 20 psig ( $1.38 \times 10^5$  pascals) GHe, producing audible leakage around the poppet shaft. The bellows adapter seal appeared to be leak-tight. Also, movement of the poppet shaft from side to side changed the intensity of the audible leakage, a strong indication that the poppet-shaft bellows seal was cracked. Finally, the poppet and the seat assemblies were removed (Figures 3-20 and 3-21). These parts and their associated static seals were in excellent condition. The mating flanges and seal recesses of the valve body and the seat showed some discoloration (Figures 3-22 and 3-23), but

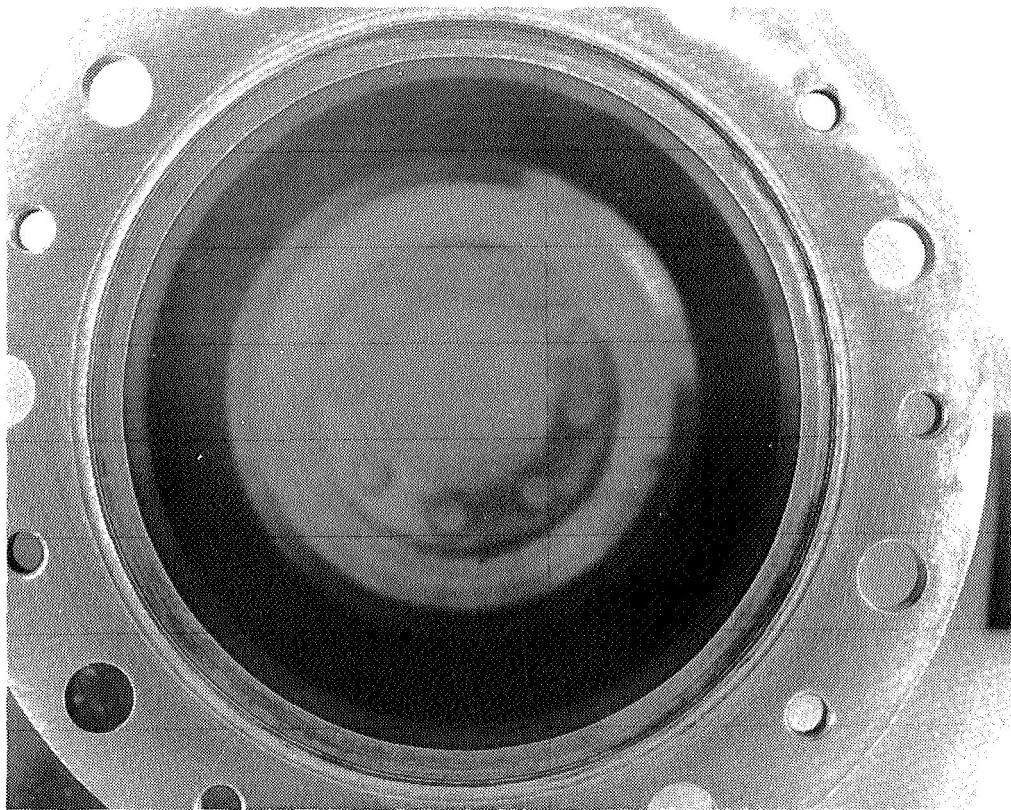
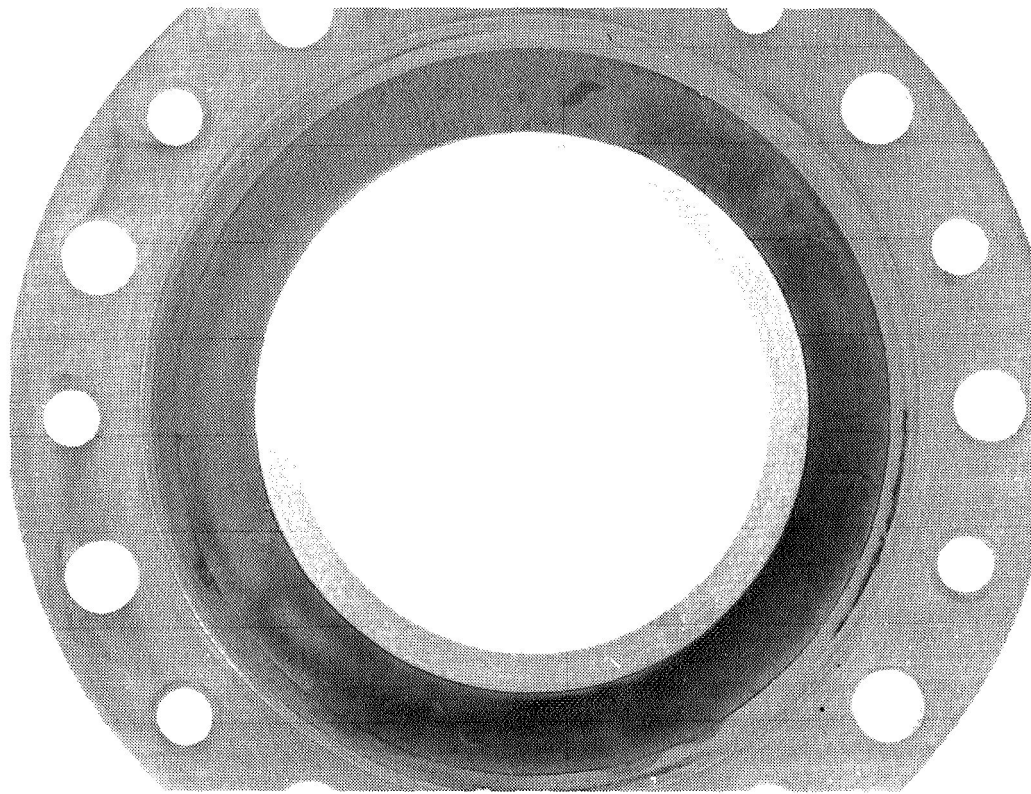
Figure 3-22. -1 Valve Body Inlet Flange After Task III Testing

Figure 3-23. -1 Valve Seat (Rear View) After Task III Testing

this was later removed in a routine cleaning operation. Figure 3-24 shows the -1 valve completely disassembled.

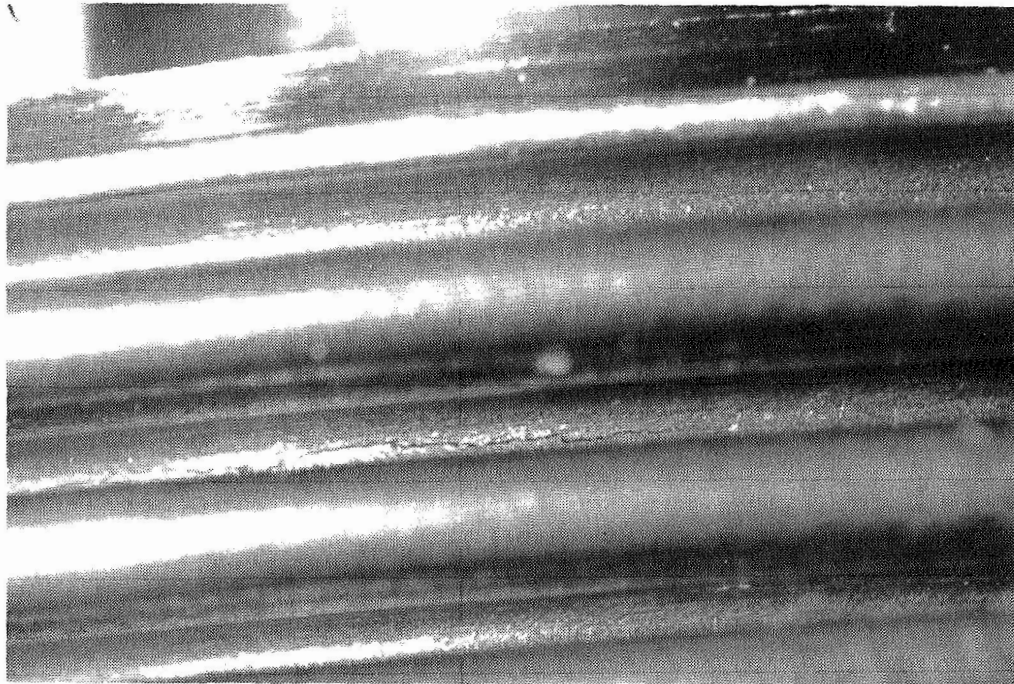
Figure 3-27. -1 Valve Poppet-Shaft Bellows Fatigue Crack

the design-integrity proof pressure of 250 psig ( $1.73 \times 10^6$  pascals). A fatigue crack occurred in the poppet-shaft bellows seal after 571 cycles. The crack, caused by a ringing vibration of the poppet shaft when the actuator piston repeatedly reached the limit of its travel during valve closing, is an explainable failure at the stringent off-design pressure condition of the test. Subsequently, both valves were exposed to a series of environmental tests.

The -1 valve was returned to Parker Hannifin Corp. for repair of the damaged bellows seal, and also for rework of the static seal recesses. The latter work was required in connection with a special test of external seal leakage. Although internal leakage rates for this valve were well within specification before rework, they became excessive after the rework. The difficulty, traced to imperfectly lapped poppet and seat sealing surfaces, was eventually solved by relapping the -1 seat and installing the -501 poppet assembly. A test to verify satisfactory external leakage characteristics of the static seals at  $LN_2$  temperature was accomplished by installing the -1 valve in an evacuated tank and monitoring vacuum decay. External leakage rates of less than  $1.2 \times 10^{-5}$  ccs were measured with the valve inlet pressurized to 100 psig ( $6.90 \times 10^5$  pascals) and  $2 \times 10^{-4}$  ccs with both the inlet and outlet portions of the valve pressurized.

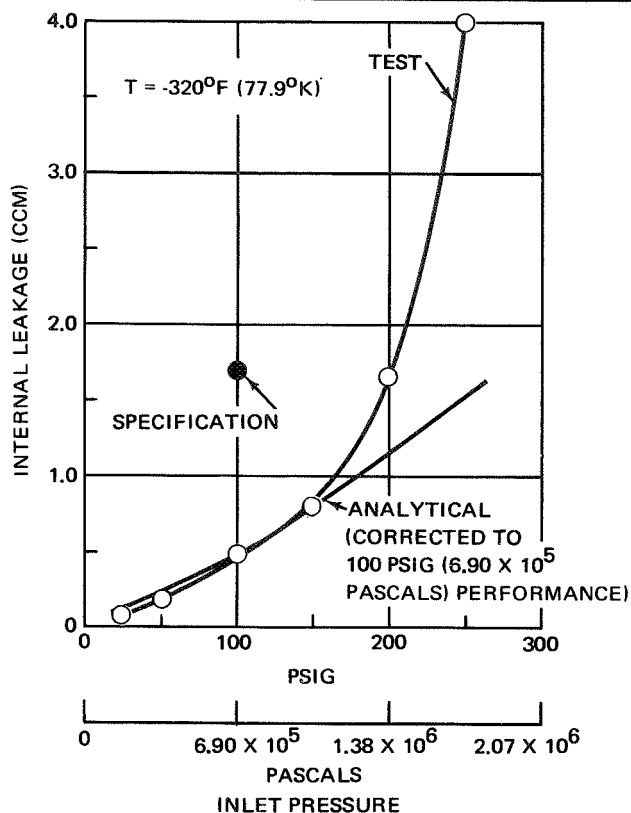
Figure 3-28. Low-Temperature Internal Leakage of -501 Valve After 373 Cycles

As expected, the -501 valve showed an improvement in internal leakage with cycling. The initial leakage of 0.27 ccm ( $4.51 \times 10^{-3}$  ccs) dropped to 0 at ambient temperature conditions at the end of the test (307 cycles), and the low-temperature data showed a drop from an unacceptable 2.85 ccm ( $4.76 \times 10^{-2}$  ccs) to an acceptable 0.47 ccm ( $7.85 \times 10^{-3}$  ccs) after cycling. This decrease in leakage appears to have occurred during the first few cycles in  $\text{LF}_2$ , with the leakage rate remaining fairly constant for the duration

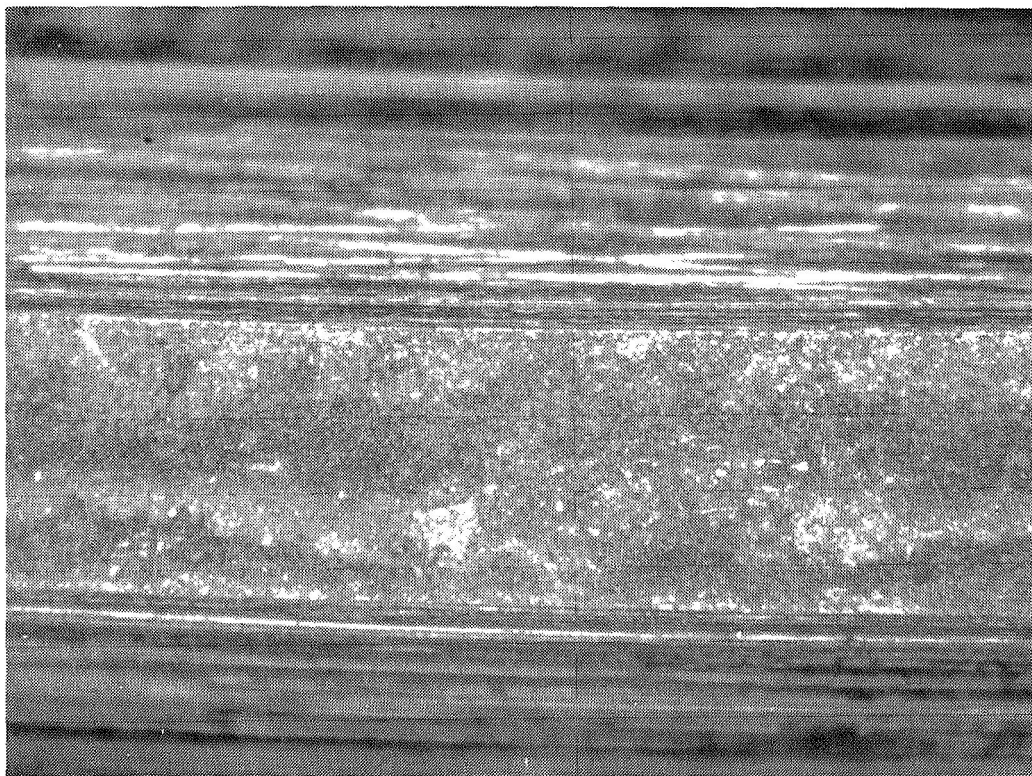
Figure 3-48. Sealing Surface of -1 Valve Seat After Vibration Tests (100X)

Finally, the valve was subjected to sinusoidal and random vibration loading profiles while exposed to 100 psig ( $6.90 \times 10^5$  pascals)  $LF_2$ . Posttest leakage checks and valve disassembly showed that the valve successfully withstood the imposed vibration loads, and demonstrated that the design is sound. Internal valve leakage rates below the NASA goal of  $10^{-8}$  lbm/sec ( $4.54 \times 10^{-9}$  kg/sec) of GHe at  $-320^\circ F$  ( $77.9^\circ K$ ) and 100 psig ( $6.90 \times 10^5$  pascals) (equivalent to  $10^{-7}$  lbm/sec [ $4.54 \times 10^{-8}$  kg/sec] of  $GF_2$  at  $-290^\circ F$  [ $94.4^\circ K$ ] and 100 psig [ $6.90 \times 10^5$  pascals]) were consistently demonstrated for both valve configurations.
