NASA CR 72732

CRYOGENIC POSITIVE EXPULSION DIAPHRAGMS

NASA Lewis Research Center
Contract NAS 3-11204
R. F. Lark, Project Manager

Final Report

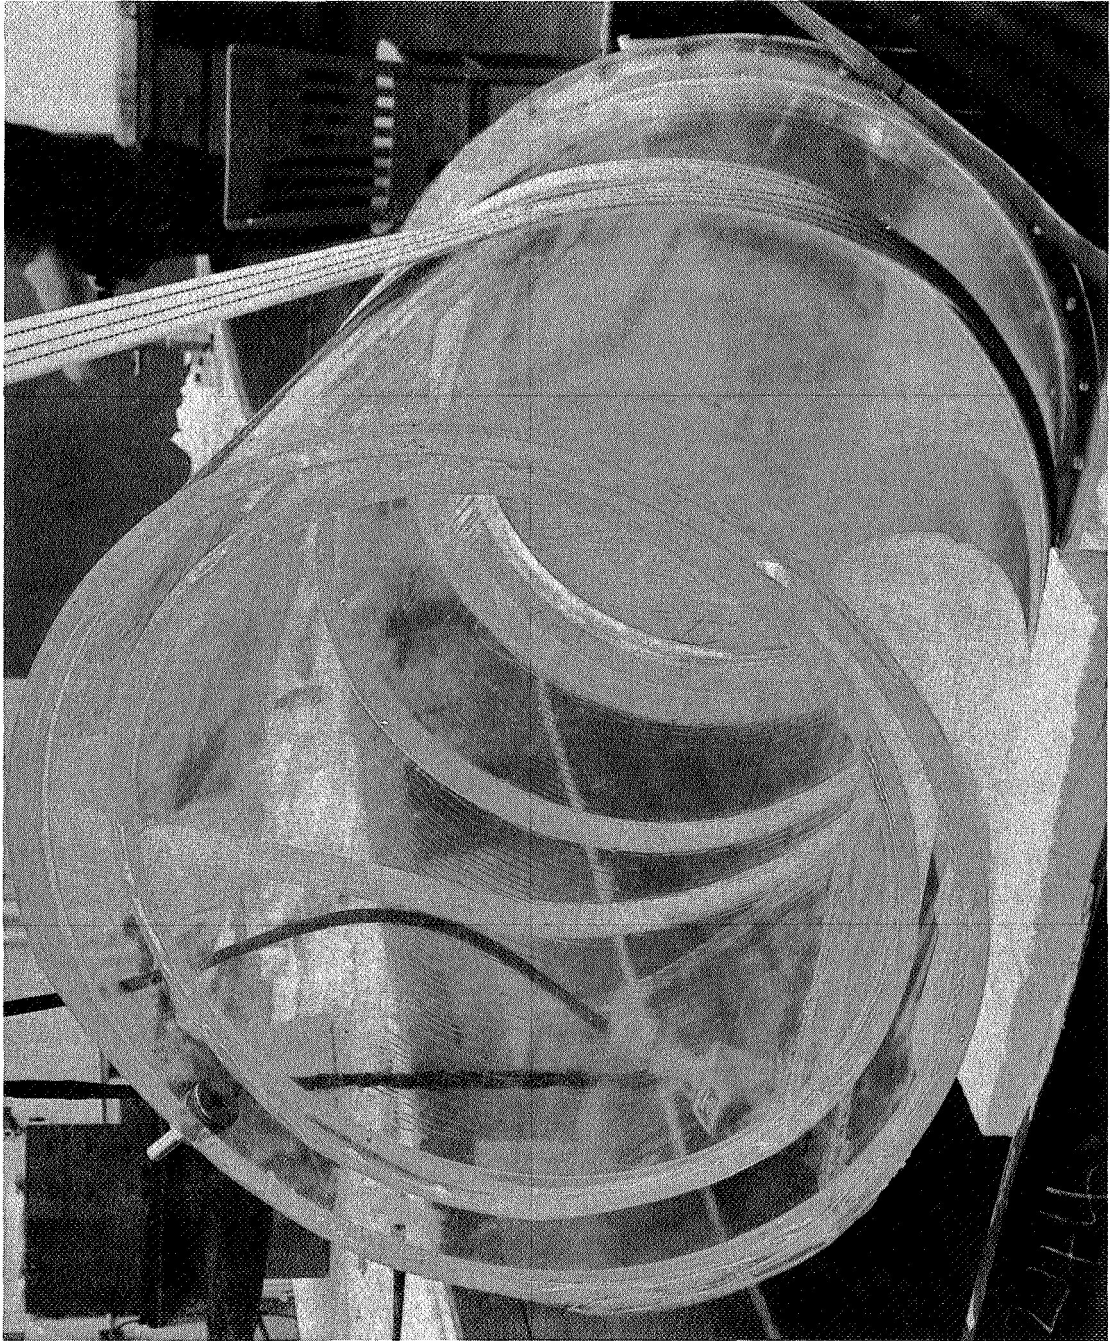
Figure 26: PLEXIGLASS DEWAR

Plexiglass - Plexiglass Unit---This unit was fabricated of cylindrical sections of plexiglass "Plex II." Each cylinder had a thick flat plexiglass bottom. A stainless steel mating flange with dovetail grooves for plexiglass potting was used. After leak check and LH₂ chill and helium leak check, the unit was tested at the Tulalip Test Site with LH₂ after an initial cooldown with gas from the liquid source. Both bottoms of the inner and outer cylinders were broken off instantaneously when liquid hydrogen contacted the inner container. This unit is shown in Figure 26 after LH₂ cold shock.

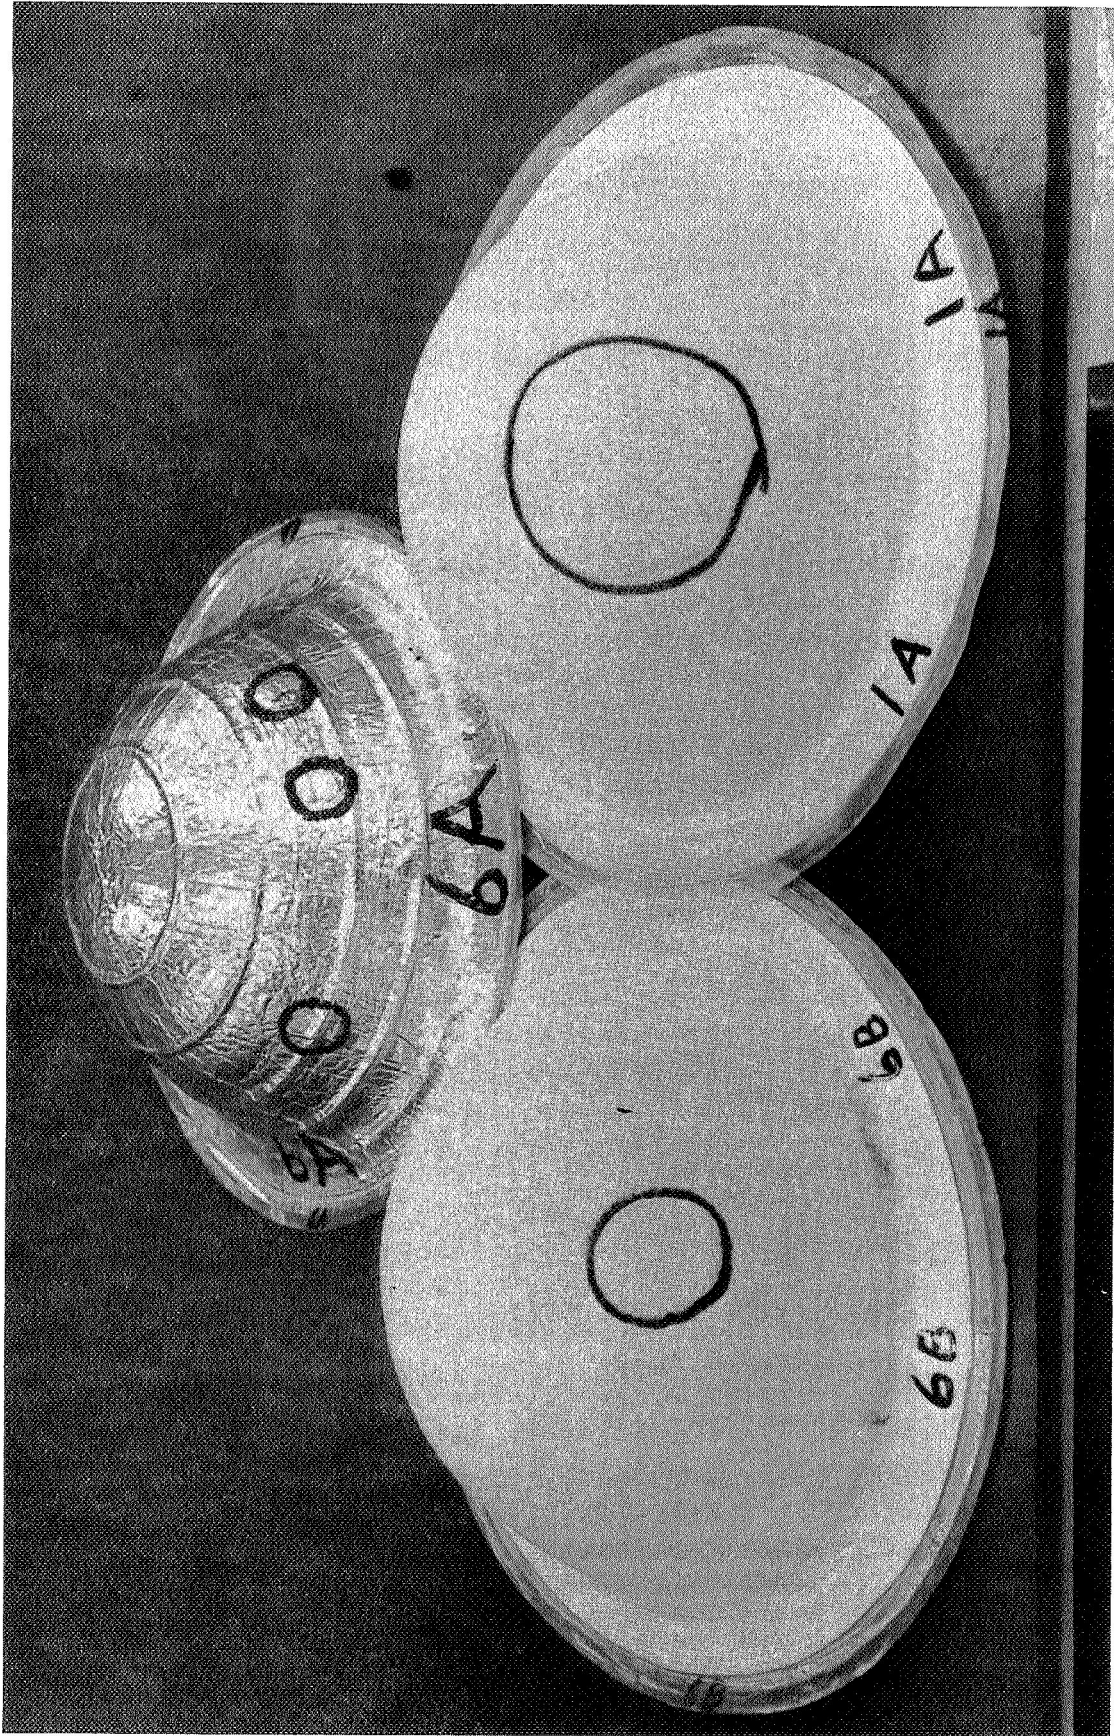
Figure 35: TEST DIAPHRAGM RESULTS

Diaphragm 1A failed in a seam joint of the butted gores as shown in Figure 35.

Excessive porosity was evident after initial vacuum purge and initial leak checks. As shown in Figure 35 the leakage occurred in the conical-hemispherical head joint area. The leak measuring equipment could not record the flow through the unit.

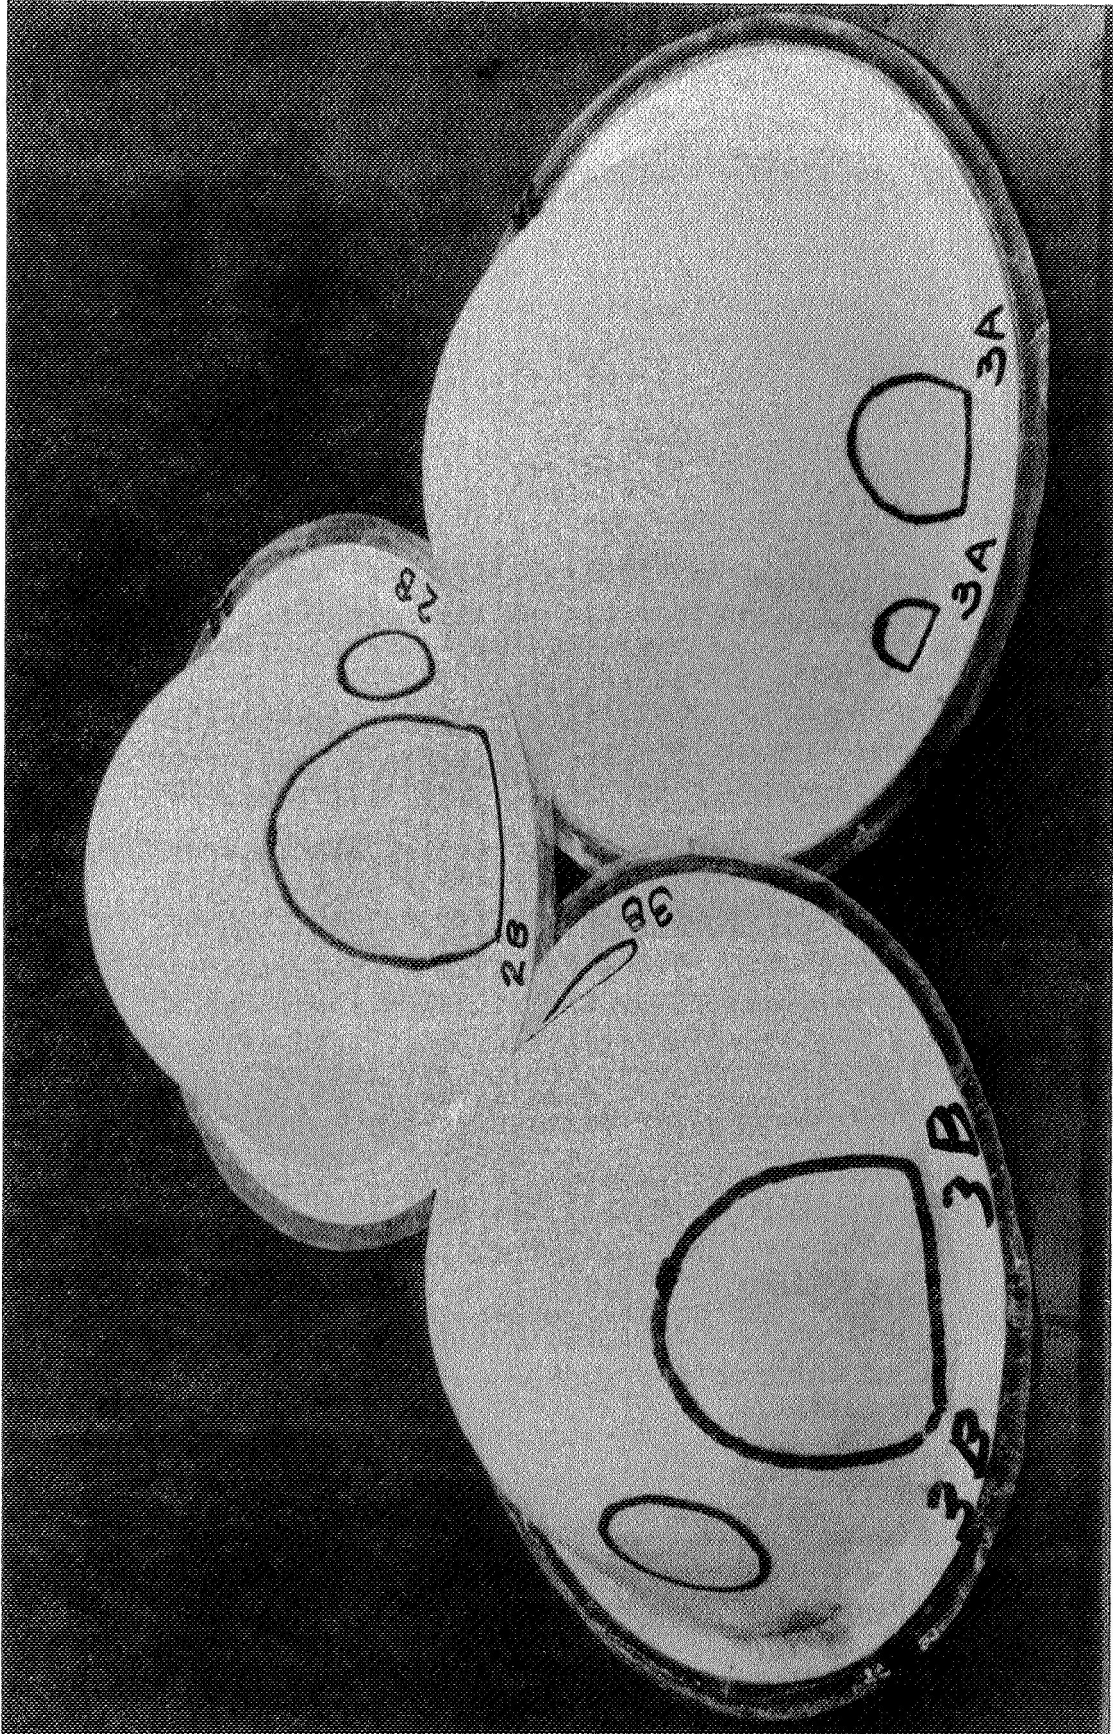
Figure 36: TEST RESULTS

The diaphragm, shown in Figure 36, indicated a large leak area which is a large leak in a three corner fold which had split to give a V-shaped tear.

The diaphragm with leakage areas located in the flange radius is shown in Figure 36.

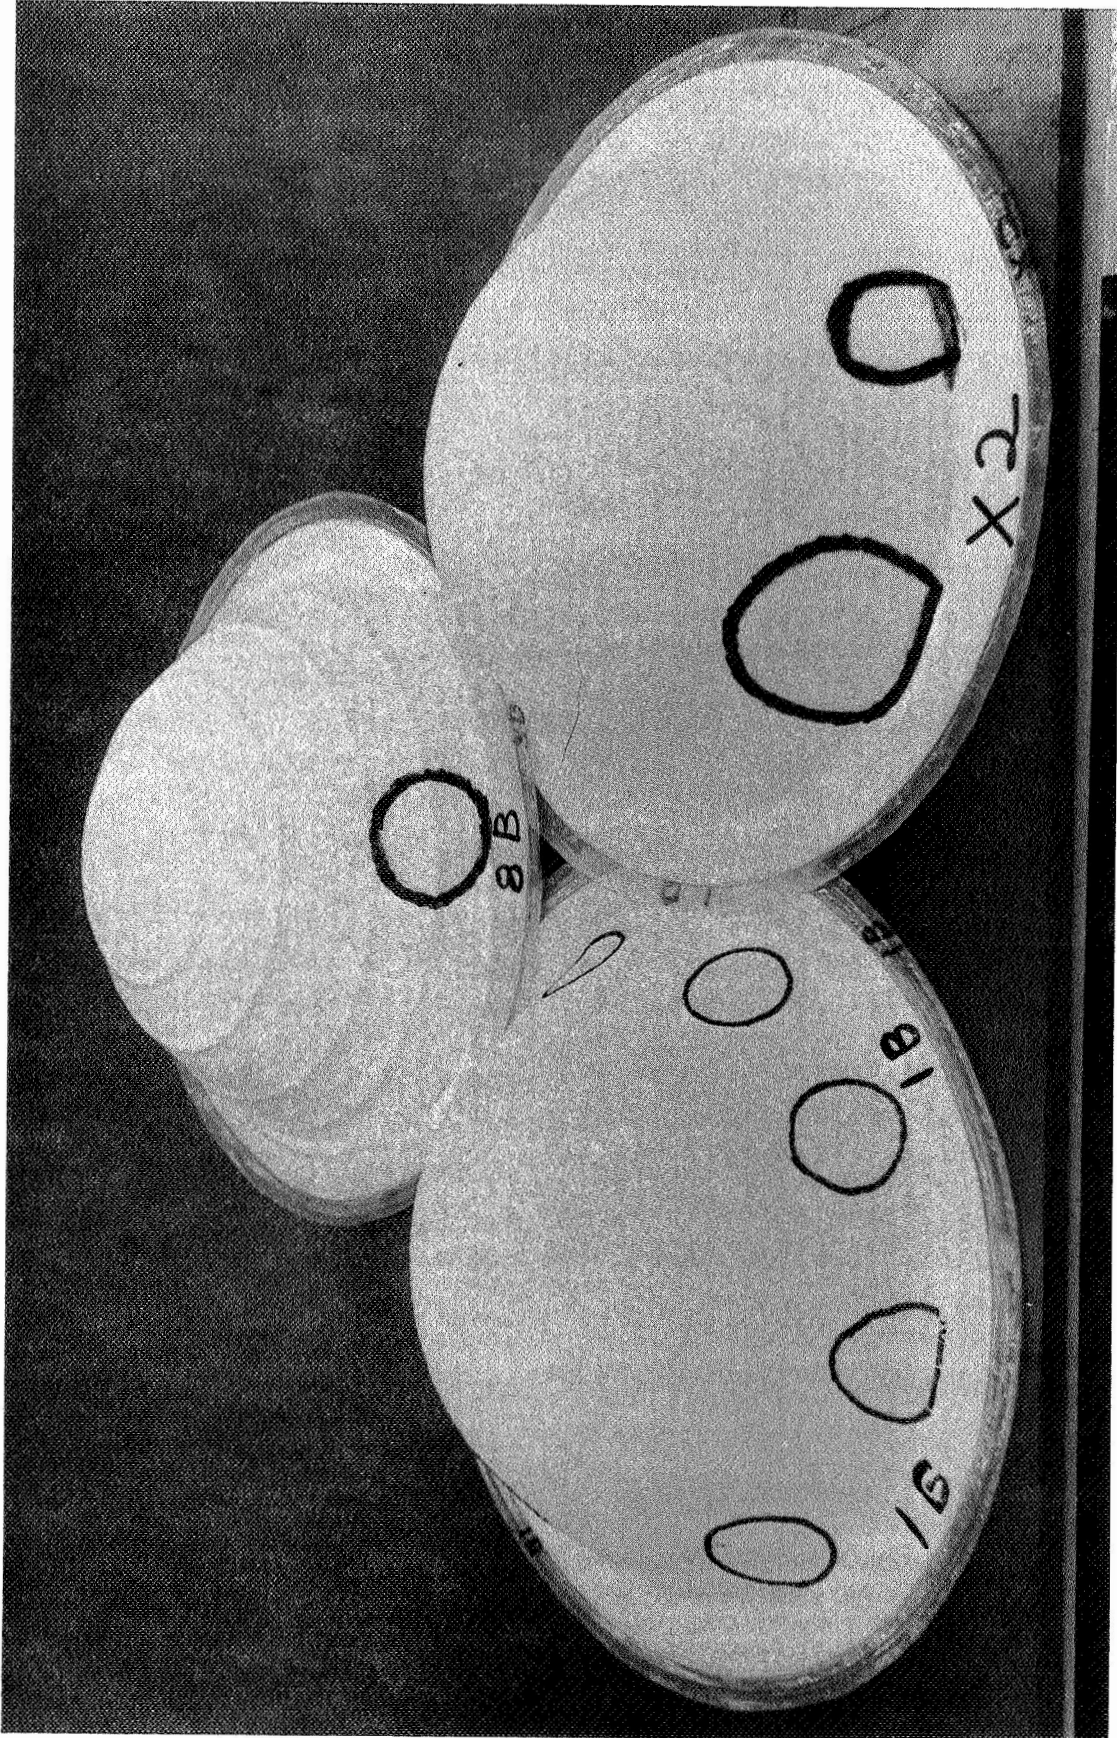
Figure 37: TEST DIAPHRAGM RESULTS

This diaphragm was repaired in the flange seal after diaphragm 1A revealed leakage in the flange seal. This modified flange seal was incorporated in all diaphragms in the fabrication phase. There was no leakage in the room temperature leak check in the cryostat and the test proceeded to the liquid hydrogen leak check. Porosity at liquid hydrogen temperature was established at 82 cc/min. which was above the requirement but filling of the diaphragm was attempted. The test was aborted as the differential pressure of one psi could not be developed. At 3.5 minutes after liquid hydrogen filling was started, liquid was observed leaking through the diaphragm. Diaphragm 1B failed due to multiple leaks in the gored seams in the flange radius area as shown in Figure 37.

As shown in Figure 37, leakage occurred in the conical section near a ring attachment point.

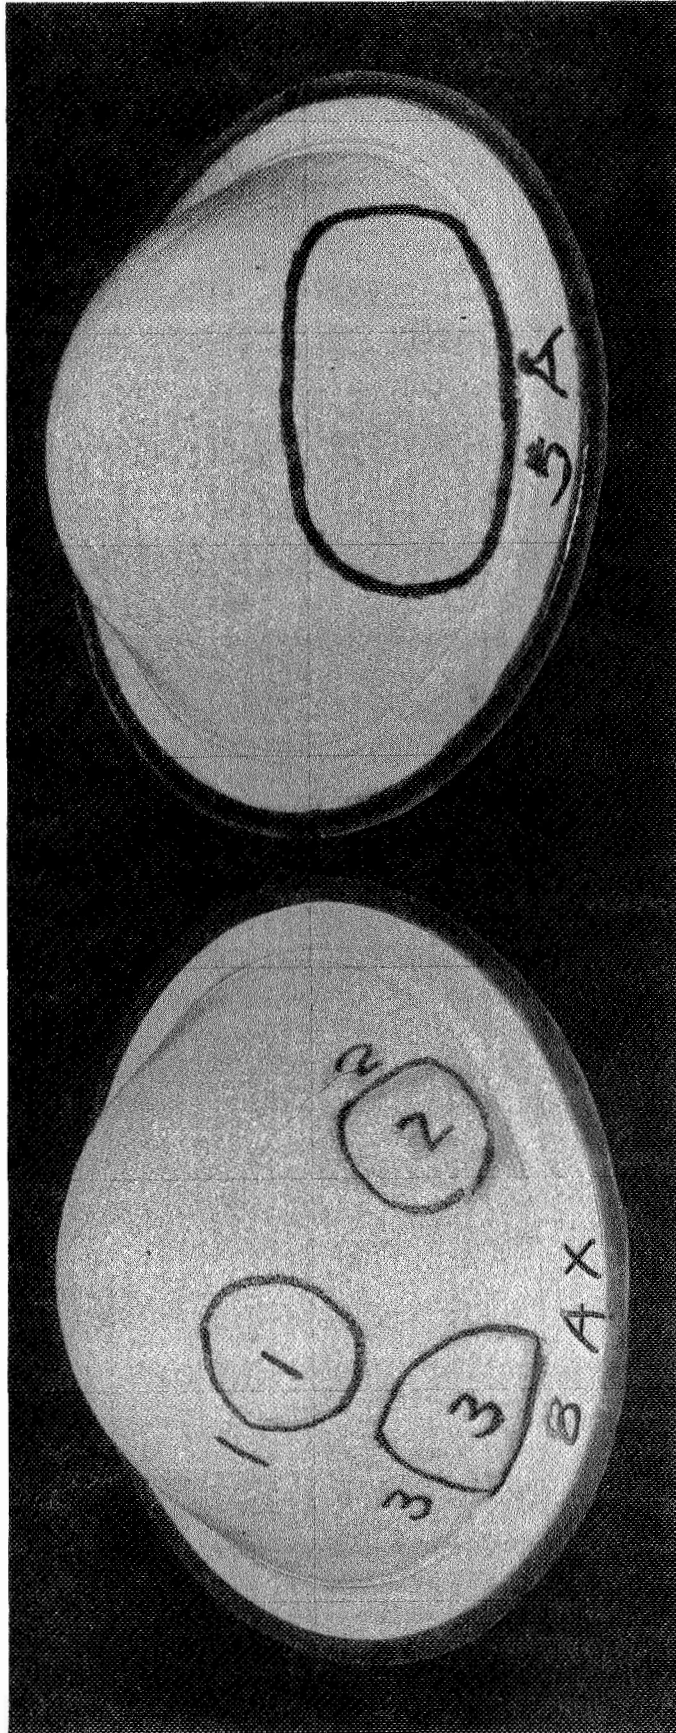
Figure 38: TEST DIAPHRAGM RESULTS

The diaphragm, shown in Figure 38, had a large leak in the conical section of the vapor barrier.

Diaphragm 8AX was fabricated identical to 8A but without the convolute rings. The unit showed no porosity during the flange and ambient tests but after vacuum purging the cryogenic leakage rate was 140 cc/min. The diaphragm was filled but the test was discontinued when liquid hydrogen appeared on the test dewar window. This unit is shown in Figure 38.

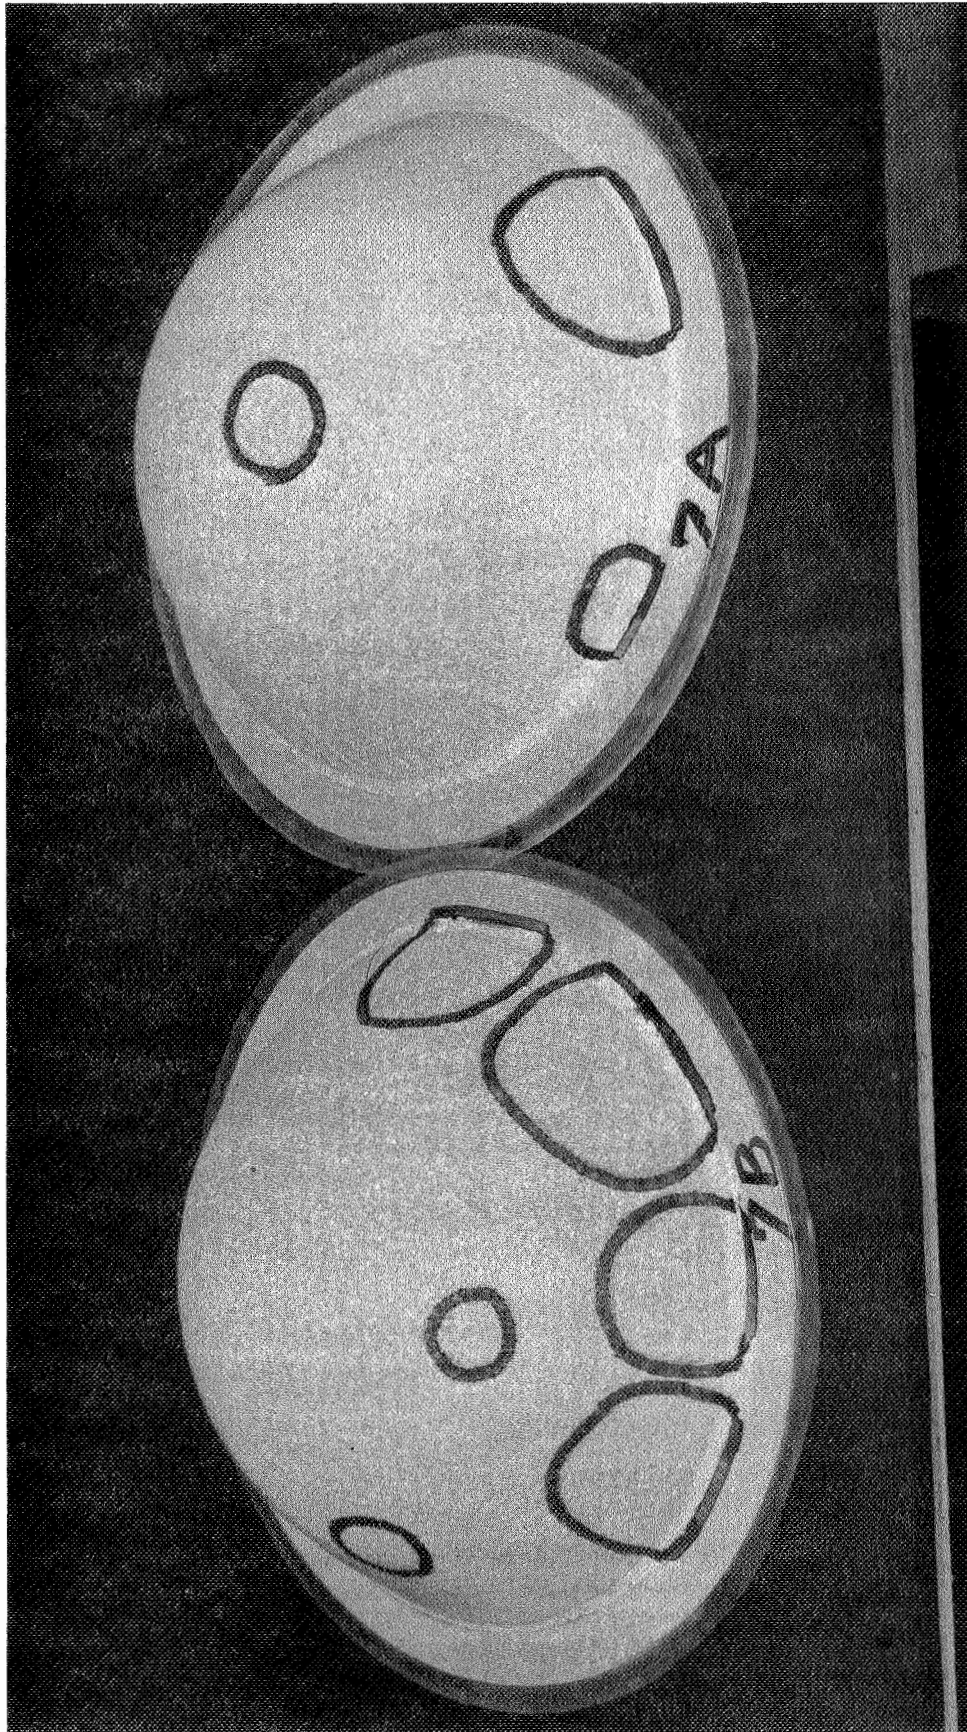
Figure 39: TEST DIAPHRAGM RESULTS

Low pressure purging of the lines and diaphragm area with helium gas thereby eliminating the need for vacuum purging was attempted as it was thought that the vacuum cycling may contribute to leakage in the diaphragm. After the initial leak tests and porosity checks, the system was inert gas purged. Conditions were then established for cryogenic porosity but the leakage was too great to measure. An attempt was made to cycle the diaphragm by filling with liquid hydrogen. Dimples appeared in the truncated cone section of the diaphragm but the unit would not cycle because of the lack of differential pressure. Figure 39 shows the leakage areas in the seams of the diaphragm.

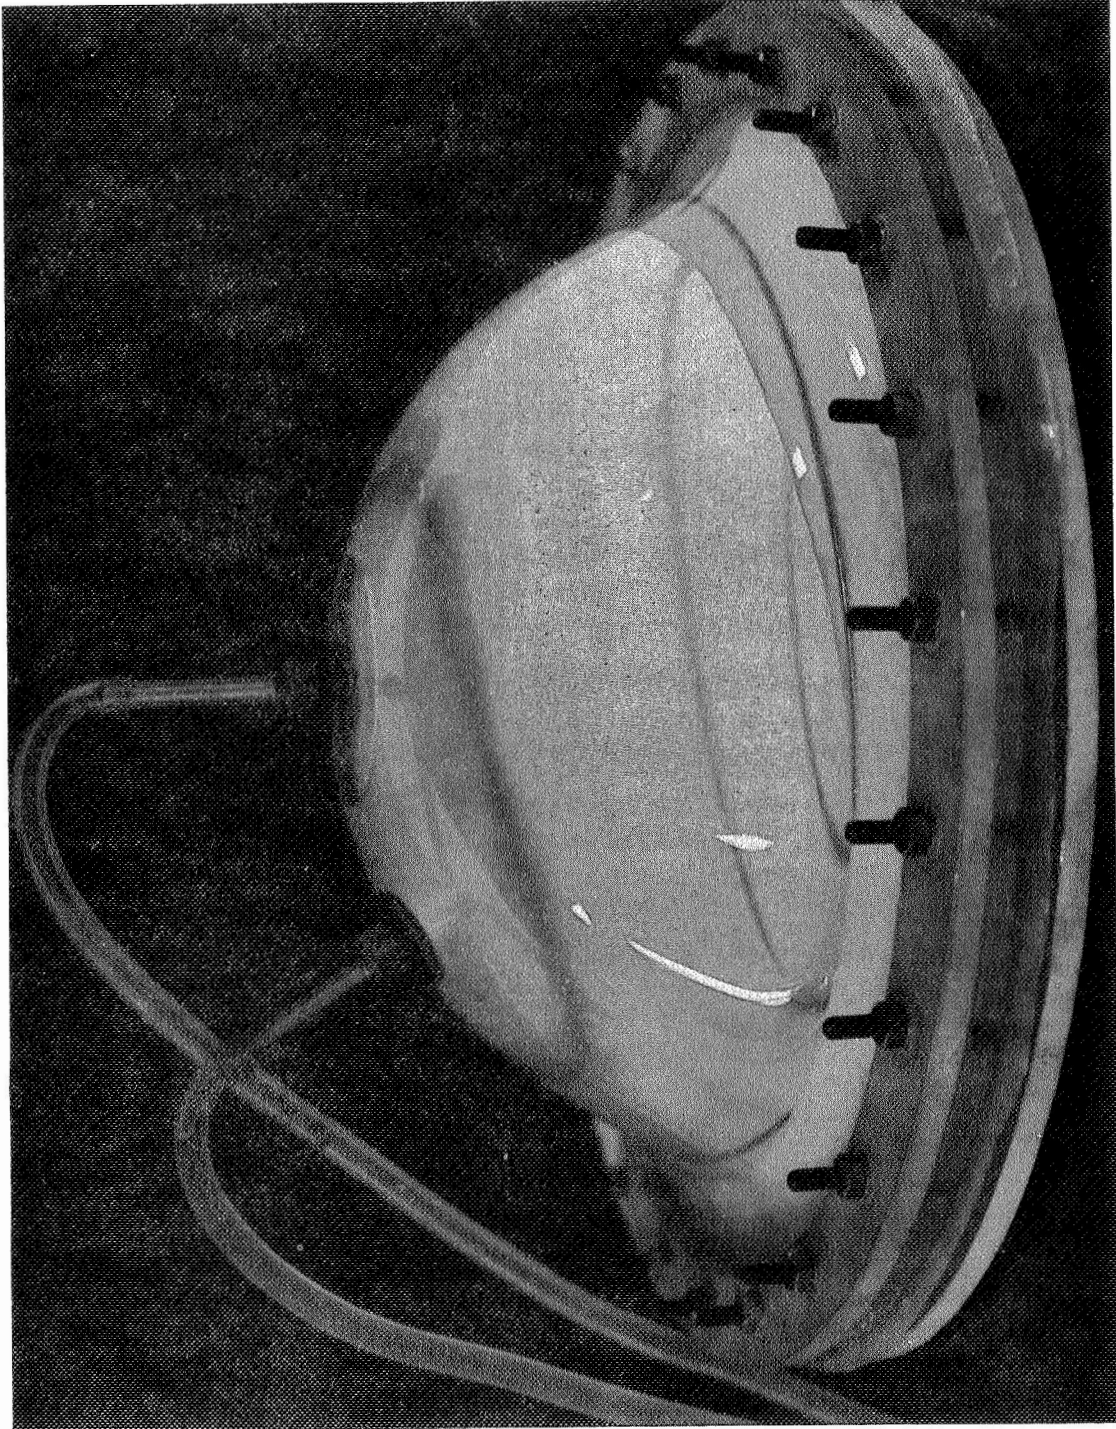
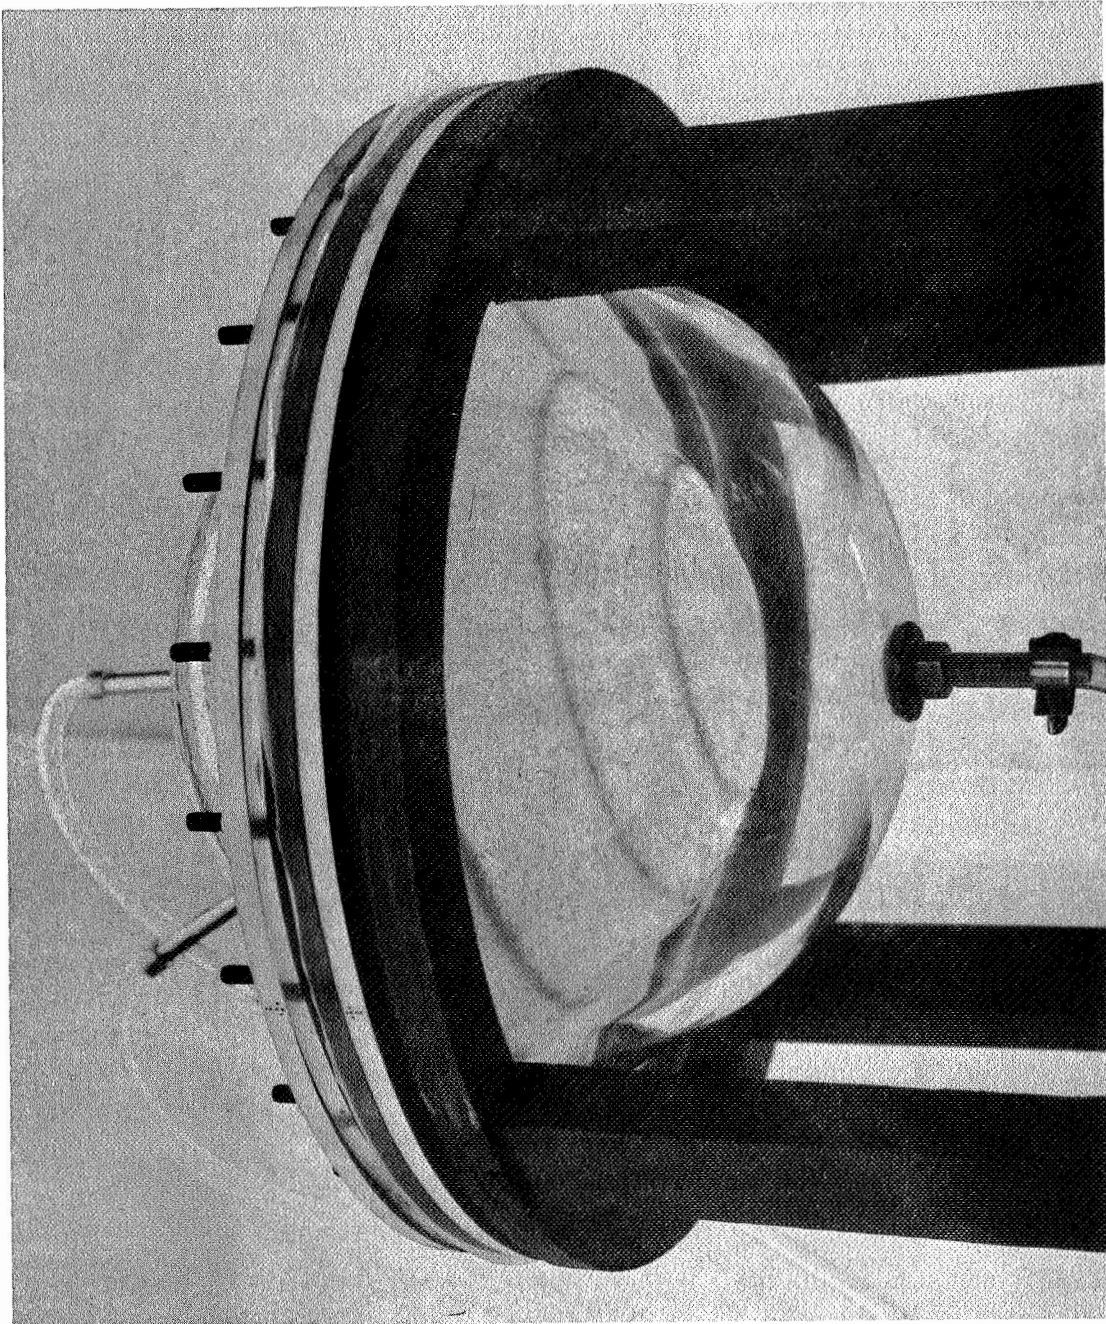
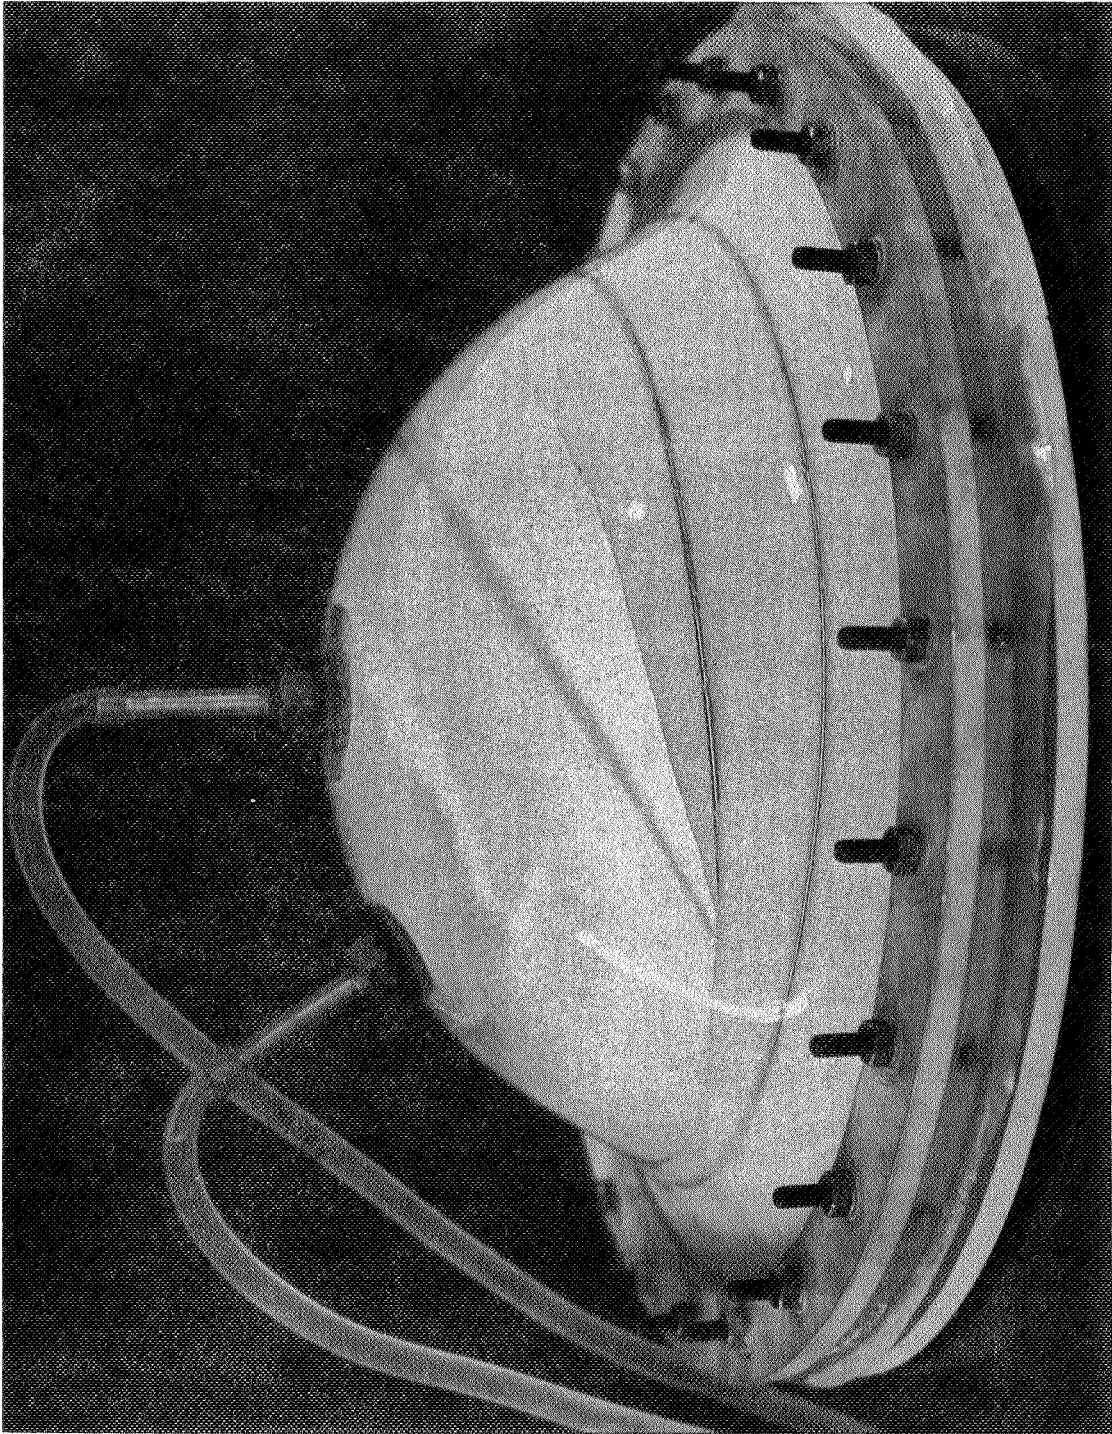
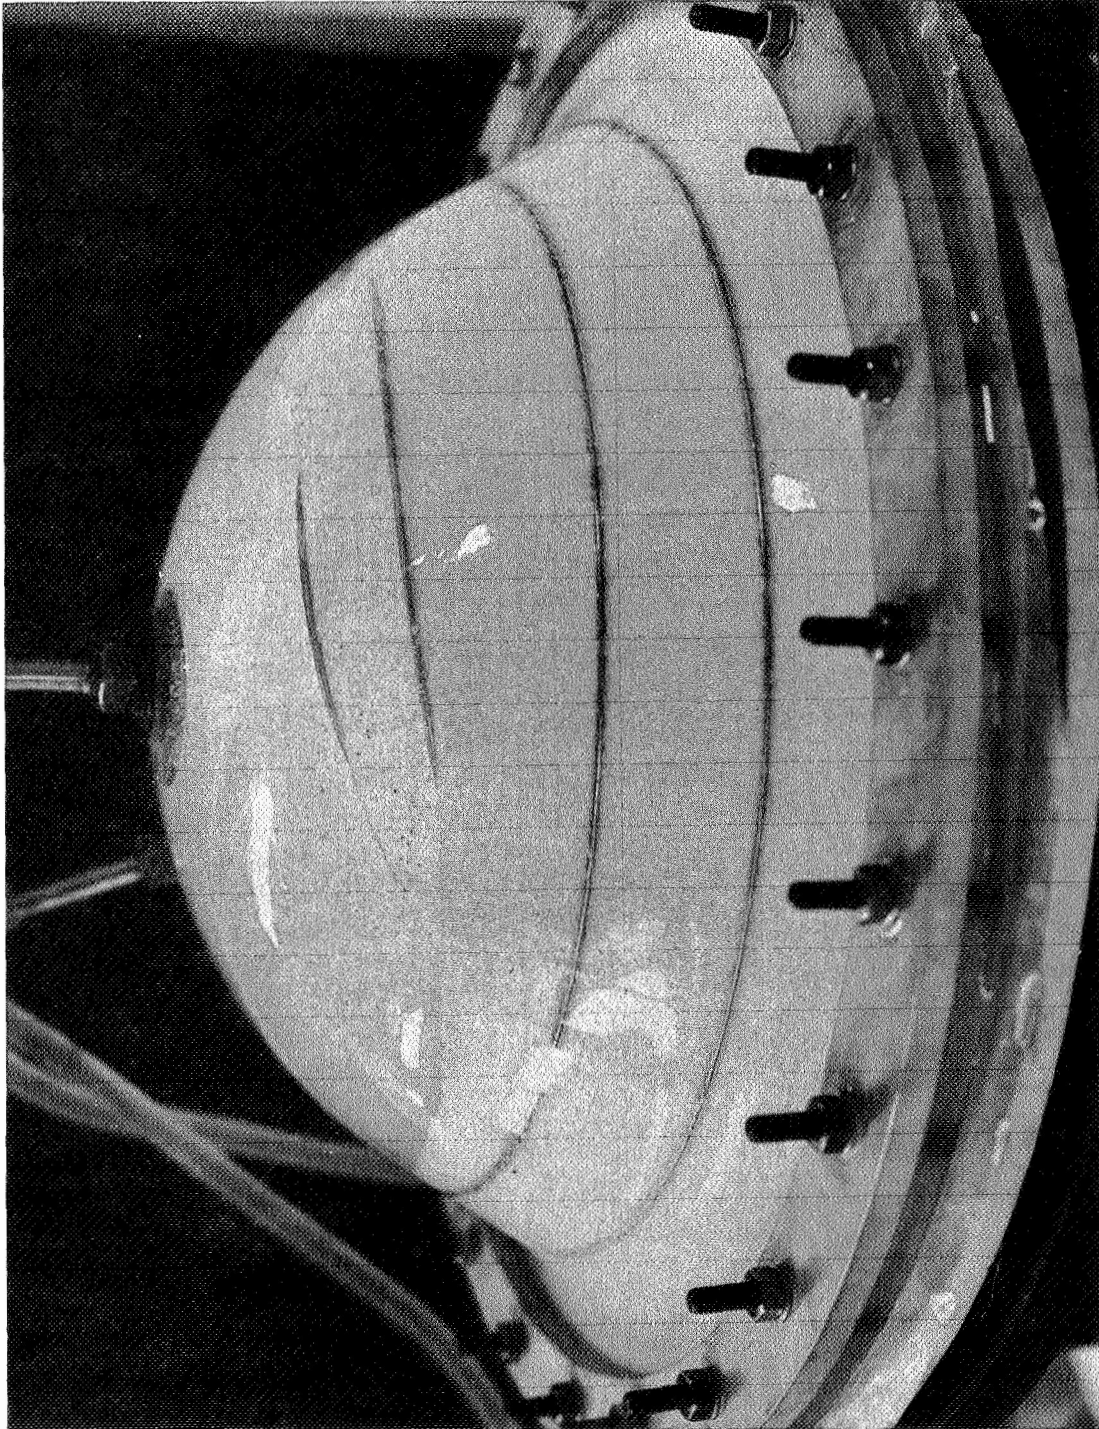
The sequence of the diaphragm unit progress during water expulsion is shown in Figures 41 through 44. The sequence shows that the diaphragm "rim rolls" and has a definite "list" during cycling. It was predicted that the diaphragm would start its reversal at the apex with the flange radius being the last area to reverse. Rim rolling imparts more severe creasing and folding conditions on the film barriers. The "list" of the diaphragm during expulsion had been observed previously in liquid oxygen diaphragms. If a list existed on the LOX diaphragm's initial cycle, this list would be identical in all cycles conducted on that particular diaphragm.

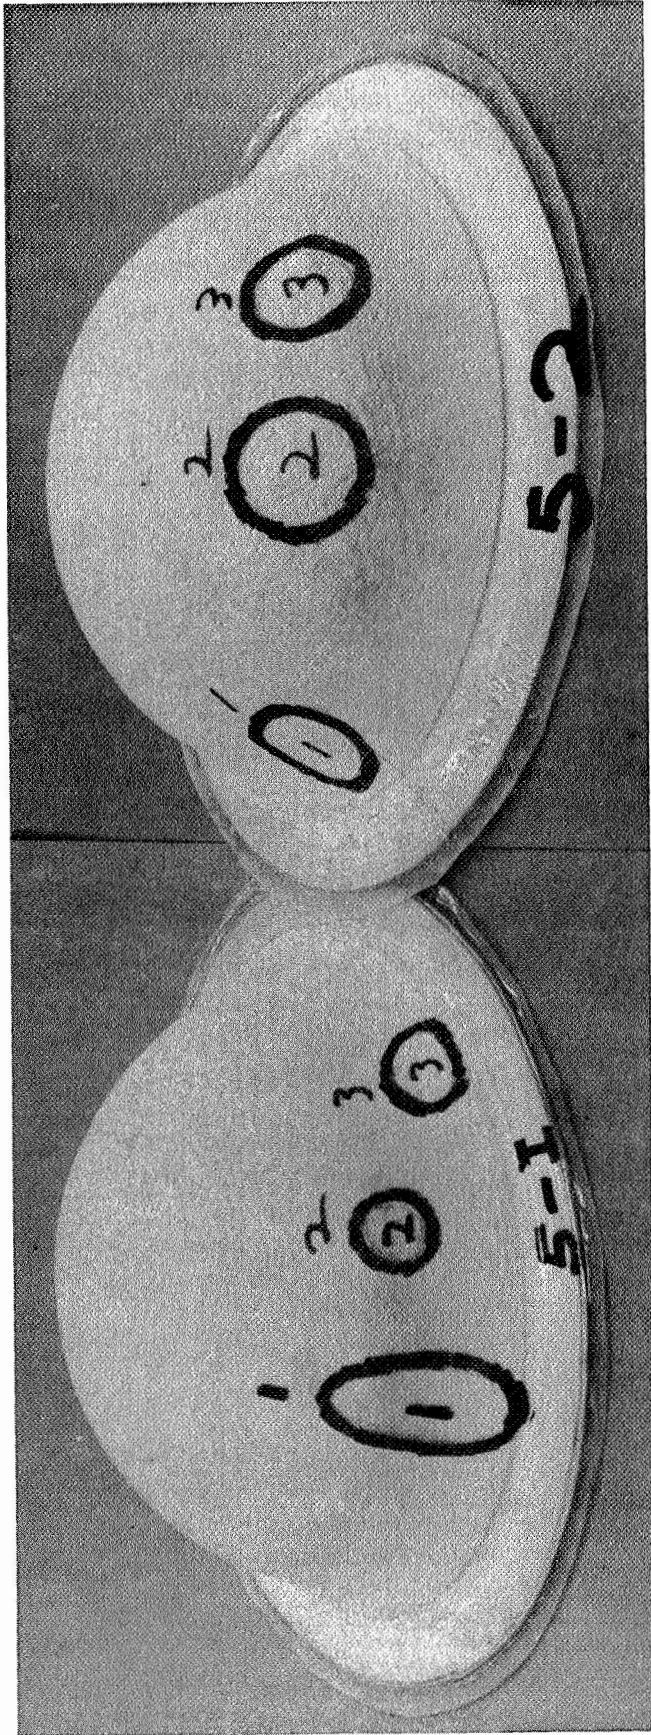
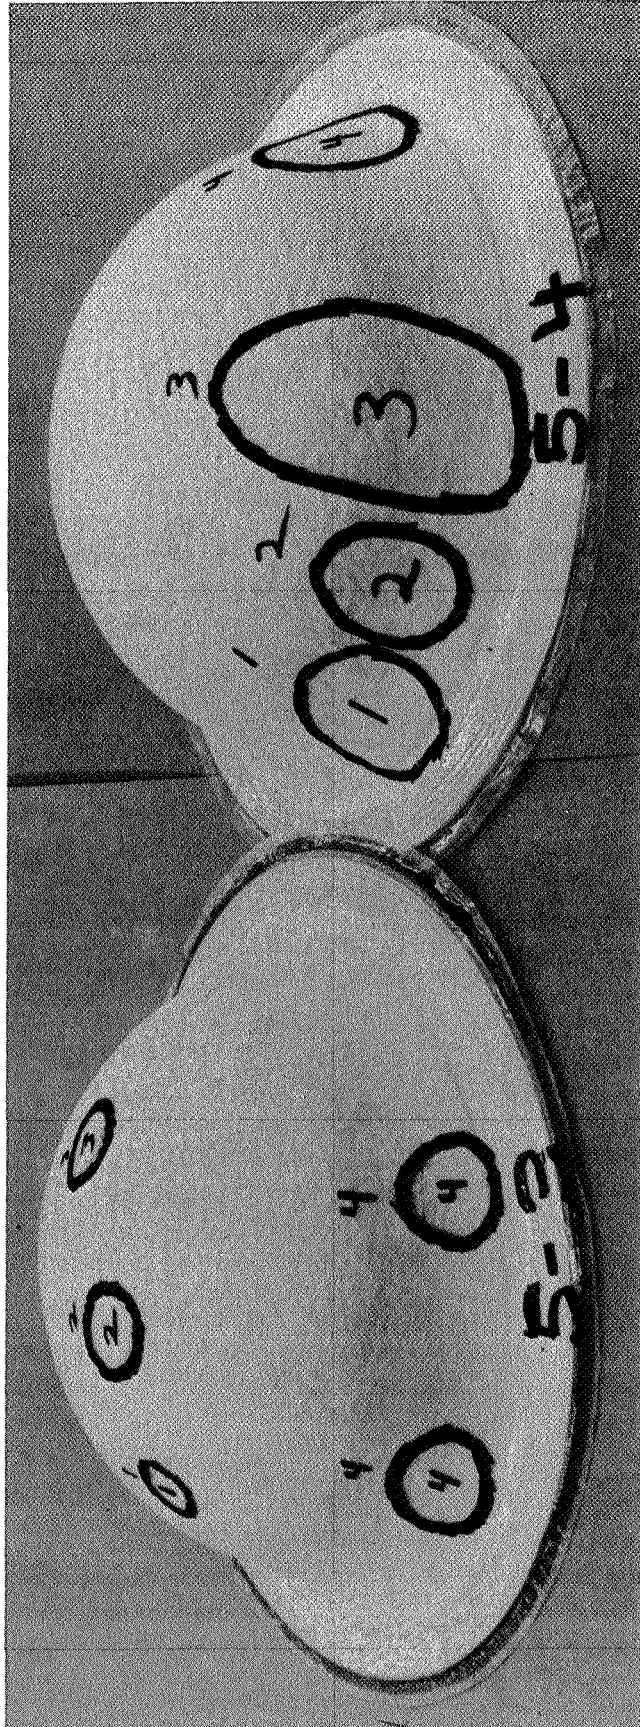
The diaphragms, shown in Figures 46 and 47, present a different leak pattern than before in that leaks appeared in the dome area of diaphragm V-3. The leak pattern for the diaphragms fabricated of gores is identical to the failures previously observed. It was surprising that diaphragm V-4 did not perform as expected and failed as rapidly as the single barrier ply units.
