SNAP-8 REFRACTORY BOILER DEVELOPMENT
TOPICAL REPORT III
EVALUATION OF SNAP-8, SN-1 BOILER

November 3, 1970

NASA Lewis Research Center
Contract NAS 3-10610
Edward R. Furman, Project Manager
Phillip L. Stone,
Materials Structures Division

NUCLEAR SYSTEMS PROGRAMS
SPACE DIVISION
GENERAL   ELECTRIC
CINCINNATI, OHIO 45215

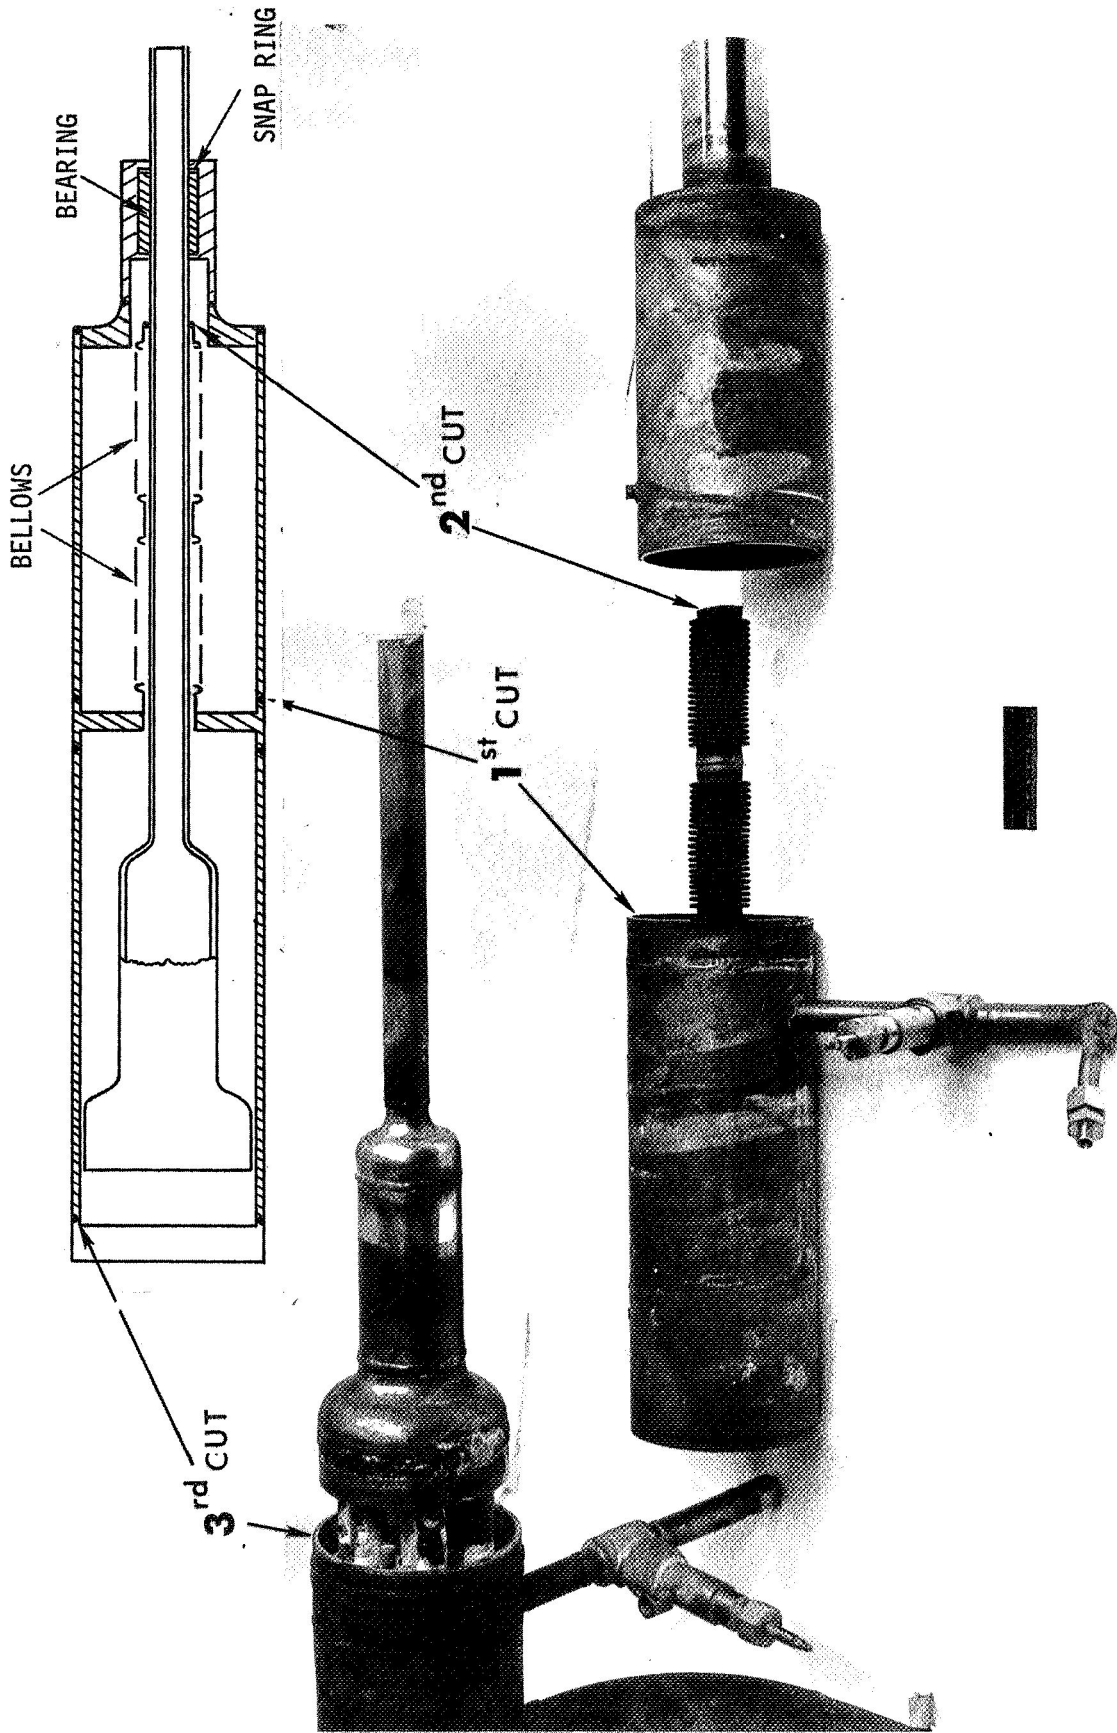
The initial cuts for sectioning of the boiler were made at the mercury inlet as shown in Figure 1. The first cut was made through the outer stainless steel shell just forward of the header on to which the bellows was welded. The snap ring was then removed from the bearing housing and the first section was slid off the end of the 1-inch-OD stainless steel tube exposing the bellows. The bellows appeared to be in excellent condition as can be seen in Figure 1. The second cut was made at the front end of the bellows while the third cut was made through the outer stainless steel shell just forward of the stainless steel header. This second section of the outer stainless steel shell with bellows attached was slid off the end of the inner tube exposing the coextruded joint and tantalum header. Some alkali metal oxide was present but it was easily removed by wiping with a damp cloth. This

Figure 1. Sectioning of the SNAP-8 Boiler for Evaluation - Removal of the Outer Stainless Steel Sheel at the Boiler Inlet. (P70-1-12C)

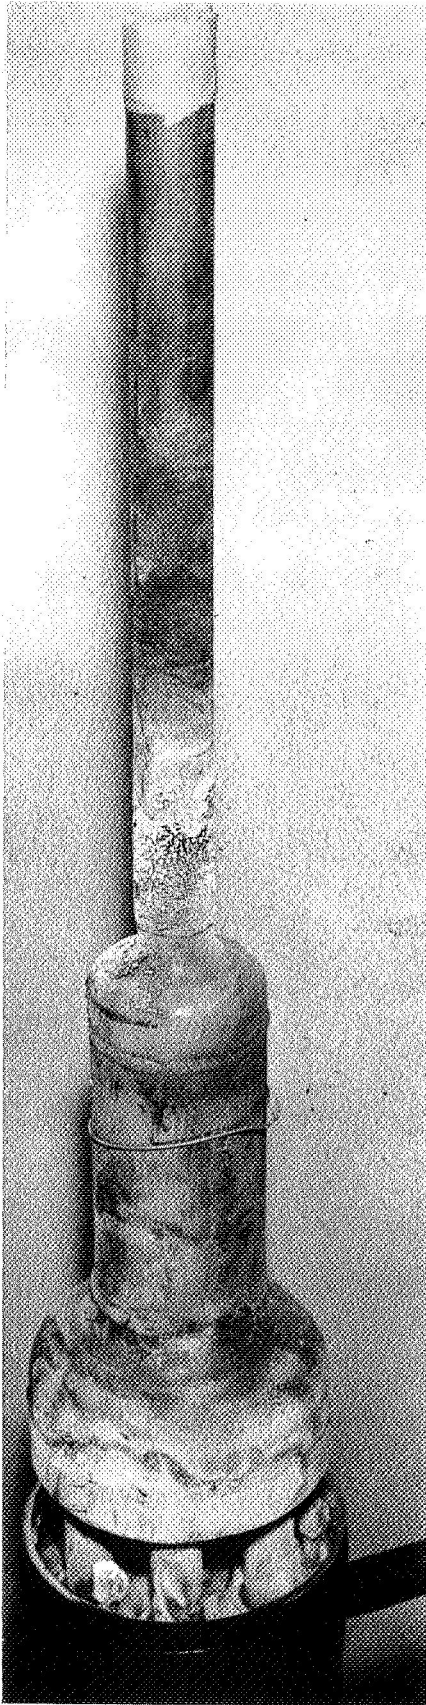
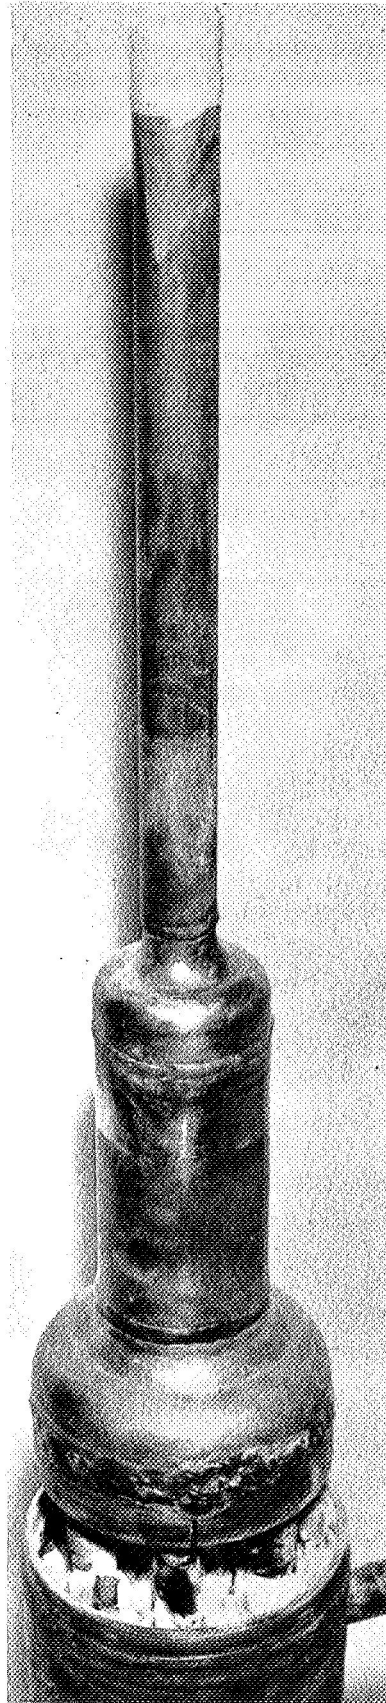
THE ASSEMBLY AS IT APPEARED WHEN OUTER SHELL WAS REMOVED

AFTER ASSEMBLY WAS CLEANED WITH DAMP CLOTH

Figure 2. Appearance of the SNAP-8 Boiler Inlet with Outer Stainless Steel Shell and Bellows Removed. (P70-1-12A & B)

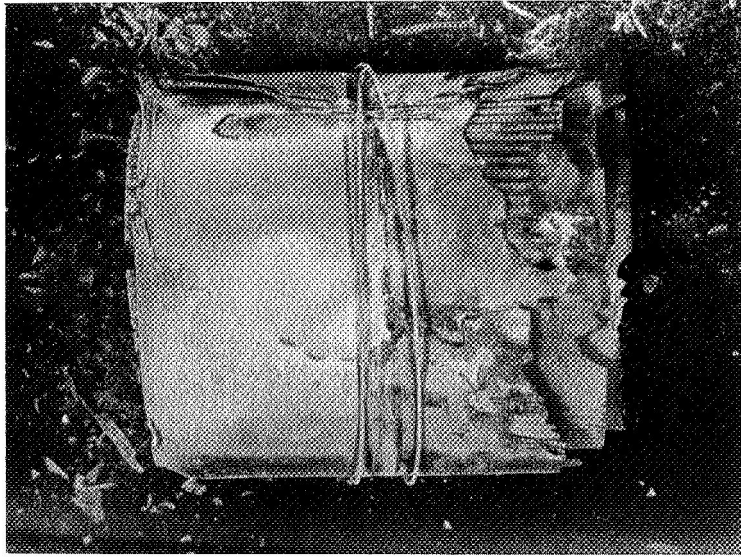
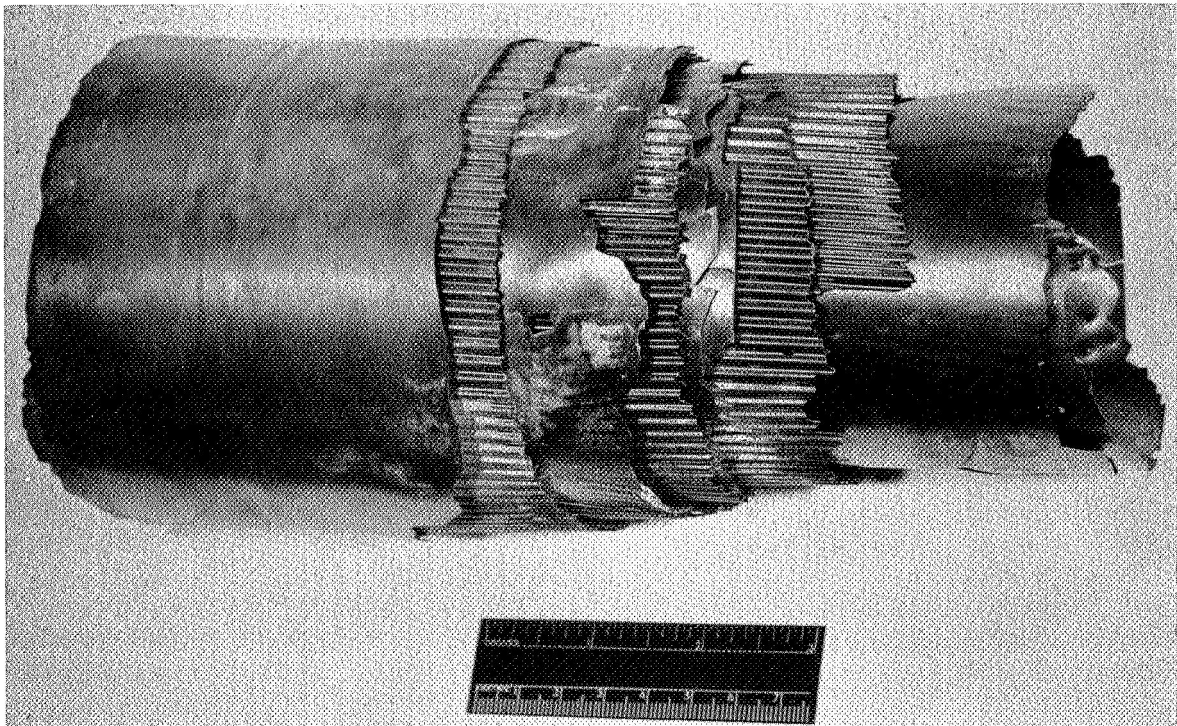
section before and after cleaning is shown in Figure 2. The zirconium getter bundle which was wrapped around the coextruded joint and exposed to the static NaK is shown in Figure 3. The zirconium foil was very brittle and analysis, shown in Table I, indicated it to be very high in hydrogen (3800 to 4800 ppm). Although the source of this high hydrogen concentration is not clear, the contamination could have occurred as a result of moisture in the air reacting with residual NaK remaining on the foil after the boiler shutdown. A pickup of approximately 200 ppm oxygen was also noted.

Figure 3. Appearance of the Zirconium Getter Bundle Removed From Around the Coextruded Joint at the Boiler Inlet - Chemical Analysis Indicated High Hydrogen Concentration. (P70-1-12F & H)

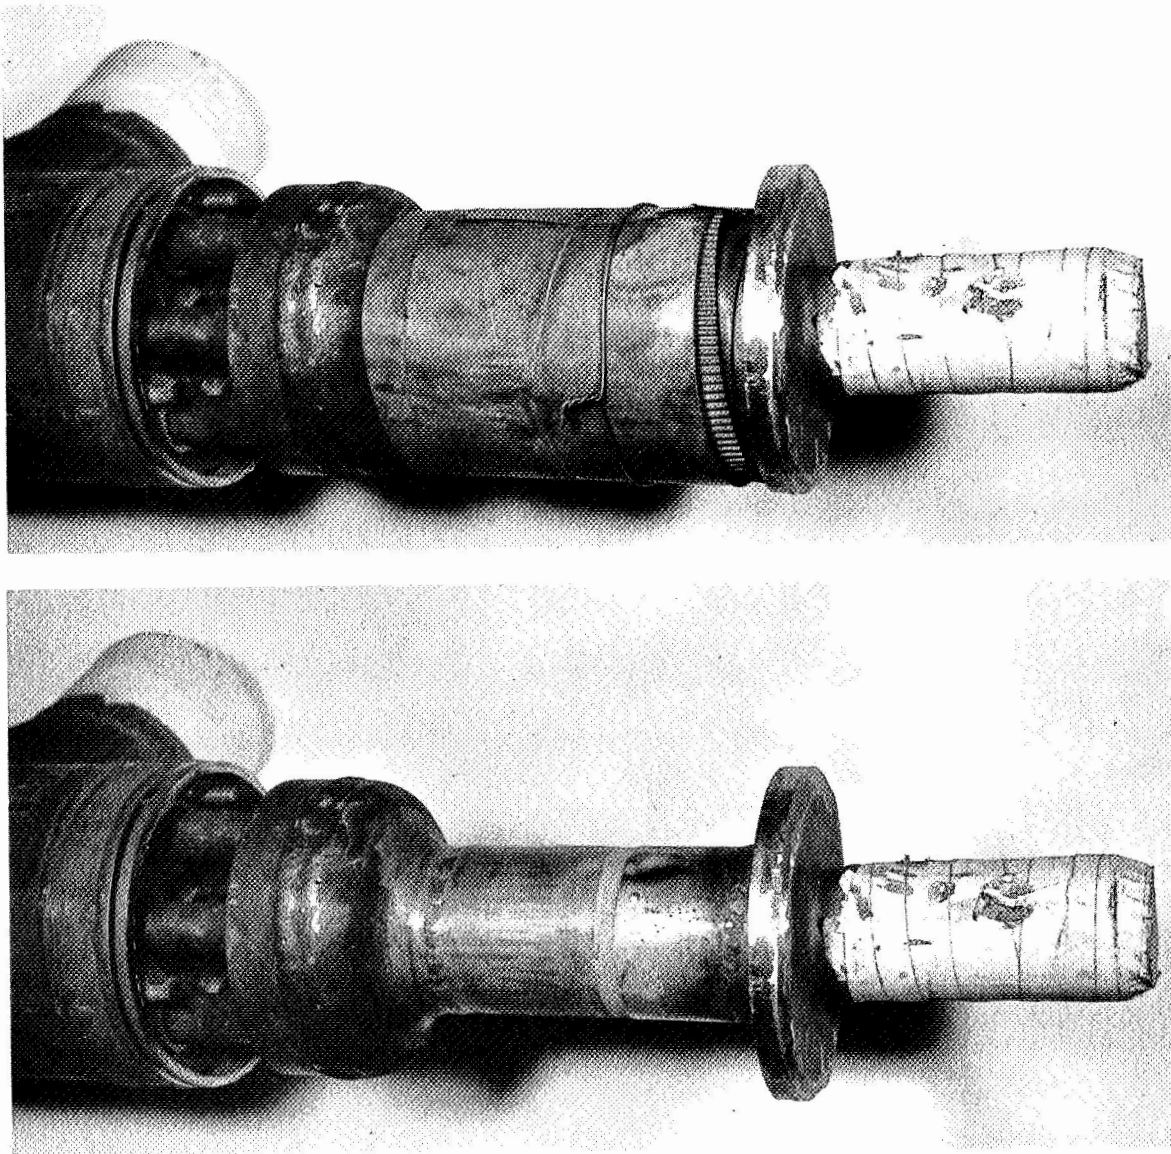
At the exit end of the boiler, the stainless steel shell was removed exposing the tantalum header, dished head, and zirconium getter bundle around the brazed bimetallic joint. As shown in Figure 4, no NaK oxide was present, and the parts looked very clean. The zirconium getter bundle unlike the one at the inlet was ductile. Chemical analysis results shown in Table I indicated a pickup of 1000 to 3000 ppm oxygen but no pickup of hydrogen, such as that found in the getter bundle at the boiler inlet, was noted. The oxygen pickup is understandable since the getters purpose was to remove oxygen from the NaK and the reaction rate would be higher at the higher temperature at the boiler exit (NaK inlet).

Figure 4. Appearance of the Boiler Exit with the Outer Stainless Steel Shell Removed. (Upper P70-1-12D, Lower P70-1-12E)

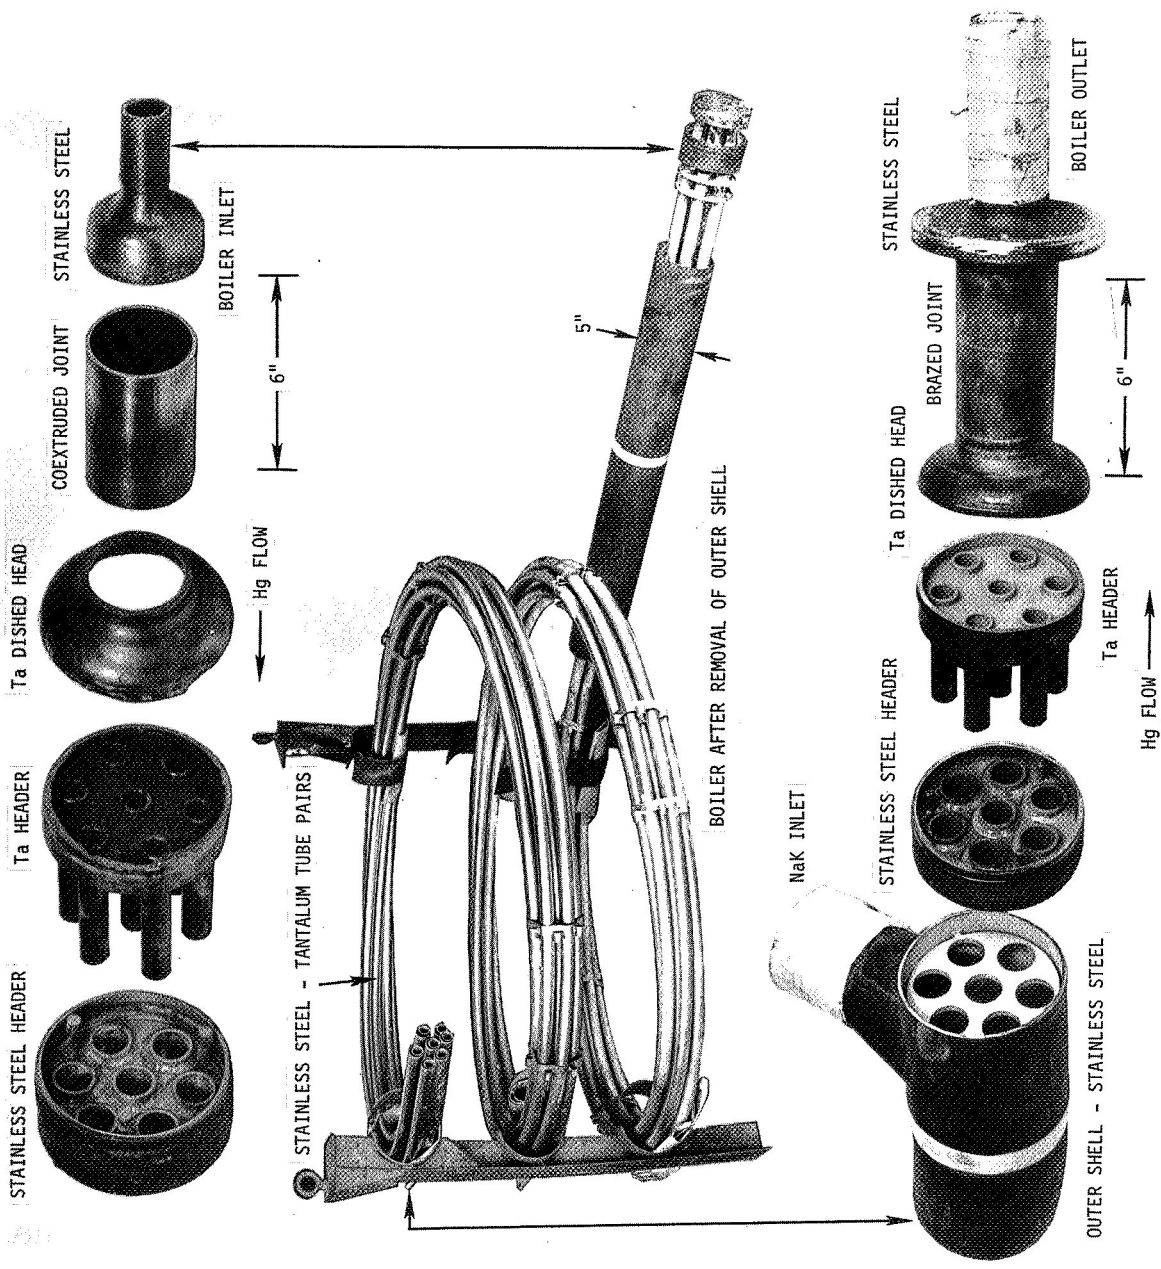
After removing the zirconium getter bundles, the coextruded joint and dished head at the boiler inlet and the brazed joint and dished head at the exit were removed by cutting through the welds between the tantalum header and the dished head. Some mercury amalgam was observed on the face of the tantalum header and the ID of the tantalum dished head at the inlet but the ID surfaces exposed to mercury at the exit were very clean. By cutting through the stainless steel and tantalum tube pairs just following the stainless steel headers, both header plates at the inlet and exit were removed from the tube bundle. A layout of all the components of the sectioned boiler is shown in Figure 5.

Figure 5. Sectioned SNAP-8 Boiler Following Testing. (P70-1-12S, Q, J)

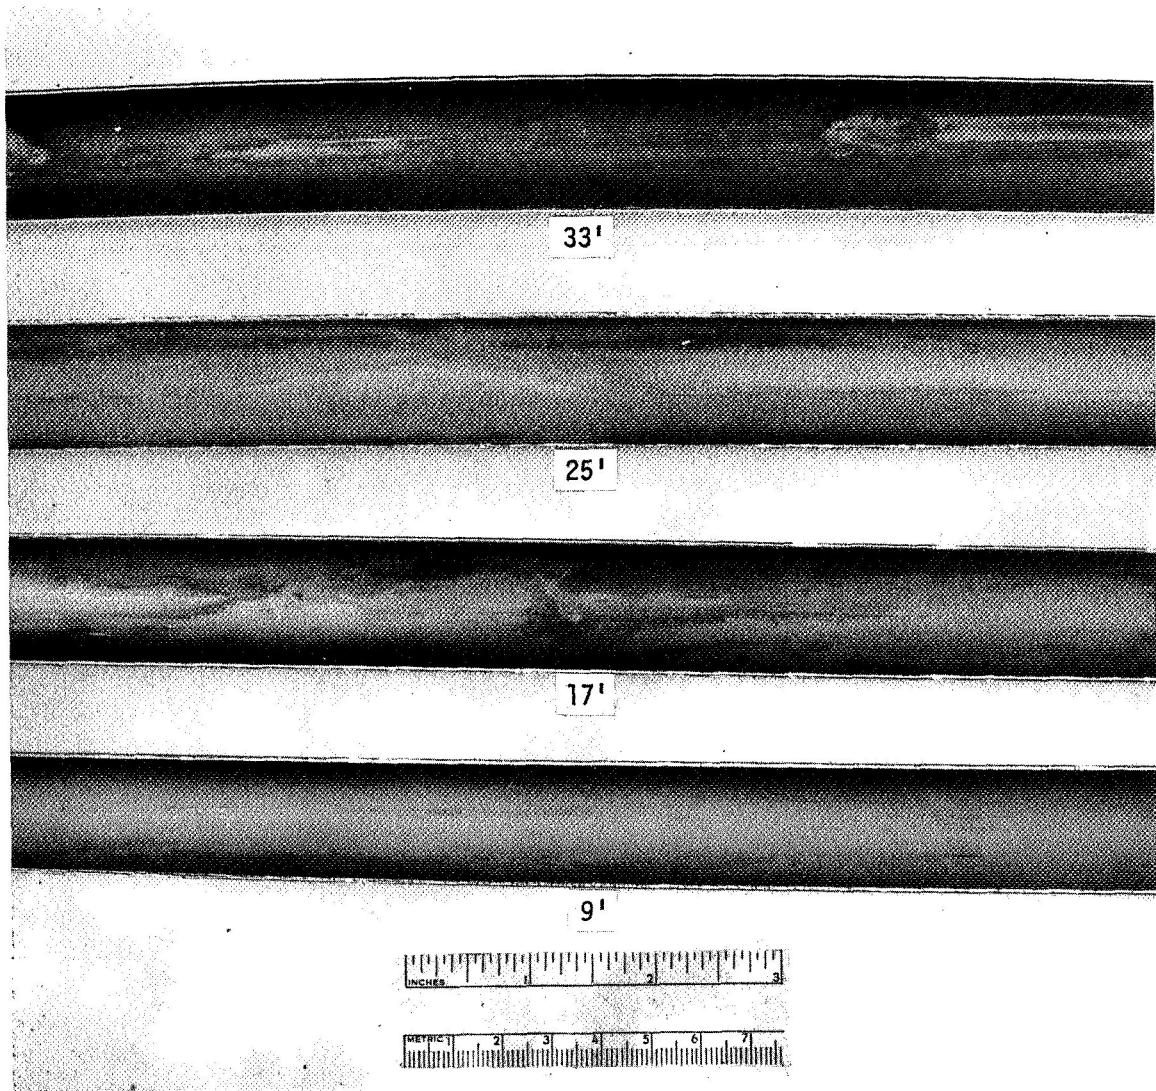
After removal from the boiler, the tubes were split longitudinally. Subsequent visual examination of the tubes indicated some discoloration or stain as shown in Figures 6 and 7 but no signs of degradation. A light gray deposit was observed on the ID of the tantalum tubes throughout the boiler in the vapor region. A darker gray deposit shown in Figure 8 was observed on the ID surface of the tantalum tube at the exit of the plug section.

Figure 6. ID of 321 Stainless Steel Tube Exposed to Static NaK at Distances Marked From the Header at the Boiler Inlet. (P70-3-14C)

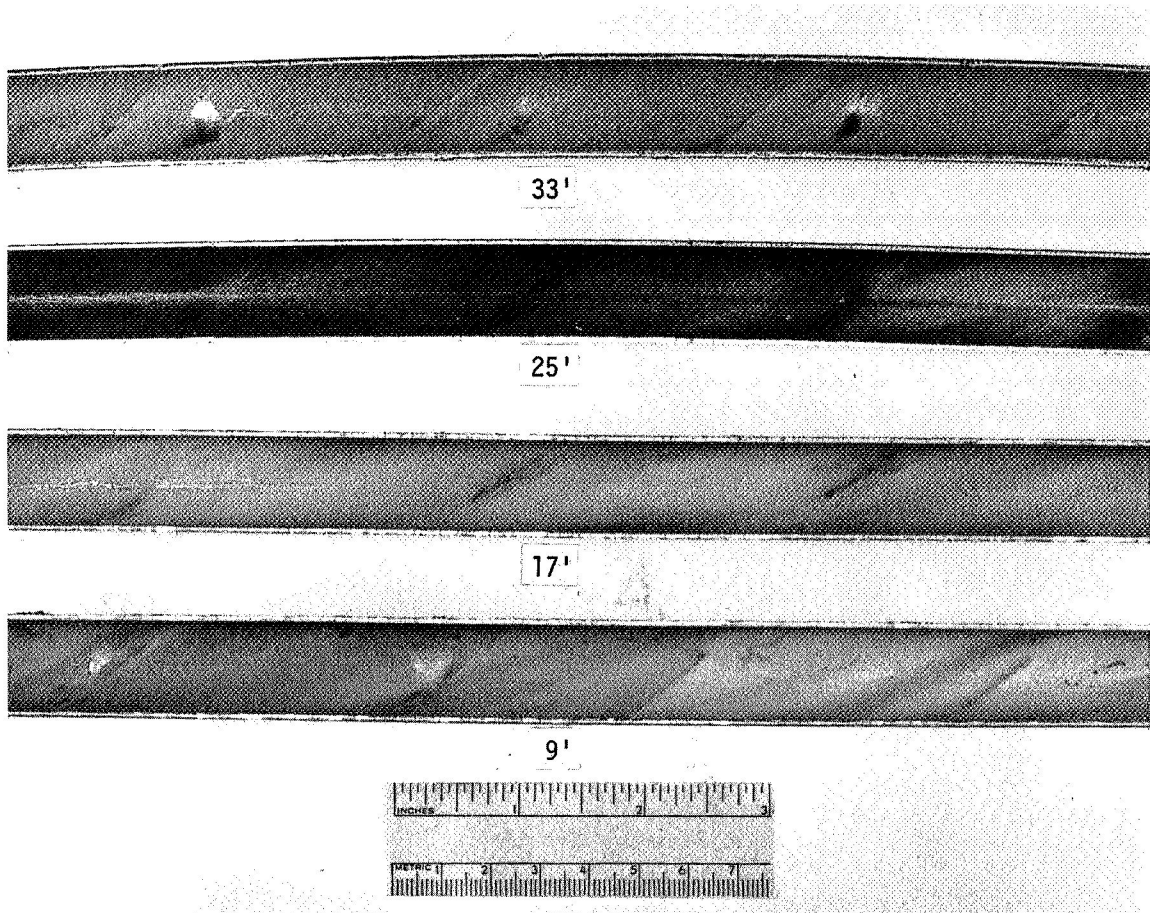
Figure 7. ID of Tantalum Tube Exposed to Mercury at Distances Marked From the Header at the Boiler Inlet. (P70-3-14D)

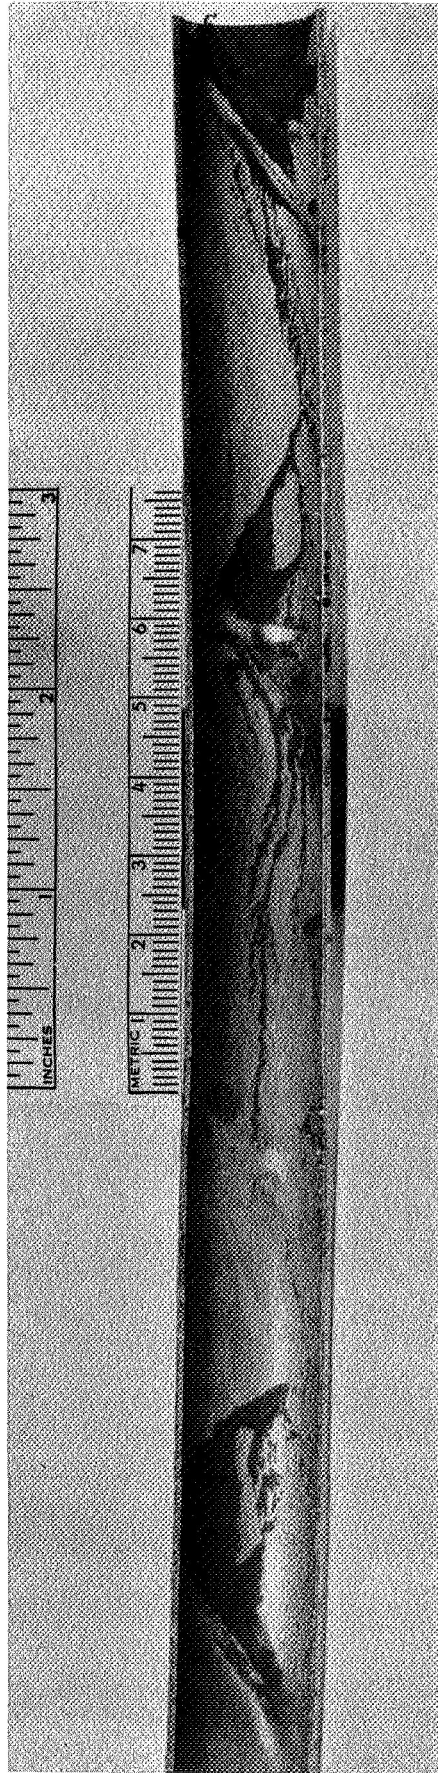
At the exit of the plug, dark gray deposits were noted on the ID of the tantalum tube as shown previously in Figure 8, and extended over a length of approximately nine inches. A section of the tube was mounted for metallographic examination, but the deposit was dissolved during the polishing process. It was discovered at this time that this deposit was water soluble. A semiquantitative spectrographic analysis of the deposit indicated the major element to be chromium (> 10%) with minor amounts (< 10%) of cobalt, iron, and nickel. All of these elements with the exception of the cobalt are major constituents of stainless steel, and cobalt is a major constituent of L605. Stainless steel and L605 are both employed in the facility piping.

Figure 8. Dark Gray Deposit on the ID Surface of a Tantalum Boiler Tube at the Exit of the Plug Section. (P70-3-14E)

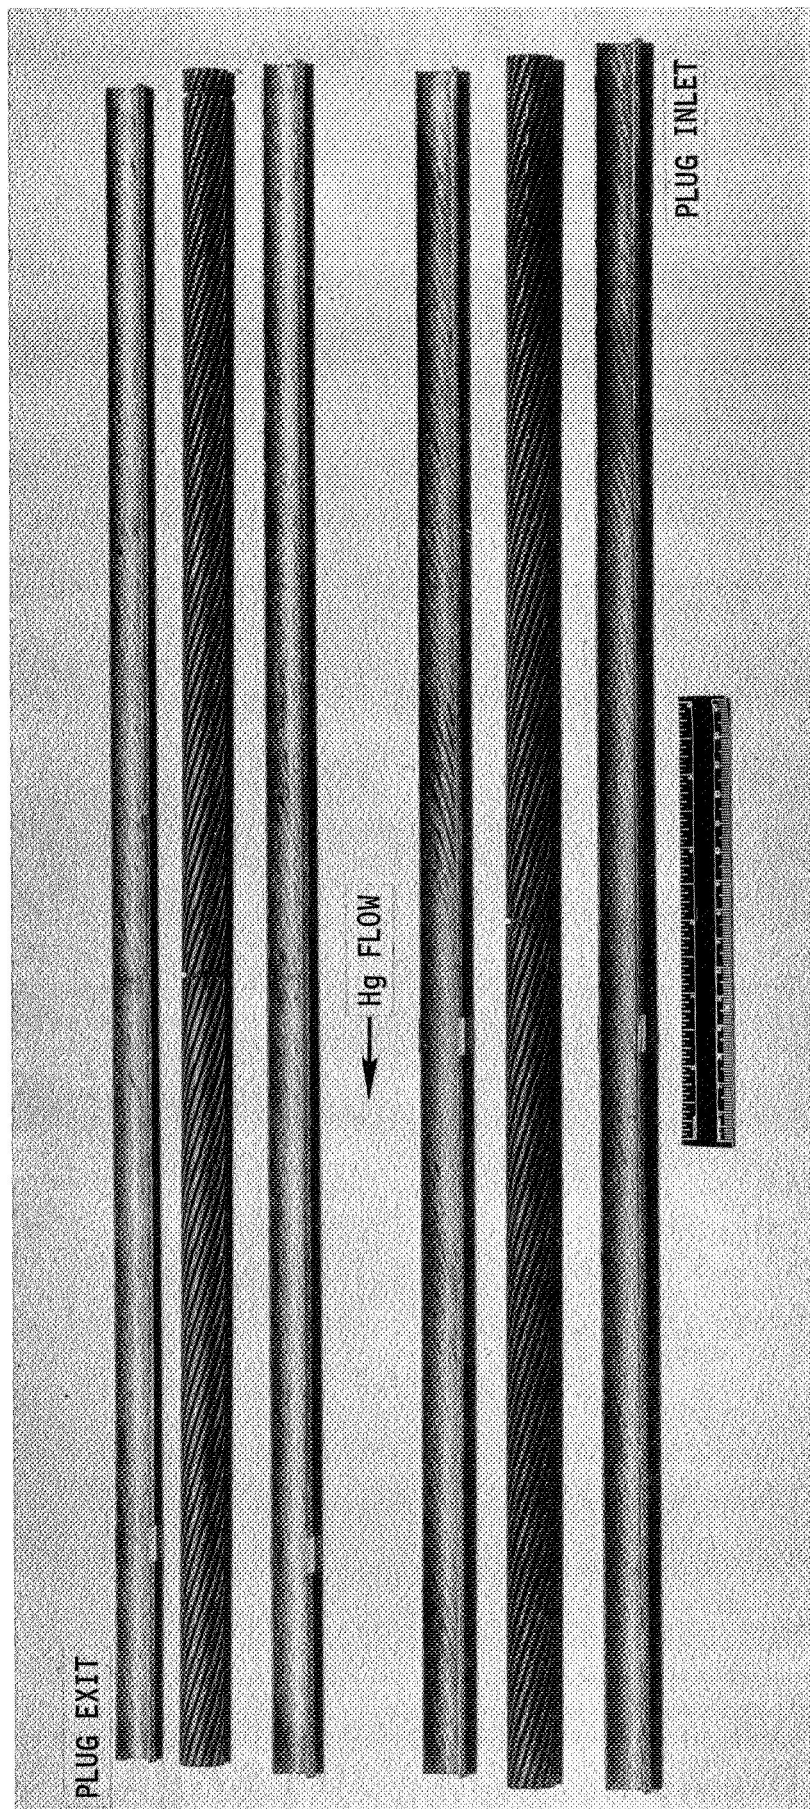
The tantalum tubes from each plug tube assembly were slit longitudinally and removed from the plug. Discoloration or staining of the tube and plug were noted but no apparent degradation. The sectioned assembly is shown in Figure 9. Dye penetrant inspection of the boiler revealed no defective welds. Dimensional inspection of the various parts of the boiler indicated no distortion.

Figure 9. Tantalum Plug and Tube Section. (P70-3-28A)

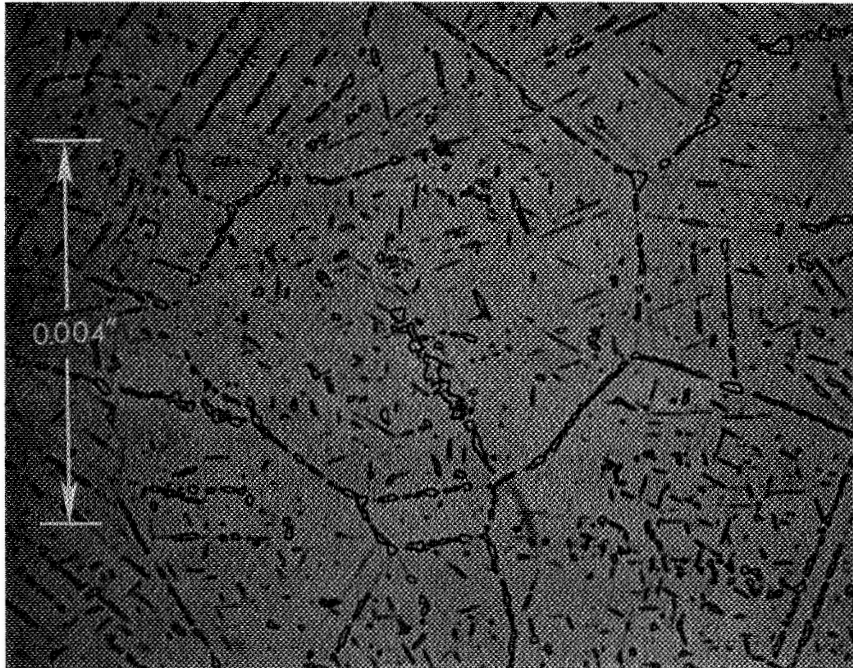
Metallographic examination of a specimen taken from the outer shell near the NaK inlet showed an almost continuous grain boundary precipitate, as shown in Figure 10, which could attribute to the brittle behavior. This precipitate is most likely $M_{23}C_6$ type of carbide phase. Metallographic examination of the OD and ID surfaces of the shell revealed nothing unusual as far as corrosion or oxidation were concerned. Hardness traverse across the wall showed no significant hardness gradient as shown in Figure 11.

Figure 10. Microstructure of the 316 Stainless Steel Outer Tube Shell at the NaK Inlet of SNAP-8 SN-1 Boiler.

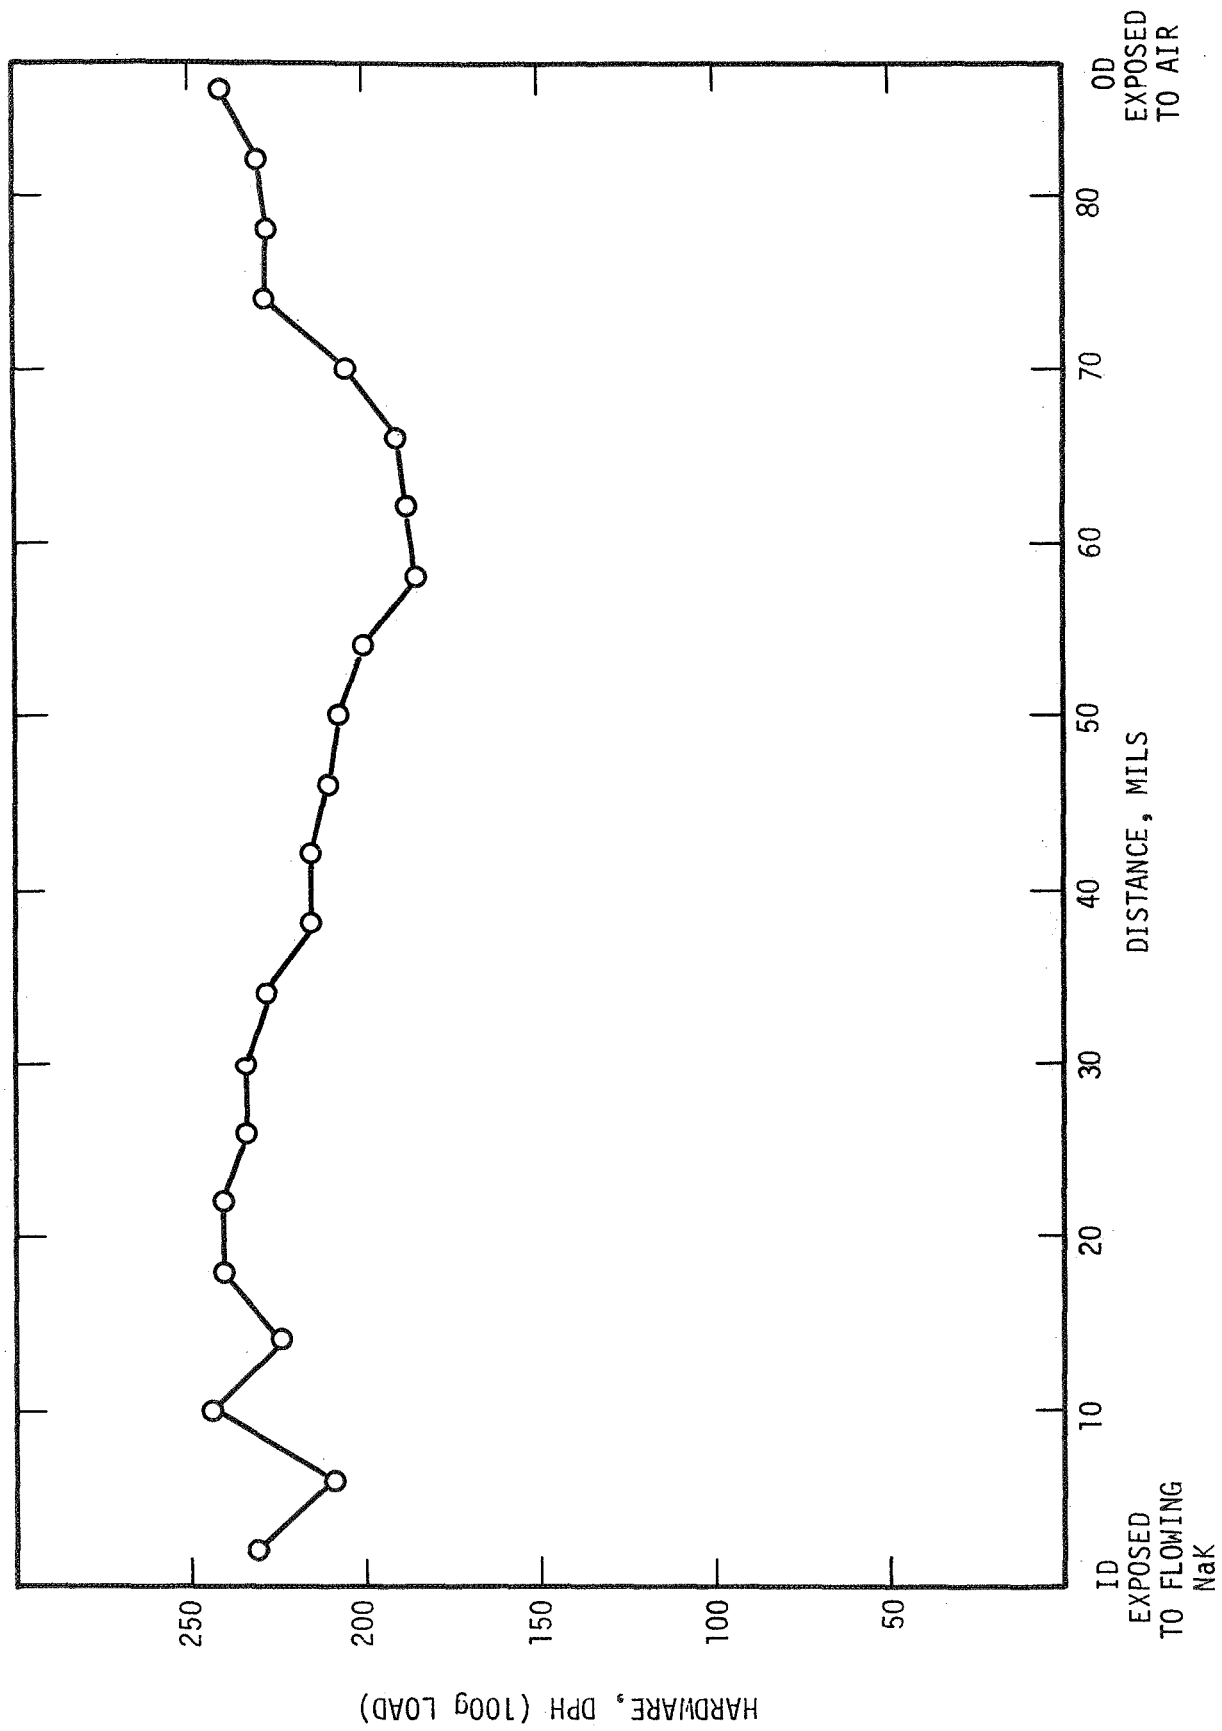
Figure 11. Hardness Across the Wall of the Outer Stainless Steel Shell.

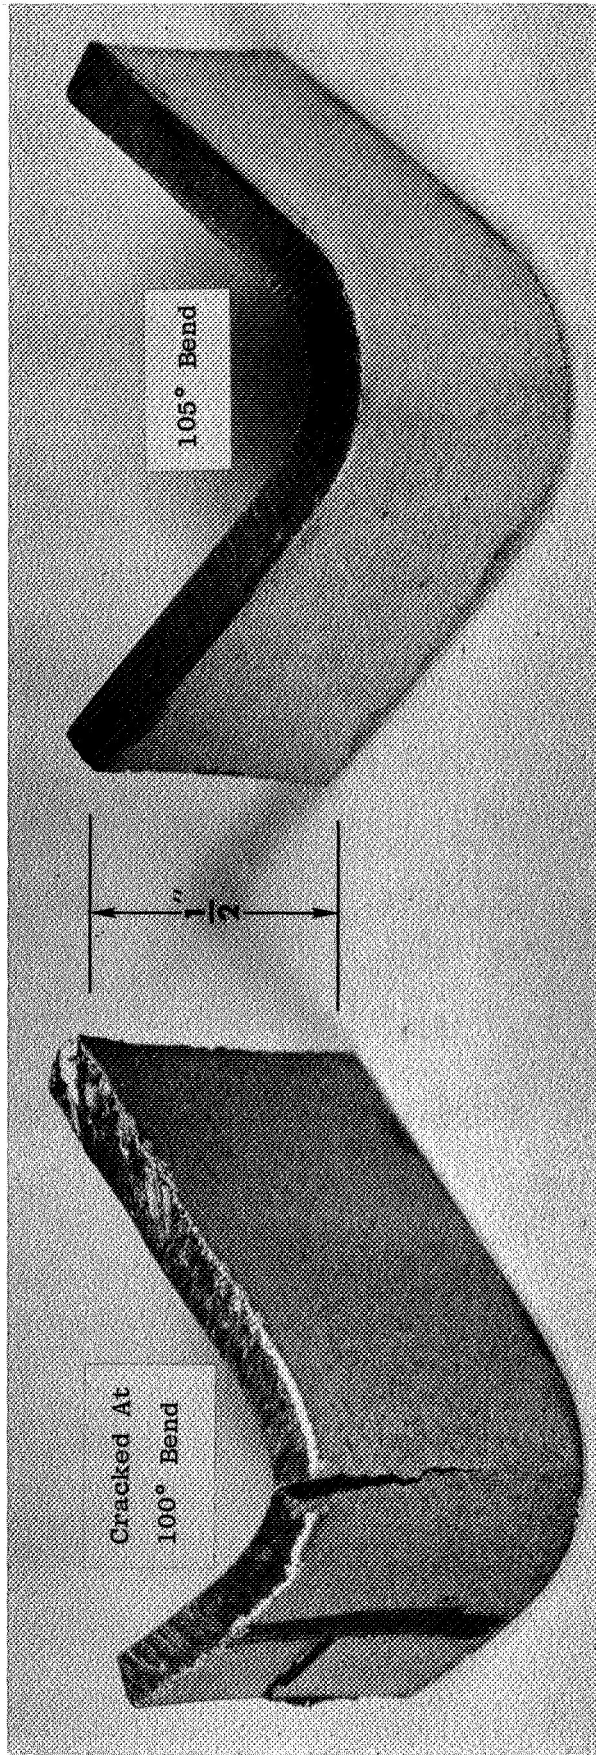
A bend specimen cut from this same area of the boiler was bent with the ID in tension over a 1t radius and cracked after 100° bend. A specimen* from the outer shell of the BRDC-2 boiler (tested at Aerojet General) was also tested. This specimen bent under the same conditions as the previous specimen from SN-1 boiler shell, bent a full 105° without cracking. The two specimens are shown in Figure 12. The BRDC-2 boiler was operated for a total of 8700 hours while the SN-1 boiler was operated for a total of 15,000 hours. There apparently was some loss of ductility of the SN-1 316 stainless steel outer shell material, but it does not appear to be detrimental to boiler operation. However, as test time is accumulated the ductility of a given boiler shell may continue to decrease.

Figure 12. Bend Specimens From Outer Stainless Steel Shell at NaK Inlet - Specimens Bent With ID Surface in Tension and 1T Bend Radius. (P70-8-12)

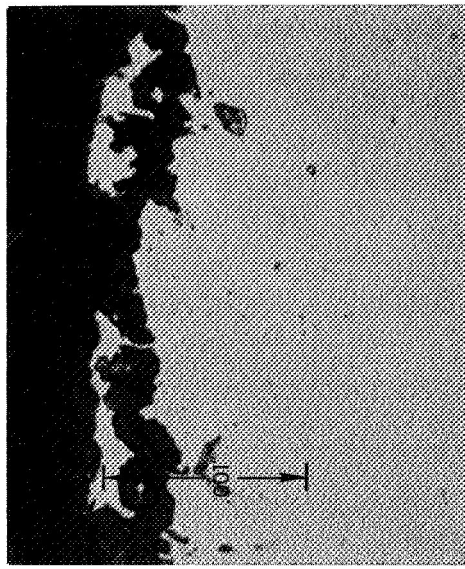
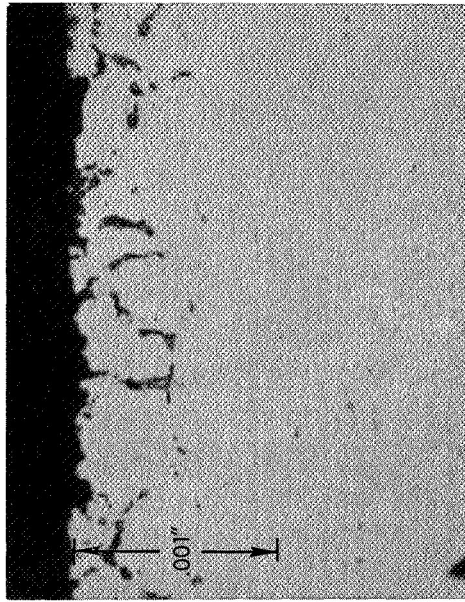
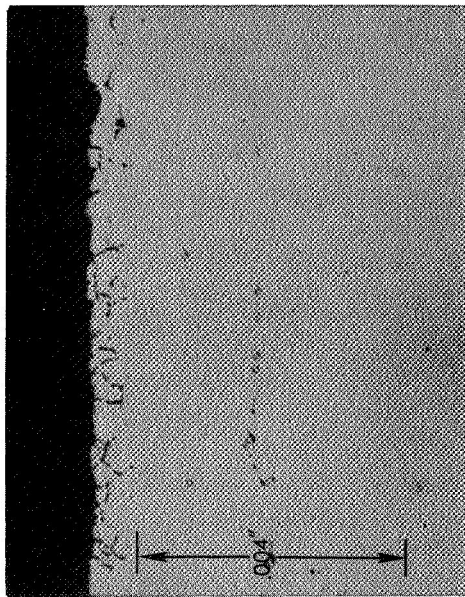
An earlier report of the February 17, 1968, boiler failure,⁽¹⁾ described a heavy deposit of NaK oxide on the OD surface of the stainless steel tubes in the plug region. At that time the NaK oxide was mechanically removed. The roughened surface was probably the result of the mechanical cleaning and subsequent oxidation or corrosion of the stainless as a result.

Metallographic examination of this area revealed some attack on the OD of the 321 stainless steel tubing to a depth of about 0.0005 inch, as shown in Figure 13. A gradient analysis for interstitial elements was obtained from the inner 1/3, center 1/3, and outer 1/3 of the tubing wall. These analyses are shown in Table III along with a gradient analysis of another section of tubing further downstream. The analysis of the tubing from the plug section showed the OD of the tube to be very high in oxygen (2017 ppm) and somewhat higher in carbon (779 ppm). The high oxygen concentration at the OD is believed to be associated with the observed attack. Sections of this tubing were noted to turn white after long-term exposure to air. The white powdery coating results from oxidation of the NaK oozing from the grain boundary attack area at the surface of the tubing.

Figure 13. OD of Stainless Steel Tube Separating the Static and Flowing NaK Circuits in Plug Area 2' Downstream of the Header at the Boiler Inlet.

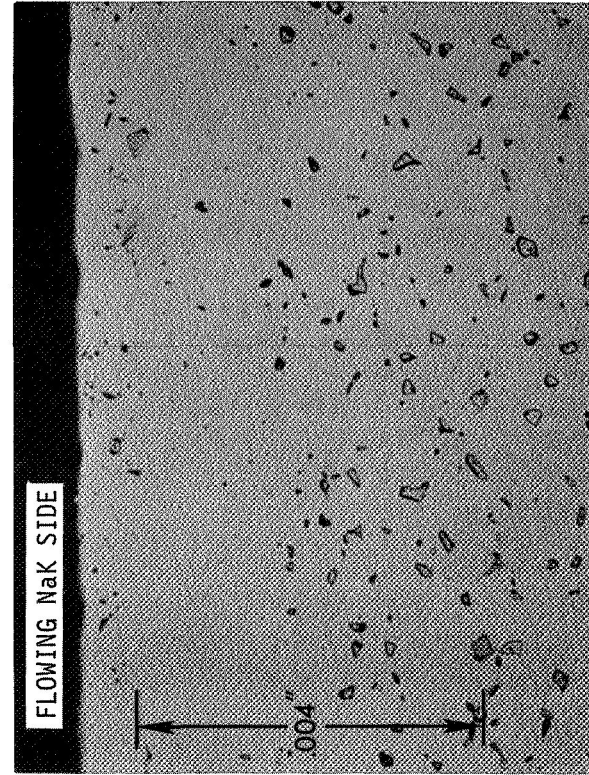
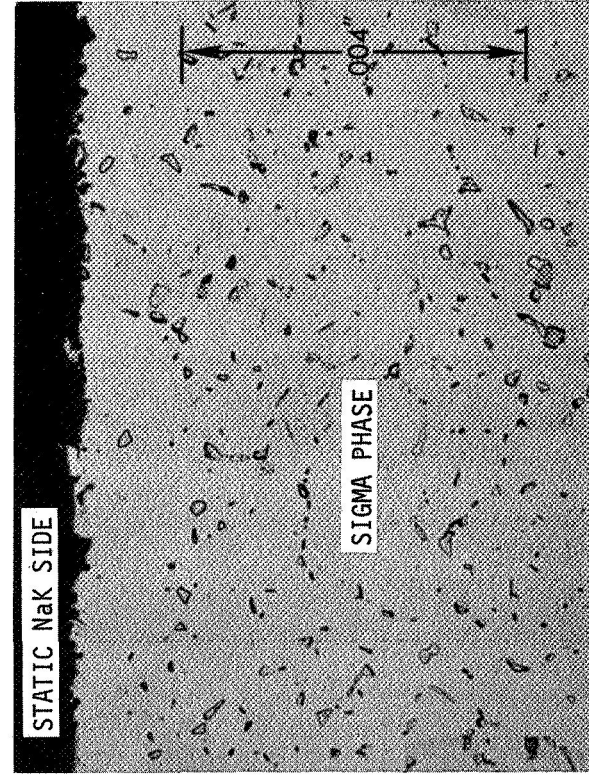
Photomicrographs shown in Figure 14 are typical of all other areas of the 321 stainless steel tubing separating the static and flowing NaK circuits. No corrosion was observed, but the areas adjacent to the surface were depleted in sigma with the effect more prevalent on the flowing NaK side. A hardness traverse across the tube wall indicated no hardness gradient as can be seen in Figure 15. Microprobe scans across the sigma depleted zone detected no change in composition. Interstitial analysis of the outer 1/3, center 1/3, and inner 1/3 of the tube wall shown in Table III, showed the oxygen and nitrogen concentrations to be somewhat higher at the surface. Apparently there has been a subtle change in composition at the tube surface which has prevented the formation of the sigma phase. The stainless steel header plates showed no sign of attack or degradation from either the static or flowing NaK sides. During the metallographic examination considerable weld shrinkage was noted in one of the center tube welds 18 feet downstream of the inlet header as shown in Figure 16. No shrinkage was noted in any of the other five welds examined.

Figure 14. 321 Stainless Steel Tubing Separating the Static NaK and Flowing NaK Circuits.

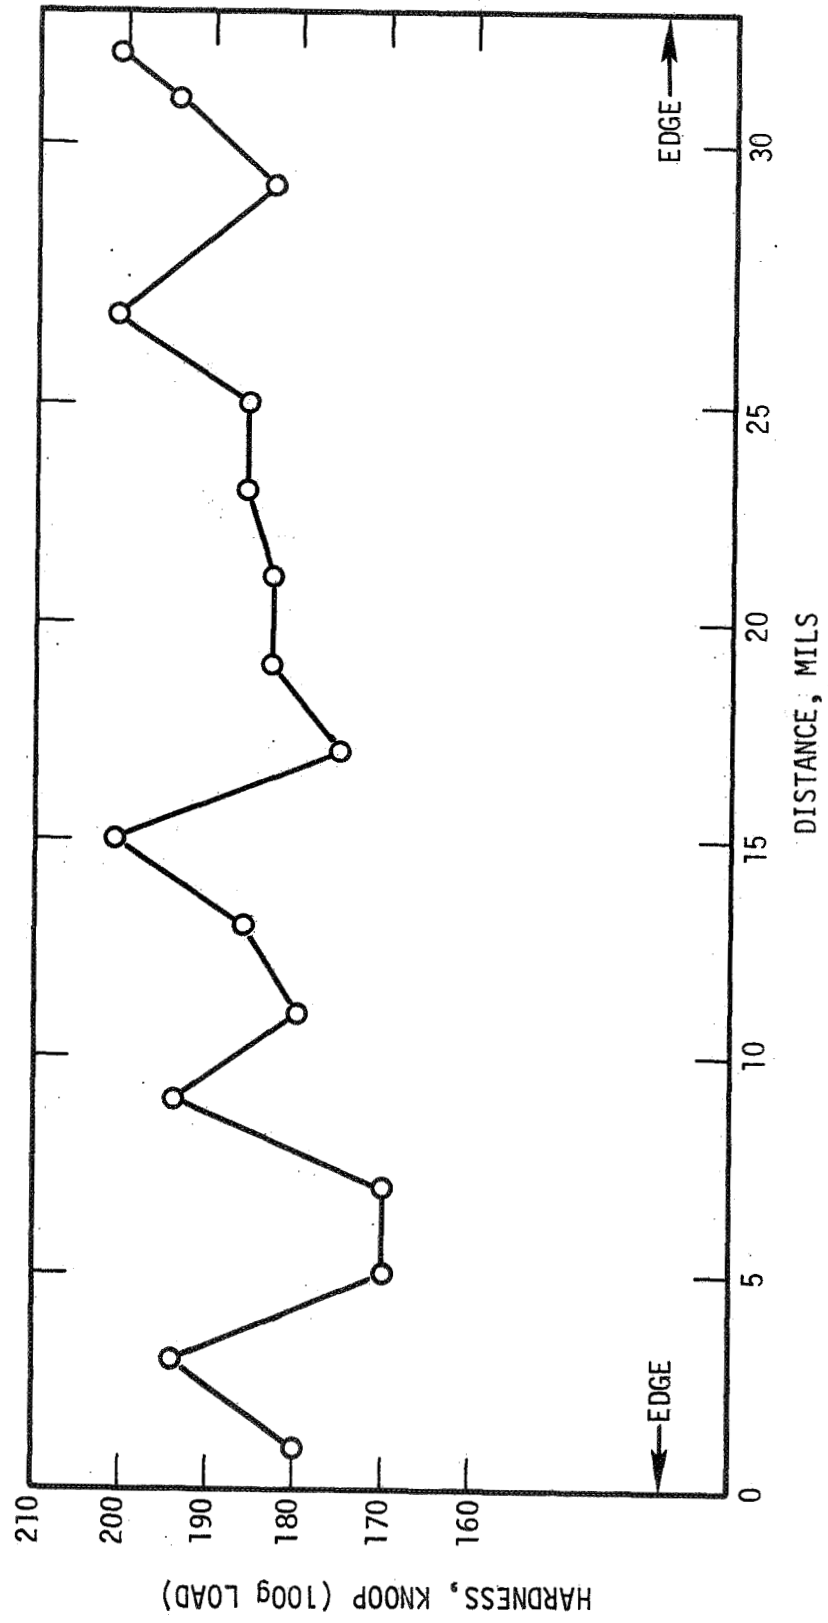
Figure 15. Hardness Across the 321 Stainless Steel Tubing Separating the Flowing and Static NaK Circuits 18 Feet From the Boiler Inlet Header.

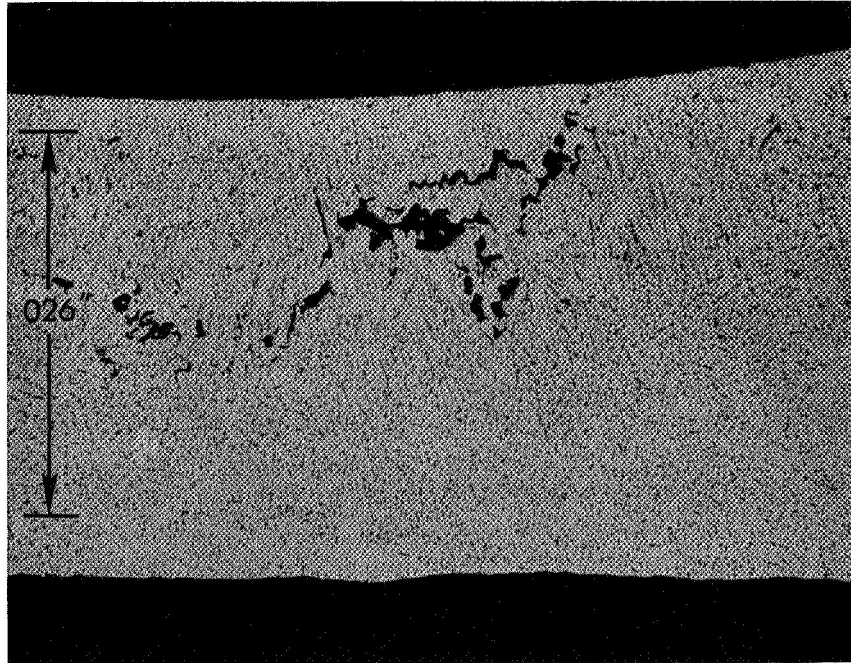
Figure 16. Weld Shrinkage in a Butt Weld in the 321 Stainless Steel Tubing Separating the Static and Flowing NaK Circuits 18 Feet Downstream From the Boiler Inlet

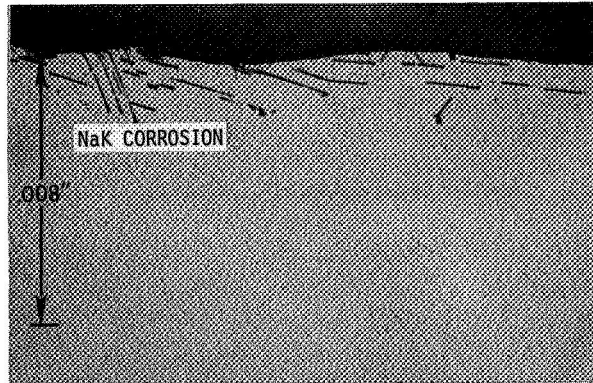
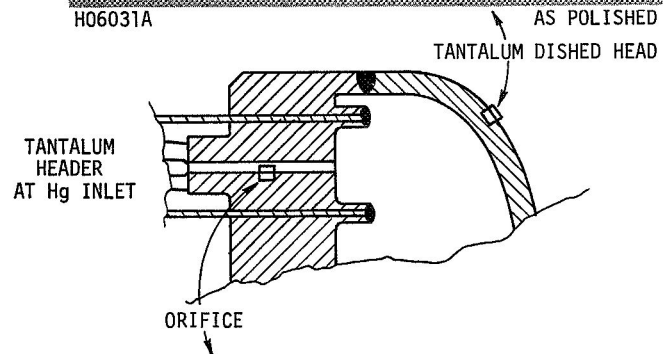
Metallographic examination of the tantalum dished head at the boiler inlet showed a minor amount of corrosion on the static NaK side. The attack shown in Figure 17 extends to a depth of 2 mils and is typical of oxygen associated alkali metal corrosion along crystallographic planes. The morphology of the corrosion suggests the possible cause as being slight oxygen contamination of the tantalum surface. The tantalum dished head at the boiler outlet showed no sign of attack although it operated at a much higher temperature (approximately 1300°F as compared to 900°F at the boiler inlet) since the tantalum dished head at the inlet was replaced during a field weld repair,⁽¹⁾ some contamination could have occurred at that time. Chemical analysis indicates the oxygen concentration of the tantalum at the boiler exit to be less than 10 ppm as compared to 40 ppm at the boiler inlet. The difference in oxygen concentration could also be explained by differences in the kinetics of oxygen dissolution in the alkali metal as influenced by the temperature difference.

NaK CORROSION ON THE
STATIC NaK SIDE OF THE
TANTALUM DISHED HEAD

Figure 17. Posttest Microstructures of the Tantalum at the Boiler Inlet.
