SNAP-8 REFRACTORY BOILER DEVELOPMENT
TOPICAL REPORT III
EVALUATION OF SNAP-8, SN-1 BOILER

November 3, 1970

NASA Lewis Research Center
Contract NAS 3-10610
Edward R. Furman, Project Manager
Phillip L. Stone,
Materials Structures Division

NUCLEAR SYSTEMS PROGRAMS
SPACE DIVISION
GENERAL   ELECTRIC
CINCINNATI, OHIO 45215

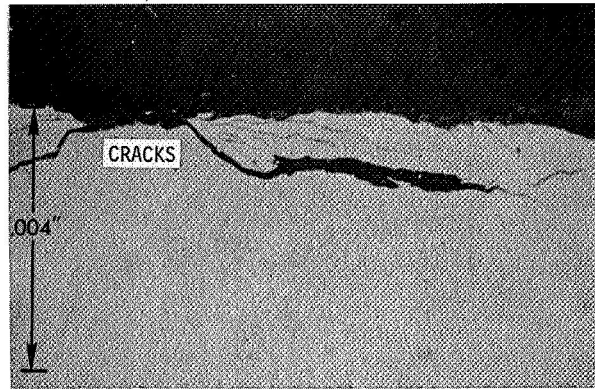
Surface cracks were observed on the ID of the tantalum orifice, shown in Figure 17. They do not appear to be corrosion but rather a result of machining. The orifices of this boiler were drilled and not polished by honing, which is now being employed in boiler manufacture.

CRACKS AT THE SURFACE
OF THE ORIFICE
(TRANSVERSE SECTION)

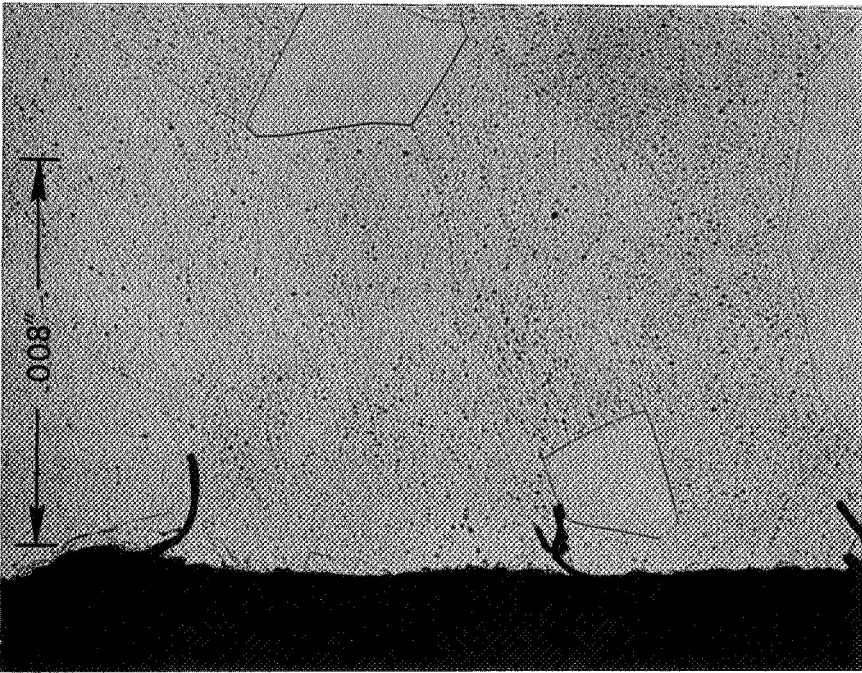
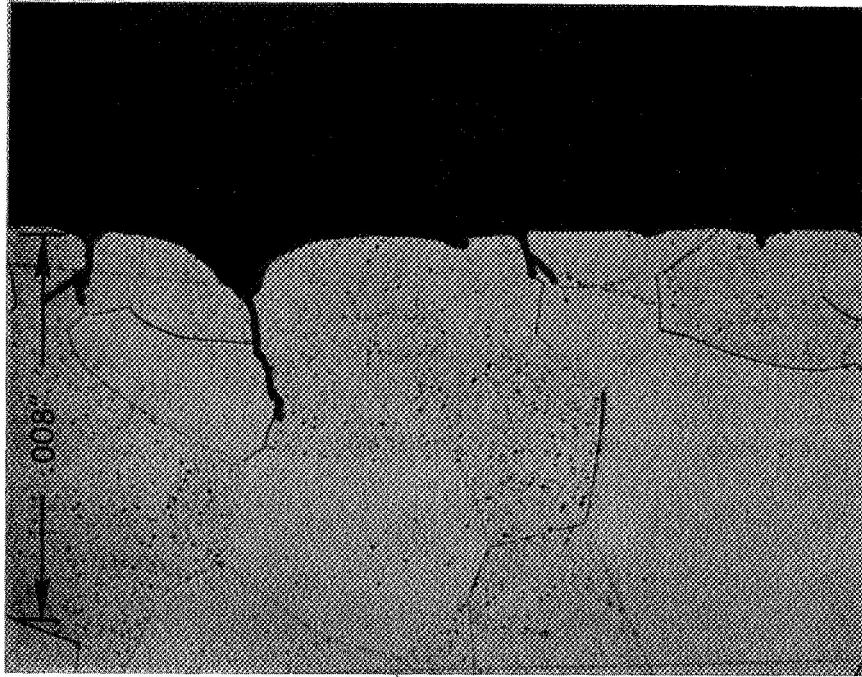
Metallographic examination of the pretest tantalum tubing used in the SN-1 boiler revealed severe grain boundary attack on both the OD and ID as shown in Figures 18 and 19. It is believed the defects could have resulted from surface contamination during processing and

subsequent acid pickling. Similar grain boundary voids have been observed in Cb-1Zr tubing processed similarly; however, this effect is not typical of standard quality refractory metal tubing.

Figure 18. Tantalum Tube - 0.670" ID x 0.040" Wall Used in the Construction of the SNAP-8 SN-1 Boiler in the Pretest Condition.

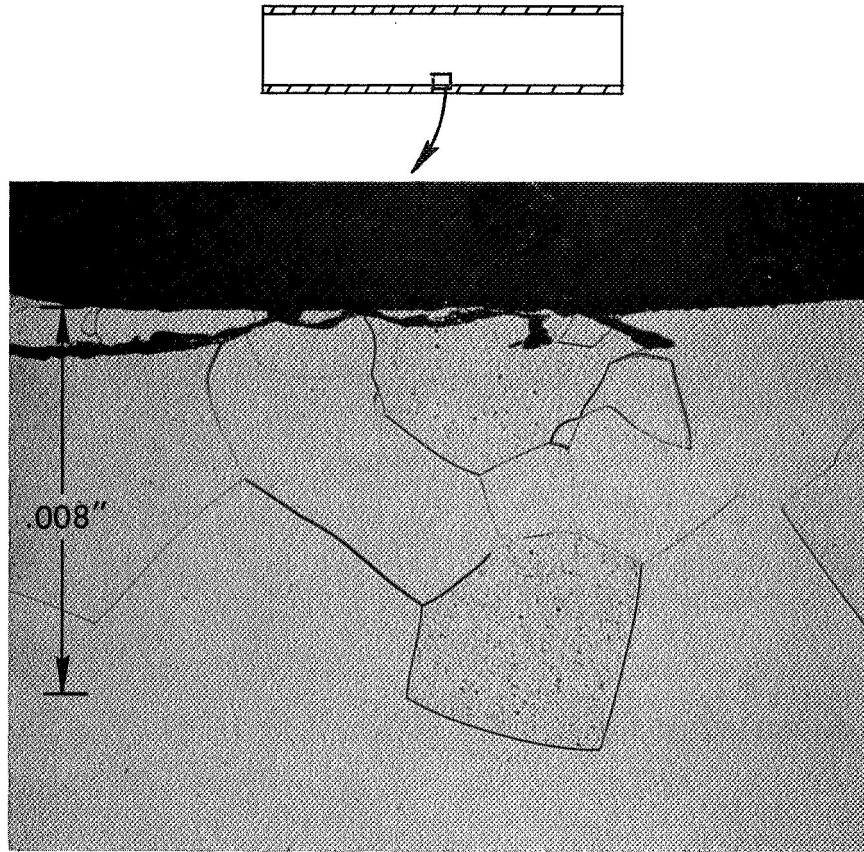
Figure 19. Tantalum Tube - 0.670" ID x 0.040" Wall Used in the Construction of the SNAP-8 SN-1 Boiler in the Pretest Condition.

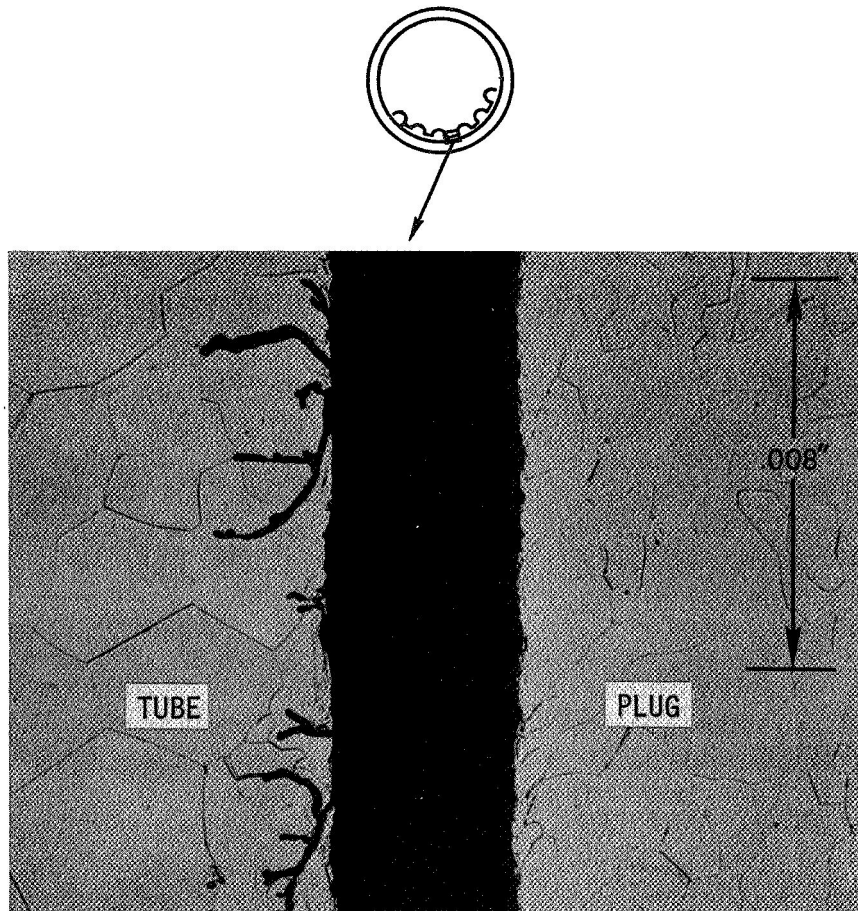
The photomicrograph in Figure 20 of a representative area of the tantalum tube-plug assembly shows the grain boundary voids in the tube while the plug shows no sign of attack. Although the liquid metal exposure would tend to accentuate these grain boundary voids no corrosion was observed.

Figure 20. Tantalum Tube - Plug Assembly at Plug Exit.

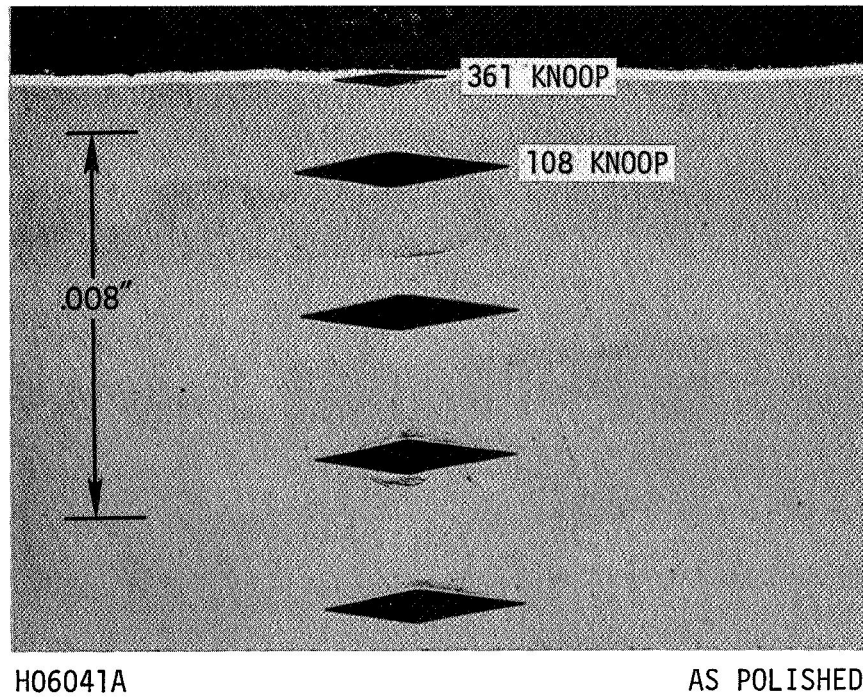
Following the dark gray deposits at the exit of the plug section and for the remaining length of the boiler, a light gray film or coating was observed on the ID surface (mercury side) of the tantalum tubing. This film, shown in Figure 21, was approximately 0.0005 inch thick and considerably harder than the base metal. Microhardness measurements show the film to have a Knoop hardness of 361 as compared to an average hardness of 100 in the tantalum. It is interesting to note that the film extends down into a lap defect in the tantalum tubing shown in Figure 22 to a depth of almost 4 mils. Photomicrographs of the tantalum tubing from other representative areas of the boiler are shown in Figure 23. X-ray diffraction analysis of the film indicated it to be predominantly isomorphous with tetragonal Ni_3Ta ; however, X-ray fluorescence analysis indicated the presence of iron, chromium, titanium, and some mercury in the coating as well as nickel.

Figure 21. The Surface Coating on the Mercury Side of the Tantalum Tubing in the Vapor Region of the Boiler.

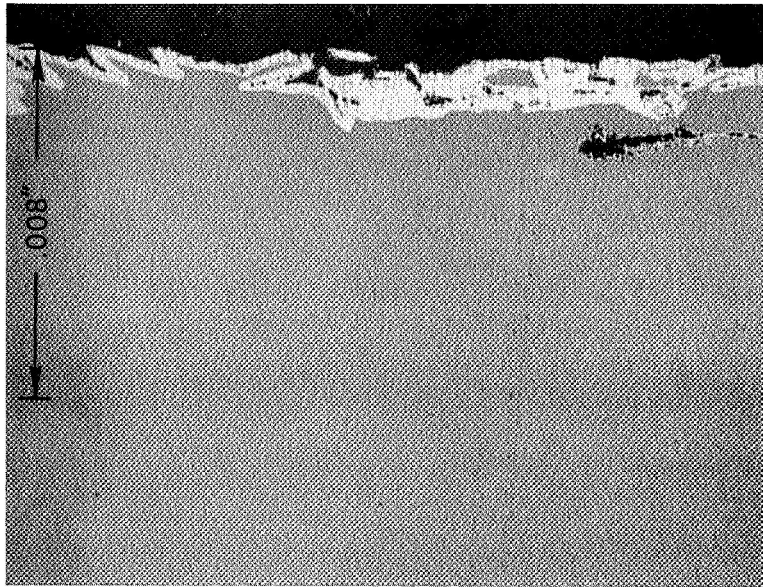
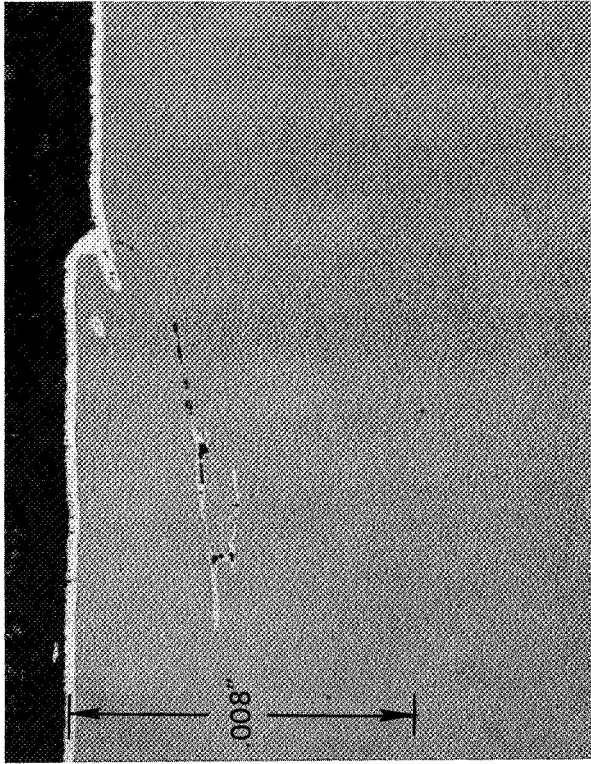
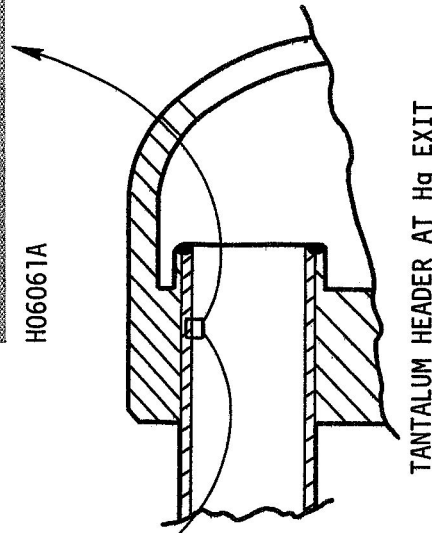
base metal. The mass transfer of stainless steel constituents occurs by dissolution in the mercury from the stainless steel facility piping and concentration in the boiler vapor region by distillation. The coating was also found on the tantalum turbulator wire which extended the full length of the boiler, the tantalum header, the dished head, and the Ta/316 SS brazed transition joint at the boiler exit. Photomicrographs of the turbulator wire are shown in Figure 24.

Figure 22. The Surface Coating on the Mercury Side of the Tantalum Tubing in the Vapor Region of the Boiler.

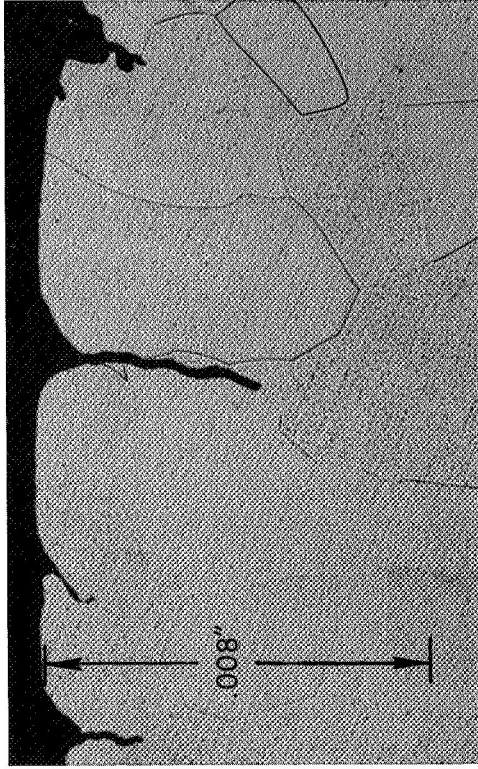
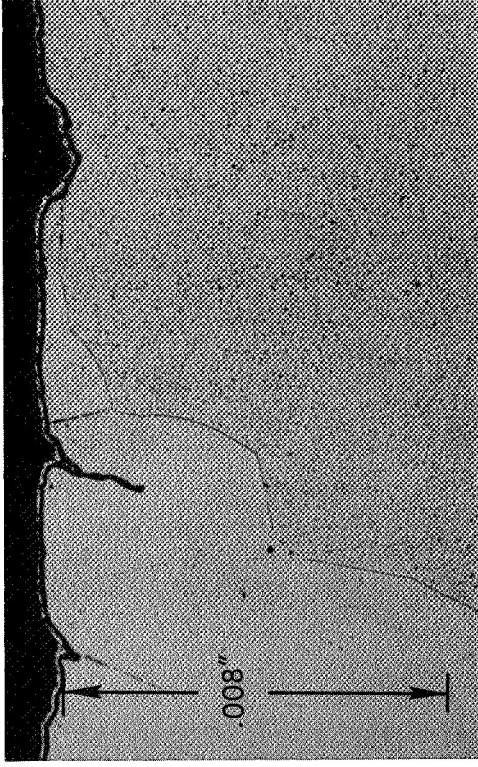
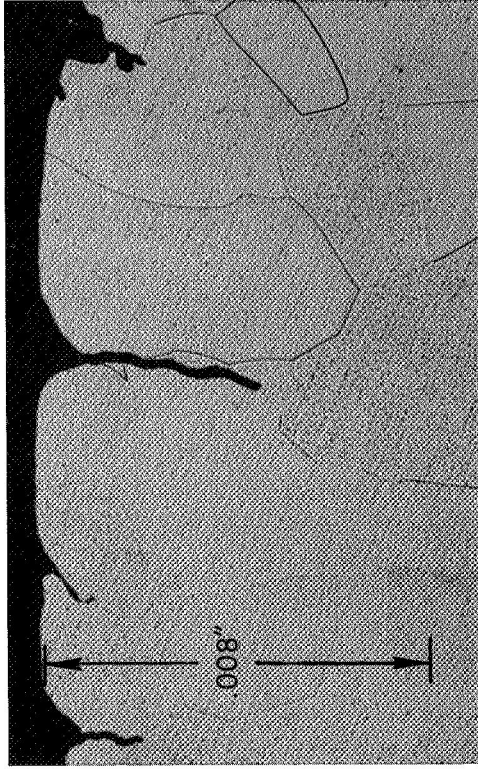
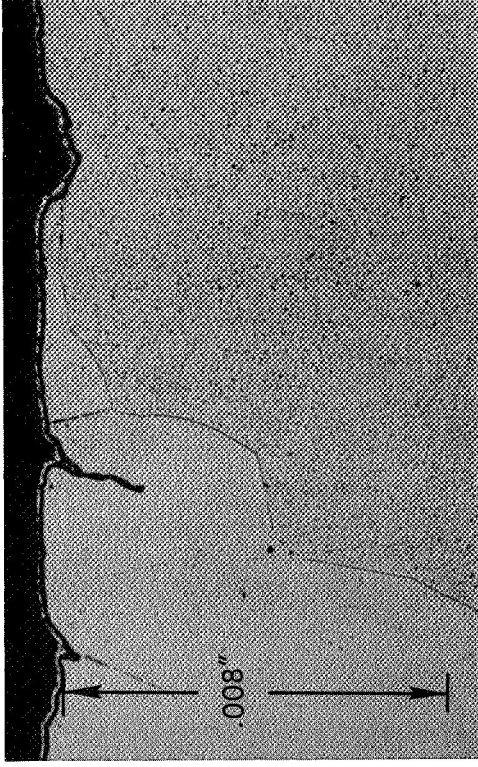
Figure 23. Tantalum Tube Separating Hg from Static NaK (A) 5' Downstream of Tantalum Header at Hg Inlet (B) 21' Downstream of Tantalum Header at Hg Inlet.

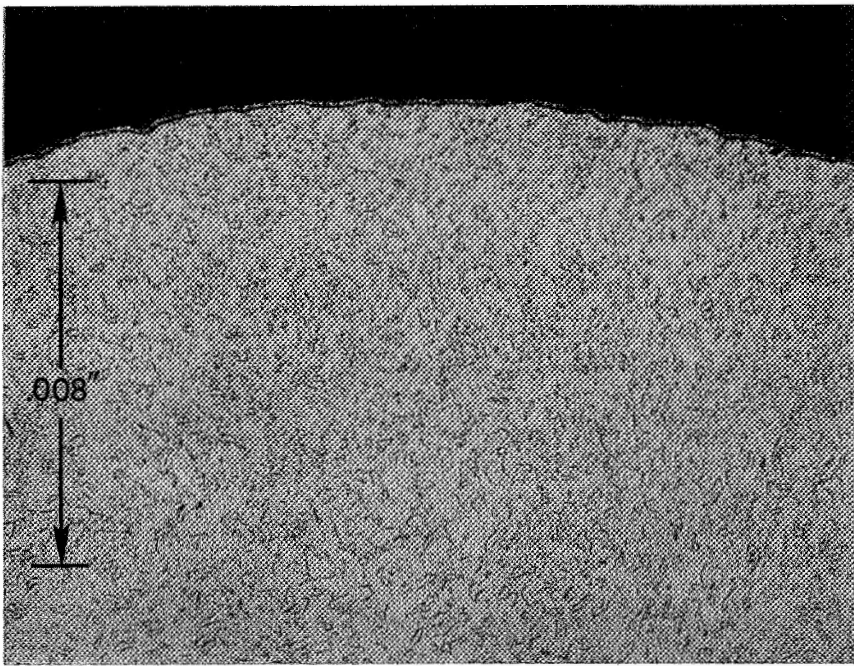
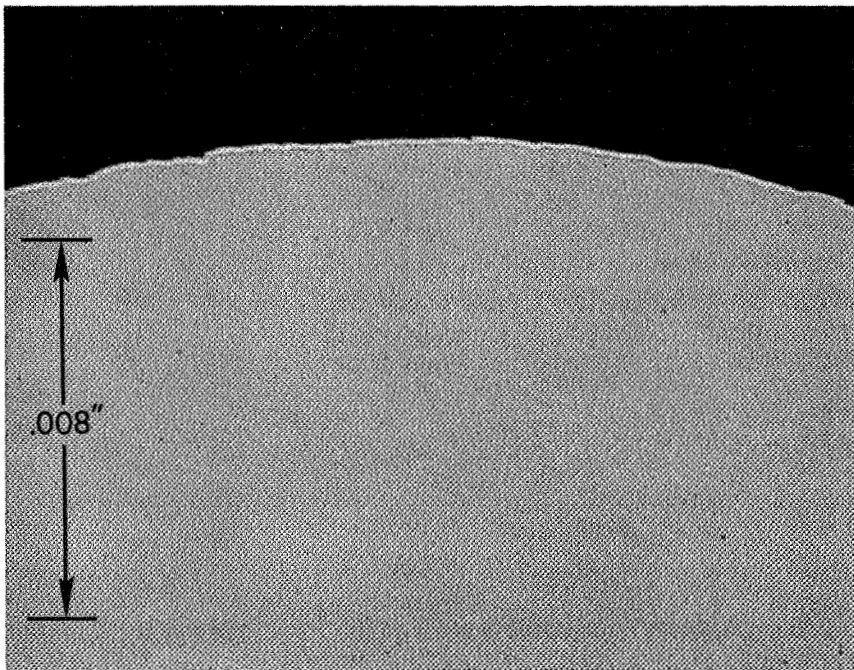
Figure 24. The Surface Coating on the Ta-10W Turbulator Wire.

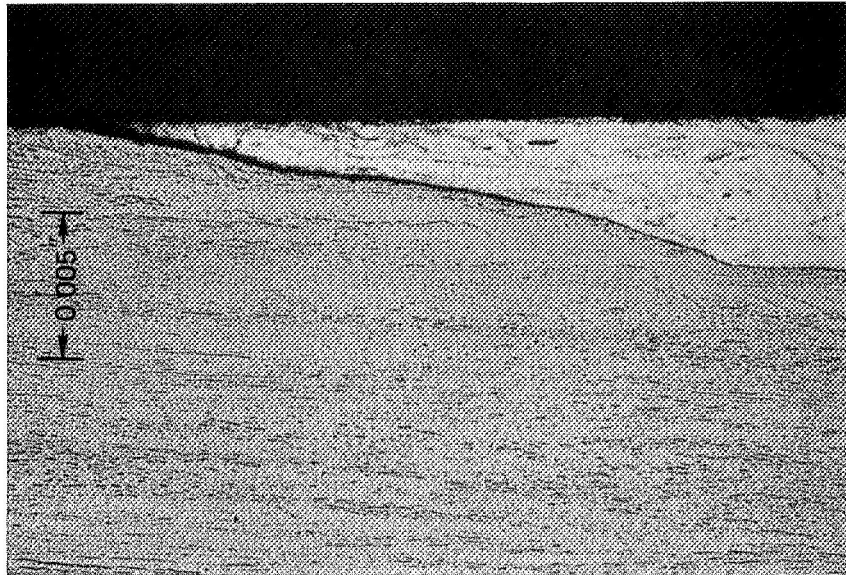
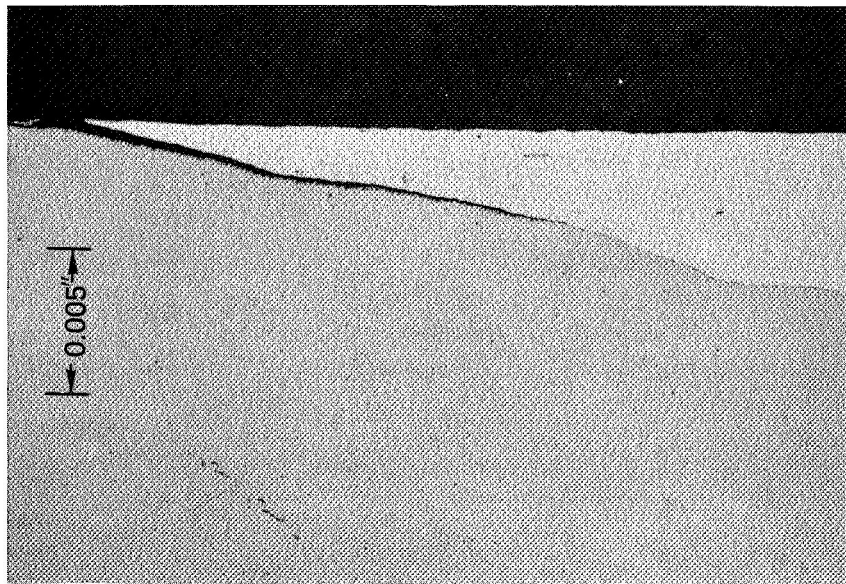
The photomicrographs in Figure 25 show the separation at the featheredge of the 316 stainless steel from the tantalum on the OD of the coextruded joint. The photomicrograph shows the separation to be 0.016 inch long. Although the specimen mounted to view the internal defect indicated by the ultrasonic inspection was ground back several times in an attempt to locate the defect. It was not found. The only defect observed in the three specimens was the one on the OD of the joint at the 316 stainless steel featheredge. The photomicrograph shown in Figure 26 is typical of the Ta/316 stainless steel interface. As can be seen, there is a discontinuous phase present at the interface, but it is less than 0.0001 inch thick and apparently had no detrimental effect on the joint. The hardness traverse across the coextruded joint shown in Figure 27 indicates a favorable hardness profile.

Figure 25. Separation of 316 Stainless Steel Feather-Edge From Tantalum on OD of Coextruded Joint From Inlet of SN-1 Boiler.

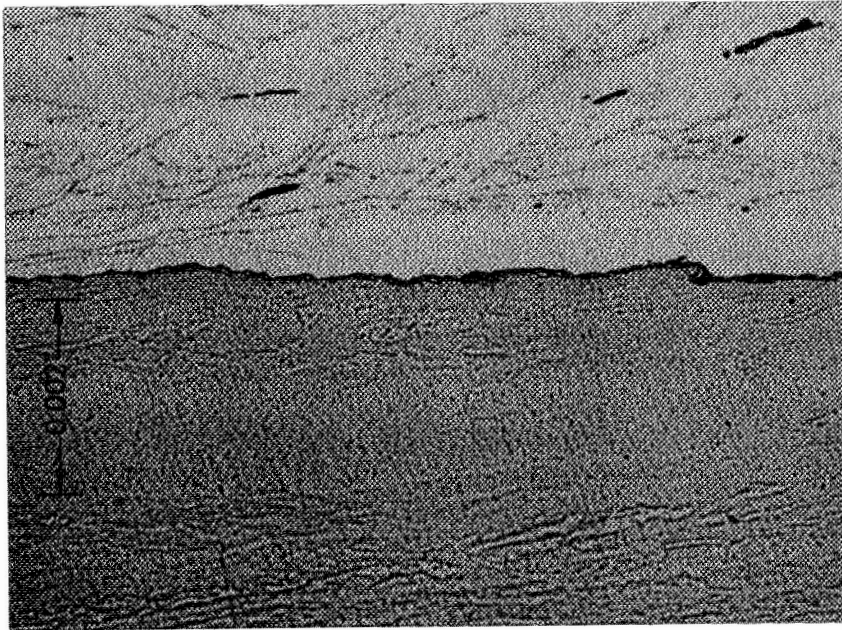
Figure 26. Tantalum - 316 Stainless Steel Interface of Coextruded Joint From Inlet at SN-1 Boiler.

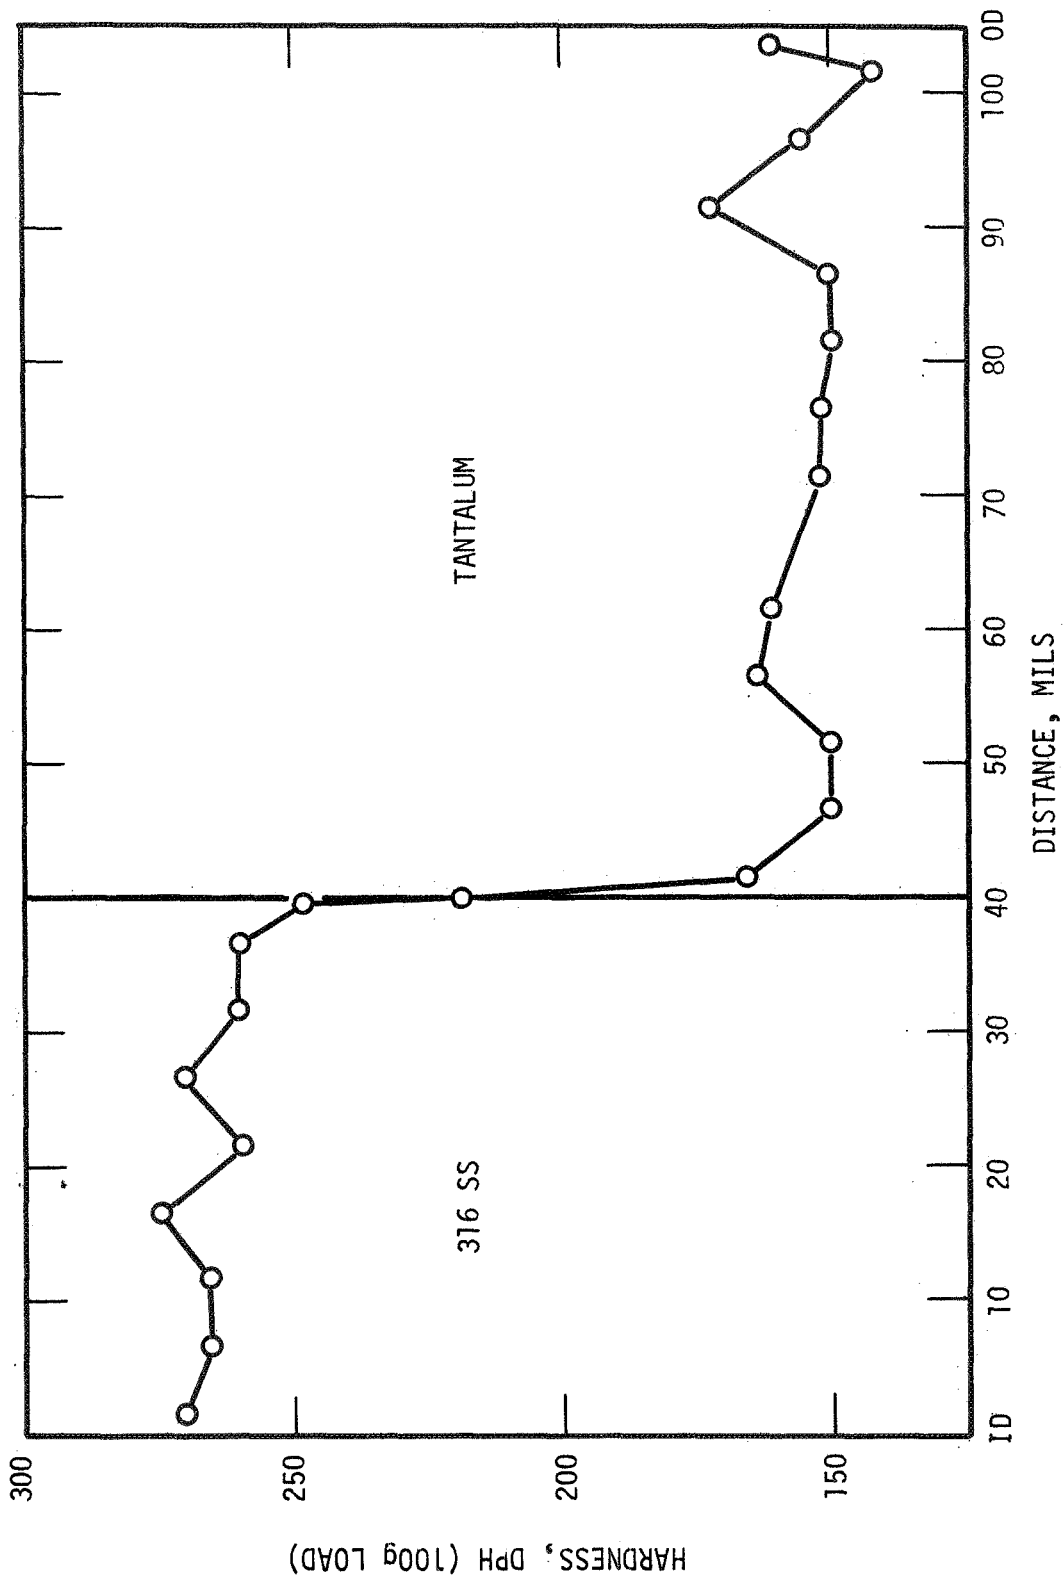
Figure 27. Hardness Traverse Across Coextruded Ta/316 Joint.

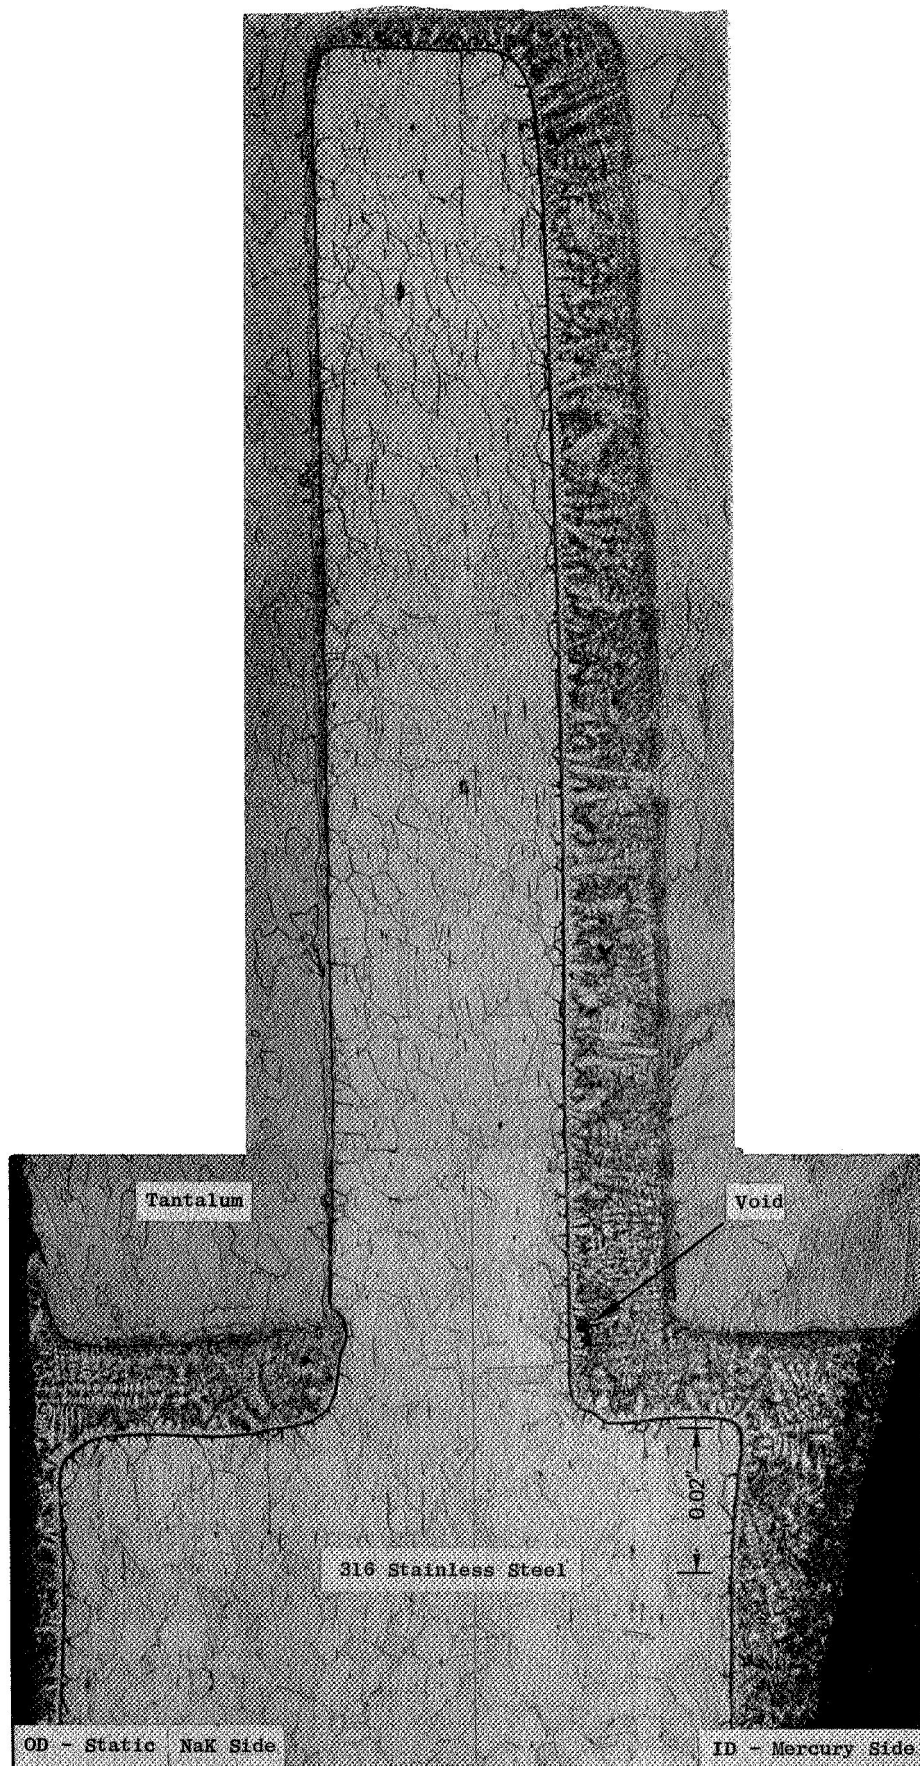
Figure 28. Microstructure of the Ta/316 SS Brazed Joint From Mercury Exit of SN-1 SNAP-8 Boiler at the Location With the Most Defects as Indicated by Ultrasonic Inspection. (H91031A, B, C, D)

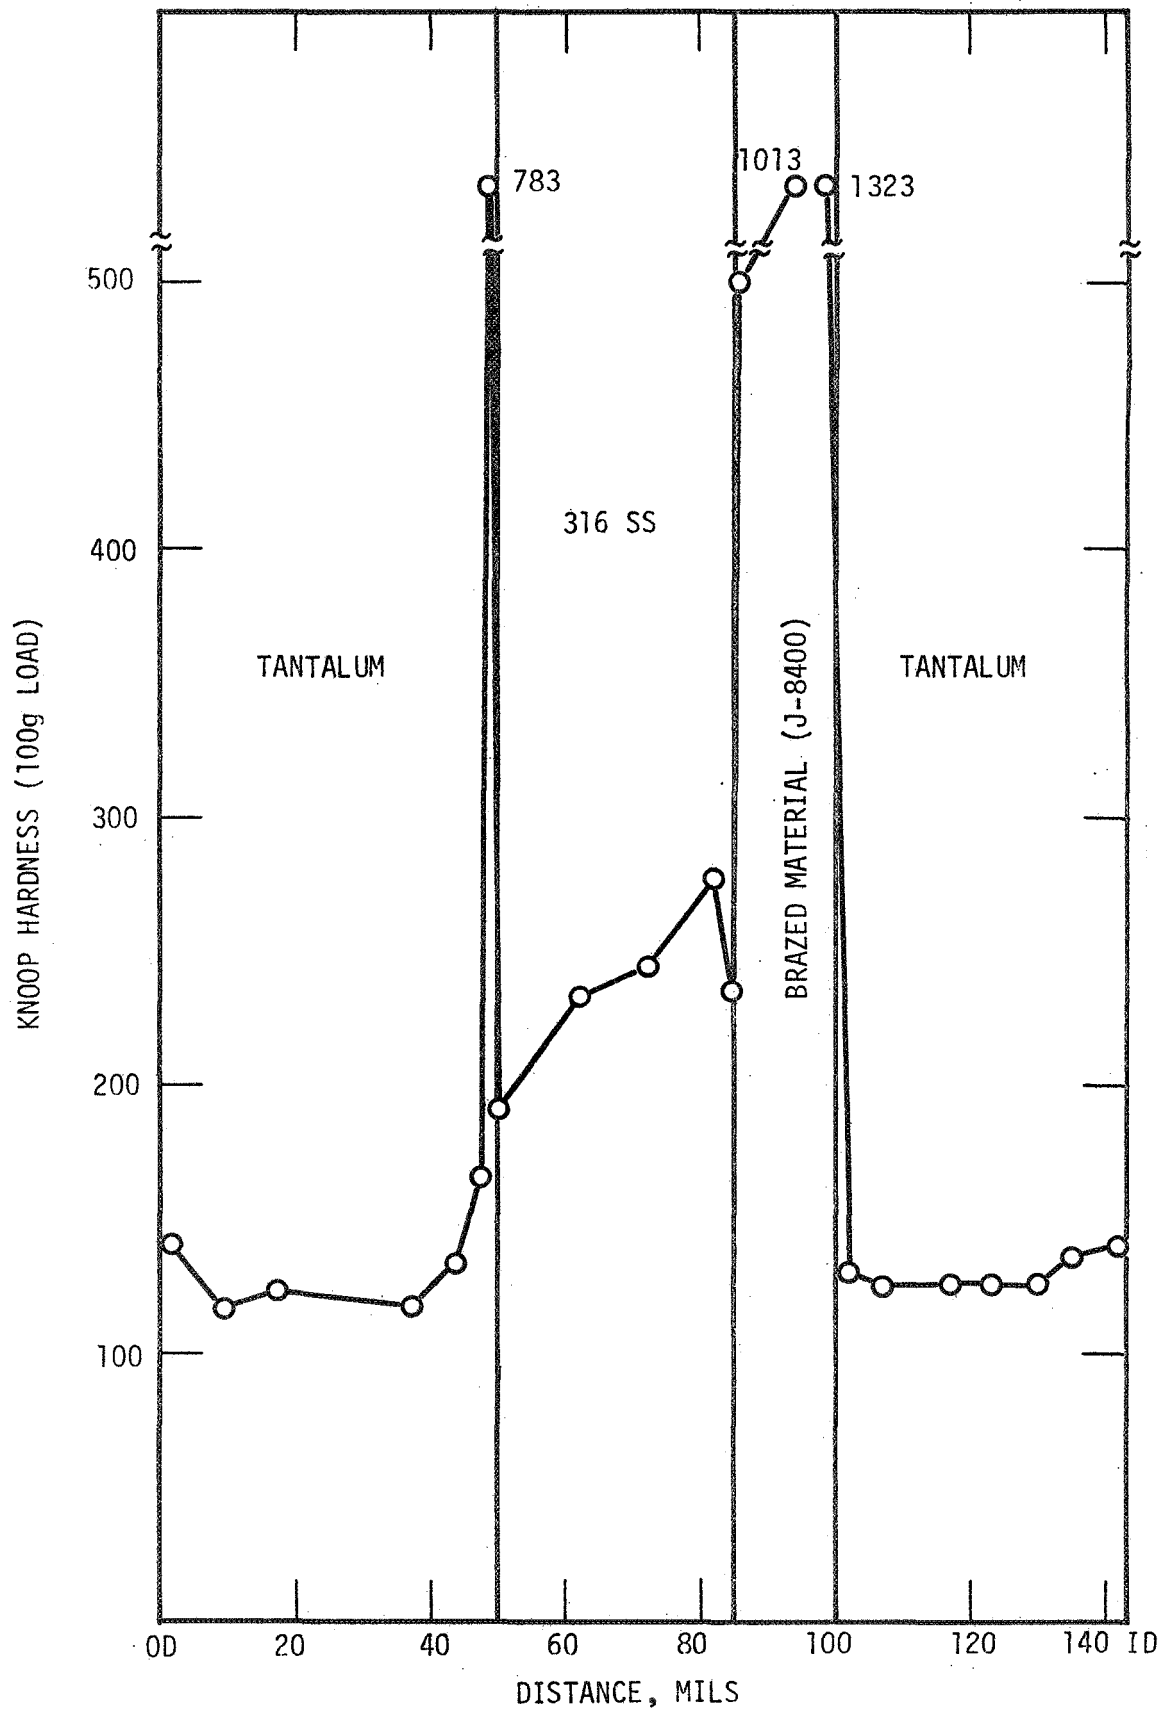
A microhardness traverse across the brazed joint is shown in Figure 29. It appears from this survey that some diffusion of the braze alloy into the 316 SS from the wide braze side has occurred. Diffusion from the narrow braze side was apparently limited by the amount of braze alloy present. The hardness of the wide braze is somewhat higher than the hardness recorded for as-brazed specimens.⁽⁴⁾ This increase of the braze hardness and increased hardness of the 316 stainless steel tongue does not appear to be detrimental to the joint.

Figure 29. Hardness Traverse Across Ta/316 Brazed Joint.
