DEVELOPMENT, FABRICATION, TESTING, AND DELIVERY OF ADVANCED FILAMENTARY COMPOSITE NONDESTRUCTIVE TEST STANDARDS

By W. M. Pless, B. L. Weil, and W. H. Lewis
Lockheed - Georgia Company
Marietta, Georgia

November 1970

Final Report

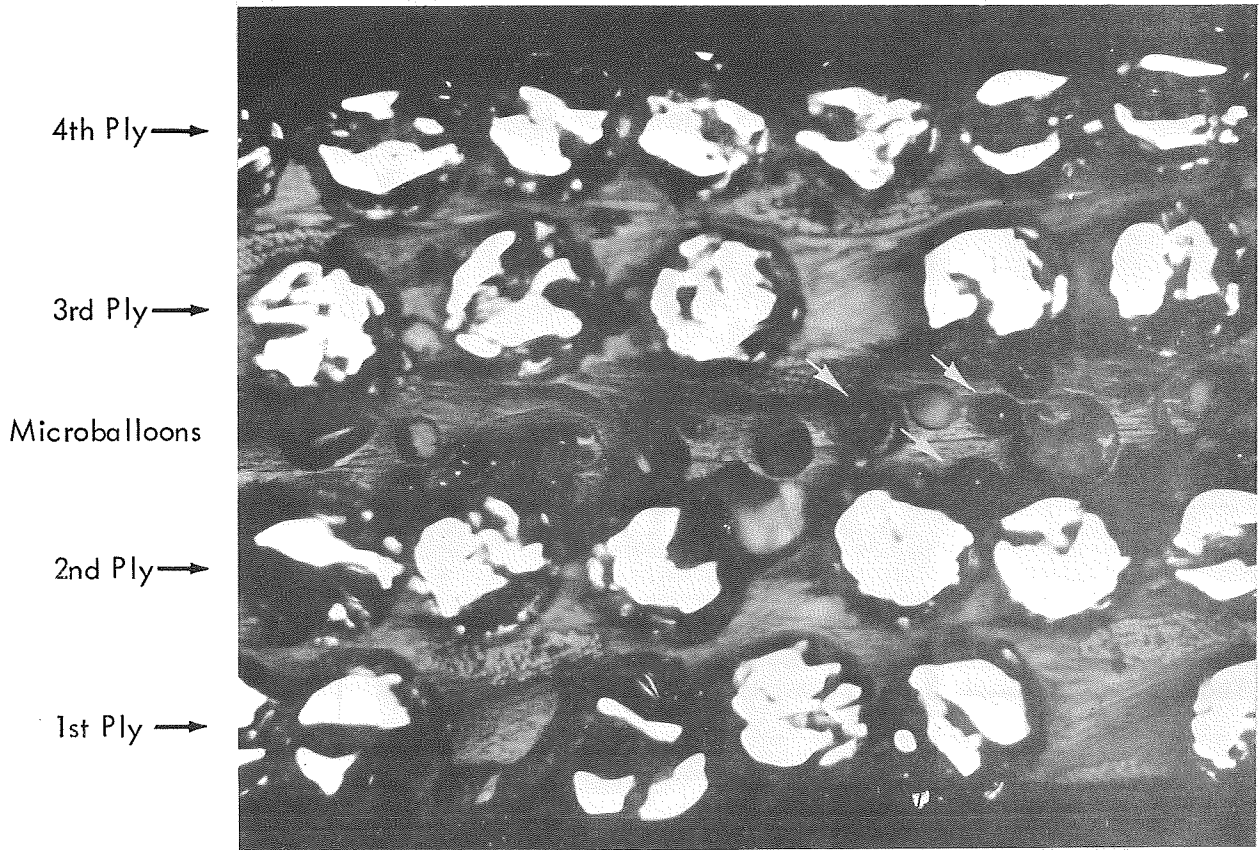
Arrow Points to Zone Shown Magnified
Below - Contains Microballoons to
Simulate Resin Porosity

FIGURE 1. PHOTOMICROGRAPH OF CROSS-SECTION OF
FOUR-PLY SEGMENT OF BORON-EPOXY
DESTRUCTIVE TEST PANEL NO. 104

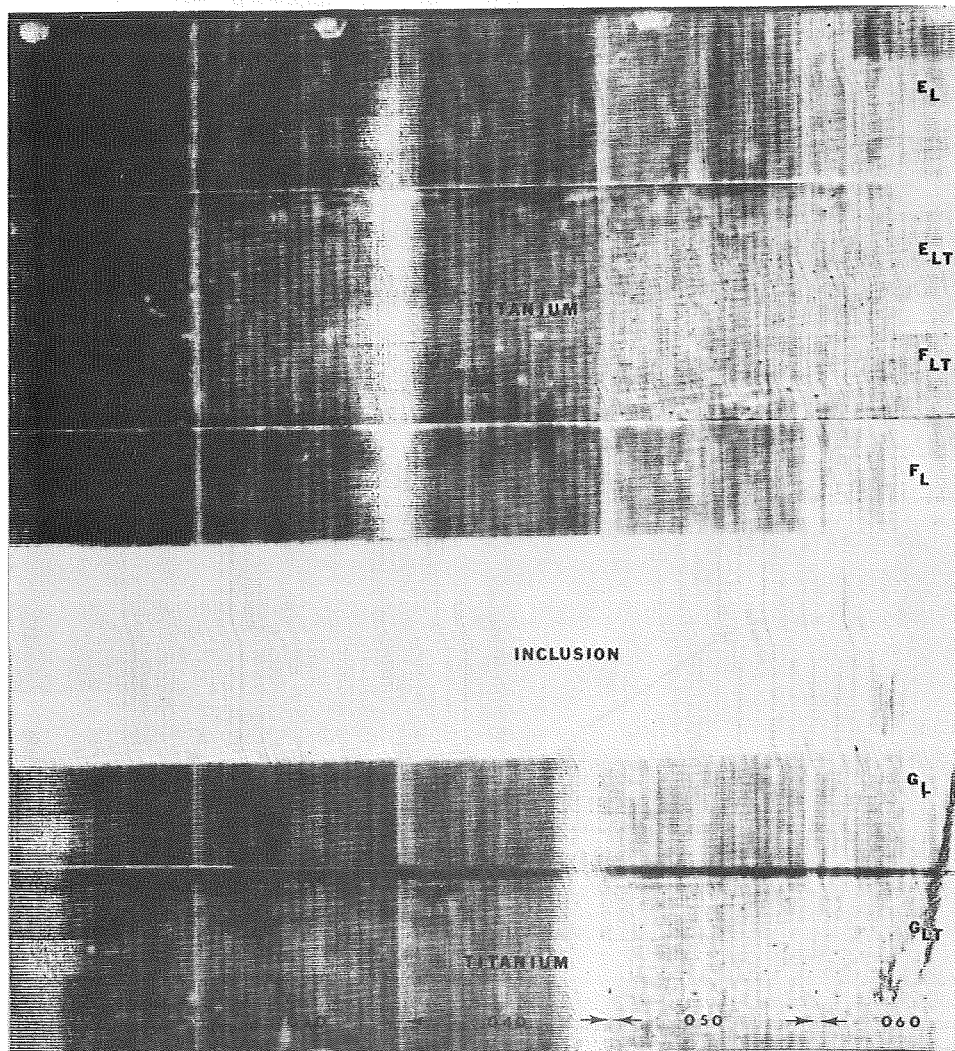
FIGURE 12. ULTRASONIC C-SCAN RECORDING AT 10 MHz OF THE FLAT GRAPHITE PANEL 207 SHOWING THE BACKING INCLUSION IN AREAS F_L AND F_{LT}

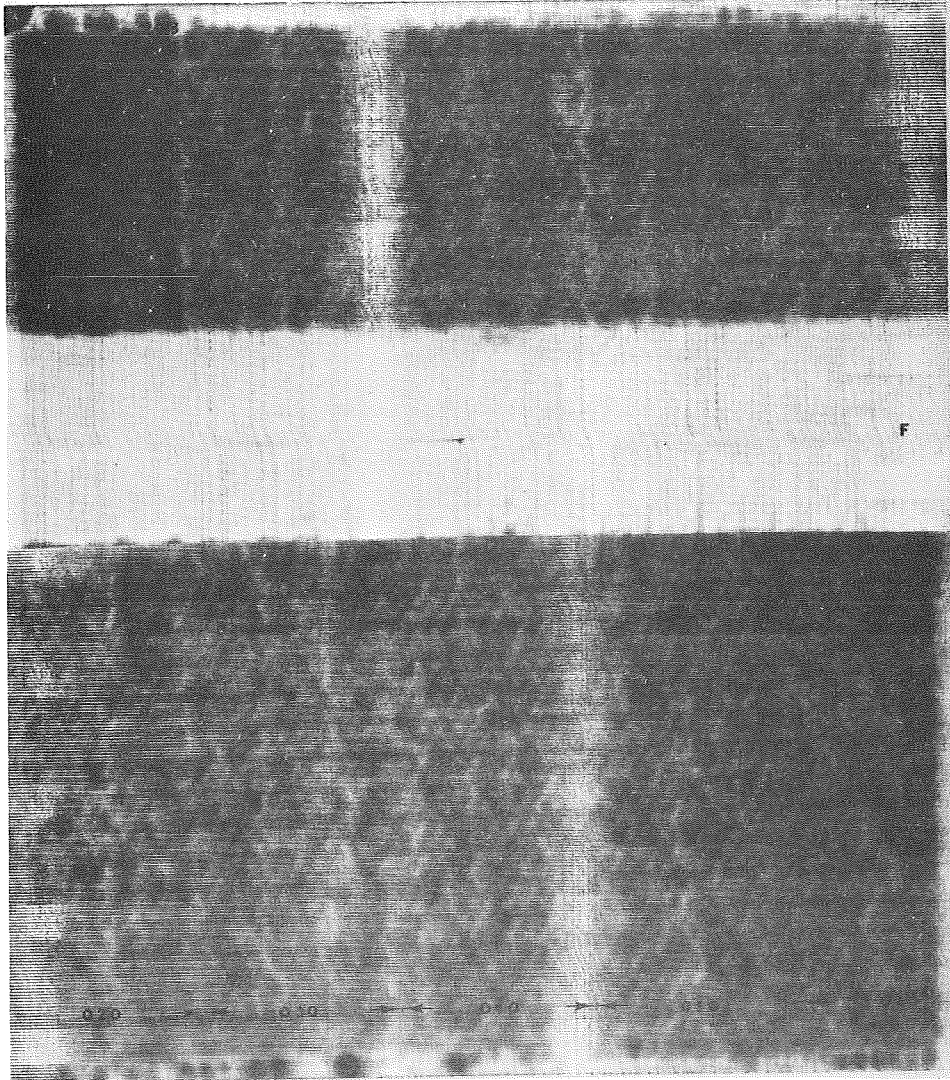
The backing inclusion is readily seen also in the C-scan recordings of honeycomb Panels 208, 209, 211, and 212 shown in Figures 14, 15, 16, and 17, respectively. Indications of the undercure condition do not appear in these recordings but would be in the lower half of the recordings (except for Panel 212, Figure 17, which was scanned on the opposite side with respect to the other panels) had the technique been sensitive to this particular defect.

FIGURE 13. ULTRASONIC C-SCAN RECORDING AT 10 mHz OF THE FLAT BORON PANEL 210 SHOWING THE BACKING INCLUSION IN AREA G_L (MISPLACED FROM AREAS F_L AND F_{LT})

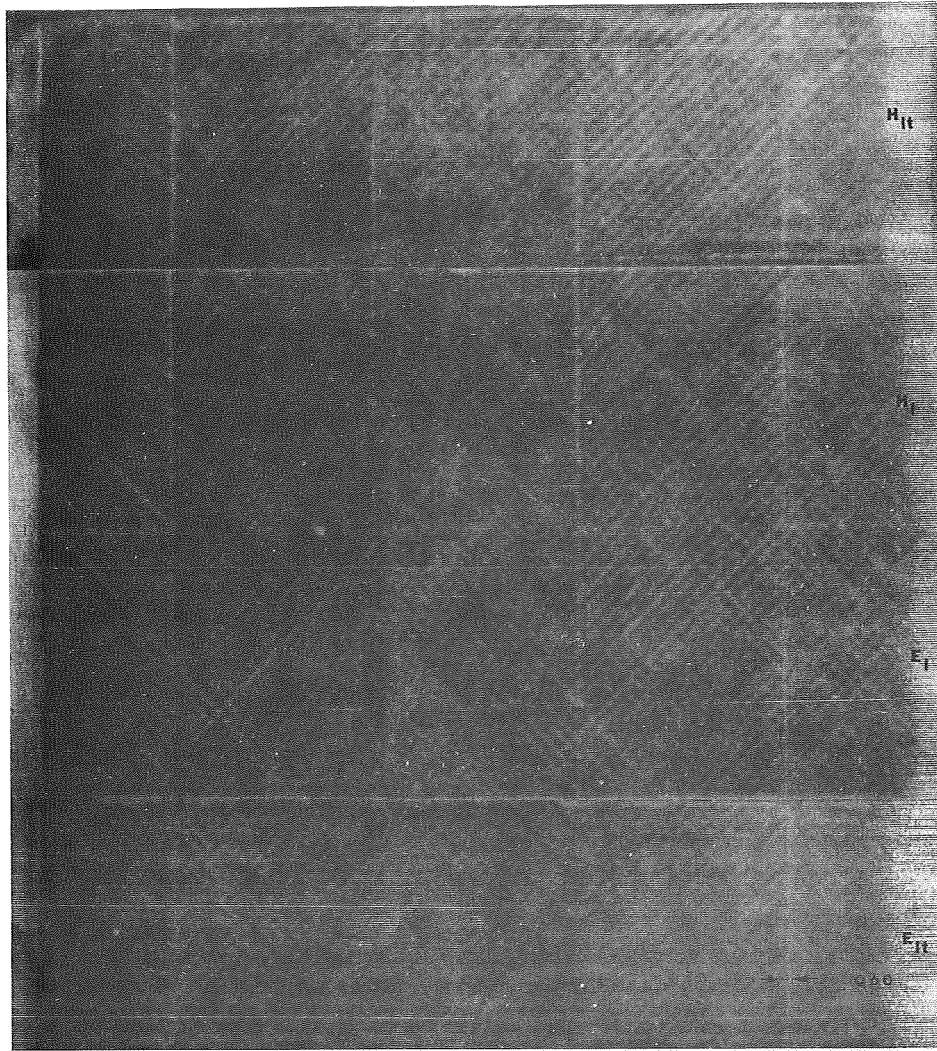
FIGURE 18. ULTRASONIC C-SCAN RECORDING AT 10 mHz OF THE FLAT GRAPHITE PANEL 313 SHOWING GROSS FIBER ORIENTATIONS

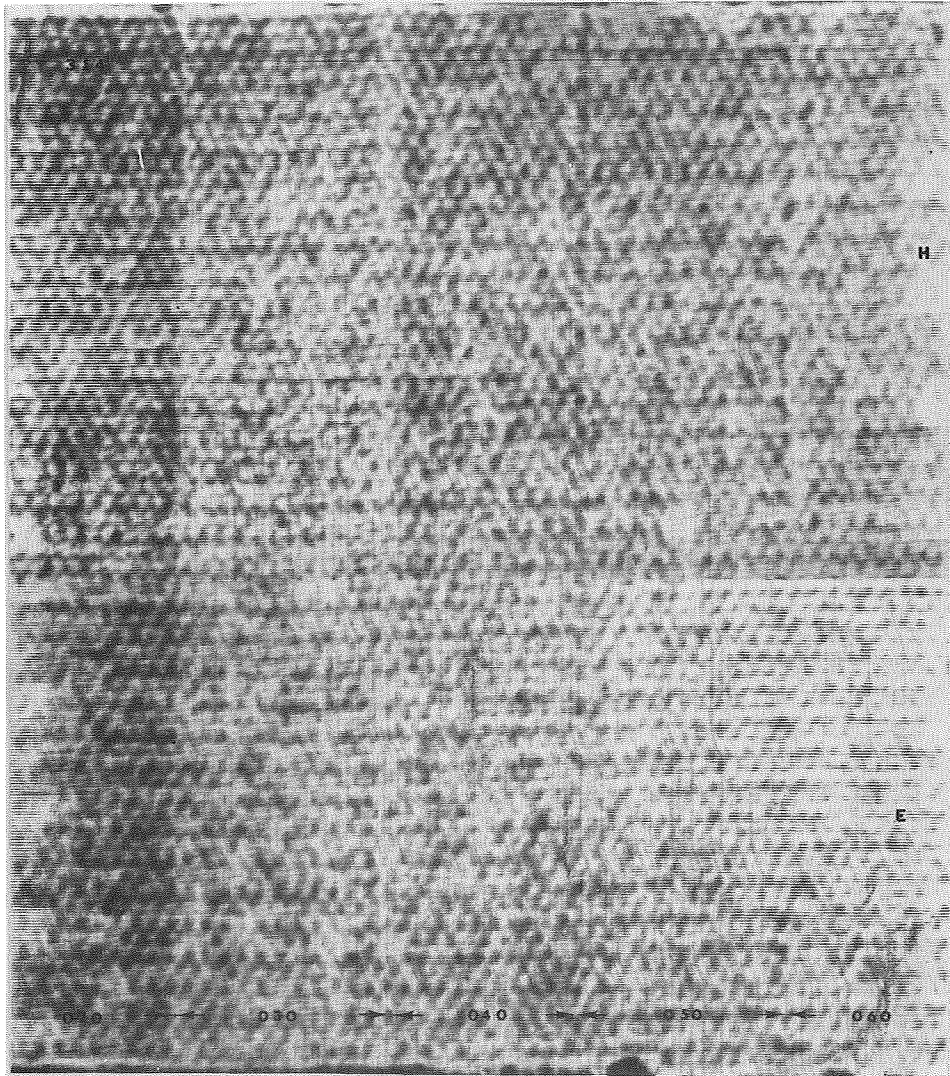
Figures 20, 21, 22, and 23 show the C-scan recordings of honeycomb Panels 314, 315, 317, and 318. The only features recognizable in the recordings are those of the honeycomb core, in all panels. Filament features cannot be seen superimposed on the core detail; thus, the second ply misalignment cannot be observed in the C-scans.

FIGURE 19. ULTRASONIC C-SCAN RECORDING AT 10 MHz OF THE FLAT BORON PANEL 316 SHOWING GROSS FIBER ORIENTATIONS

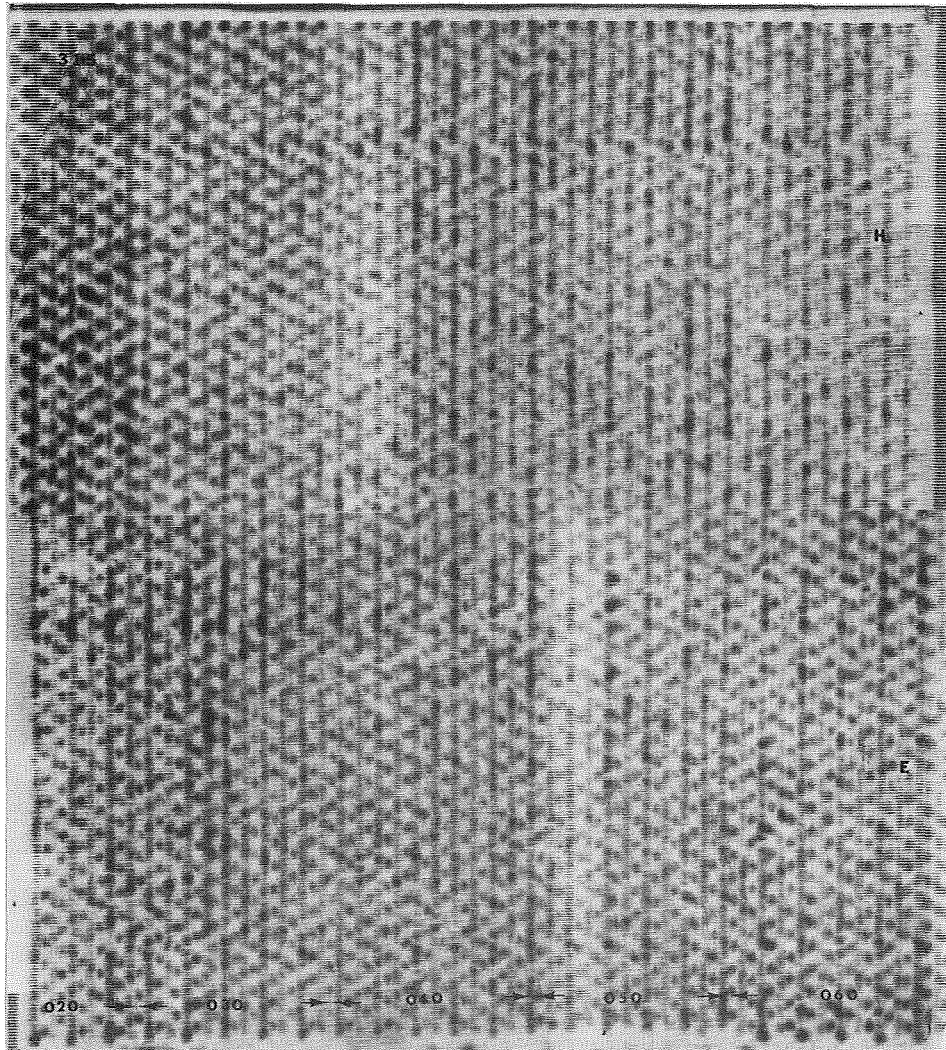
FIGURE 20. ULTRASONIC C-SCAN RECORDING AT 2.25 MHz OF THE 1/2-INCH GRAPHITE/HONEYCOMB PANEL 314

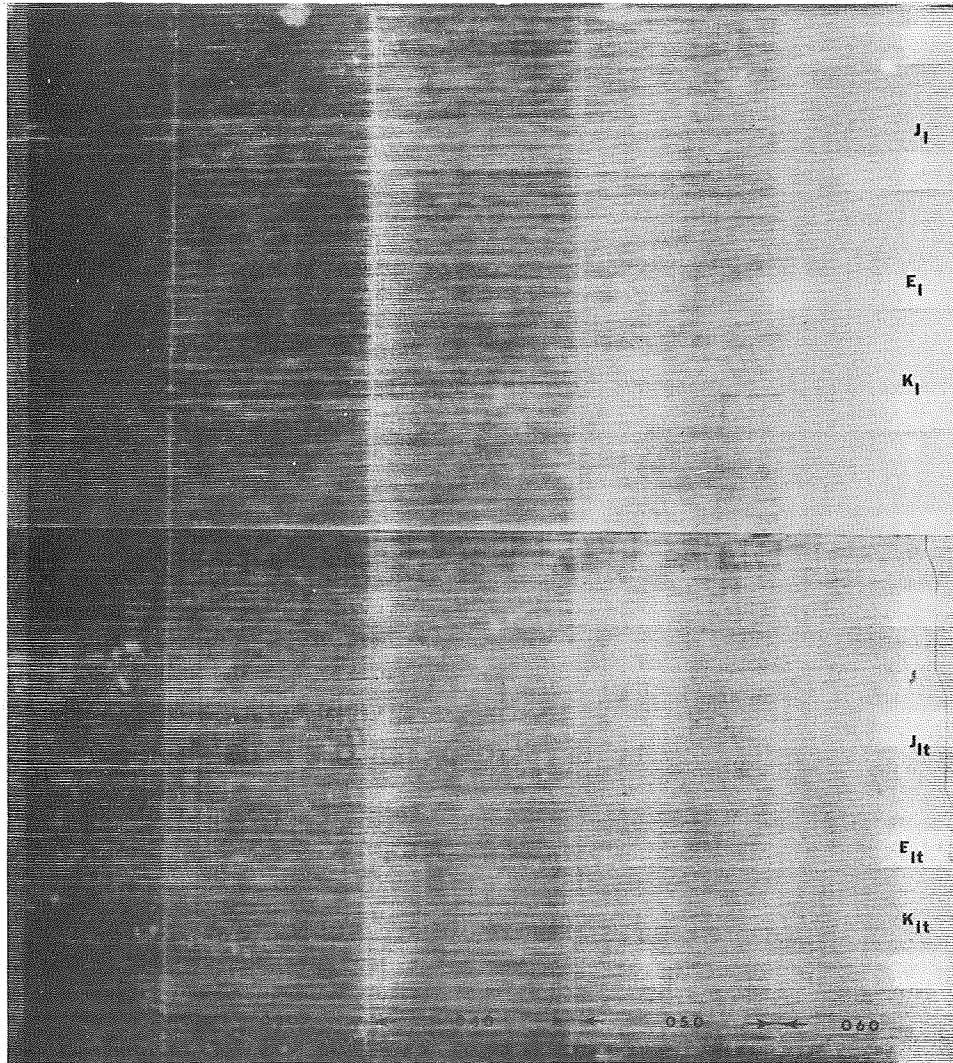
FIGURE 24. ULTRASONIC C-SCAN RECORDING AT 10 mHz OF THE FLAT GRAPHITE PANEL 419 SHOWING THE 1/4-INCH SLOTS (L_I, L_{II}), OVERLAPS (J_I, J_{II}), AND SPACING VOIDS (K_I, K_{II}) IN THE FIBER PLYS

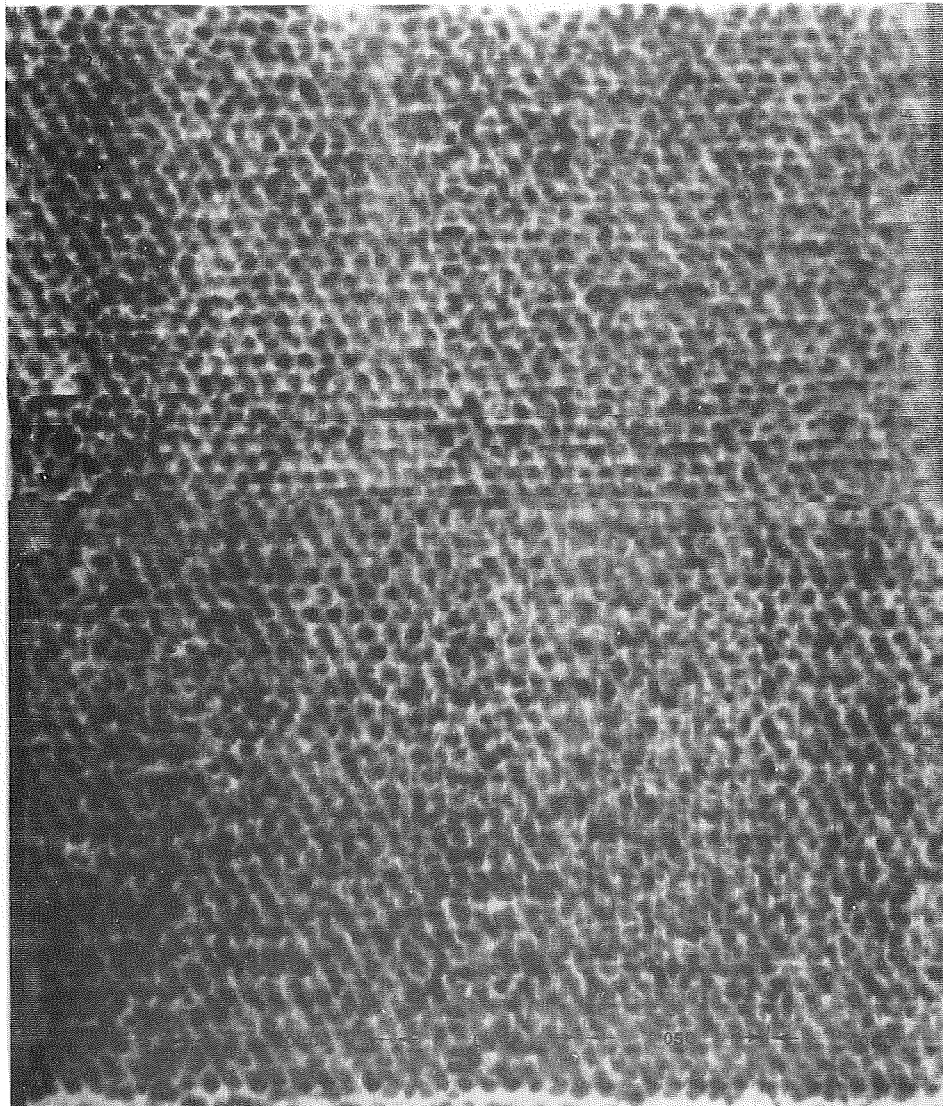
The C-scan recordings for the honeycomb Panels 420, 421, 423, and 424 are in Figures 26, 27, 28, and 29, respectively. None of the slots, overlaps, fiber spacings, and slits are apparent in these recordings as the signal-to-noise ratio (with respect to the defect signals) is quite low for the setup used. This is due to the complexity of these panels. The thickness steps are generally observable in all the panels.

FIGURE 26. ULTRASONIC C-SCAN RECORDING AT 2.25 MHz OF THE 1/2-INCH GRAPHITE/HONEYCOMB PANEL 420

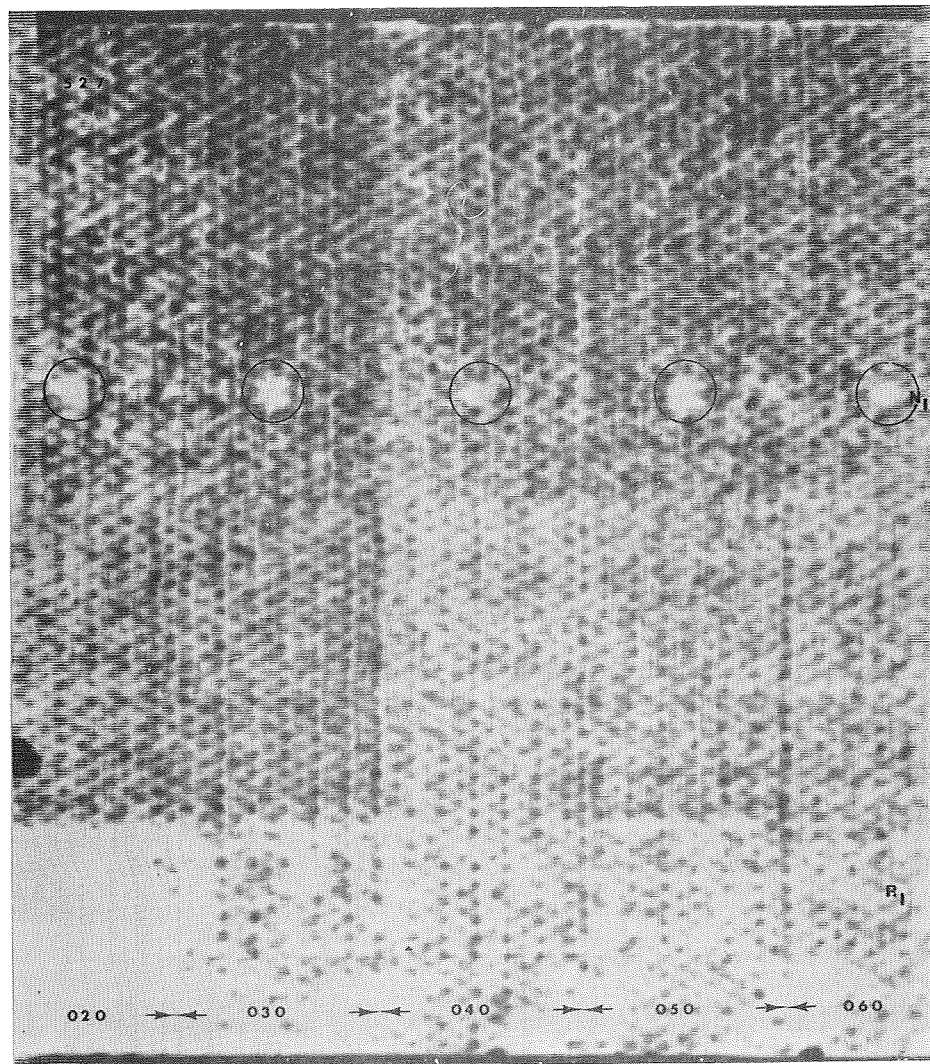
Figures 32 and 33 show the C-scan recordings for two No. 527 panels (1/2-inch honeycomb with graphite facesheets). Figure 32 is a C-scan of the original No. 527(A) panel with all intended defects but also with many unintentional disbonds which limit the usefulness of the panel. As a result of the obviously poor quality in the original panel, a second Panel 527(B) was fabricated, but the laminate/honeycomb disbond inserts and the crushed core were inadvertently left out of this panel. The C-scan of this second panel (Figure 33) shows only the 1/4-inch interlaminar disbonds and the general disbond area produced by the preaged material. A new panel was constructed to conform to the design for Panel No. 527C. This panel includes all of the designed artificial defects and includes no unintentional disbonds. The ultrasonic C-scan of this panel is shown in Figure 71 which reveals the presence of all intentional defects and no unintentional disbond areas.

FIGURE 32. ULTRASONIC C-SCAN RECORDING AT 2.25 MHz OF THE 1/2-INCH GRAPHITE/HONEYCOMB PANEL 527 (#2) SHOWING ALL THE INTENDED DEFECTS AS WELL AS MANY UNINTENTIONAL DISBONDS

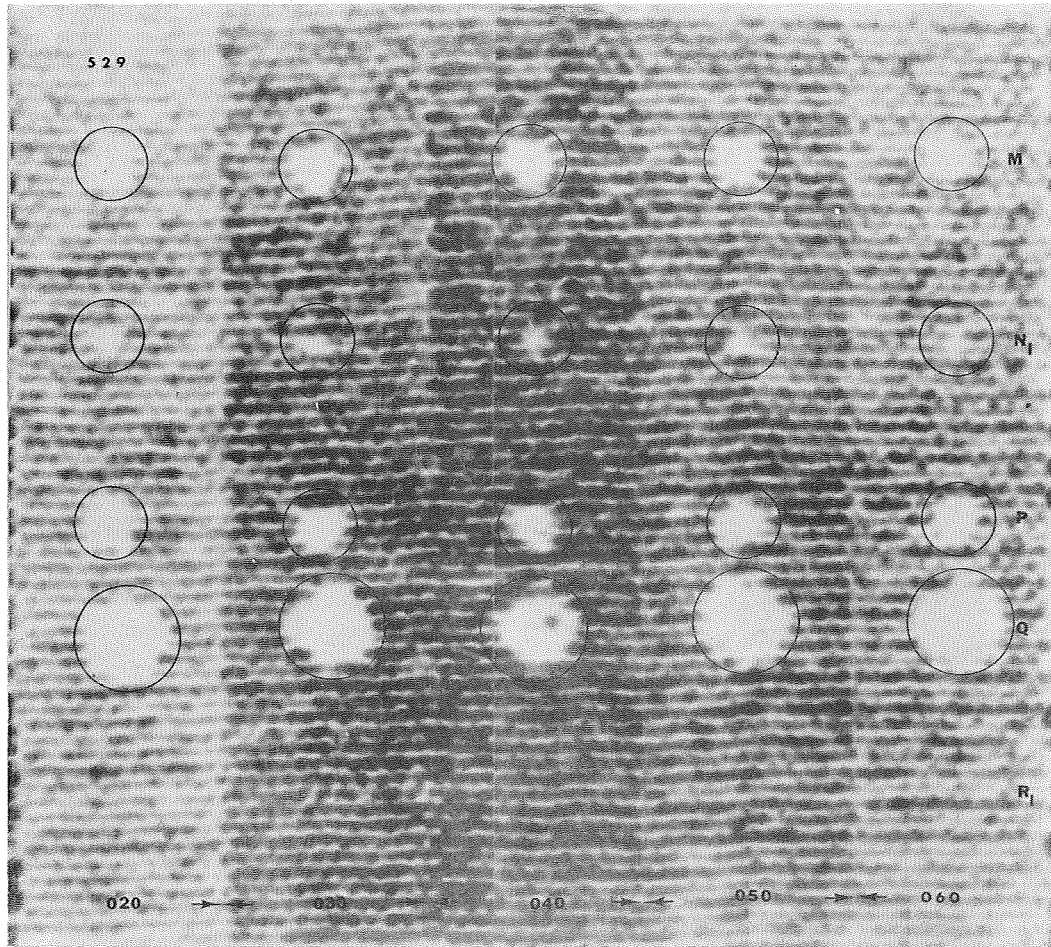
Figures 34, 35, and 36 show the C-scan recordings for honeycomb Panels 528, 529, and 530. The far-side and near-side core-to-laminate disbonds and the crushed core are easily visible in these recordings. The 1/4-inch interlaminar disbonds between 2nd and 3rd plies are easily observable in the 1/2-inch-thick Panel 529, but are only partially observable in the 1-inch-thick Panels 528 and 530. The honeycomb core and adhesive layer tend to cause overlapping of the structural images on the recordings, distorting feature boundaries and causing the defects to appear smaller than their actual size. The small representation of some of the 1/2-inch near-side disbonds suggests that a near-side disbond as small as 1/4 inch may be completely obscured by the tendency for features to become overlapped. This tendency can probably be alleviated by using a search unit of smaller diameter and increasing the operating frequency. The preaged area on the lower fourth of each panel does not appear on the recordings for Panels 528, 529, and 530, but does appear on the recording for Panel 527. The behavior of the preaged material in forming good or bad bonds with adjacent material during the curing process was unpredictable.

FIGURE 34. ULTRASONIC C-SCAN RECORDING AT 2.25 MHz OF THE 1-INCH GRAPHITE/HONEYCOMB PANEL 528 SHOWING THE INTER-LAMINAR (N₁), FAR-SIDE (M) AND NEAR-SIDE (P) ADHESIVE DISBONDS, AND THE CRUSHED CORE (Q)

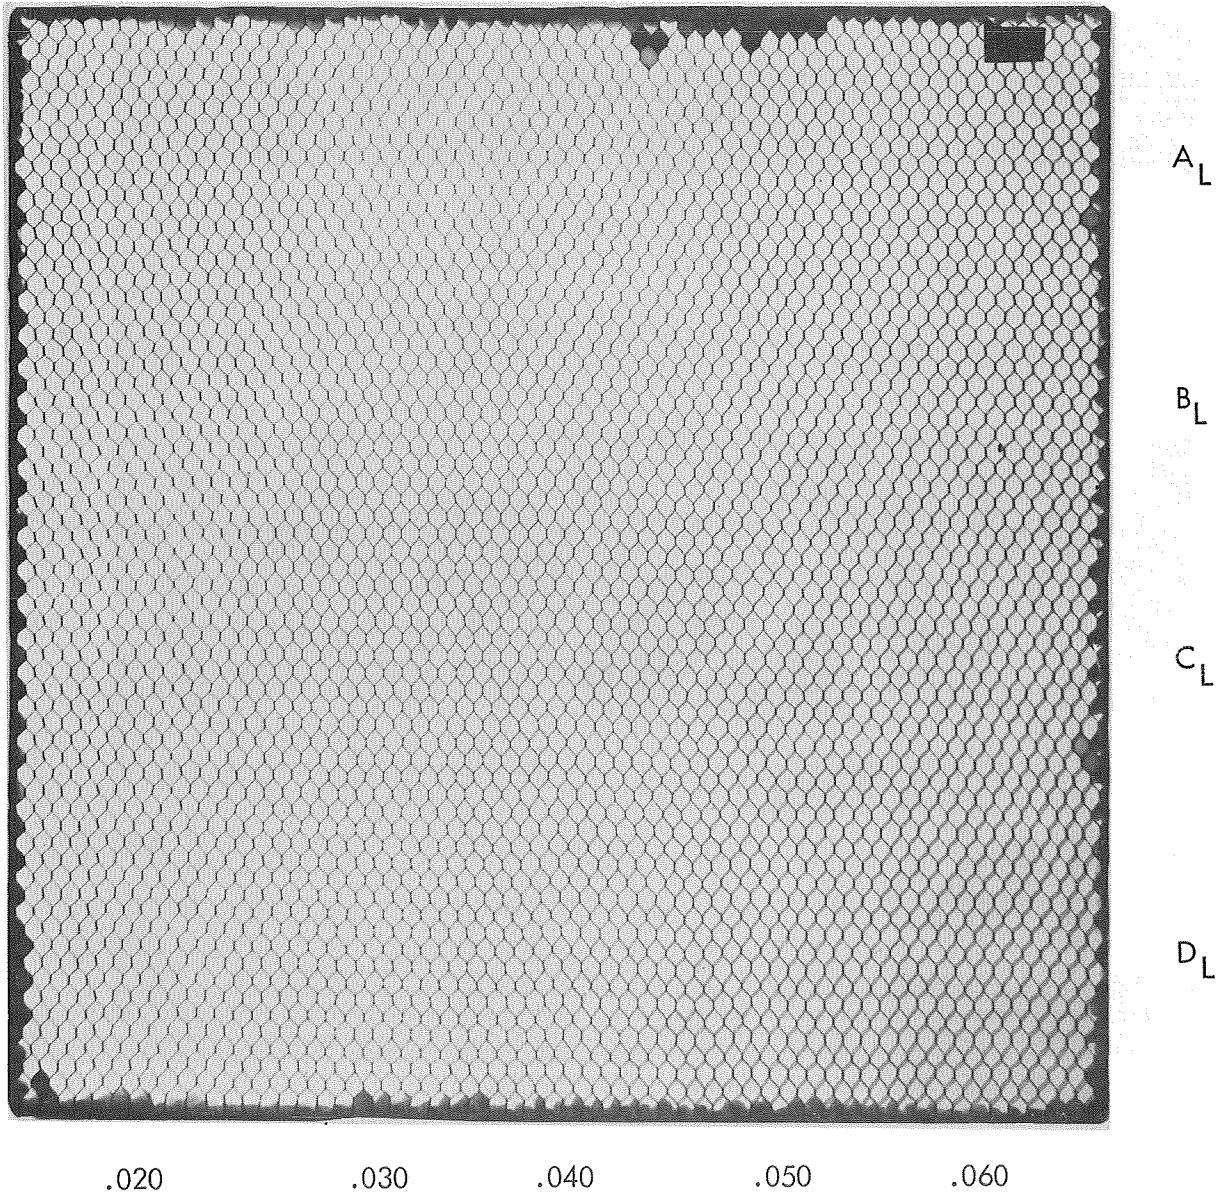
FIGURE 37. RADIOGRAPHIC PRINT OF THE FLAT GRAPHITE PANEL 101 (POROSITY AND RESIN VARIATIONS NOT DISCERNIBLE)

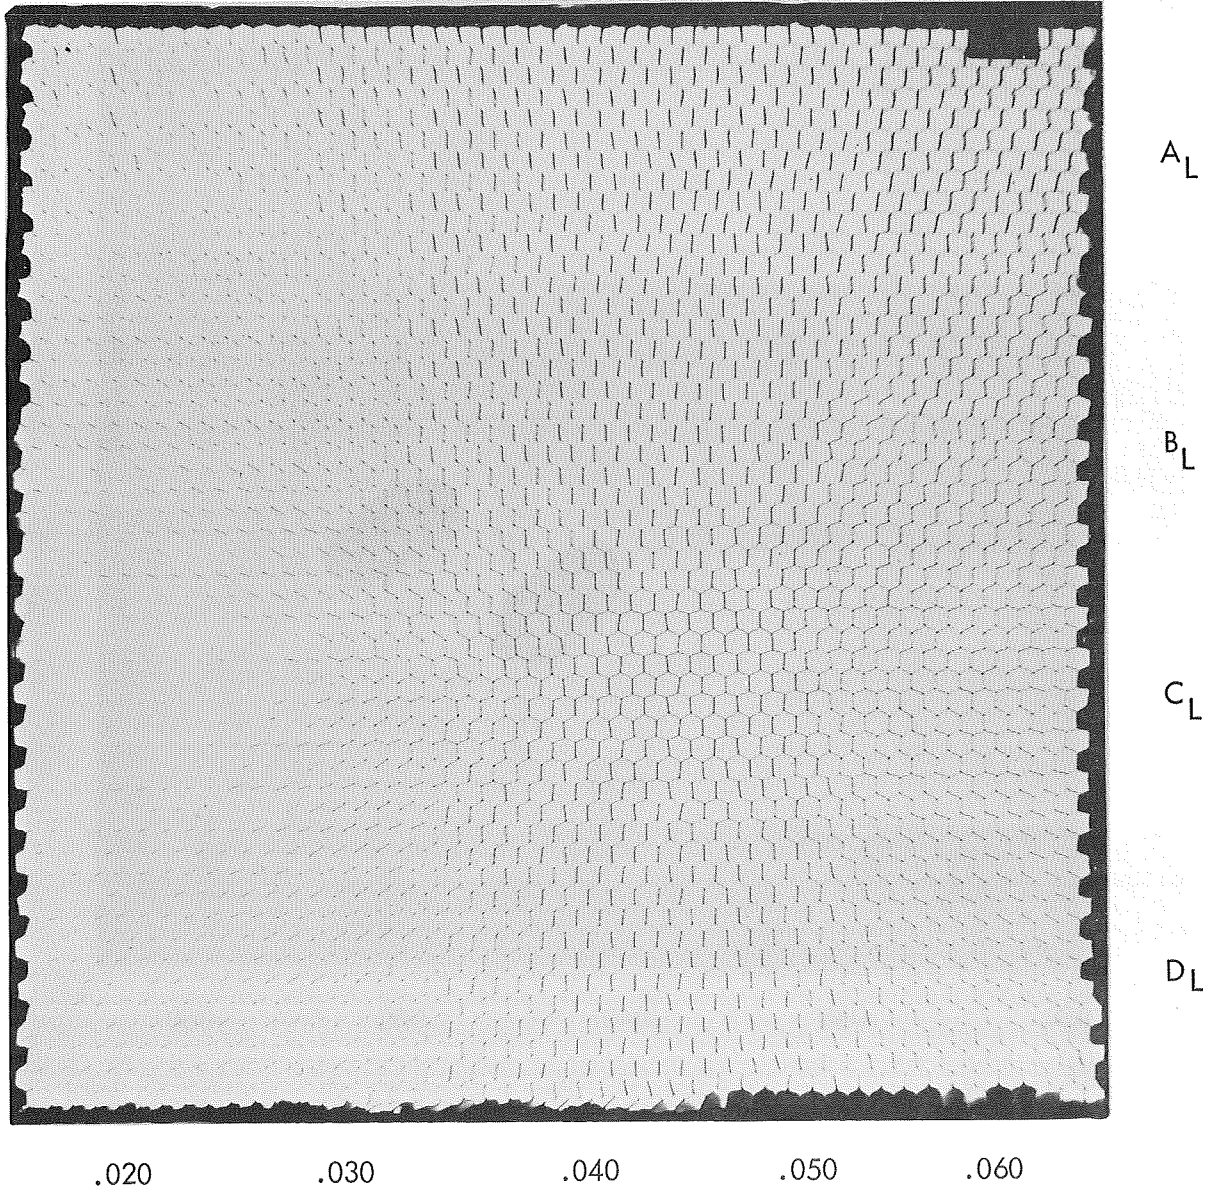
FIGURE 38. RADIOGRAPHIC PRINT OF THE 1/2-INCH GRAPHITE/HONEYCOMB PANEL 102 (POROSITY AND RESIN VARIATIONS NOT DISCERNIBLE)

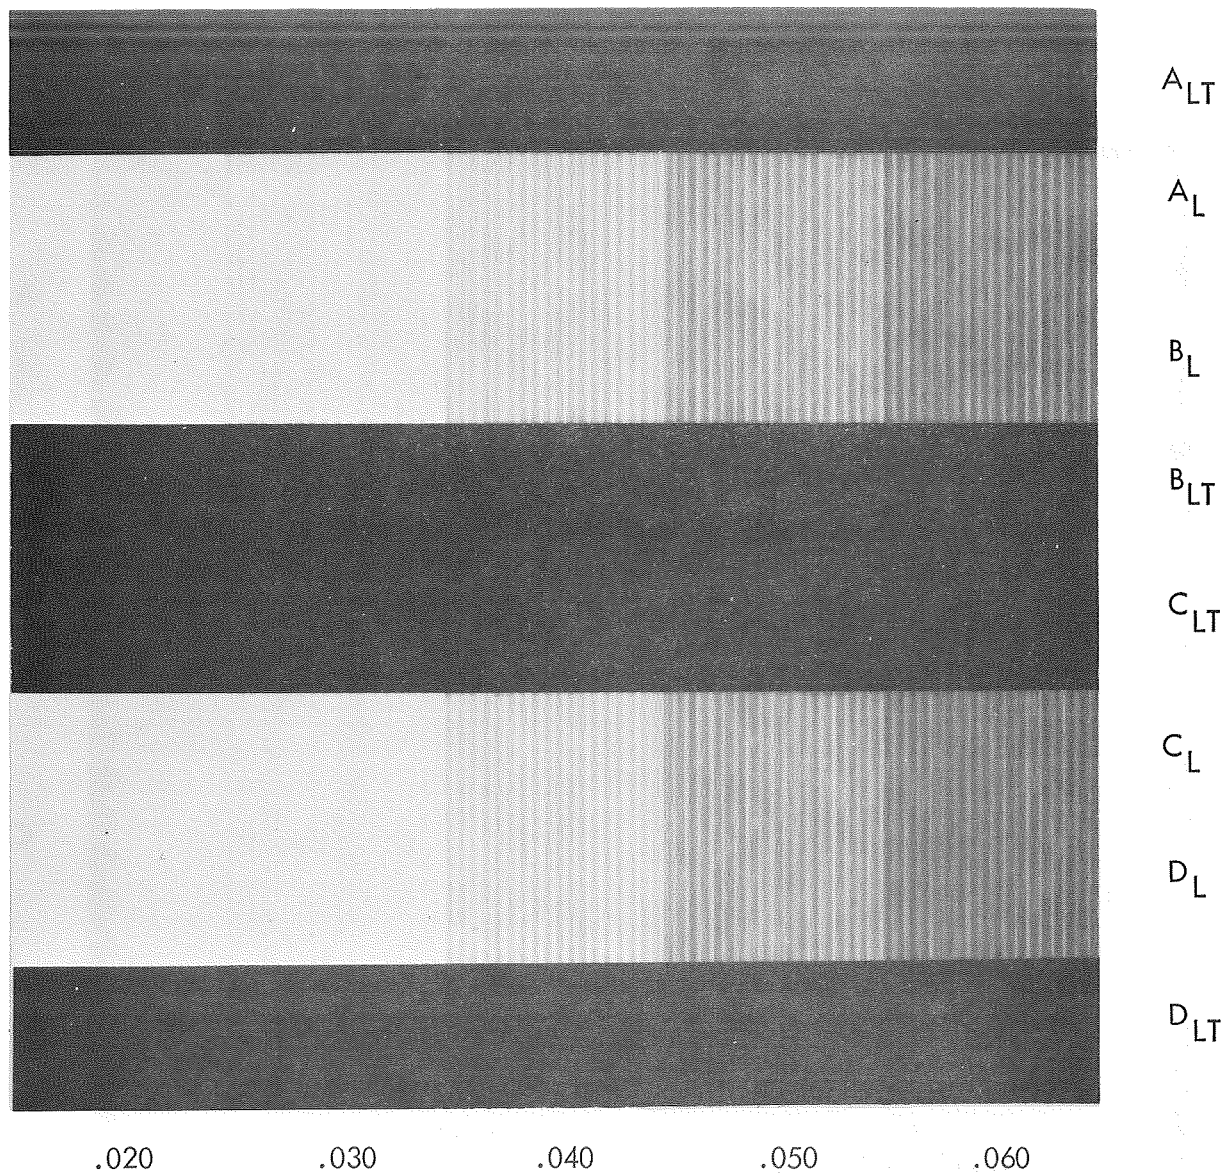
FIGURE 39. RADIOGRAPHIC PRINT OF THE 1-INCH GRAPHITE/HONEYCOMB PANEL 103 (POROSITY AND RESIN VARIATIONS NOT DISCERNIBLE)

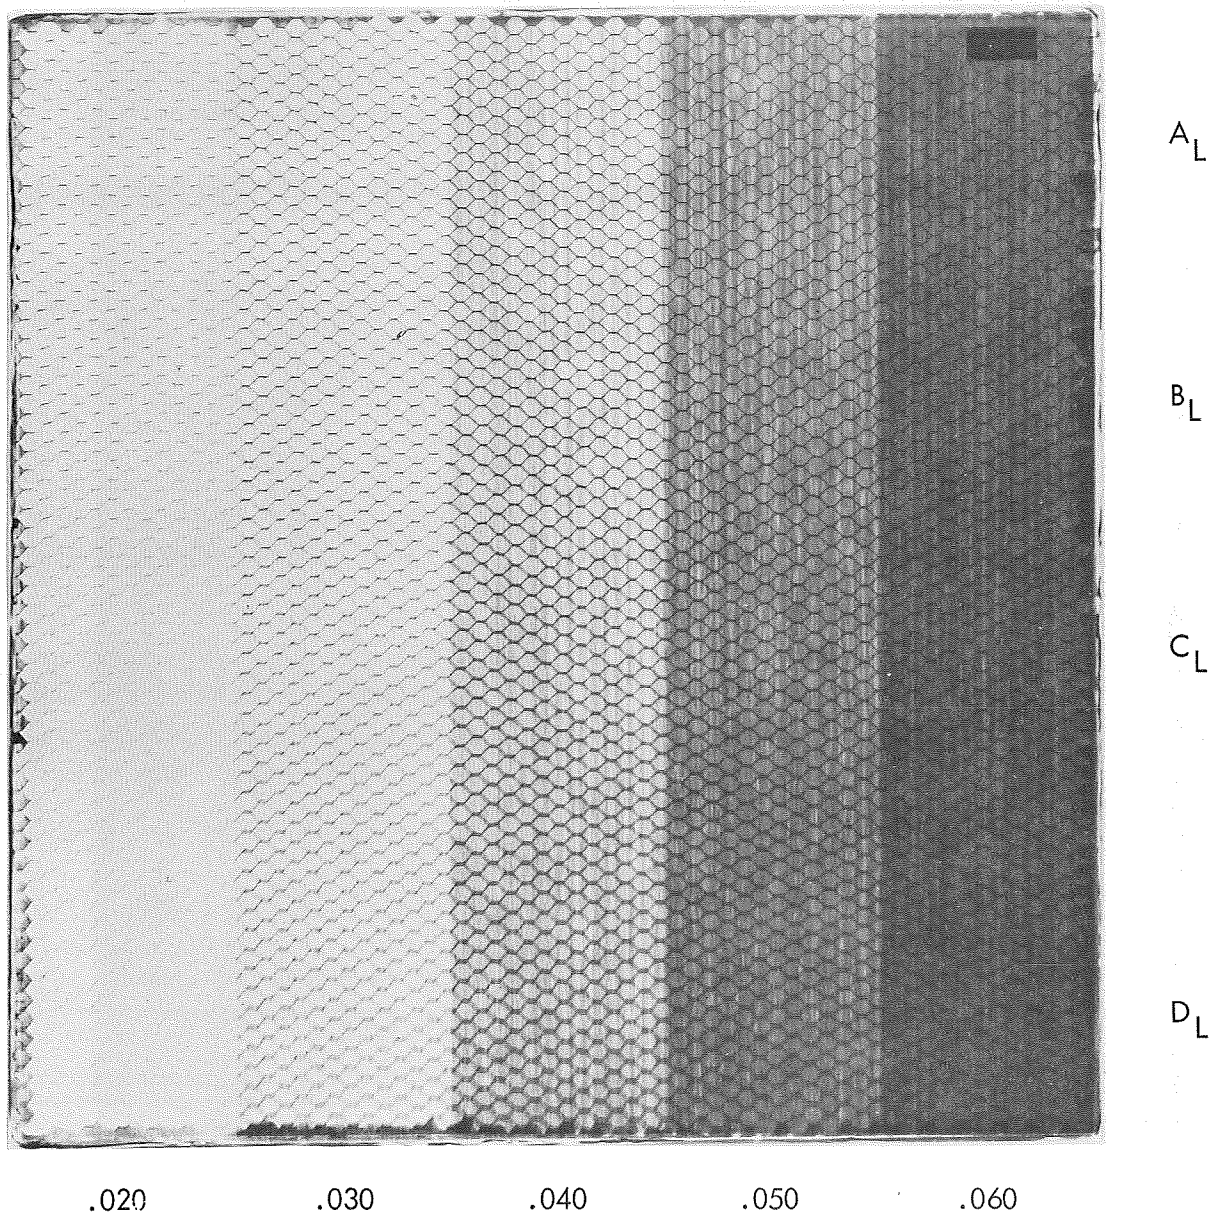
FIGURE 40. RADIOGRAPHIC PRINT OF THE FLAT BORON PANEL 104 (POROSITY AND RESIN VARIATIONS NOT DISCERNIBLE)

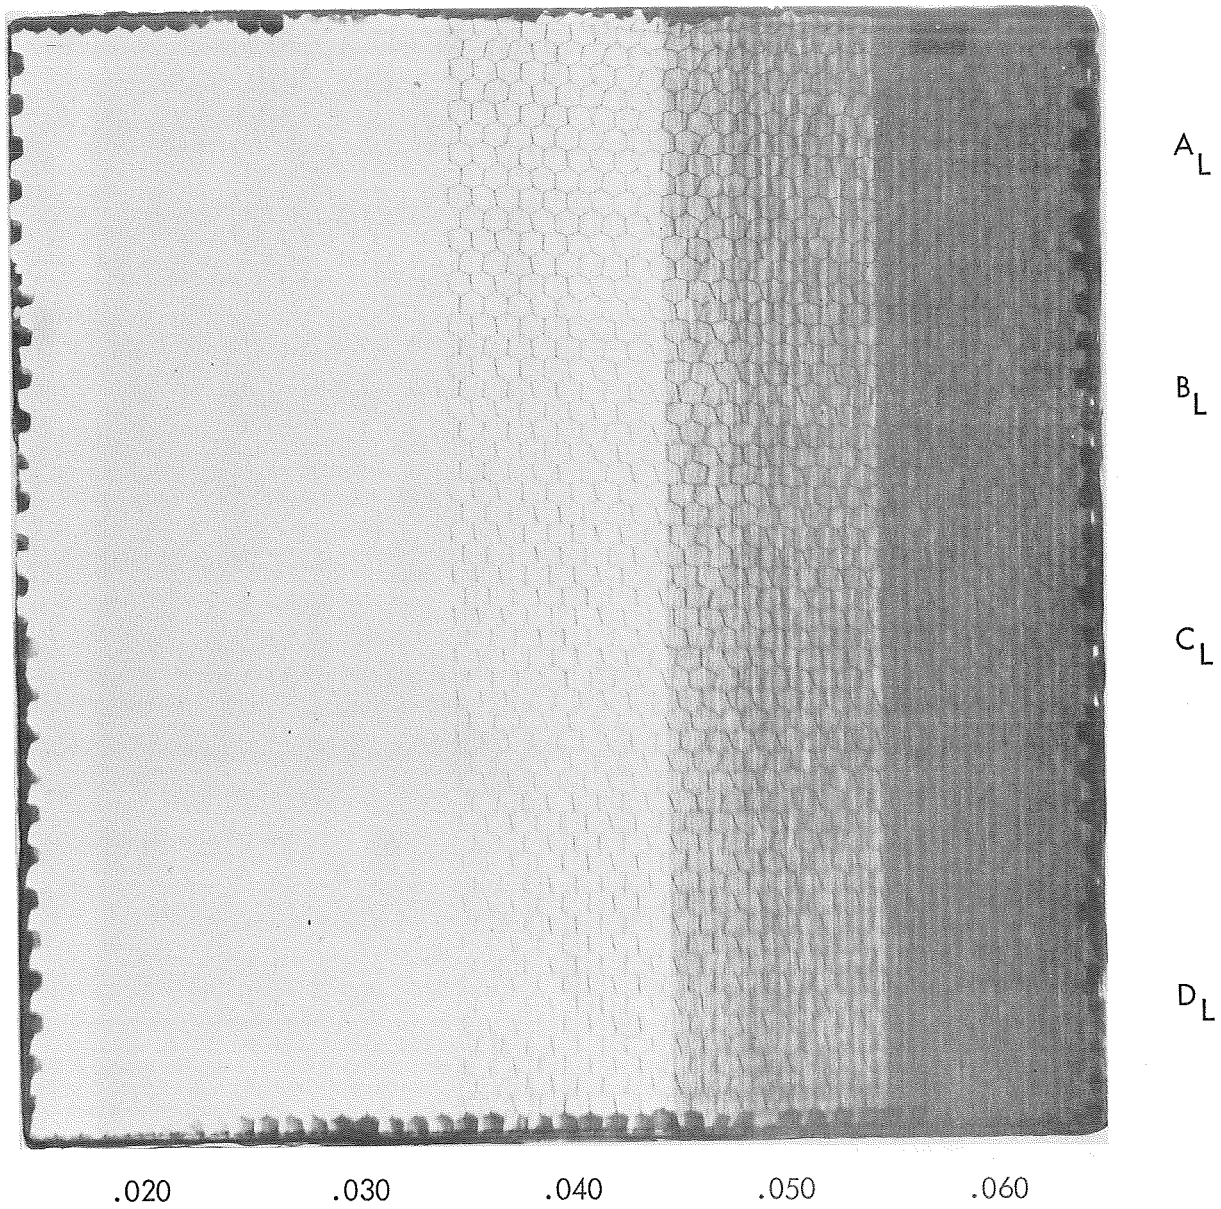
FIGURE 41. RADIOGRAPHIC PRINT OF THE 1/2-INCH BORON/HONEYCOMB PANEL 105 (POROSITY AND RESIN VARIATIONS NOT DISCERNIBLE)

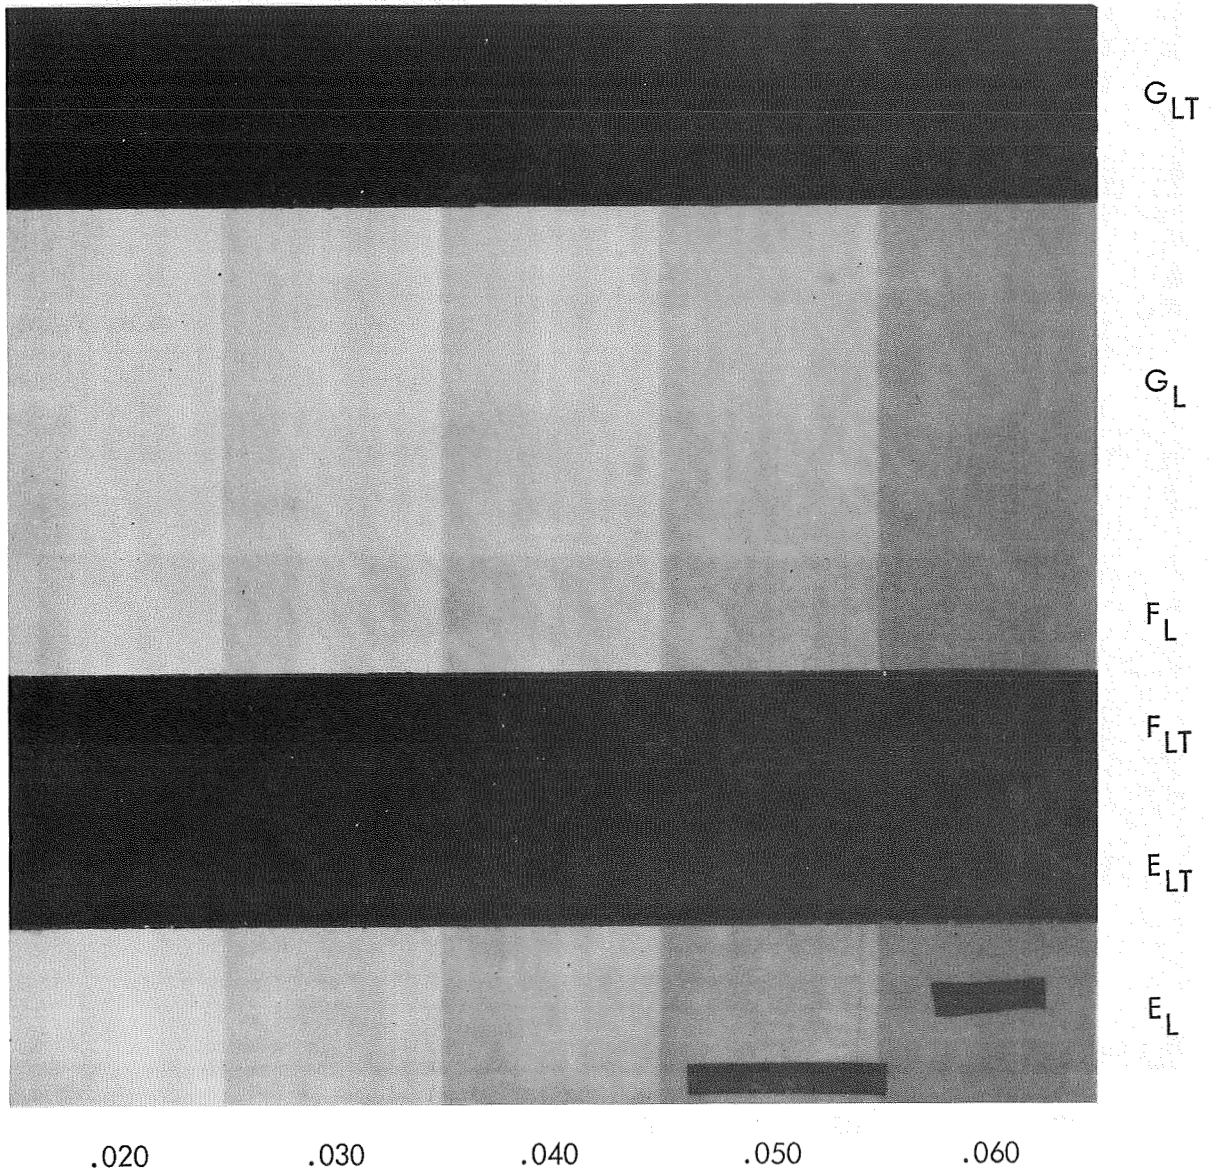
FIGURE 42. RADIOGRAPHIC PRINT OF THE 1-INCH BORON/HONEYCOMB PANEL 106 (POROSITY AND RESIN VARIATIONS NOT DISCERNIBLE)

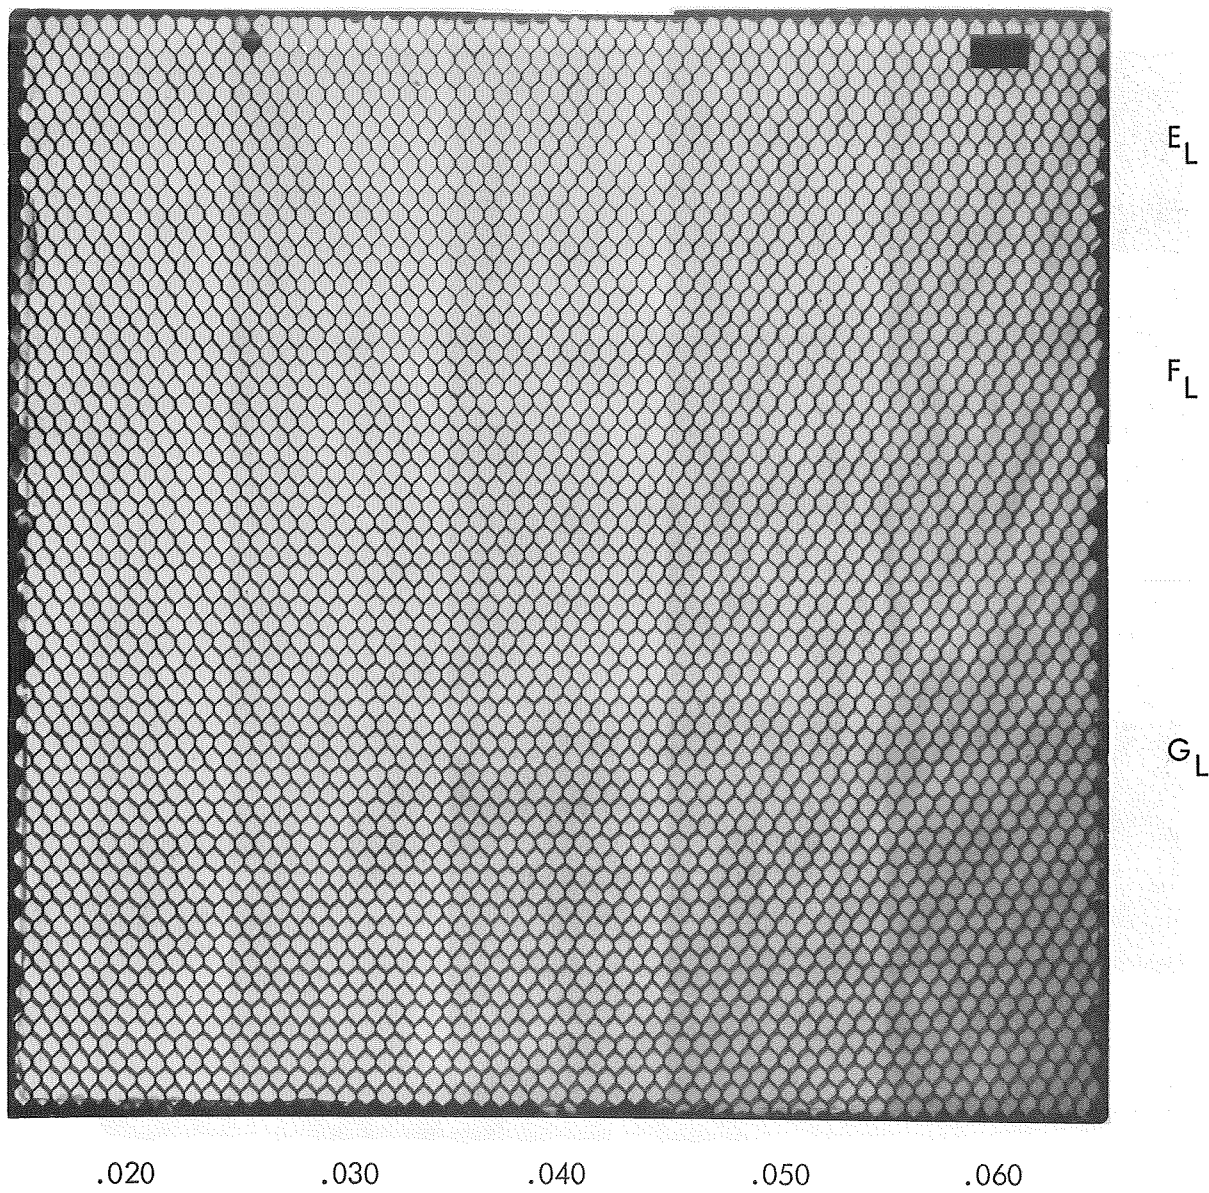
FIGURE 43. RADIOGRAPHIC PRINT OF THE FLAT GRAPHITE PANEL 207 (SHOWING THE BACKING INCLUSION (F_L))
