DEVELOPMENT, FABRICATION, TESTING, AND DELIVERY OF ADVANCED FILAMENTARY COMPOSITE NONDESTRUCTIVE TEST STANDARDS

By W. M. Pless, B. L. Weil, and W. H. Lewis
Lockheed - Georgia Company
Marietta, Georgia

November 1970

Final Report

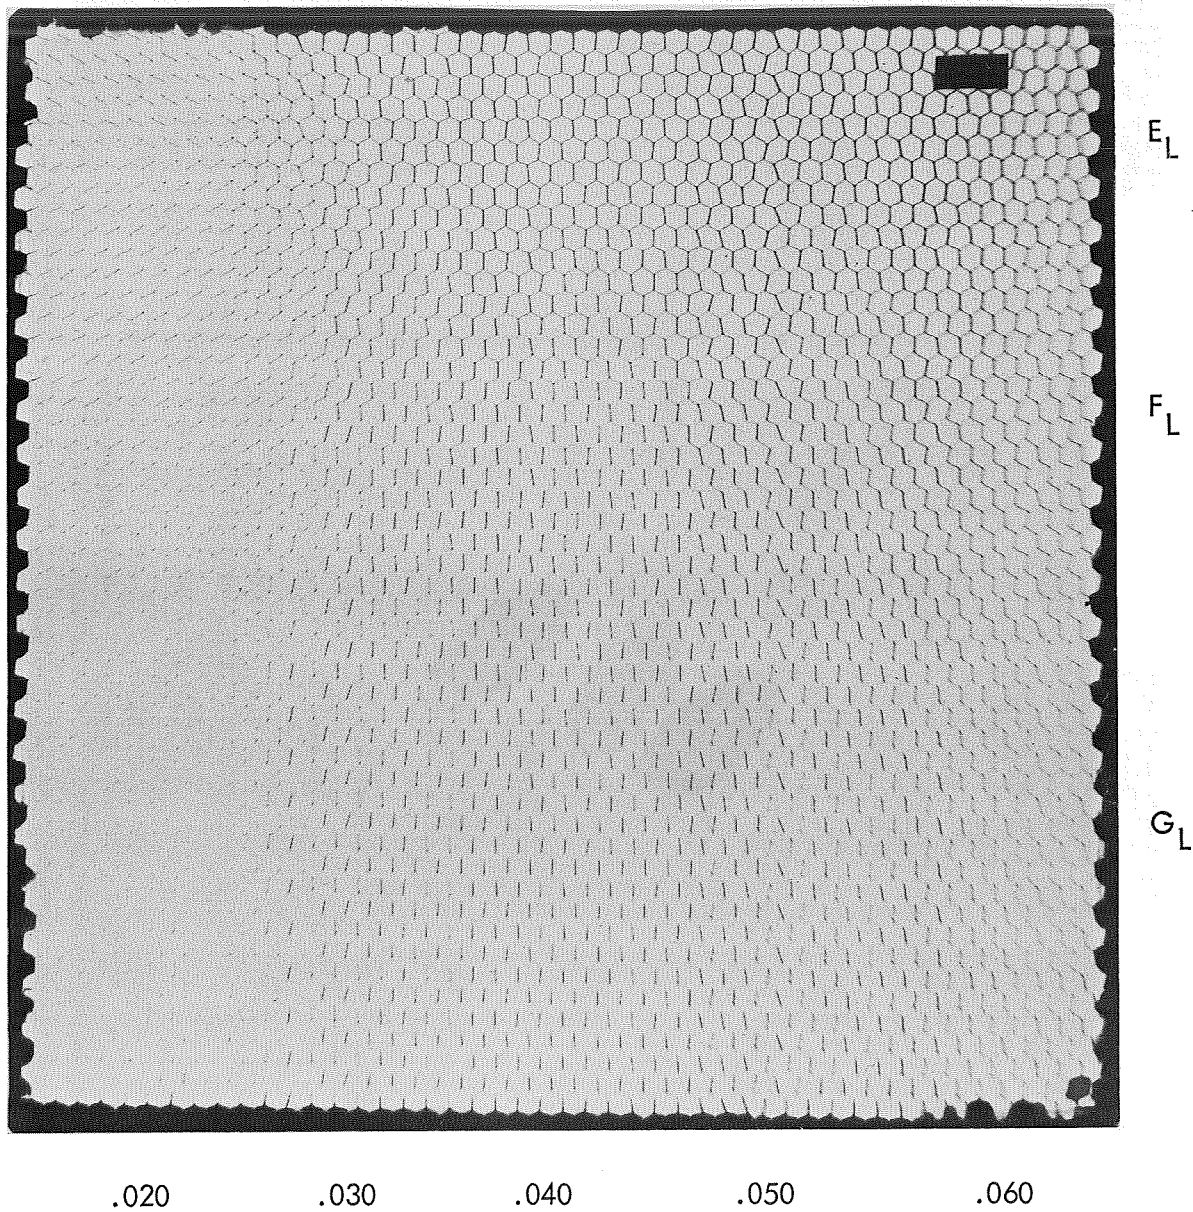
FIGURE 44. RADIOGRAPHIC PRINT OF THE 1/2-INCH GRAPHITE/HONEYCOMB PANEL 208. BACKING INCLUSION (F_L) AND UNDERCURE (G_L) ARE NOT DISCERNIBLE.

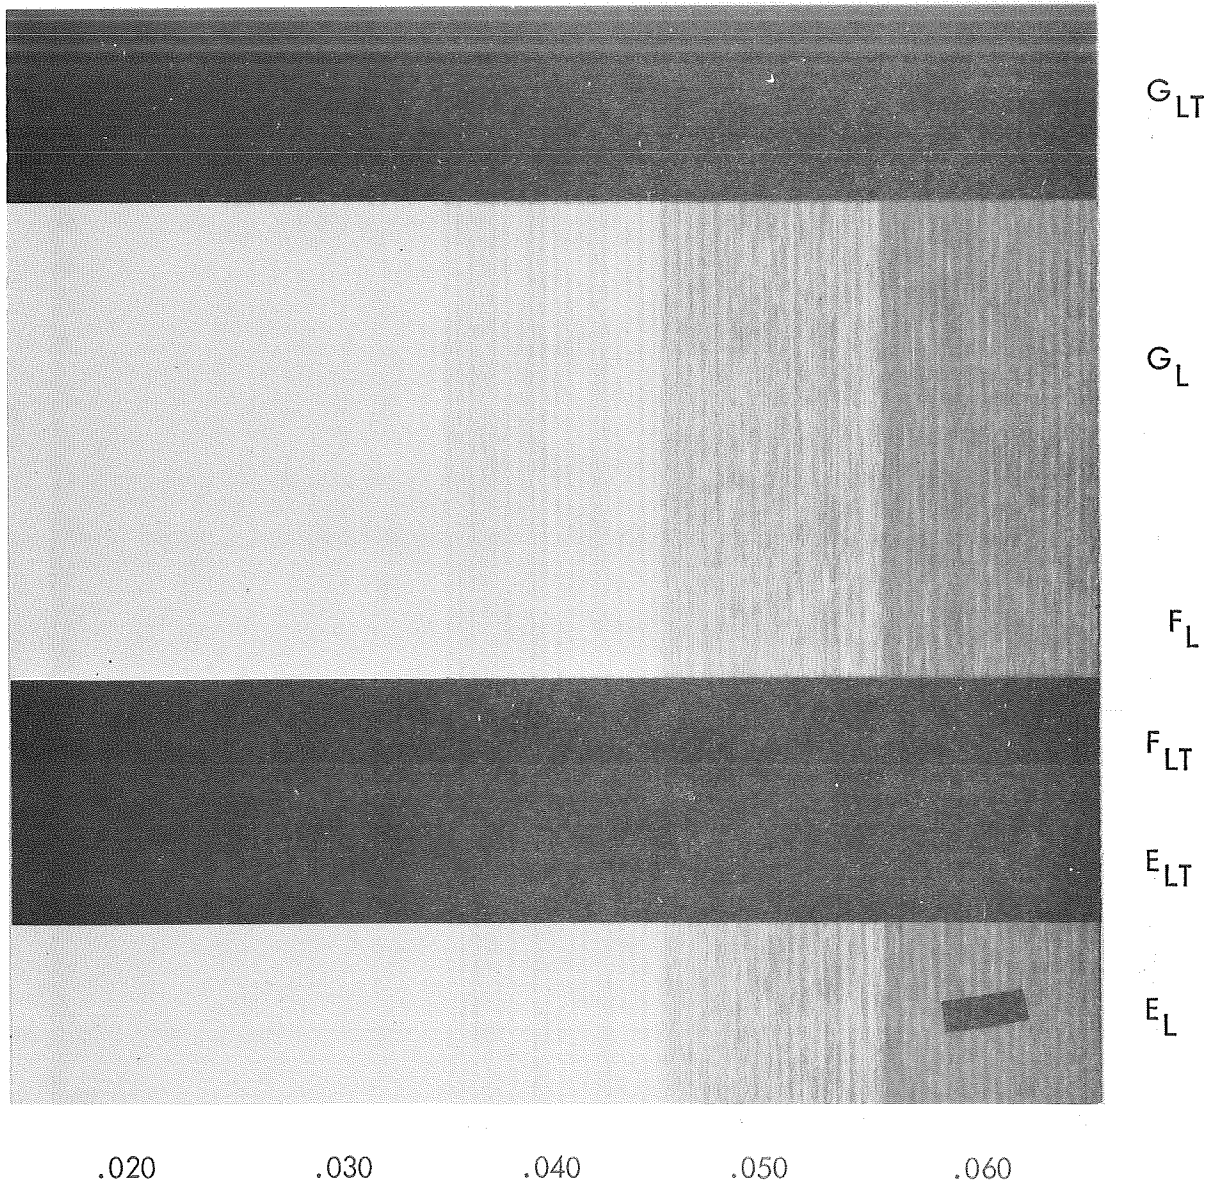
FIGURE 45. RADIOGRAPHIC PRINT OF THE 1-INCH GRAPHITE/HONEYCOMB PANEL 209. BACKING INCLUSION (F_L) AND UNDERCURE (G_L) ARE NOT DISCERNIBLE.

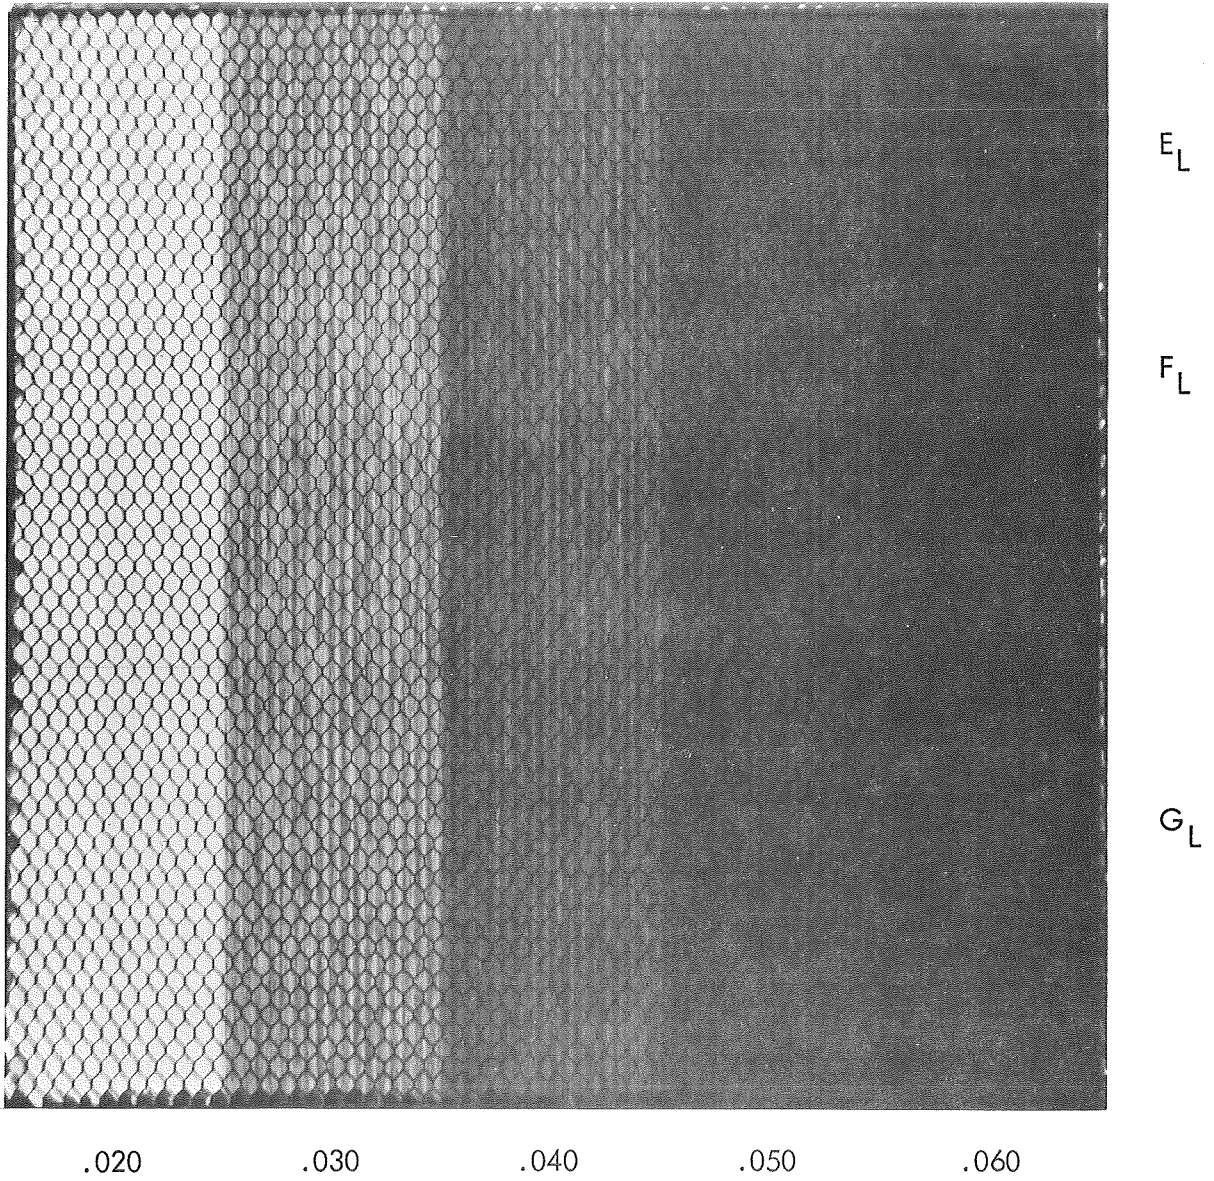
FIGURE 46. RADIOGRAPHIC PRINT OF THE FLAT BORON PANEL 210. BACKING INCLUSION (F_L) AND UNDERCURE (G_L) ARE NOT DISCERNIBLE.

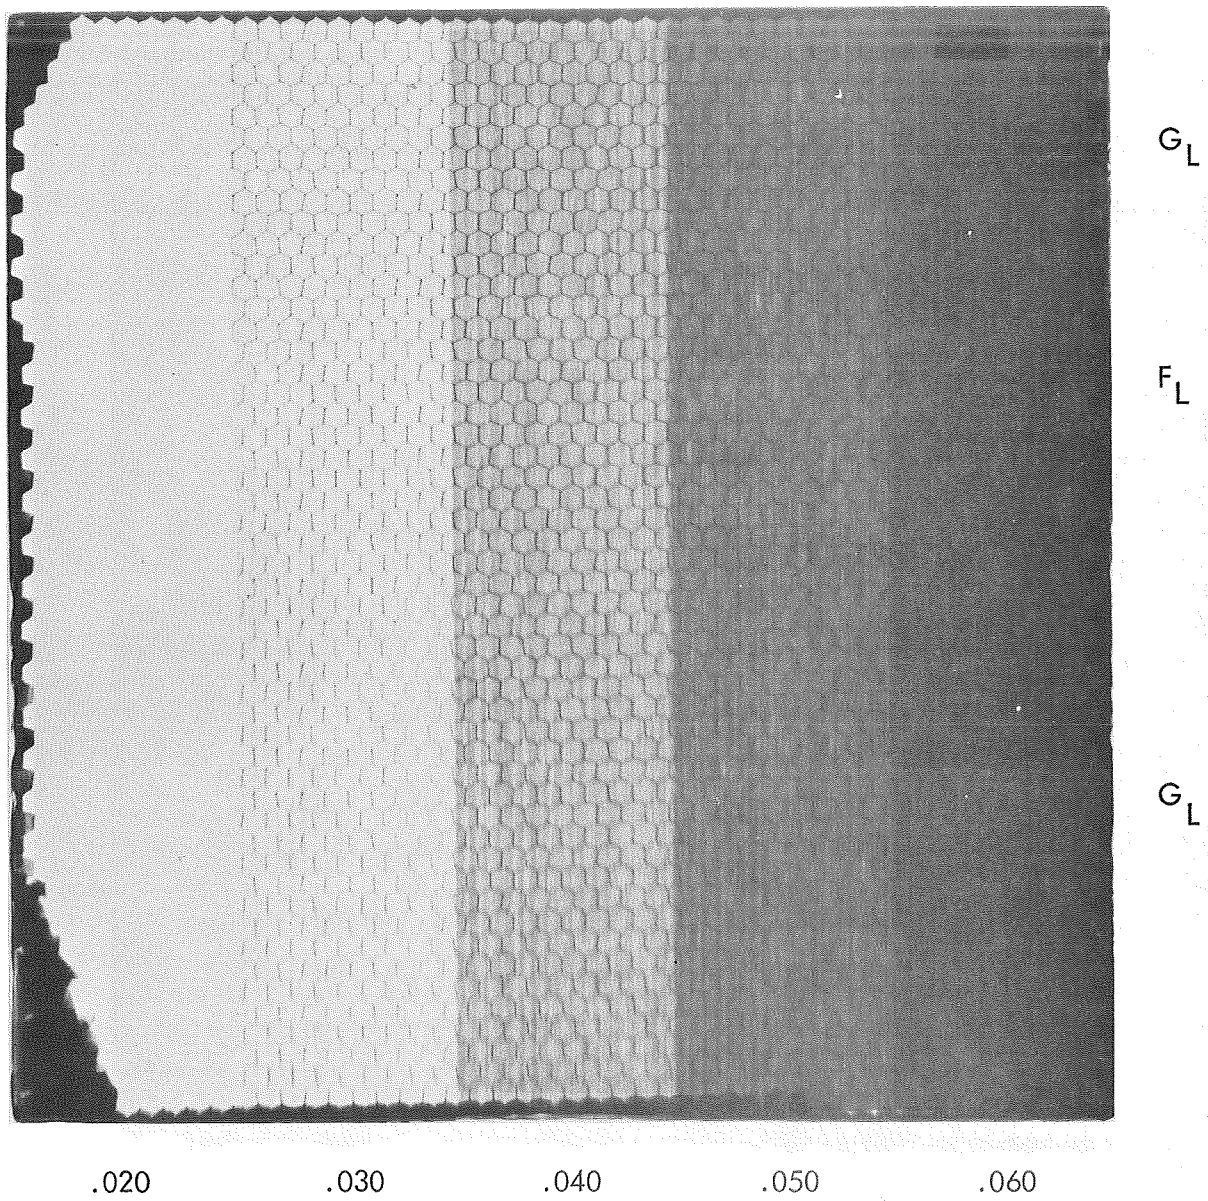
FIGURE 47. RADIOGRAPHIC PRINT OF THE 1/2-INCH BORON/HONEYCOMB PANEL 211. BACKING INCLUSION (F_L) AND UNDERCURE (G_L) ARE NOT DISCERNIBLE.

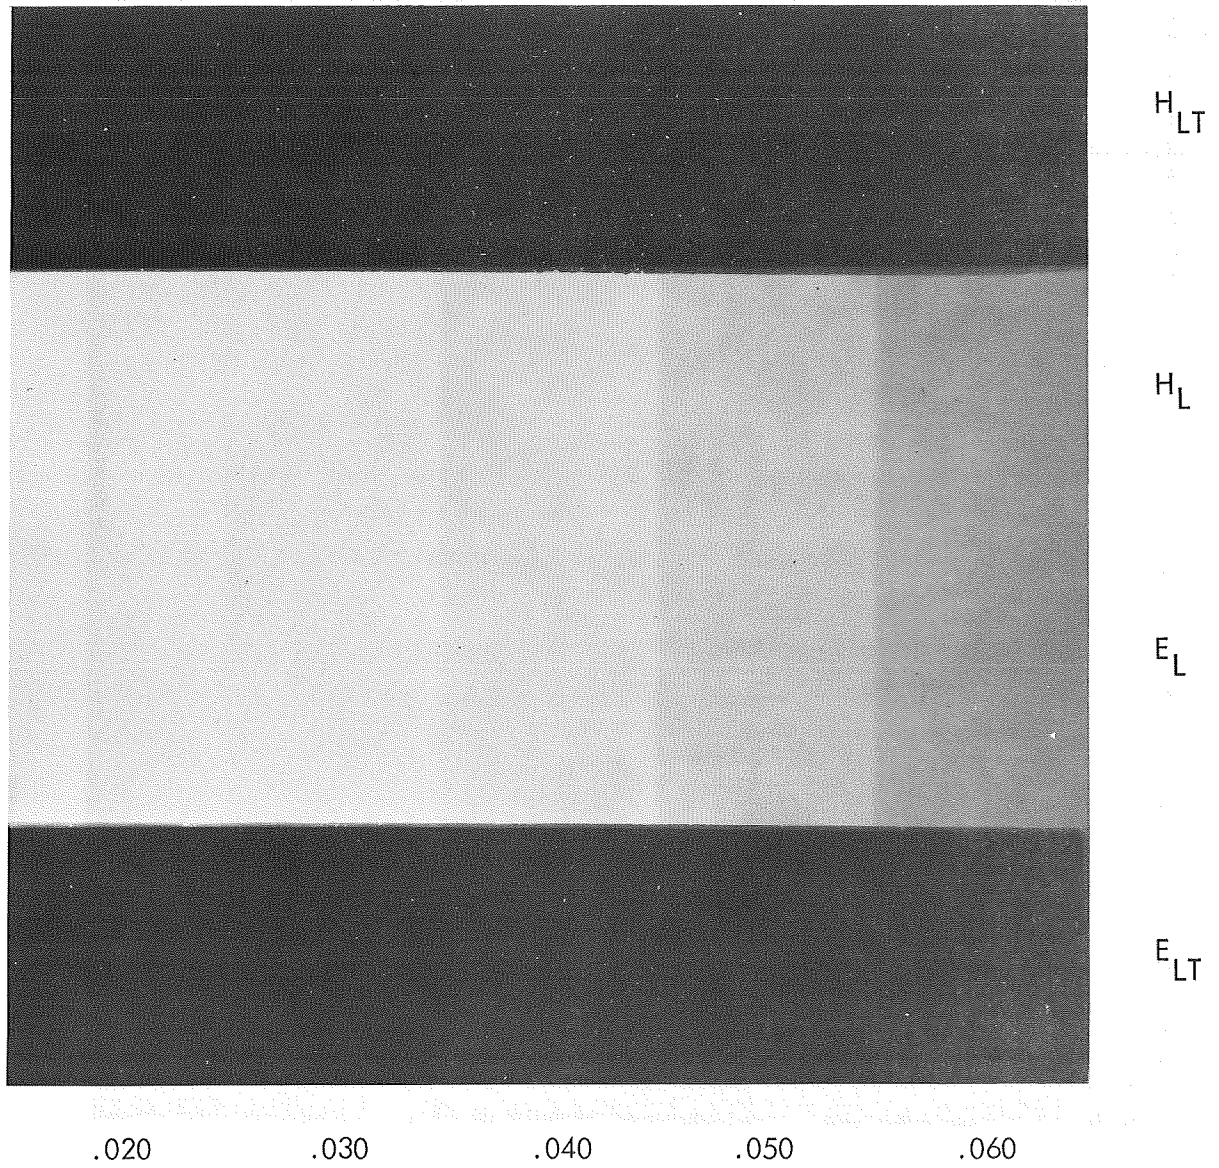
FIGURE 48. RADIOGRAPHIC PRINT OF THE 1-INCH BORON/HONEYCOMB PANEL 212. BACKING INCLUSION (F_L) AND UNDERCURE (G_L) ARE NOT DISCERNIBLE.

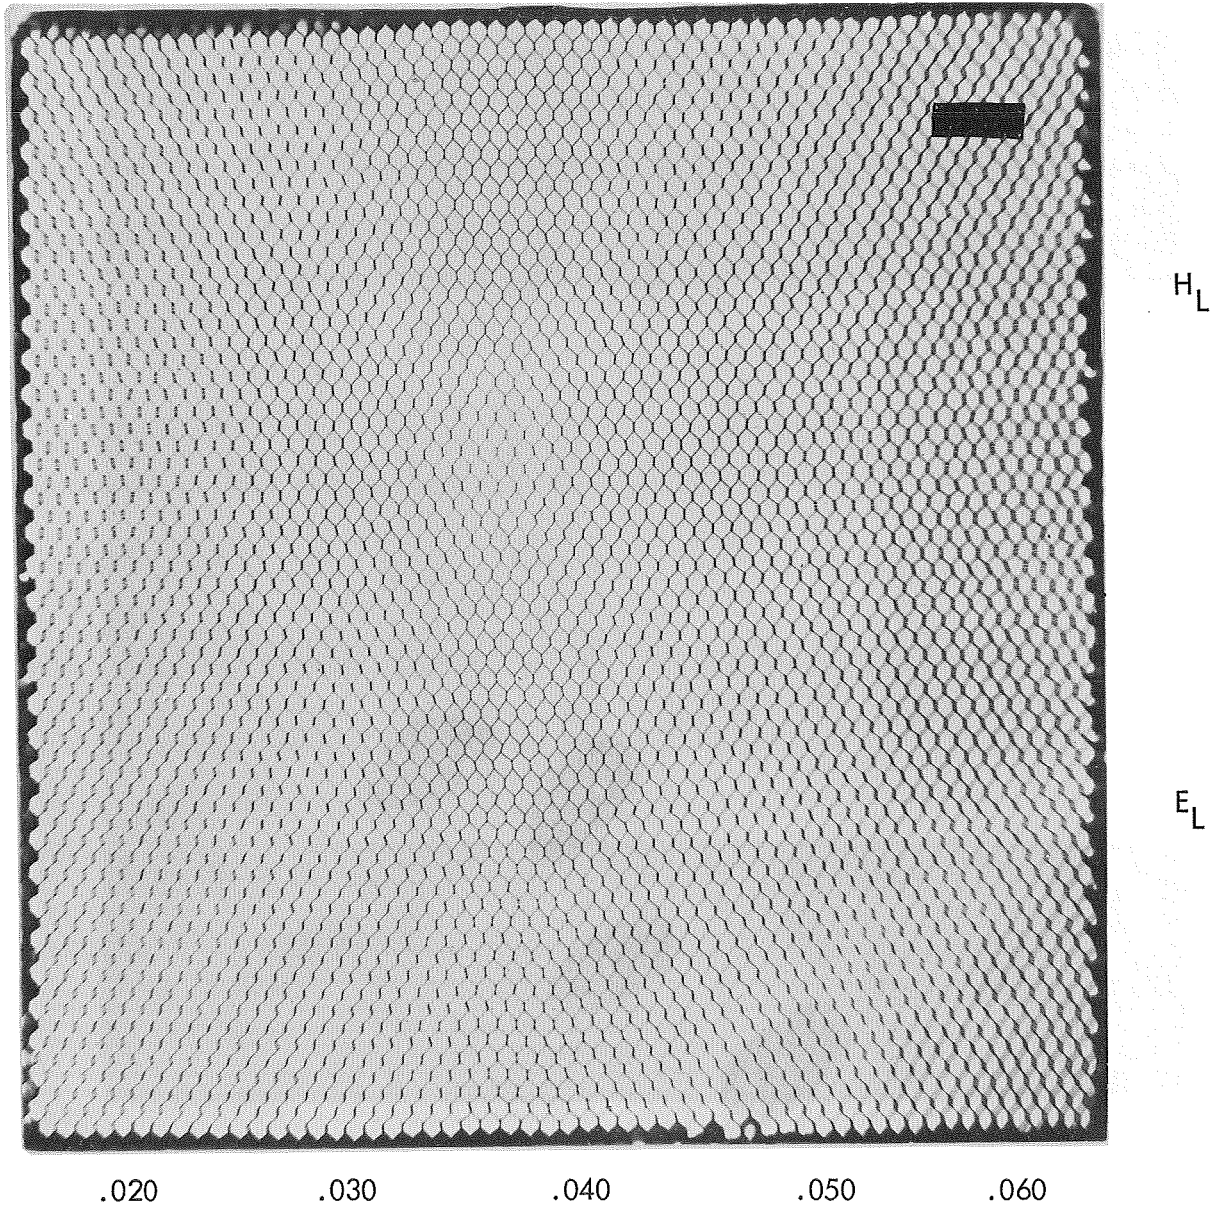
FIGURE 49. RADIOGRAPHIC PRINT OF THE FLAT GRAPHITE PANEL 313 SHOWING THE MISALIGNED PLY (H_L) AS A SLIGHTLY DARKER REGION

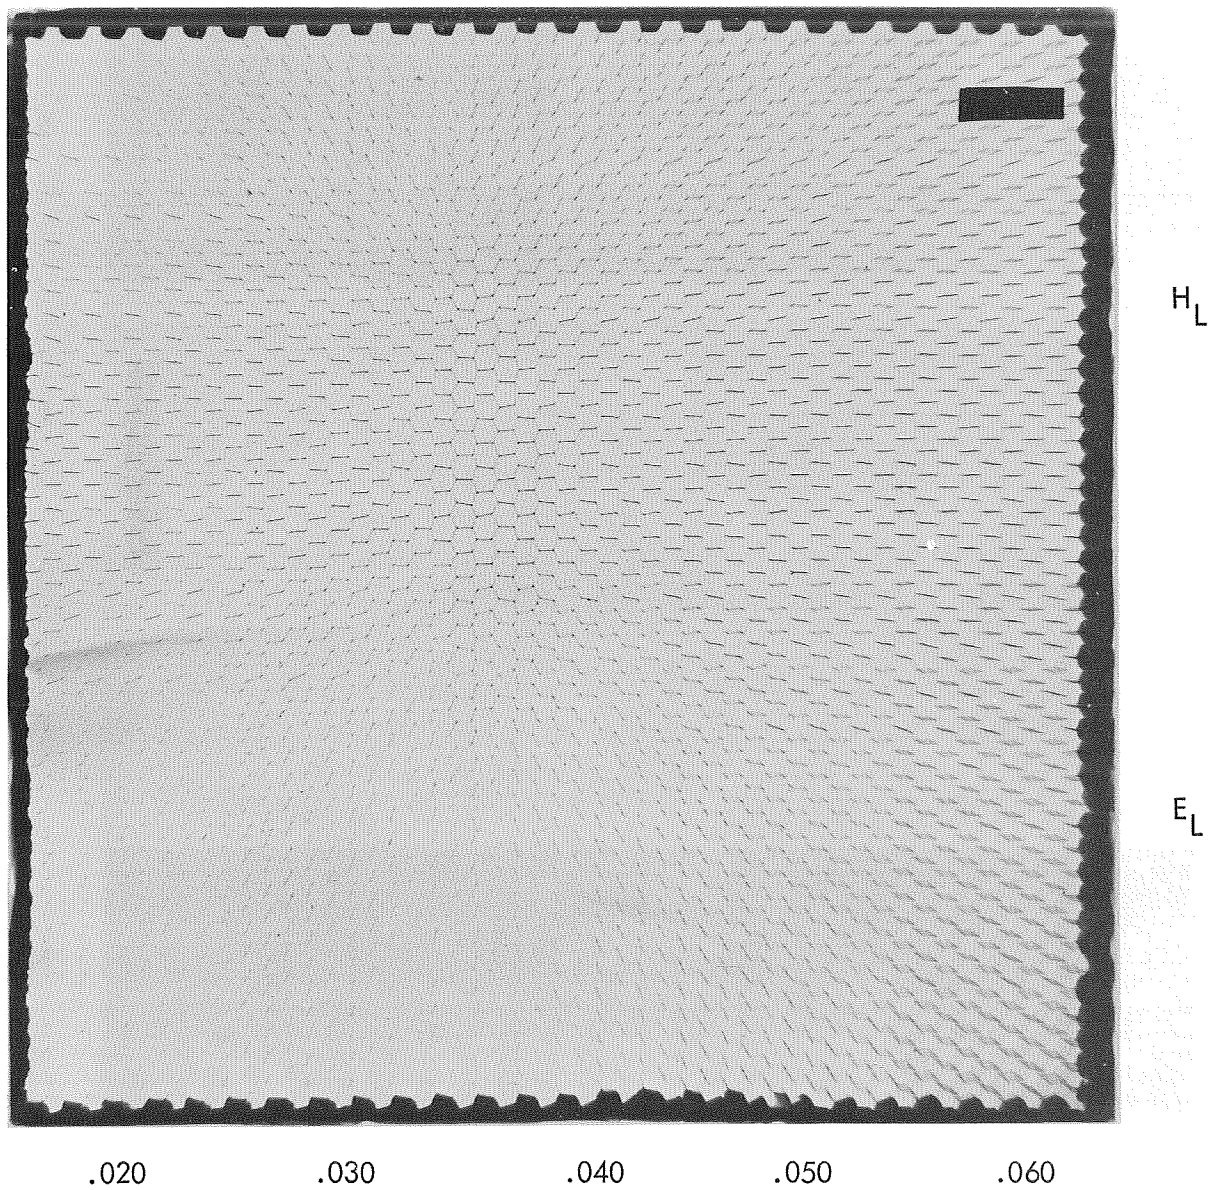
FIGURE 50. RADIOGRAPHIC PRINT OF THE 1/2-INCH GRAPHITE/HONEYCOMB PANEL 314. MISALIGNED PLY (H_L) IN FACE SHEET IS NOT DISCERNIBLE.

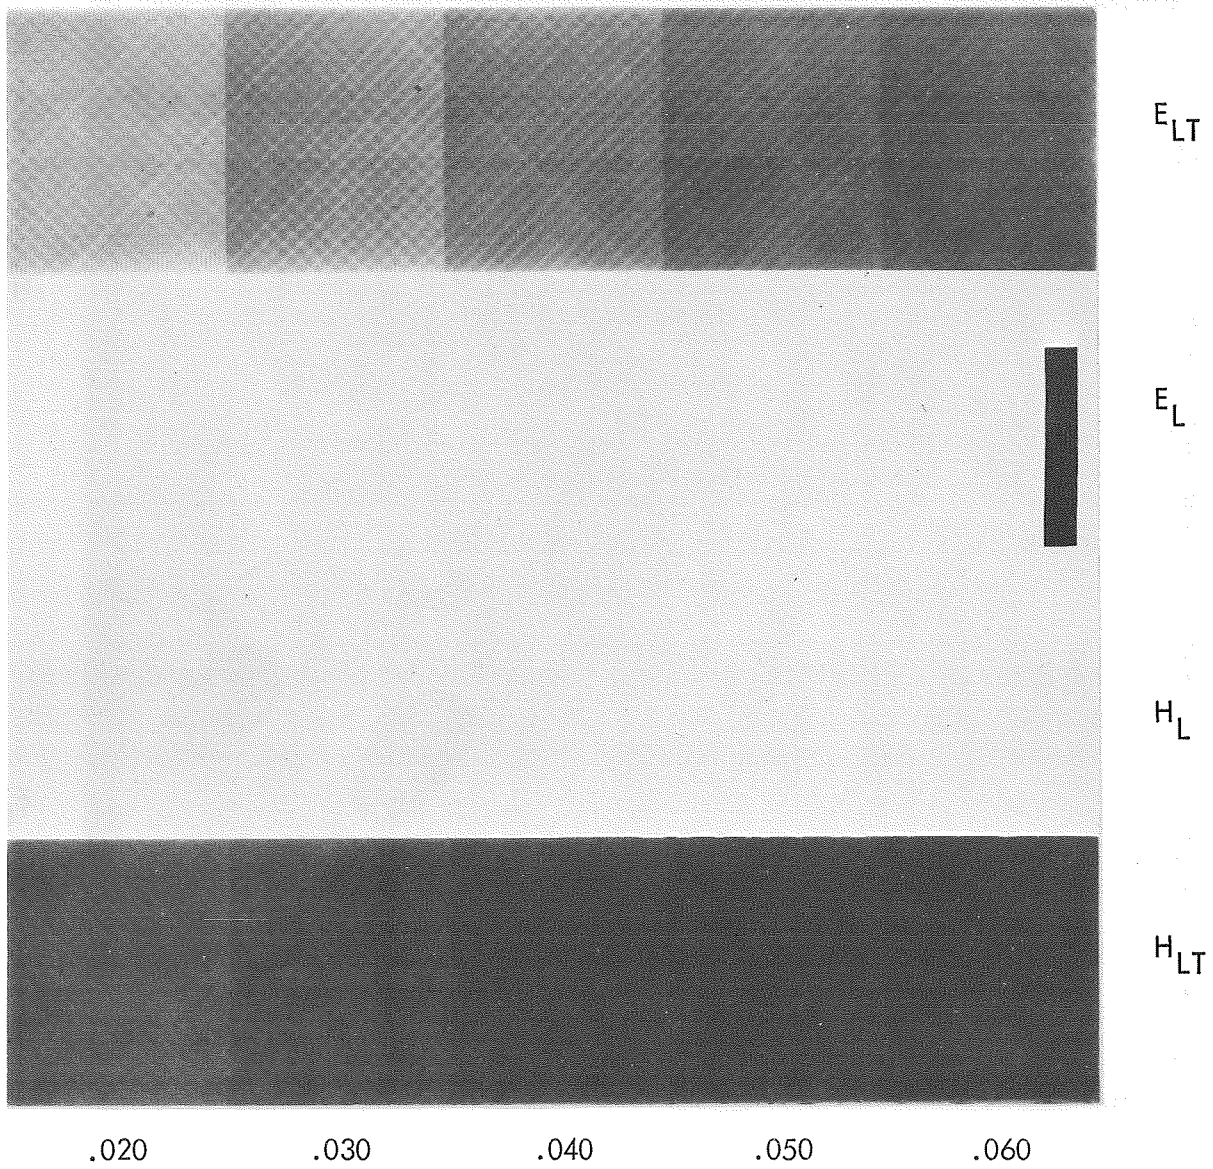
FIGURE 51. RADIOGRAPHIC PRINT OF THE 1-INCH GRAPHITE/HONEYCOMB PANEL 315. MISALIGNED PLY (H_L) IN FACE SHEET IS NOT DISCERNIBLE.

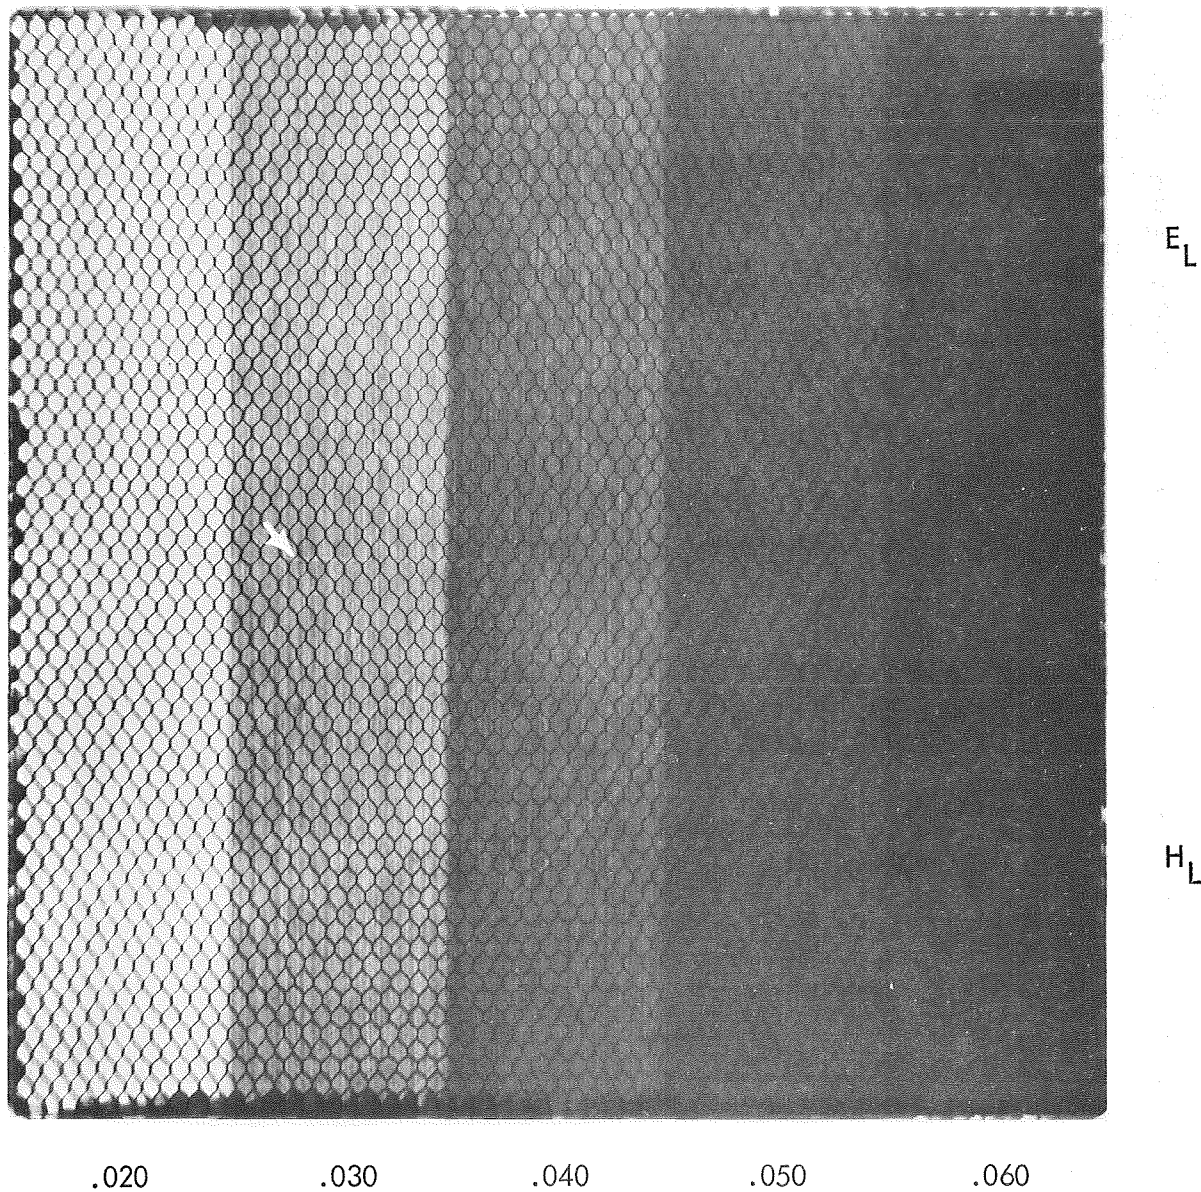
FIGURE 52. RADIOGRAPHIC PRINT OF THE FLAT BORON PANEL 316, SHOWING FIBER MISALIGNMENT IN THE LEFT-HAND PORTION OF H_{LT}

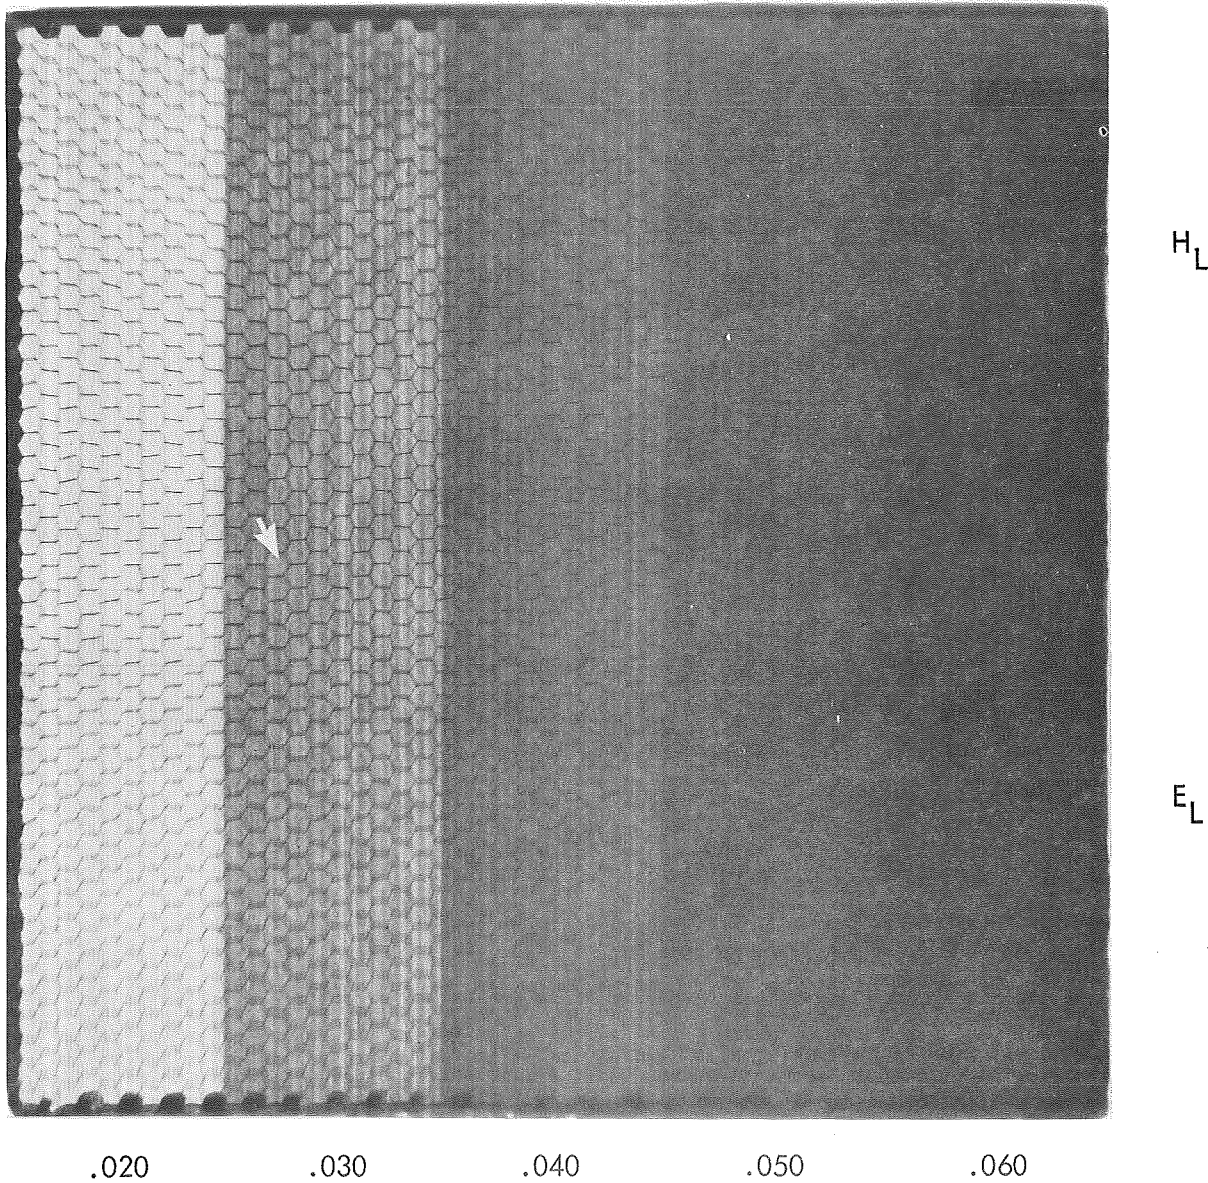
FIGURE 53. RADIOGRAPHIC PRINT OF THE 1/2-INCH BORON/HONEYCOMB PANEL 317 SHOWING PLY SEPARATION DUE TO BUTT JOINT MISALIGNMENT (ARROW)

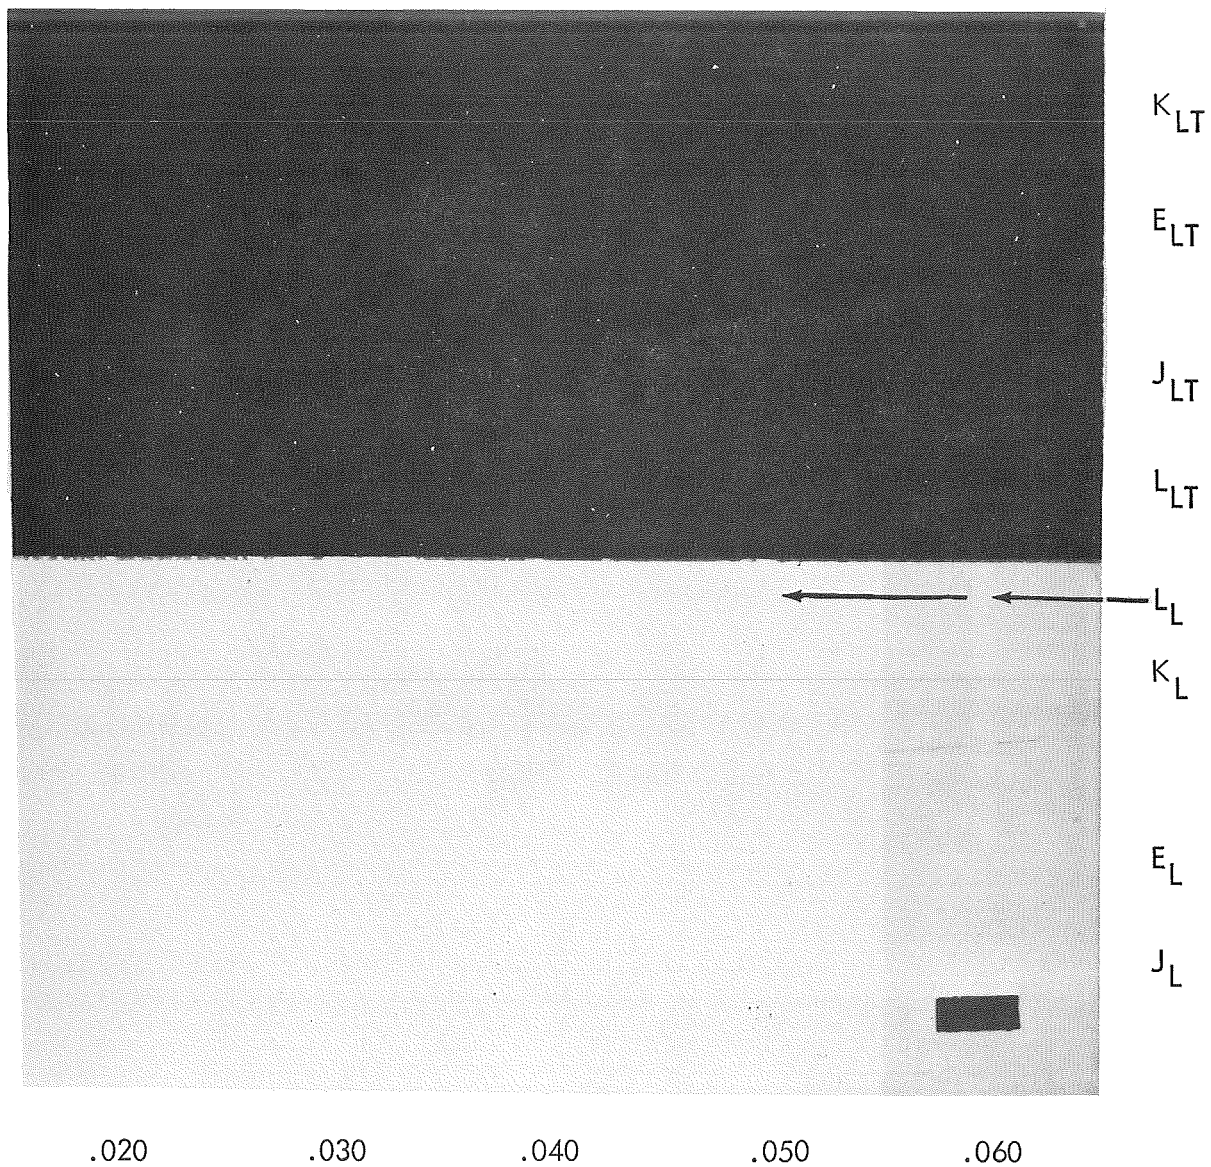
FIGURE 54. RADIOGRAPHIC PRINT OF THE 1-INCH BORON/HONEYCOMB PANEL 318 SHOWING PLY SEPARATION DUE TO BUTT JOINT MISALIGNMENT (ARROW)

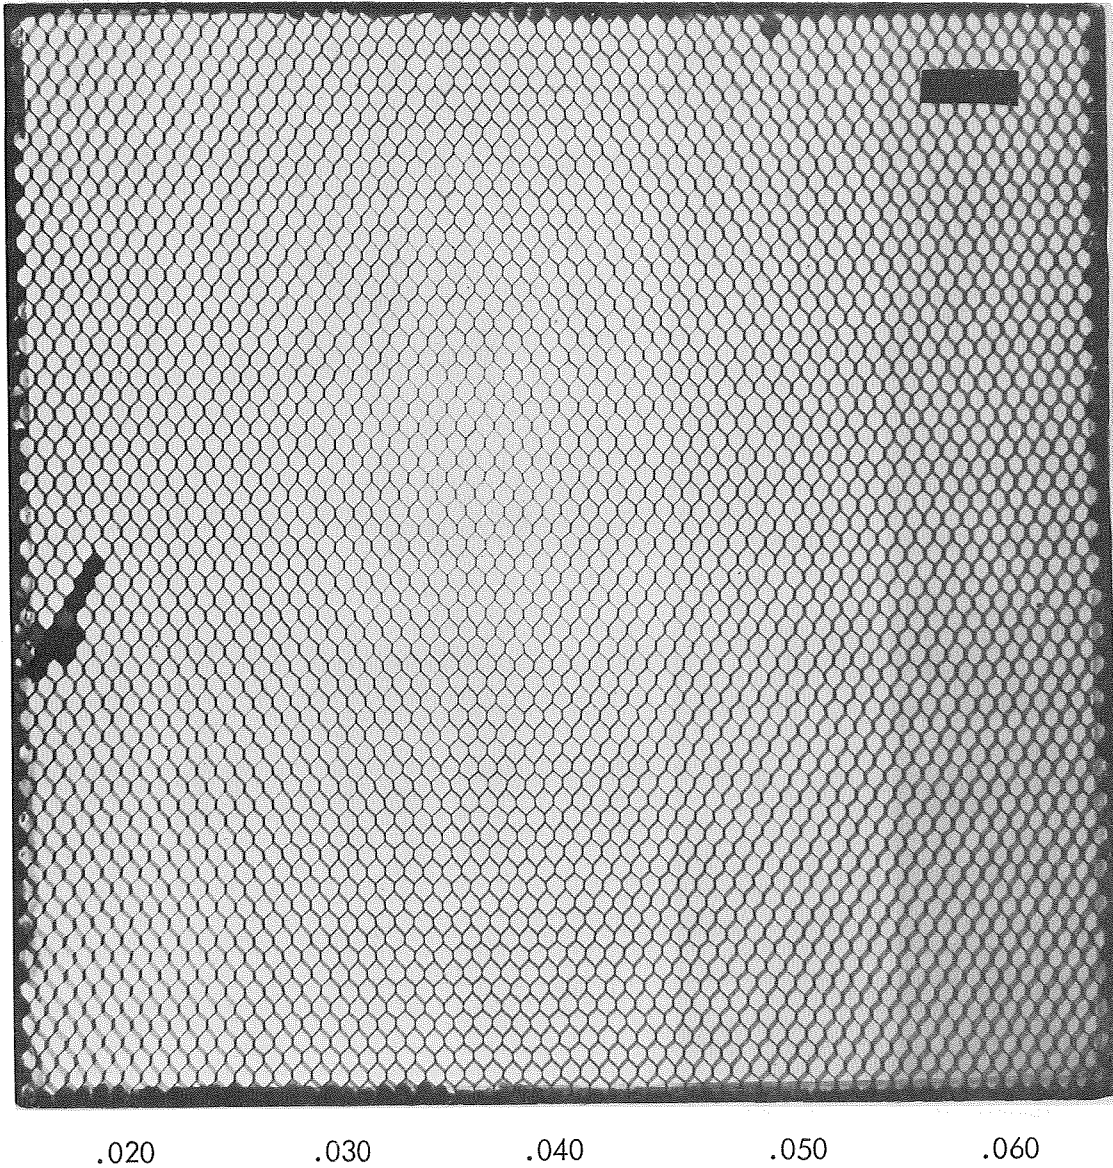
In Figure 55, the radiograph for Panel 419 reveals all defects including the fiber gaps (1/4-inch slots), overlaps, and spacing in the plain area. In honeycomb Panels 420 and 421 shown in Figures 56 and 57, respectively, the 1/4-inch slots are visible only in the 0.020-inch thickness step of Panel 421 and are not discernible in other thickness ranges or in Panel 420. The second-ply voids and overlaps are visible in both panels. The radiograph for Panel 420 shows sealant infusion in the core near the center edge of the 0.020-thickness step.

FIGURE 55. RADIOGRAPHIC PRINT OF THE FLAT GRAPHITE PANEL 419 SHOWING THE 1/4" SLOTS, OVERLAPS AND SPACING VOIDS IN THE FIBER PLYS (MOST INDICATIONS LOST IN REPRODUCTION)

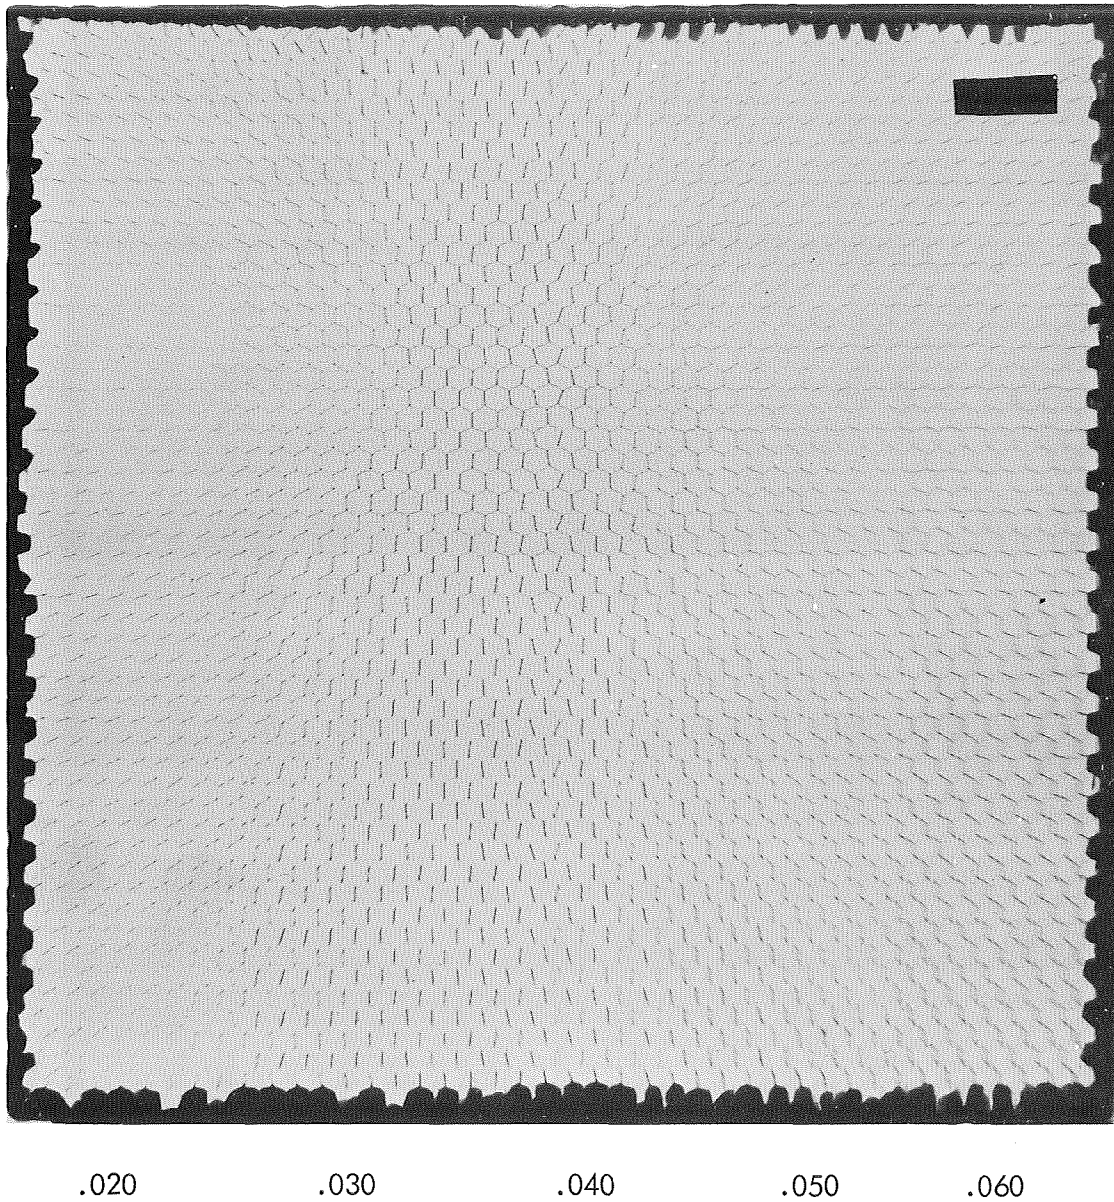
FIGURE 56. RADIOGRAPHIC PRINT OF THE 1/2-INCH GRAPHITE/HONEYCOMB PANEL 420 SHOWING THE OVERLAPS AND SPACING VOIDS IN THE FIBER PLIES (LOST IN REPRODUCTION)

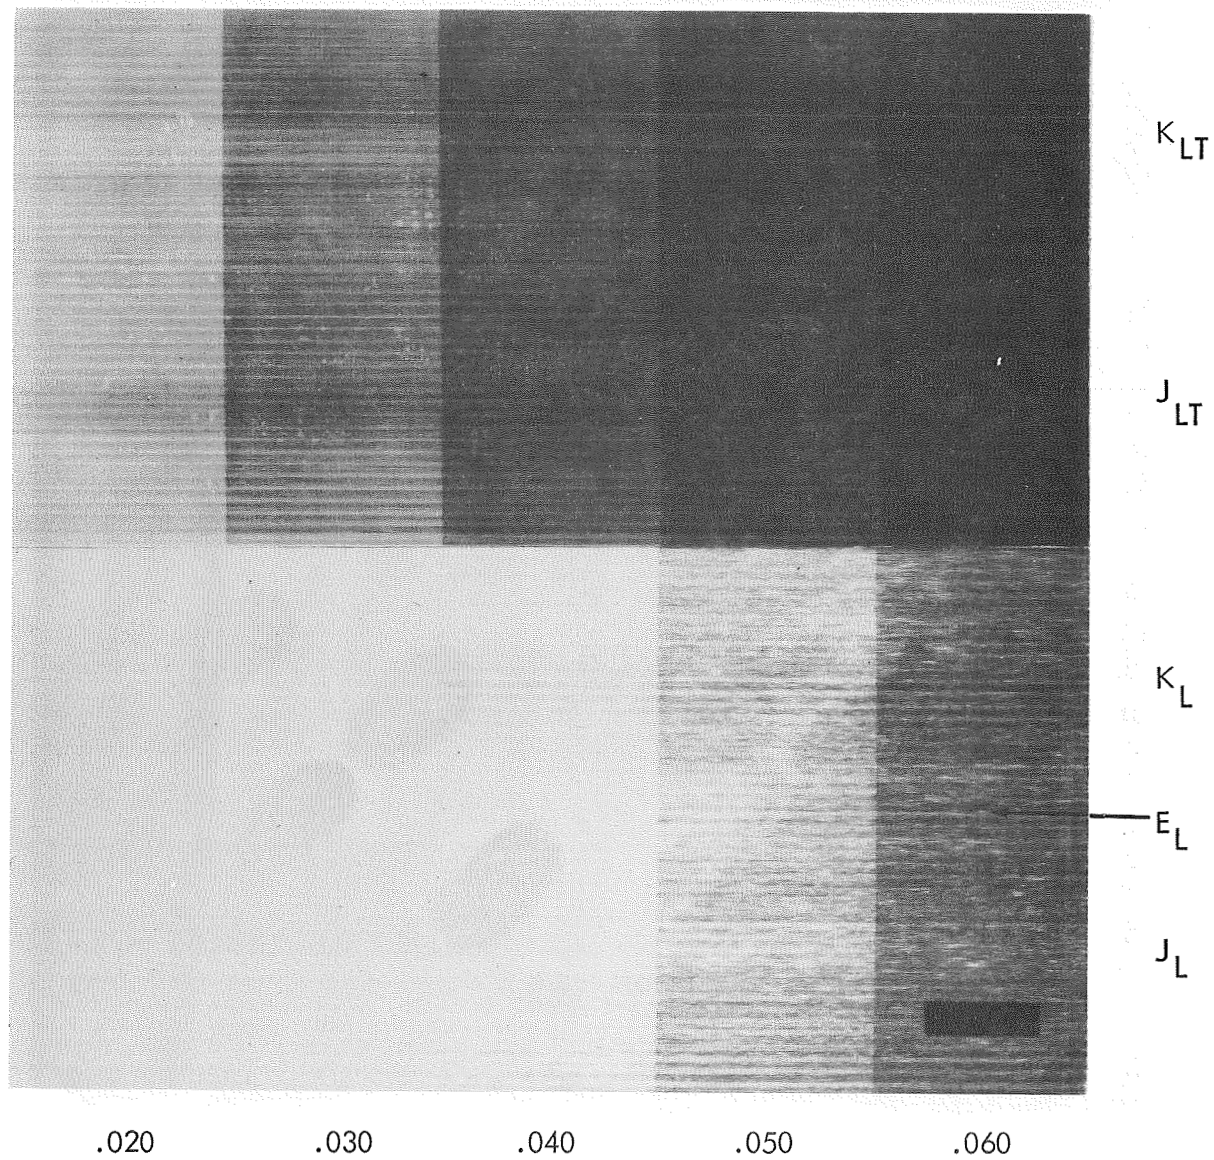
FIGURE 57. RADIOGRAPHIC PRINT OF THE 1-INCH GRAPHITE/HONEYCOMB PANEL 421 SHOWING THE 1/4-INCH SLOT (IN THE 0.020-INCH THICK SECTION), THE OVERLAPS, AND THE SPACING VOIDS IN THE FIBER PLYS (LOST IN REPRODUCTION)

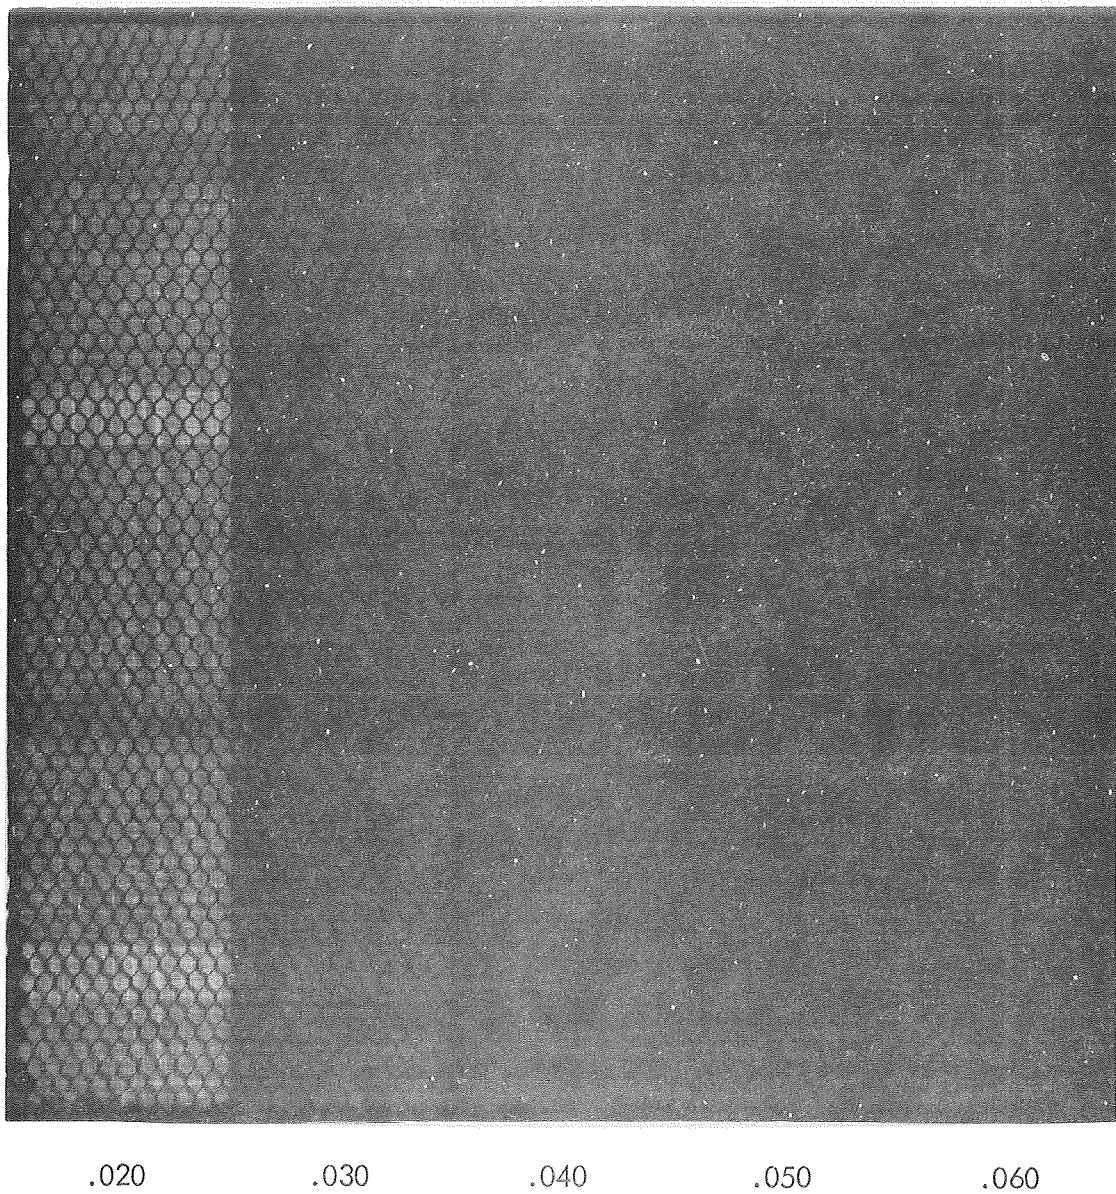
The radiograph for the flat boron Panel 422 in Figure 58 shows the slits, void, and overlap in the plain area. Slits are also visible in the substrate area. For honeycomb Panels 423 and 424 (Figures 59 and 60), voids and overlaps are visible, but the slits are not discernible in either panel. These slits may be revealed if the defective face sheet is placed nearest the film during radiographic exposure.

FIGURE 58. RADIOGRAPHIC PRINT OF THE FLAT BORON PANEL 422 SHOWING THE SLITS, OVERLAPS, AND SPACING VOIDS IN THE FILAMENT PLIES (SOME INDICATIONS LOST IN REPRODUCTION)
