DEVELOPMENT, FABRICATION, TESTING, AND DELIVERY OF ADVANCED FILAMENTARY COMPOSITE NONDESTRUCTIVE TEST STANDARDS

By W. M. Pless, B. L. Weil, and W. H. Lewis
Lockheed - Georgia Company
Marietta, Georgia

November 1970

Final Report

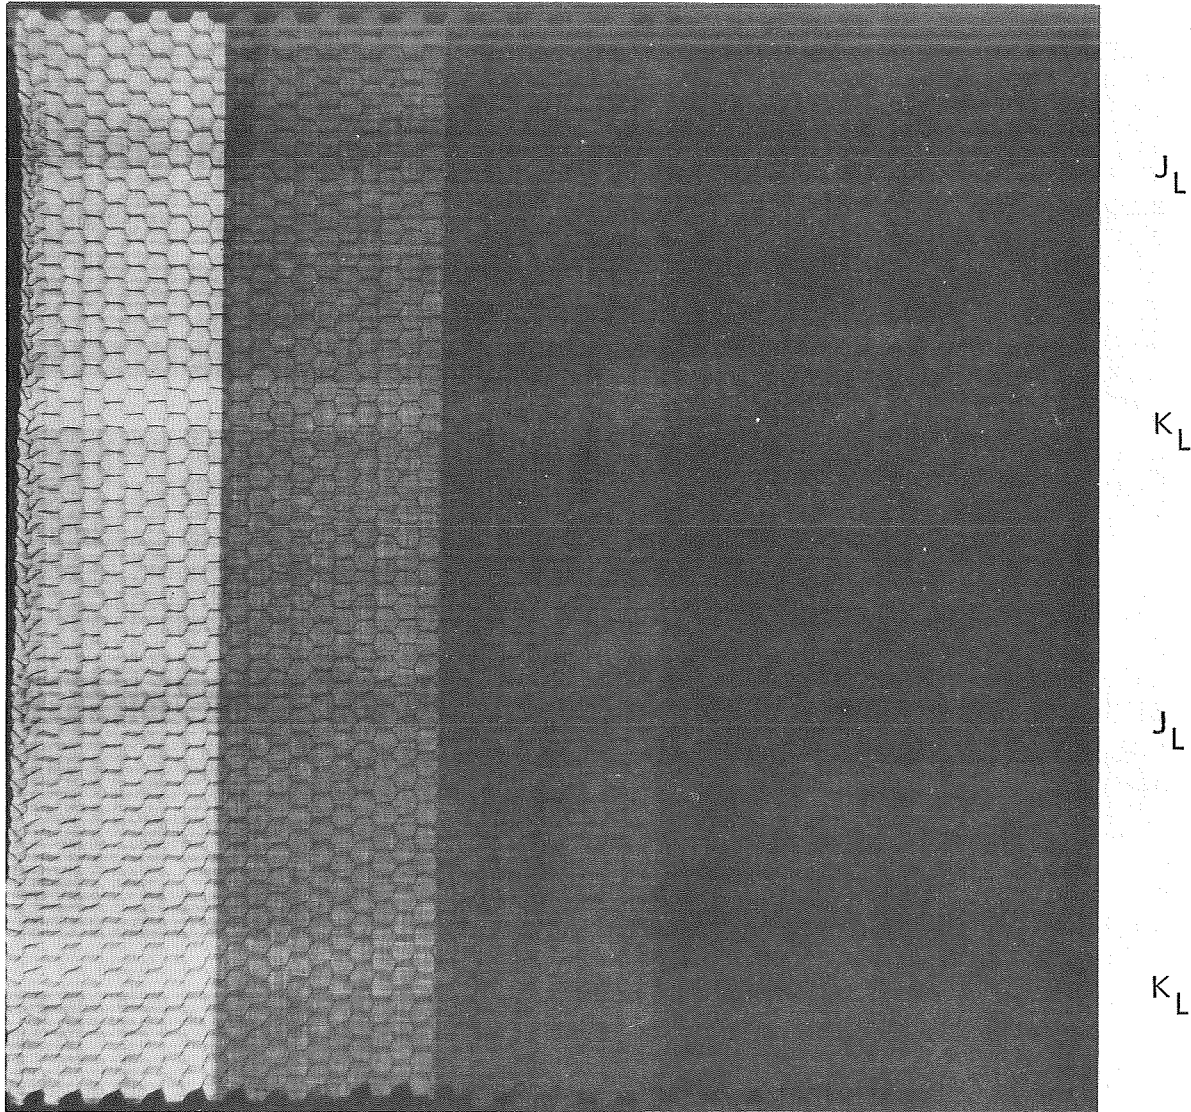
The radiograph for the flat boron Panel 422 in Figure 58 shows the slits, void, and overlap in the plain area. Slits are also visible in the substrate area. For honeycomb Panels 423 and 424 (Figures 59 and 60), voids and overlaps are visible, but the slits are not discernible in either panel. These slits may be revealed if the defective face sheet is placed nearest the film during radiographic exposure.

FIGURE 59. RADIOGRAPHIC PRINT OF THE 1/2-INCH BORON/HONEYCOMB PANEL 423 SHOWING THE OVERLAPS (DARK HORIZONTAL BANDS) AND SPACING VOIDS (LIGHT HORIZONTAL BANDS) IN THE FILAMENT PLYS

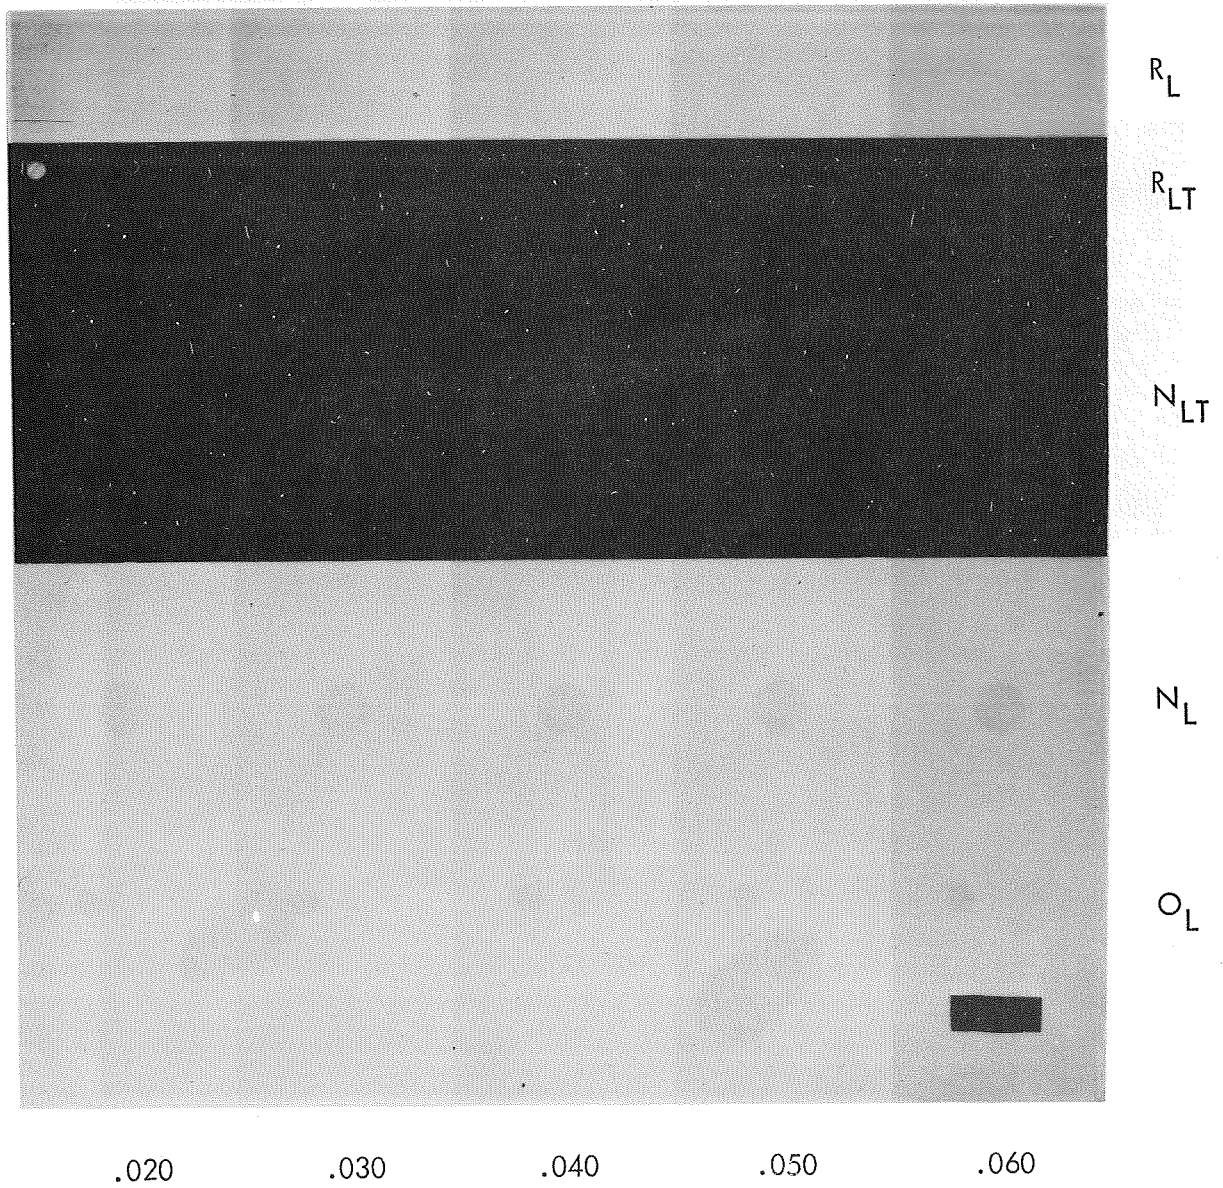
FIGURE 60. RADIOGRAPHIC PRINT OF THE 1-INCH BORON/HONEYCOMB PANEL 424 SHOWING THE OVERLAPS (DARK HORIZONTAL BANDS) AND SPACING VOIDS (LIGHT HORIZONTAL BANDS) IN THE FILAMENT PLIES

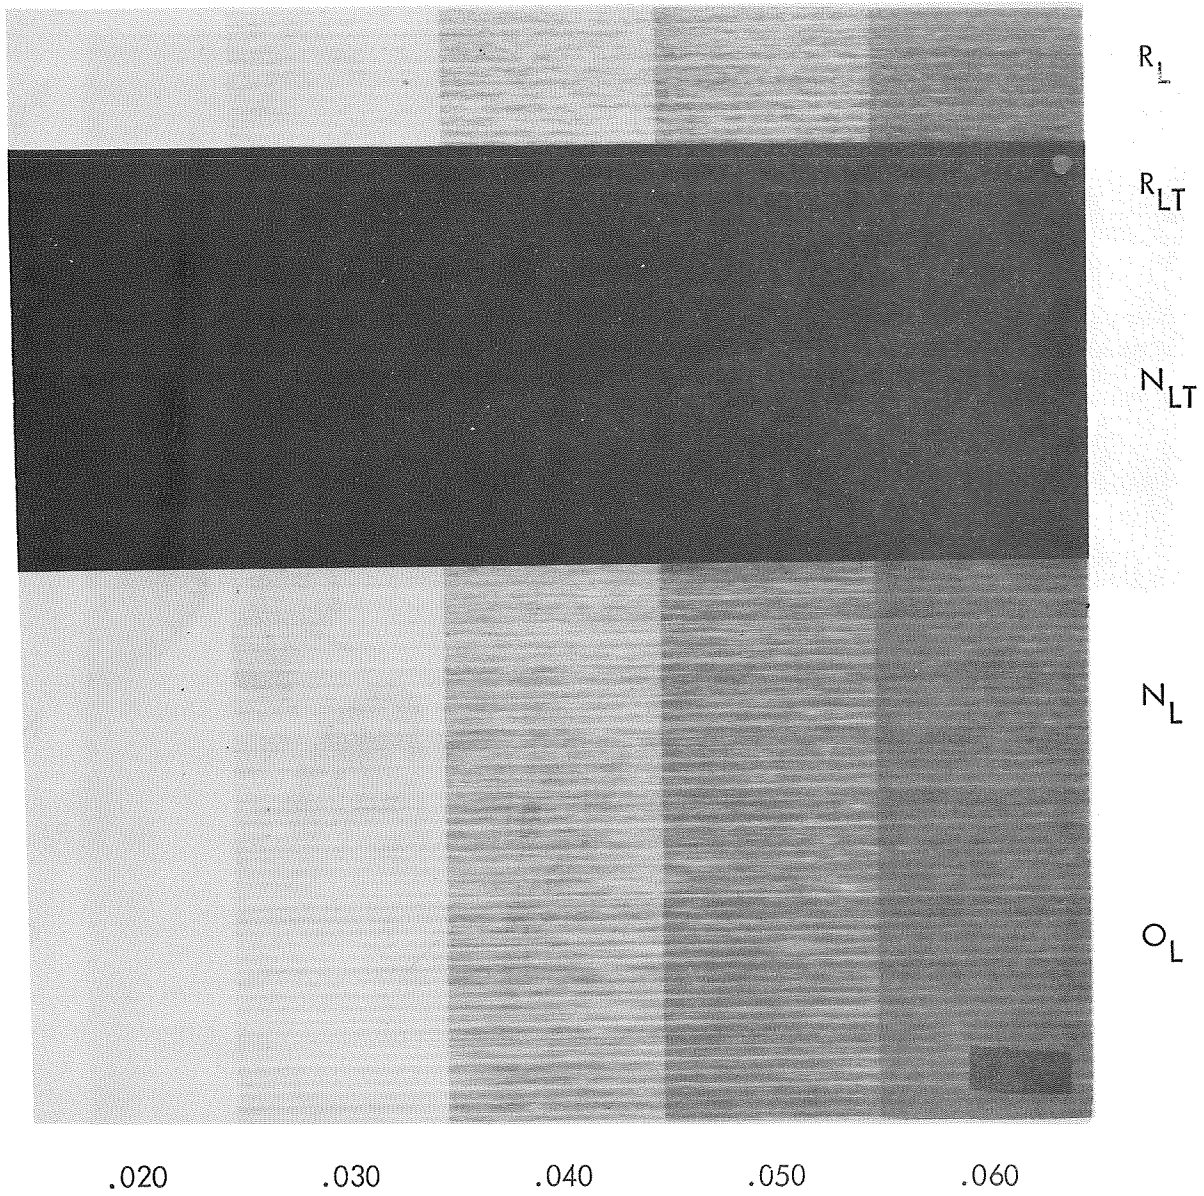
FIGURE 61. RADIOGRAPHIC PRINT OF THE FLAT GRAPHITE PANEL 525
 SHOWING THE 1/4-INCH AND 1/2-INCH INSERTS
 CAUSING DISBONDS

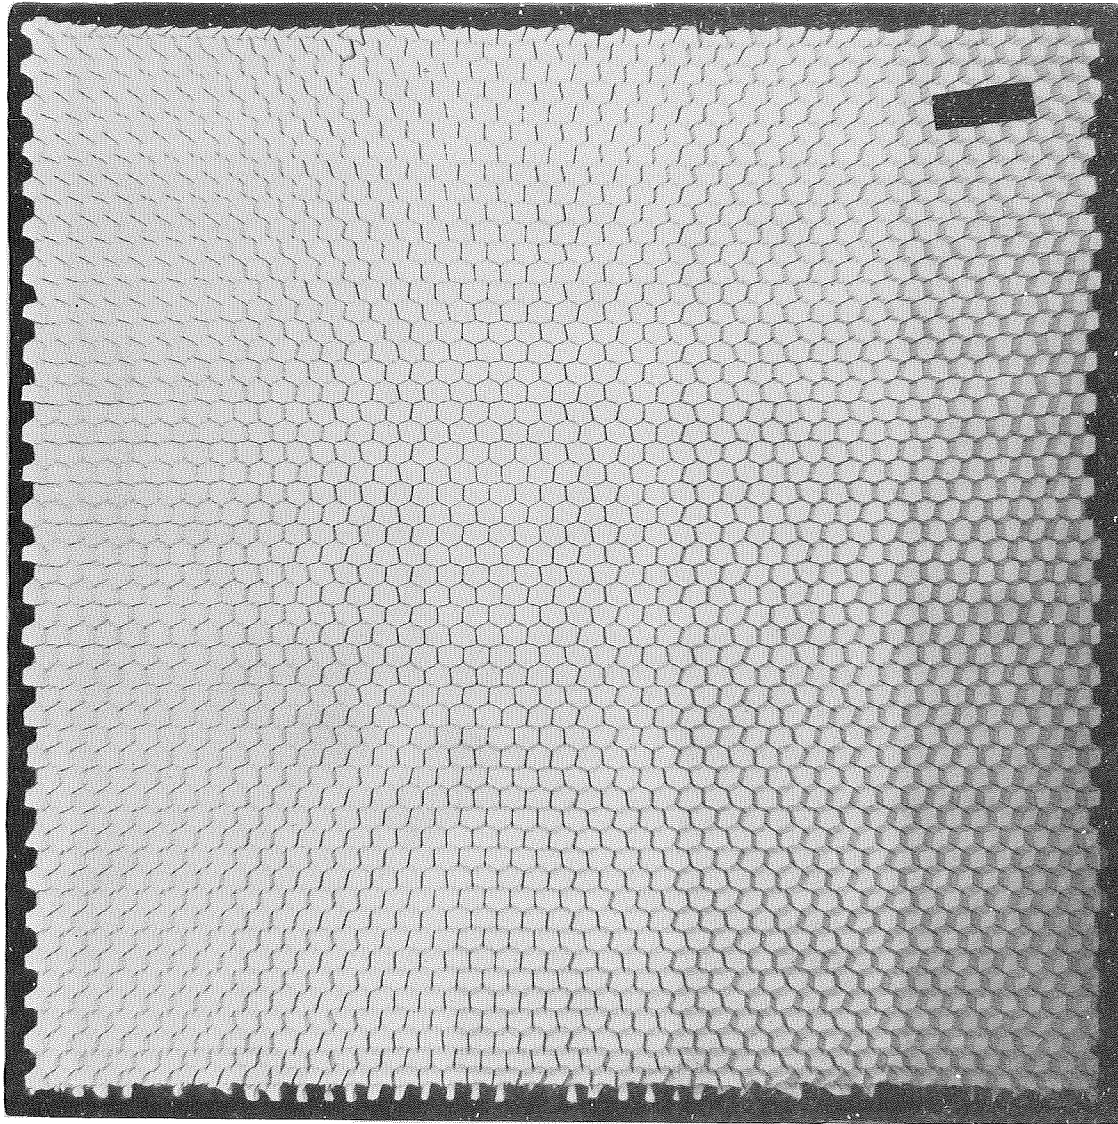
FIGURE 62. RADIOGRAPHIC PRINT OF THE FLAT BORON PANEL 526
(INSERTS NOT DISCERNIBLE)

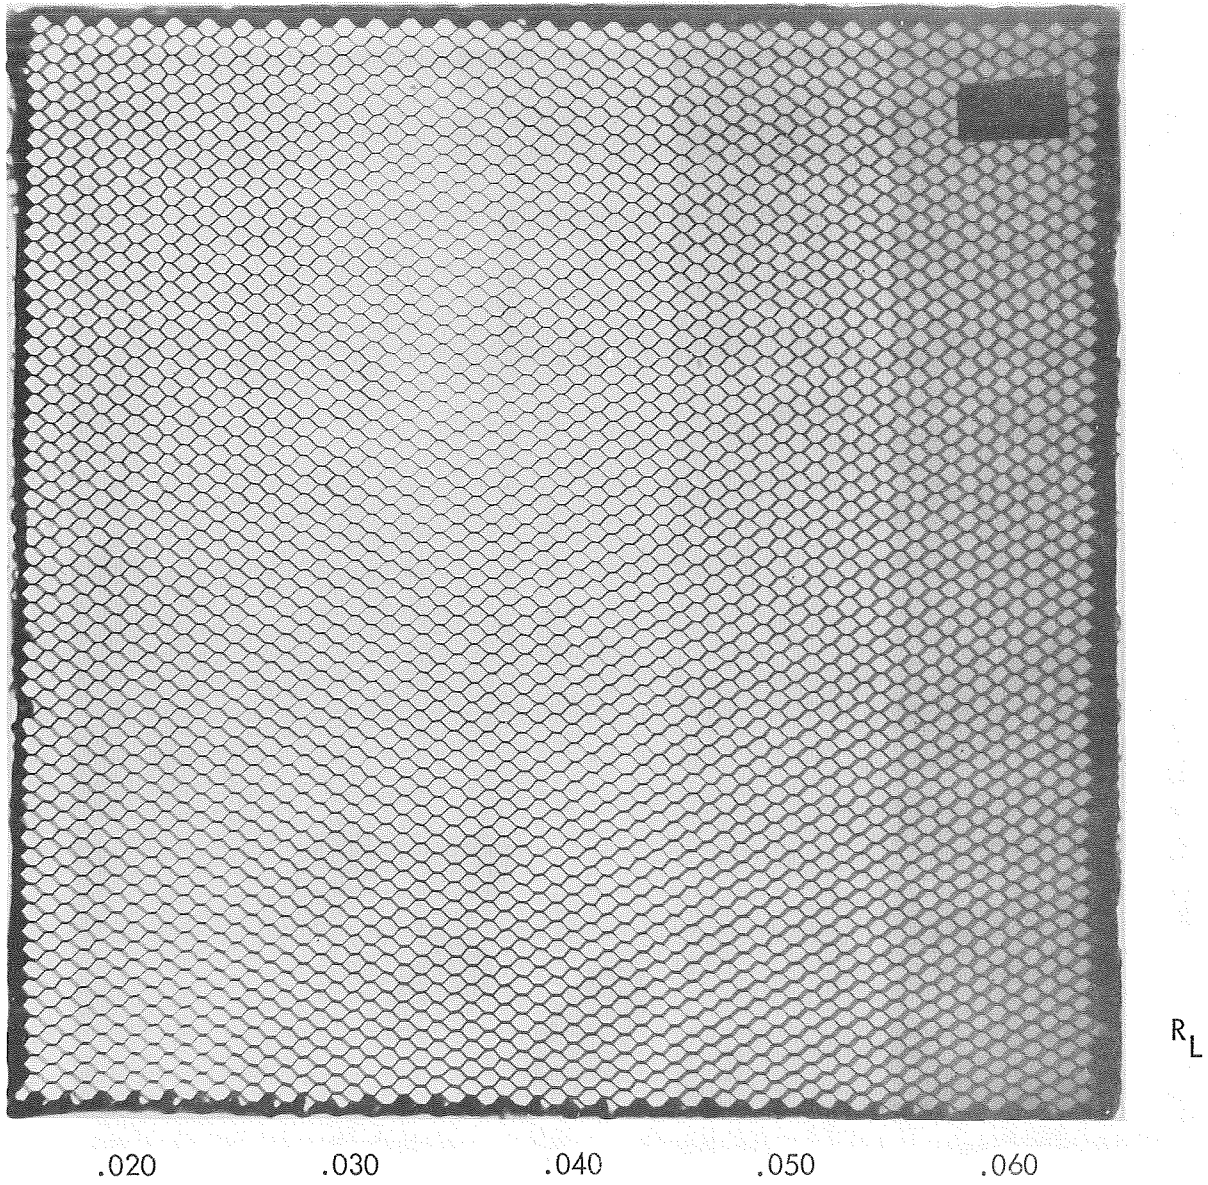
The radiographs for graphite honeycomb Panel 528 are shown in Figure 63. The crushed core, armalon/tehdar inserts for far- and near-side disbonds and second-ply disbonds are visible in Panel 528. Figures 64 and 65 show the radiographs for the two 527 panels. In Figure 64, only the 1/4-inch inserts between second and third plies are visible, and the other intentional defects are not discernible. In Figure 65, all defects are discernible. The pre-aged area in either panel is not discernible. A print of the radiograph for Panel No. 427C is shown in Figure 72. Only the crushed core defects are visible in the reproduction.

FIGURE 63. RADIOGRAPHIC PRINT OF THE 1-INCH GRAPHITE/HONEYCOMB PANEL 528, CONTAINING THE CRUSHED CORE AND THE INTER-LAMINAR, NEAR-SIDE, AND FAR-SIDE DISBONDS (NOT DISCERNIBLE IN THIS REPRODUCTION)

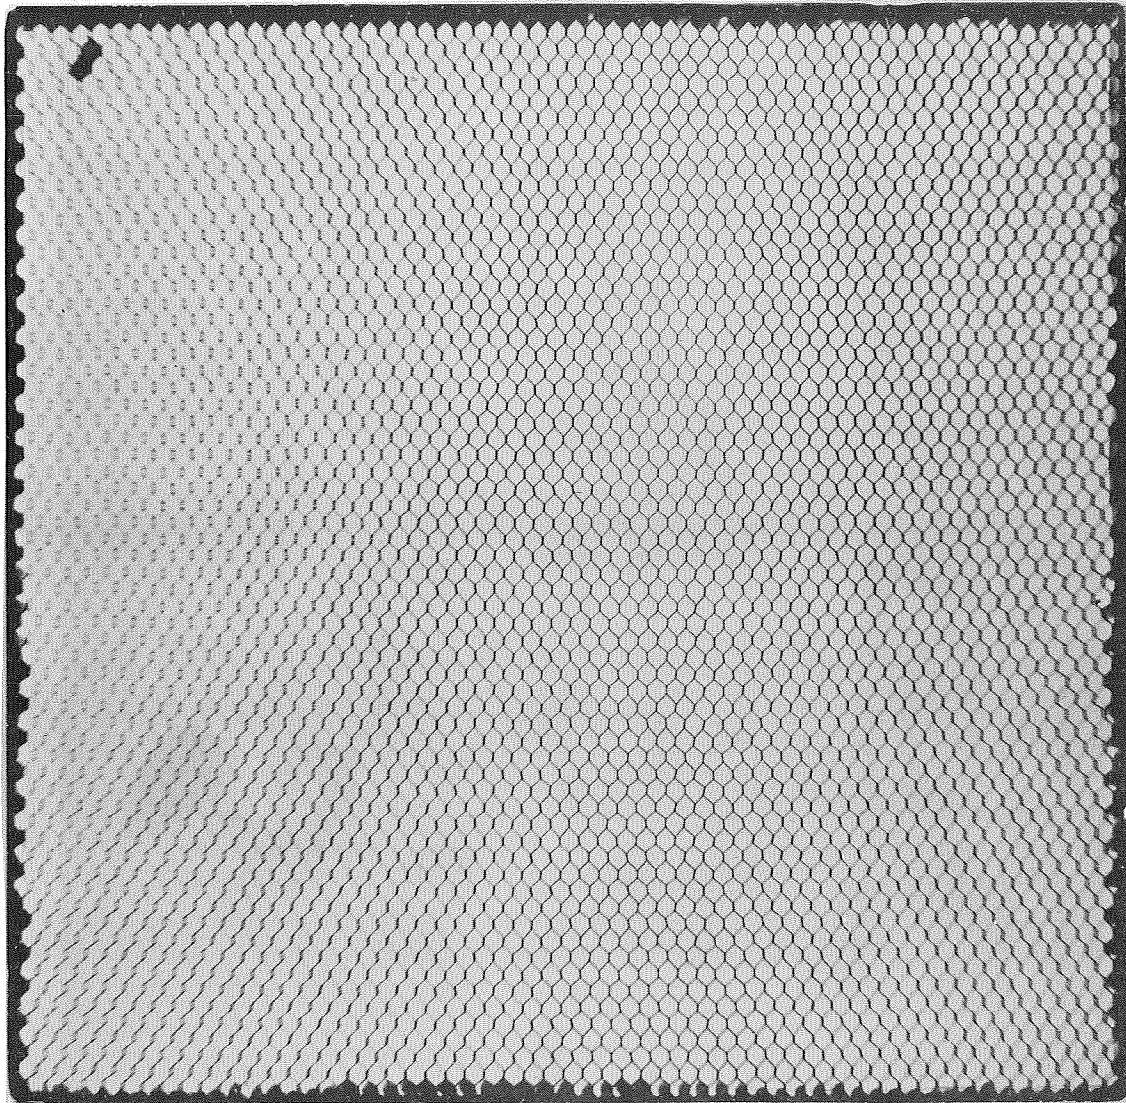
FIGURE 64. RADIOGRAPHIC PRINT OF THE 1/2-INCH GRAPHITE/HONEYCOMB PANEL 527 (#1), CONTAINING THE 1/4-INCH INSERTS FOR INTERLAMINAR DISBONDS

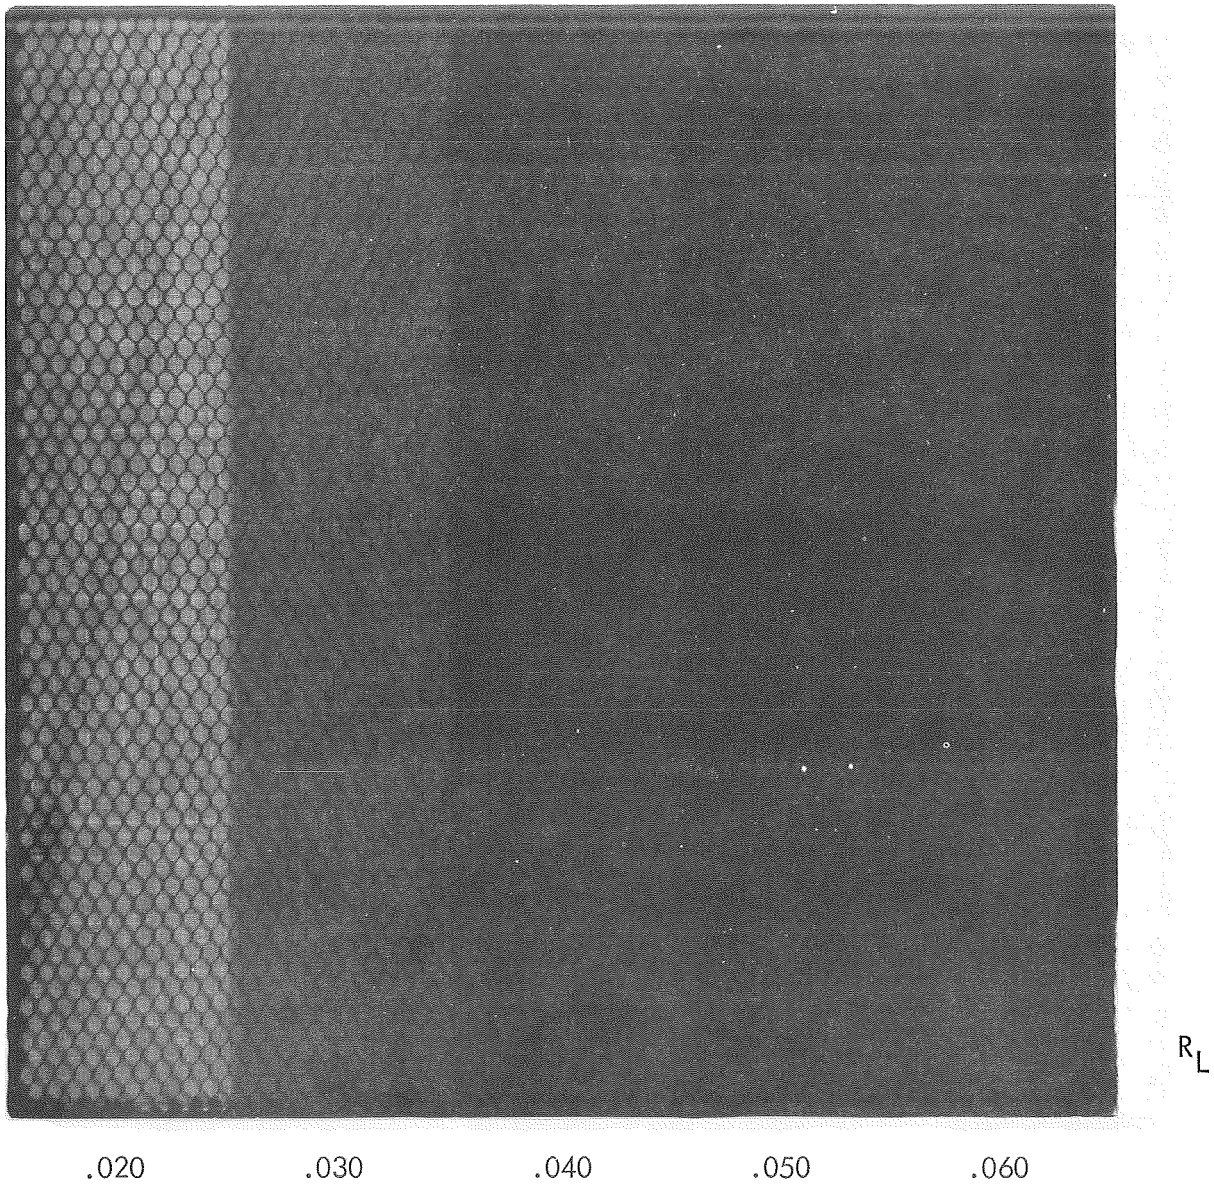
FIGURE 65. RADIOGRAPHIC PRINT OF THE 1/2-INCH GRAPHITE/HONEYCOMB PANEL 527 (#2), CONTAINING INTERLAMINAR, FAR-SIDE, NEAR-SIDE, AND GENERAL DISBONDS AND CRUSHED CORE (NOT DISCERNIBLE IN THIS REPRODUCTION)

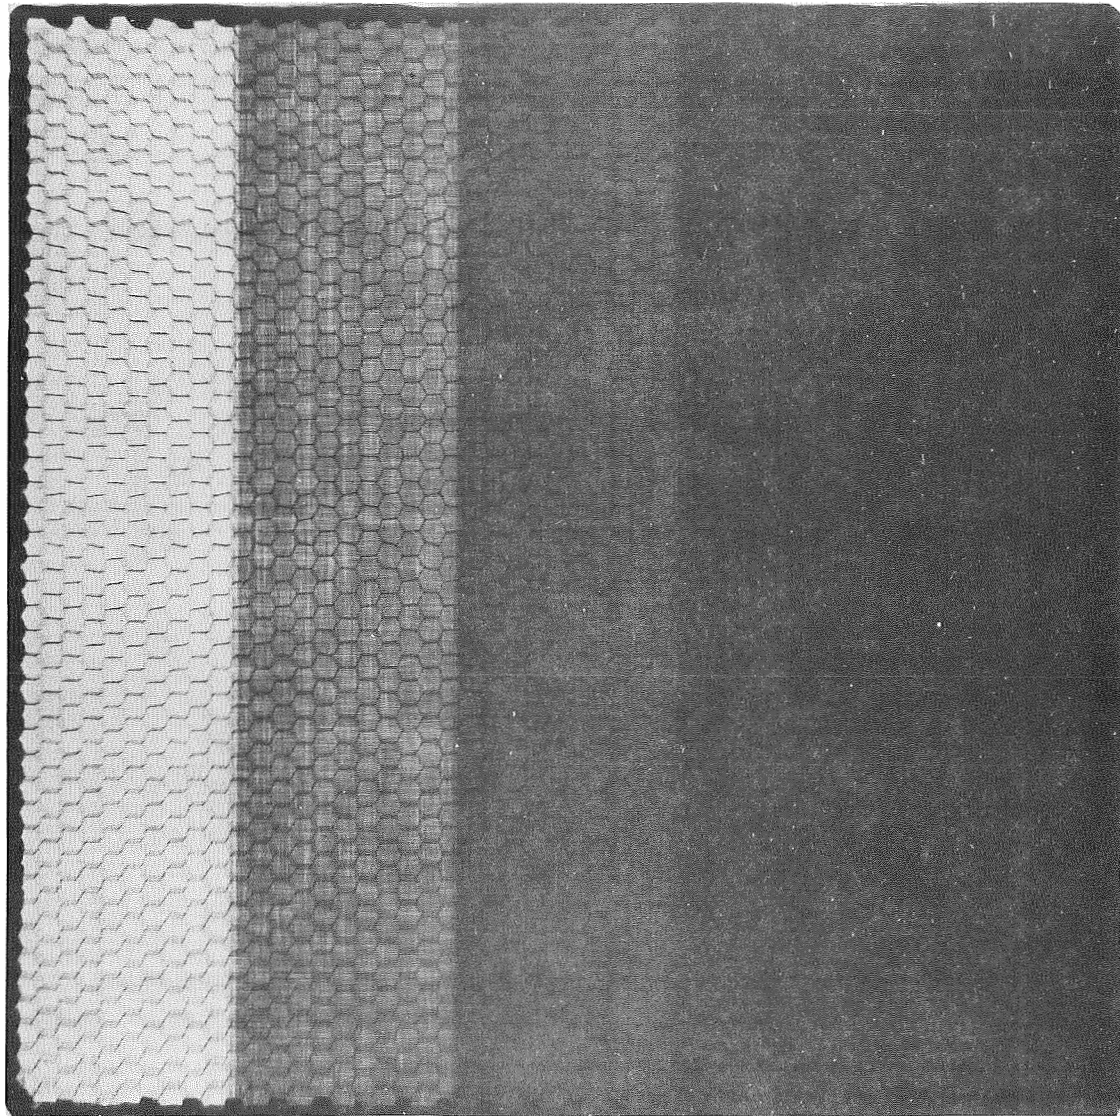
FIGURE 66. RADIOGRAPHIC PRINT OF THE 1/2-INCH BORON/HONEYCOMB PANEL 529 CONTAINING CRUSHED CORE AND INTERLAMINAR, FAR-SIDE, AND NEAR-SIDE DISBONDS (NOT DISCERNIBLE IN THIS REPRODUCTION)
