FURNACE-TUBE CONTAMINATION

NASA Grant NGR 05-010-041

Dept. of Electrical Engineering

Univ. of Calif., Santa Barbara

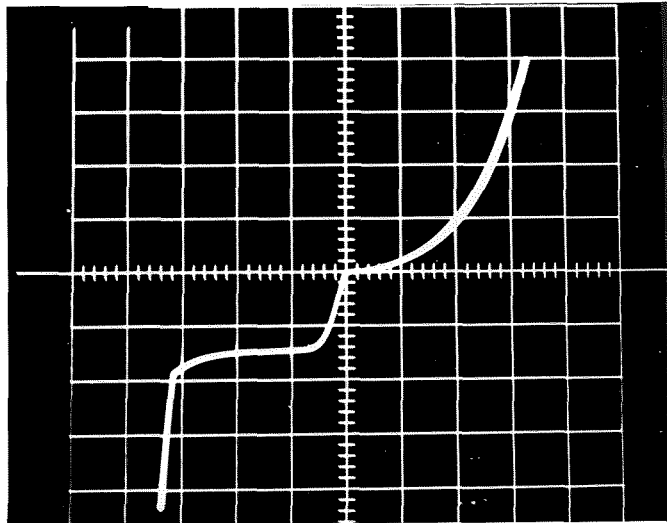
Next, three more sets of diodes were made using the same substrate wafer and the same POCl_3 predeposition furnace for predeposition and drive. Two groups had the oxide grown in the oxidation furnace, one with wet O_2 (Fig. 11) and one with dry O_2 (Fig. 12). The oxide for the third group was grown in the boron drive furnace, which was expected to be clean (Fig. 13). Since all three groups had channel currents, it was concluded that the POCl_3 predeposition furnace was contaminated.

Fig. 13 n^+ -p junction (Dry O_2 , boron drive furnace)
(same substrate wafer and phosphorous prede-
position furnace as for Fig. 11.)

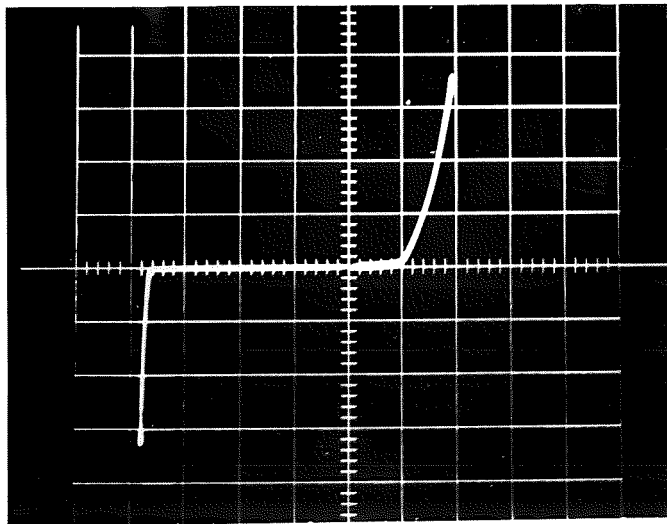
The cleanliness of the N_2 line was next investigated by comparing diodes from the BCl_3 predeposition furnace with a set from a new and clean BBr_3 predeposition furnace. Oxides were grown in the boron drive furnace (new tube and no N_2). A separate N_2 bottle was connected to the BCl_3 furnace (new tube). The BBr_3 furnace also had a new tube but previously had "house" nitrogen flowing through it. The results are shown in Figs. 14 and 15 and were nearly identical. According to Grove², Fig. 6.28, a one-sided step junction with a substrate resistivity of $1.0 \Omega\text{-cm}$ or 5×10^{15} impurities/ cm^3 should have a breakdown of about 100 volts. Considering

Fig. 15 p⁺-n junction (BBr₃ predeposition furnace, oxide grown in boron drive furnace) 0.45 μa leakage @ 20v.

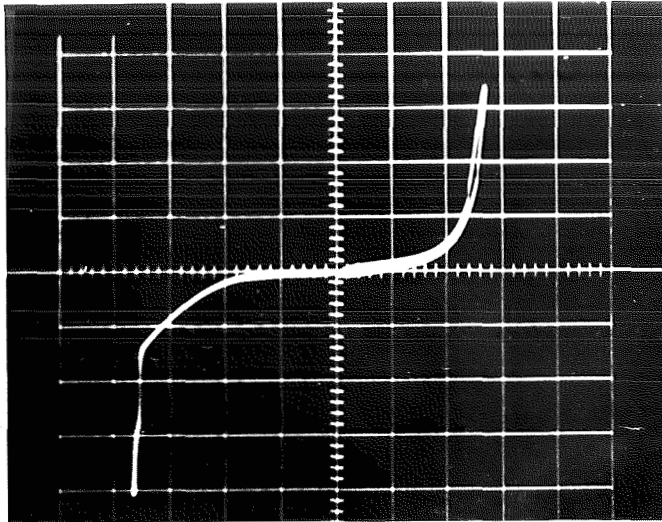
In an attempt to eliminate the contamination in the oxide furnace, a new tube was installed. Figure 22 shows the results from a BBr_3 predeposition and oxide grown with wet O_2 in the oxidation furnace. Since the oxidation furnace was running at 950°C , the junctions remained shallow. The resulting sharp curvature of the junction probably is responsible for the low breakdown voltage. However, the soft breakdown does indicate contamination. In an effort to eliminate the contamination, all glassware was recleaned and the solenoid valves bypassed with Teflon tubing. The result of this process is shown in Fig. 23. The leakage current at 20-volts reverse bias was 60 nanoamps. While this level of reverse leakage current is considered to be satisfactory, some improvement is possible by the use of higher-resistivity water for the wet- O_2 oxidation.

Fig. 22 p⁺-n junction (oxide in oxidation furnace)
leakage current @ 20 v. - 1μa.

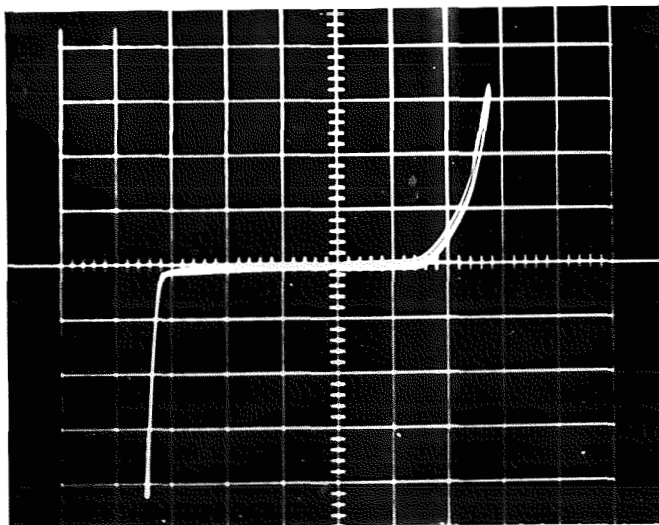
Fig. 23 p⁺-n junction (solenoid valves of oxidation
furnace by-passed) leakage current @ 20v. -
60 na.

It was found that jungling on the POCl_3 predeposition furnace allowed pressure to build up and force liquid POCl_3 into the valves and flow meters. This was felt to be responsible for the degraded results when using the POCl_3 predeposition furnace. Solenoid valves were eliminated and the jungling simplified and correct. A leaky valve was probably responsible for the poor results from the BCl_3 furnace. Additional checks on the BBr_3 and the two drive furnaces indicated that they were still clean.
