HARVARD COLLEGE OSO-IV  
POINTED EXPERIMENT  
AN ANALYSIS OF THE  
MALFUNCTION DURING  
ORBIT 637

BY: R. Dower  
N. Hazen  
J. Rechavi

Technical Report No. 7  
NASA Contract NASw-184

February 1969

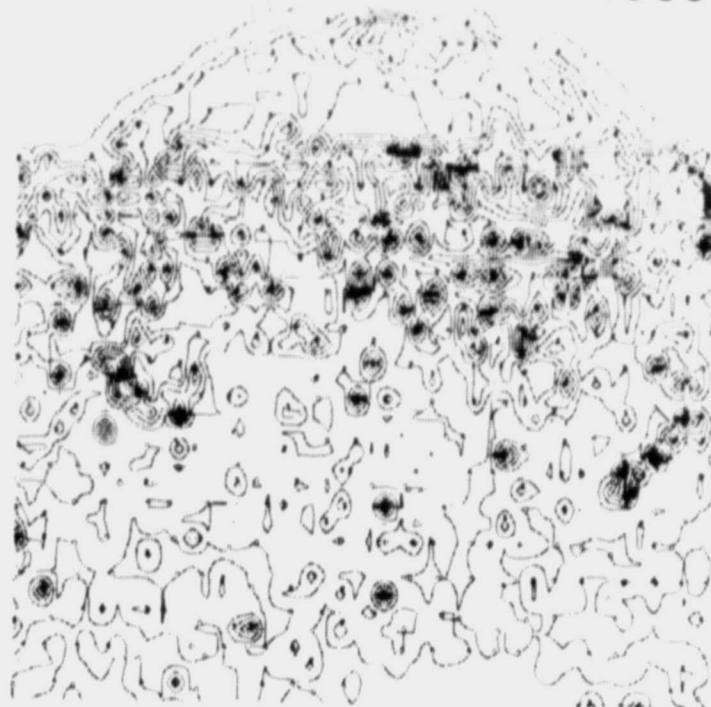
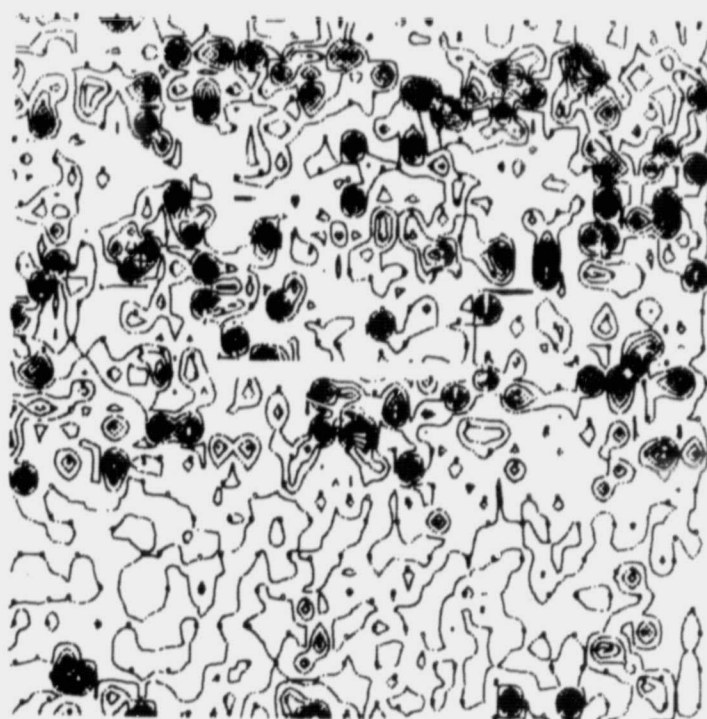
Figure 5B  
RASTER PLOTS AFTER UV  
TERMINATION

indicate intensity by the dotted lines of constant intensity (isophotes). The highest data count recorded during each raster is printed above the raster picture as a maximum intensity figure. Raster 2 and raster 3 show the coherent solar images and very close correlation with expected intensities. Raster 4 begins at the top with a good rounded solar image, then the picture suddenly deteriorates as an image of the sun in ultraviolet light. The plots of raster 5 show no apparent relationship to a solar image.

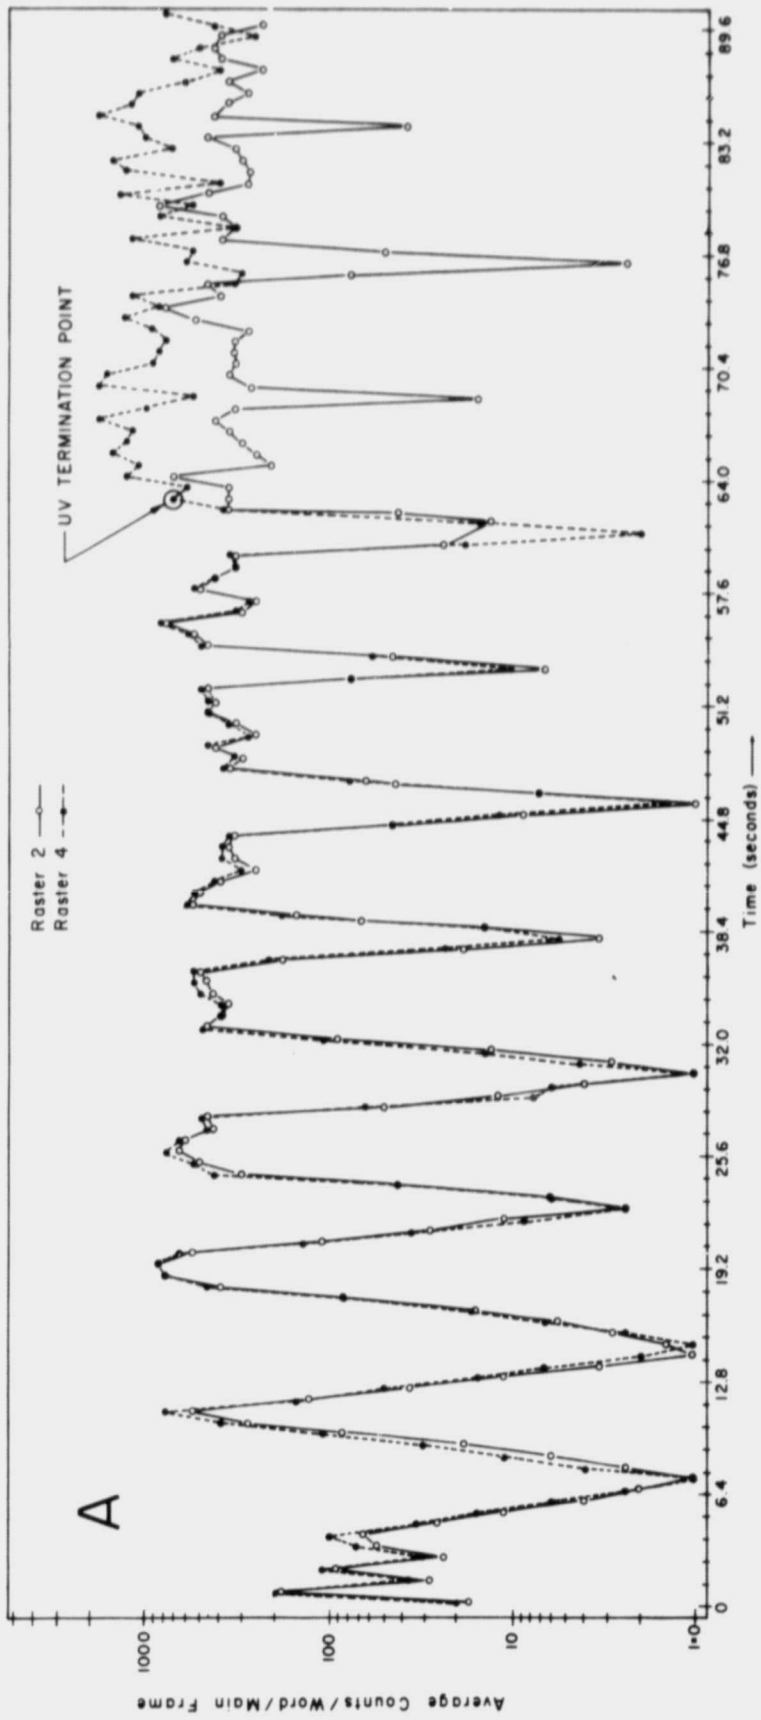
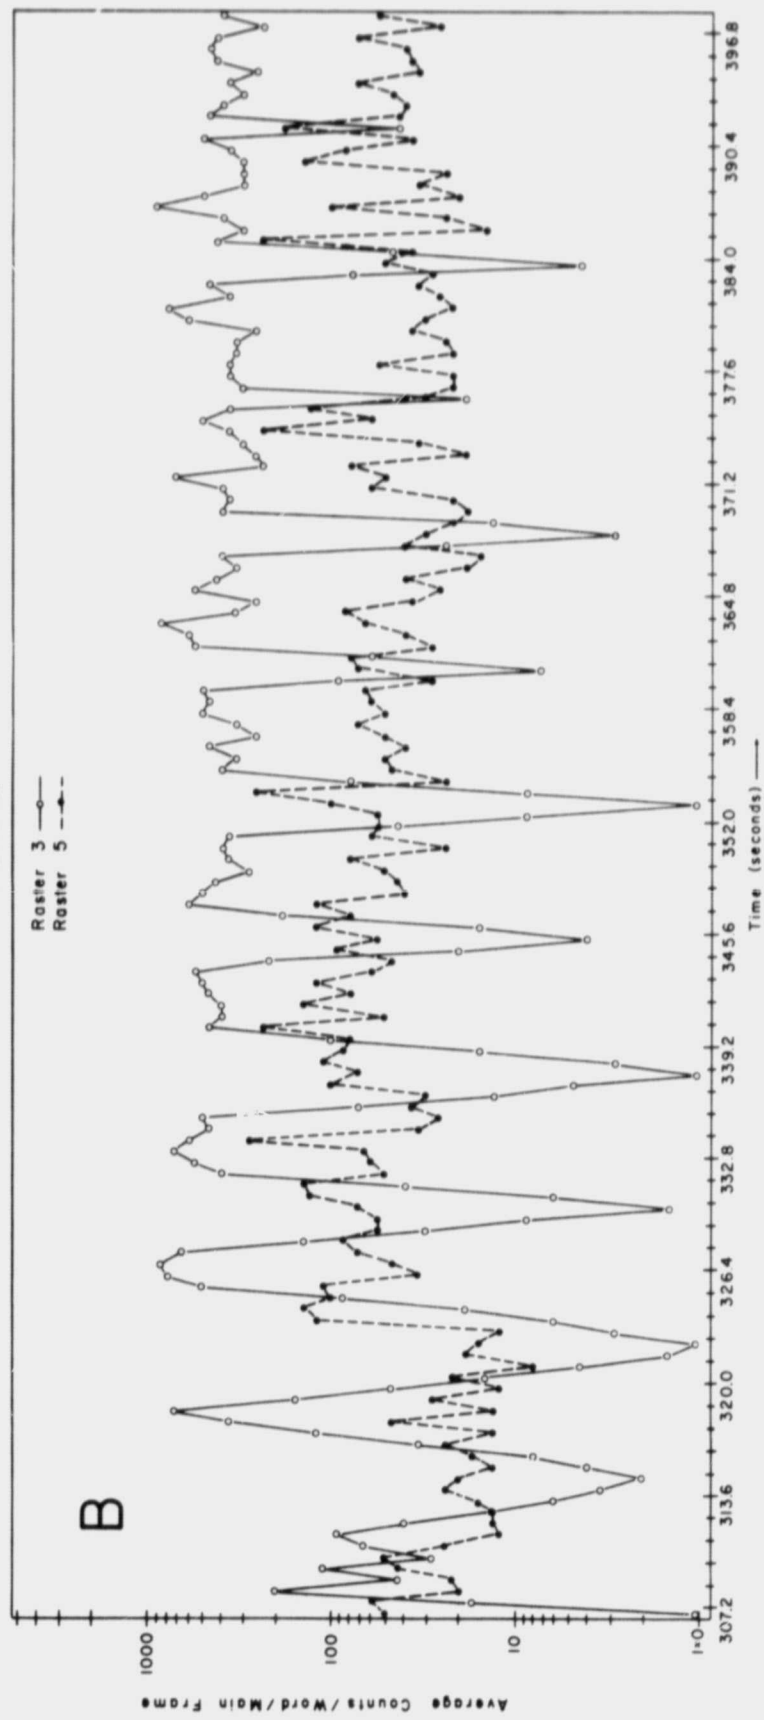
Figure 7 — DATA COUNT COMPARISONS  
NEAR TIME OF UV TERMINATION

The count numbers from raster 4 and the four rasters following it were compared with corresponding counts from rasters 2 and 3 to determine whether or not the HCO instrument was transmitting any significant ultraviolet data underlying the noise, after the malfunction point. This would help to determine the condition of the high voltage power supply and detector. The comparison was made by using a computer to plot the average count for each data main frame (which contains four Harvard data words) on a logarithmic scale vs. time for the several rasters in orbit 637. Then the plots for rasters 2 and 3 were overlaid on the plots of corresponding points of subsequent rasters. These plots are shown in Figure 7.

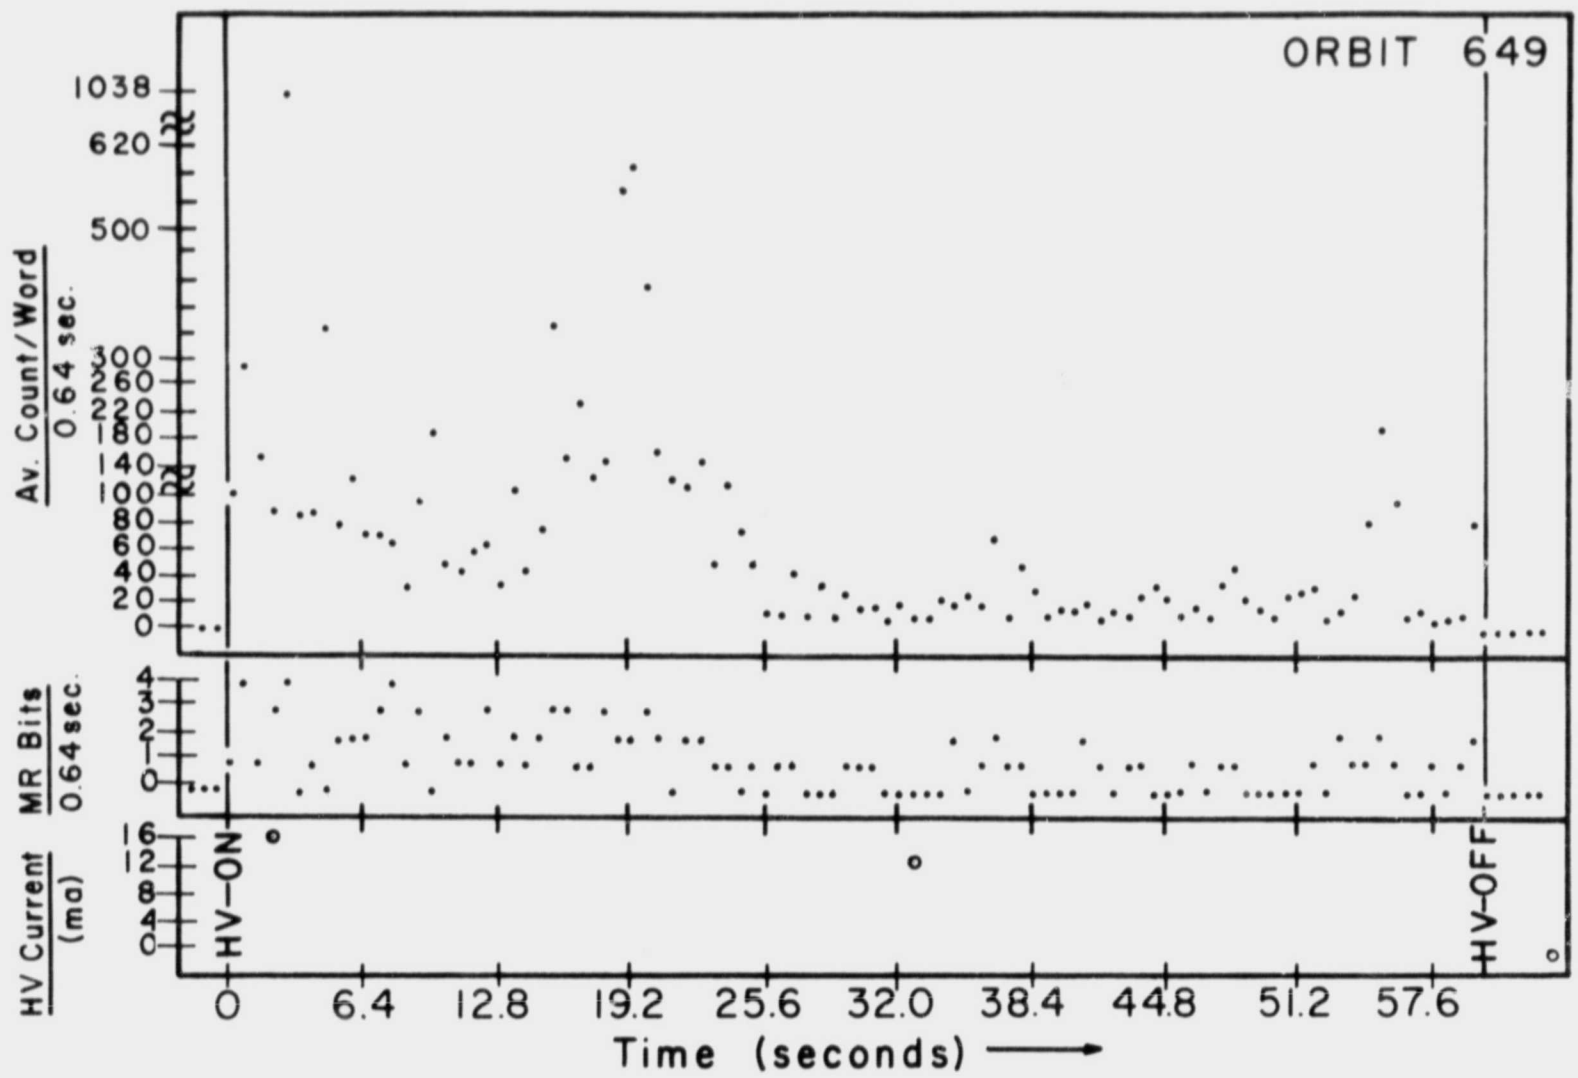
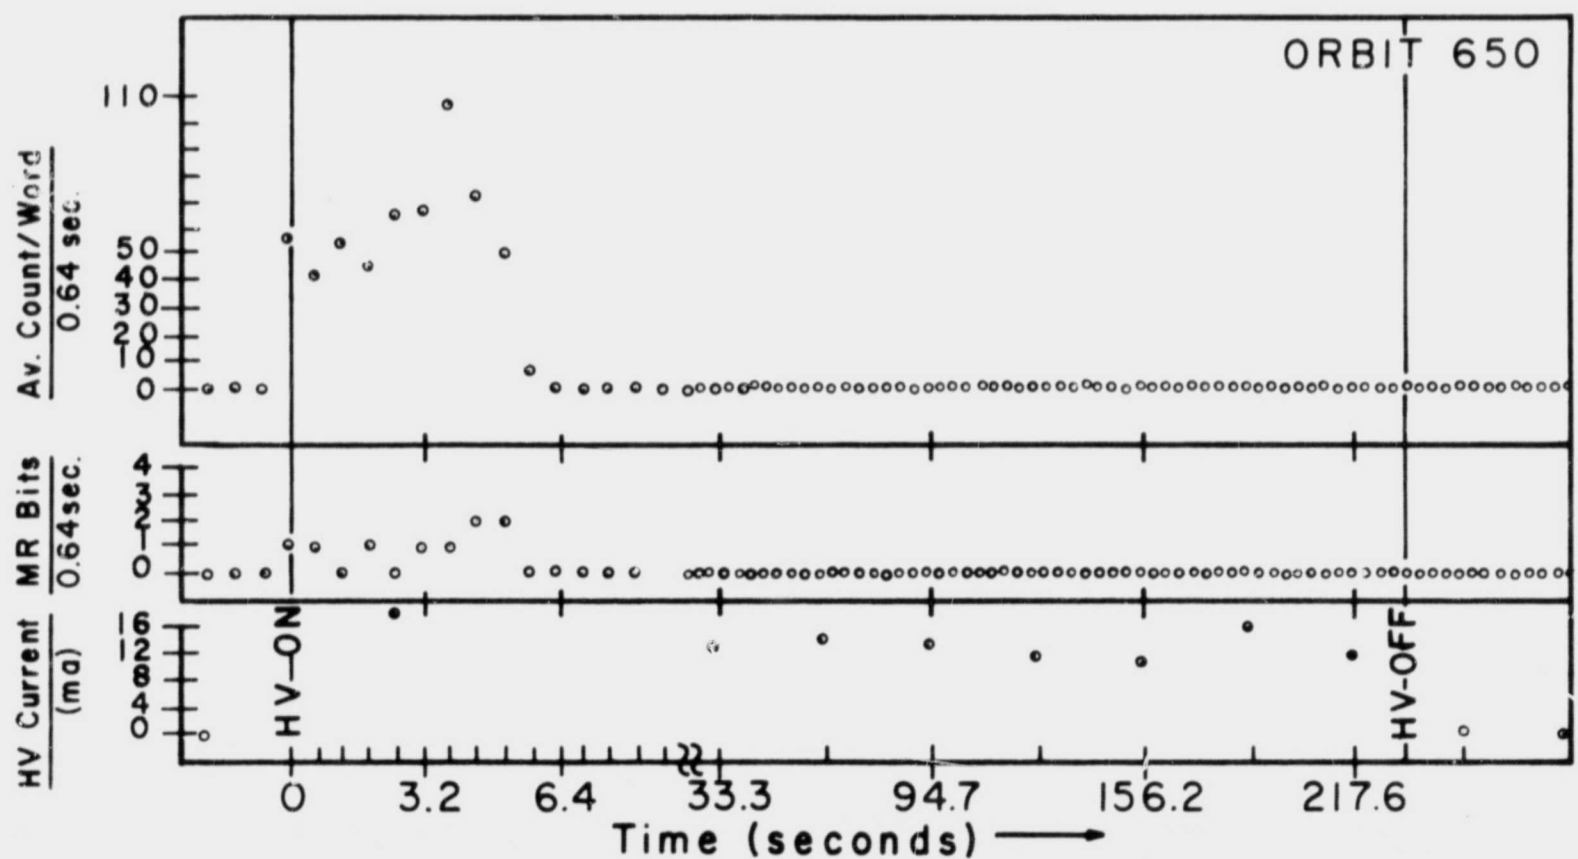
Figure 10—HARVARD DATA — ORBITS 649, 650

In orbit 650 the HV power supply was turned on for 3 minutes 30 seconds. Count noise and false MR indications appeared during the first six seconds. After that zero counts, the absence of false MR indications and high, fluctuating HV monitor readings indicate Mode II operation until the instrument was turned off. These data are plotted in Figure 10.

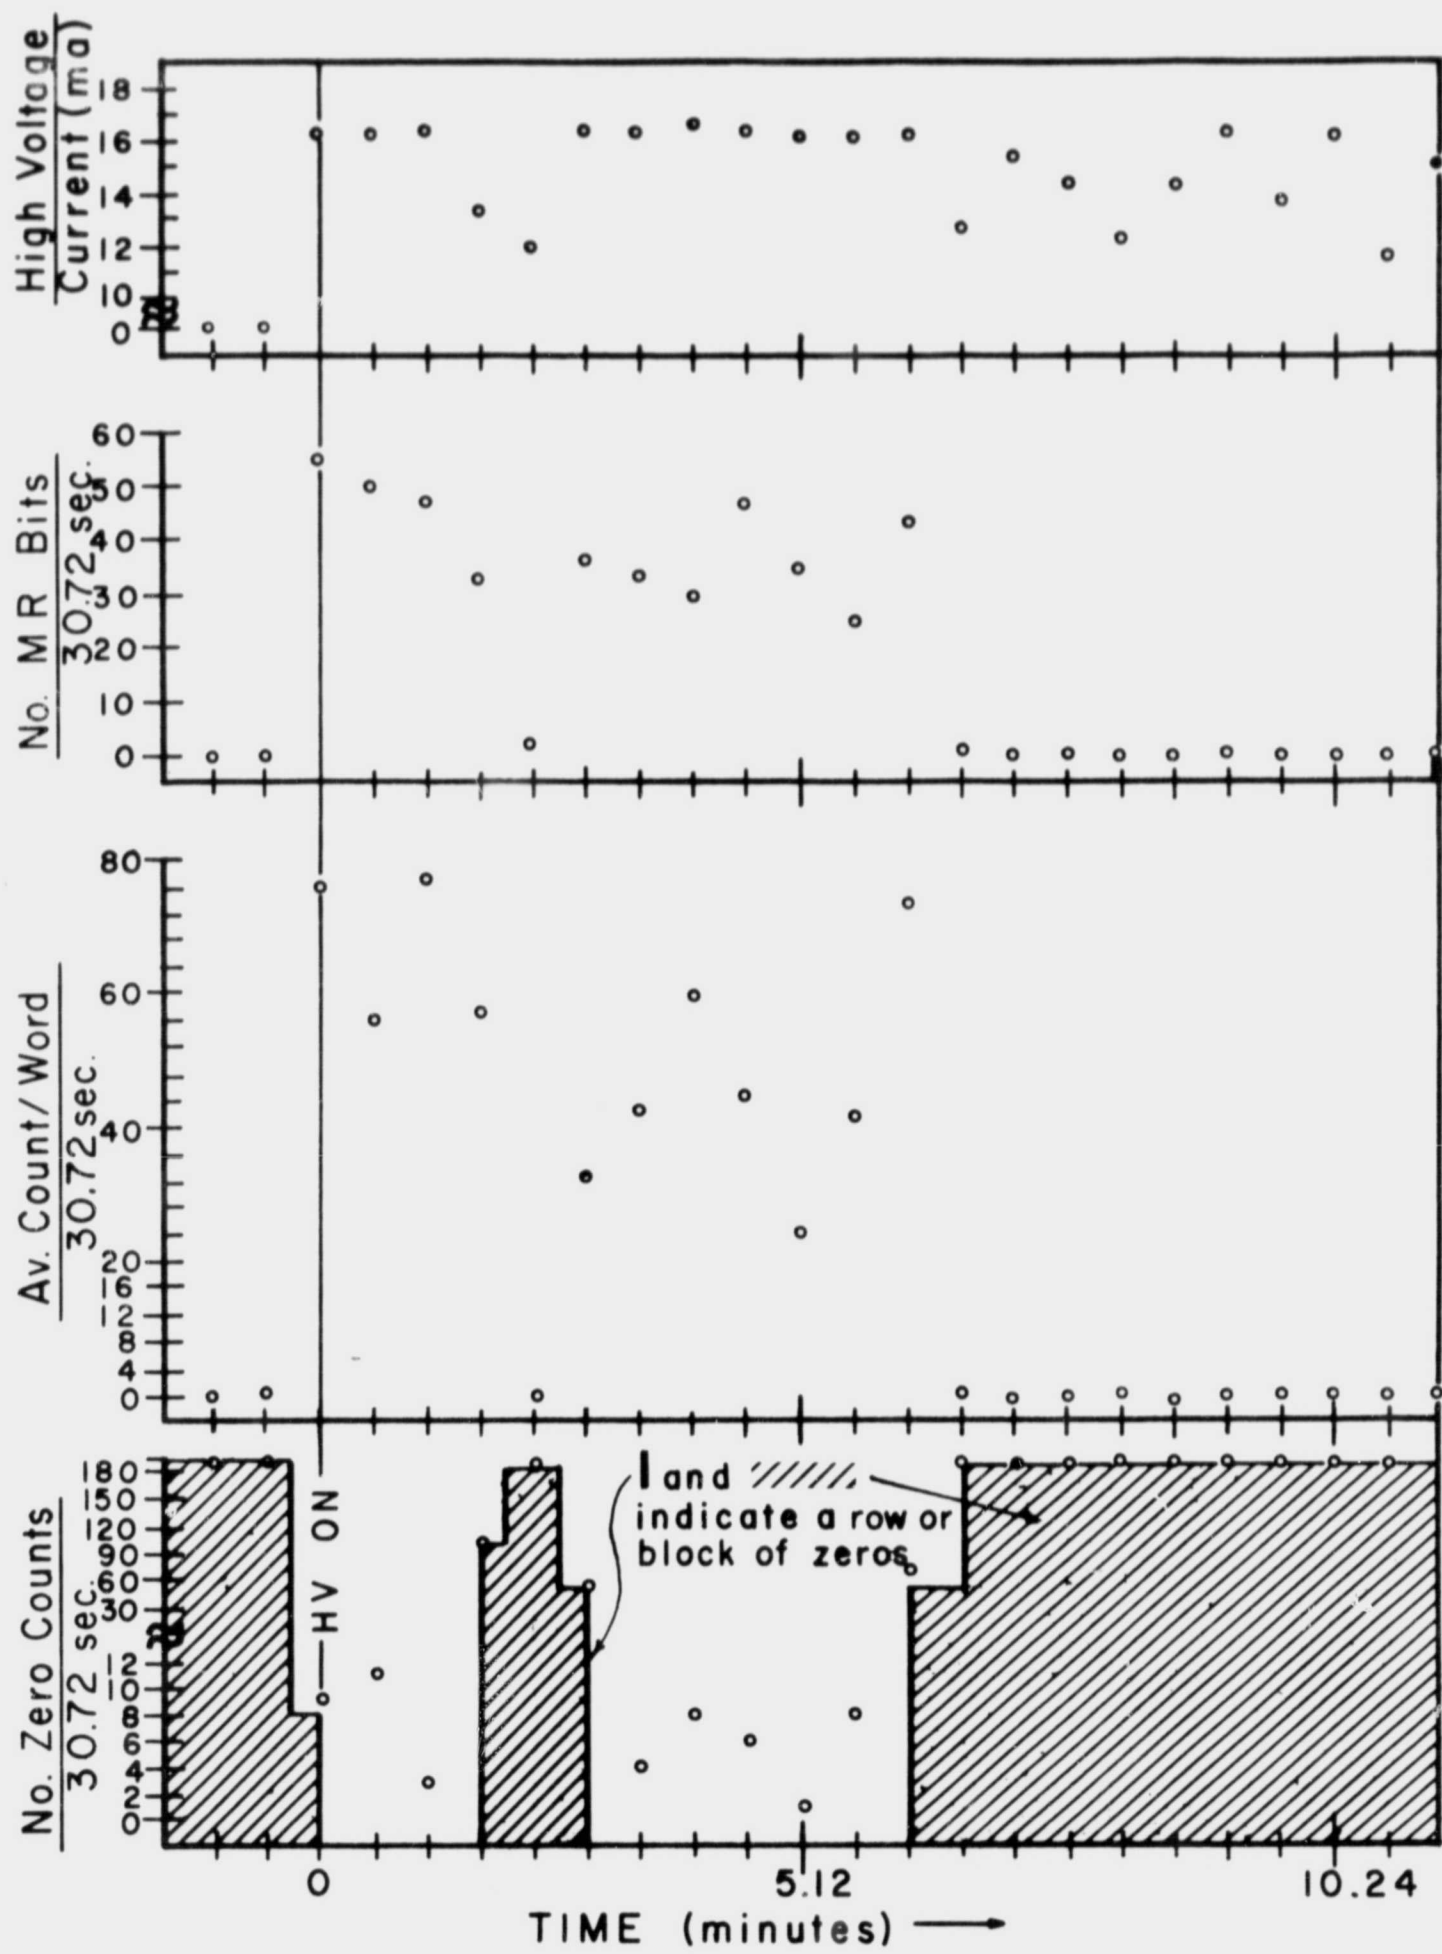
Figure II-HARVARD DATA- ORBIT 1238

Five weeks later on January 8, 1968 during orbit 1238 the HV power supply was turned on for 2 hours and 50 minutes. For 1 minute and 45 seconds noise counts, false MR indications, and high, constant HV current readings indicate Mode I operation. This was followed by one minute of Mode II, three minutes of Mode I, then Mode II until the HV was turned off. Figure 11 shows plots of data from orbit 1238.

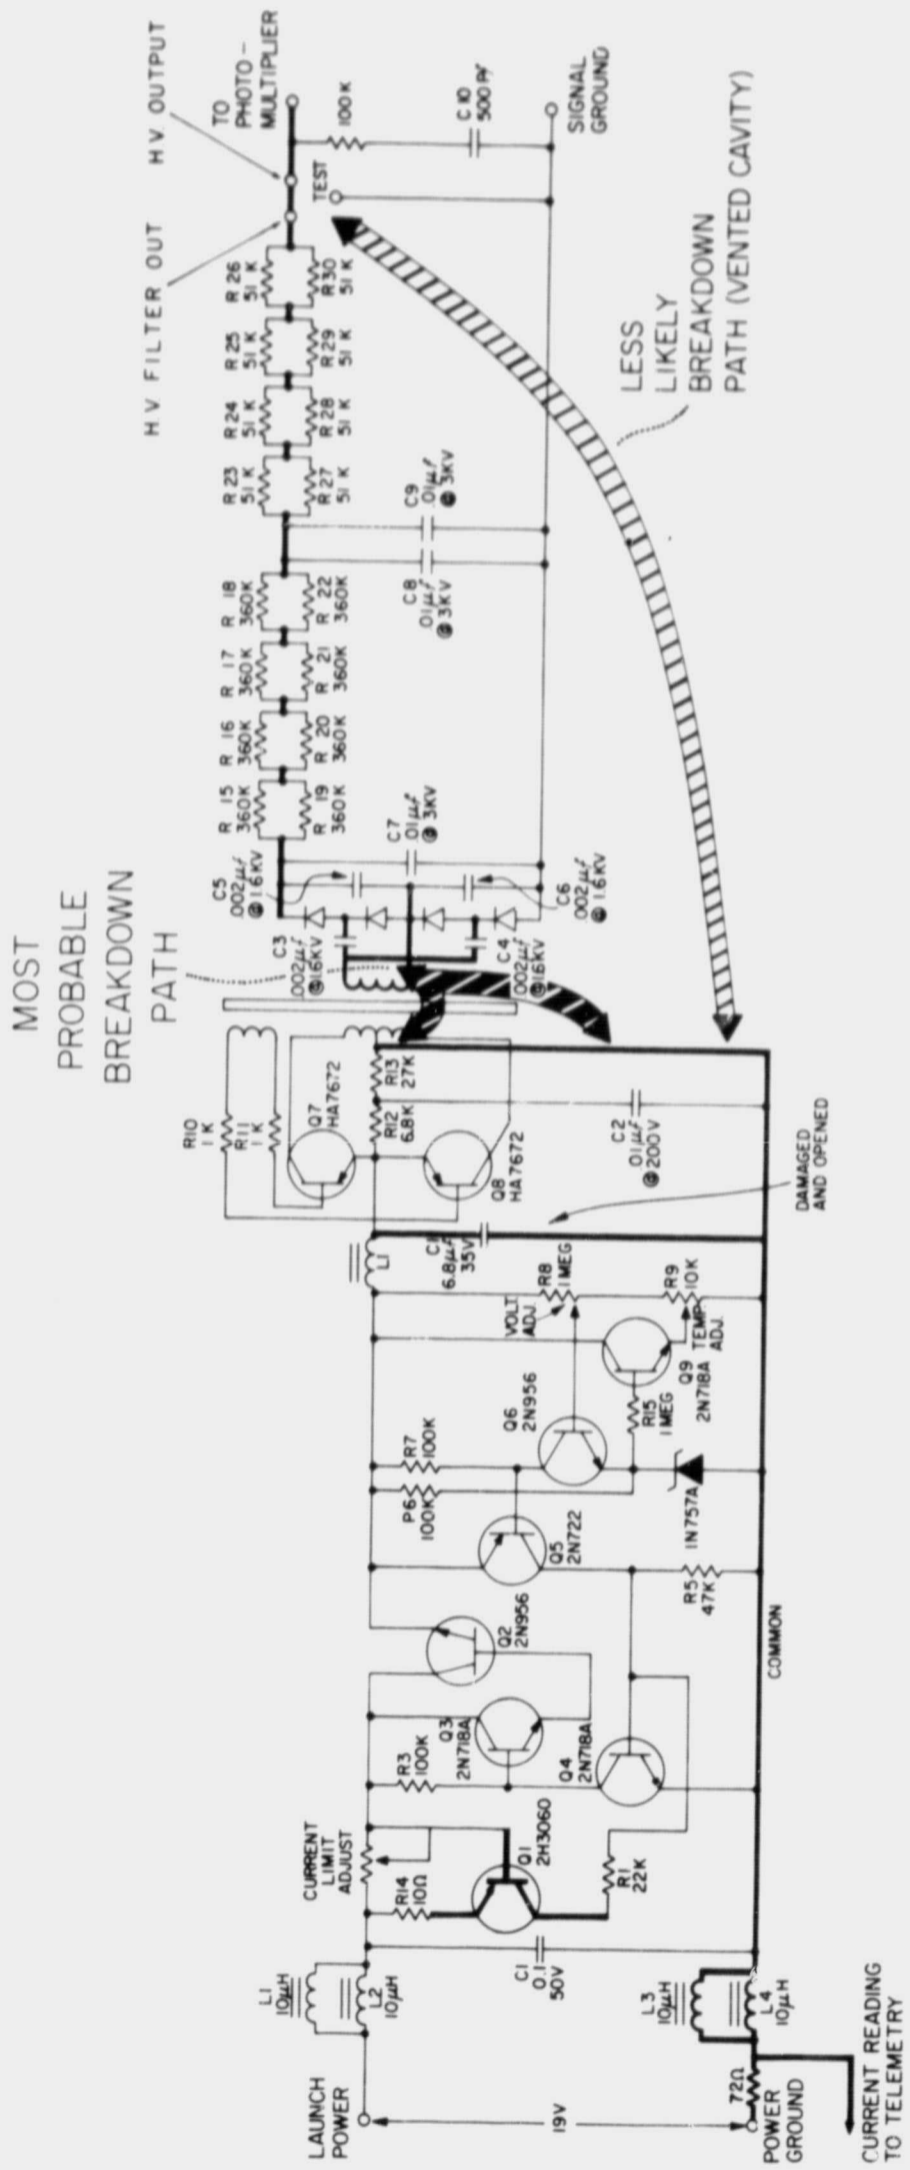
FIGURE 13 - HIGH VOLTAGE SUPPLY

Capacitor C1 is a 6.8 microfarad tantalum unit with a 35-volt rating. Although its rating is compatible with the basic circuit requirement, laboratory tests have shown that these capacitors became open circuited when a 90-volt potential of the proper polarity was applied. But capacitors of this type are also very susceptible to reversed polarity exposure and fail at a very few volts potential.

Possible involvement of the transistor Q4 (Figure 13) was not studied in the laboratory. There is reason to believe that it would have the same degree of susceptibility to transients on the common line, although it might be more apt to recover after such an event. The loss of this transistor would produce loss of regulation and oscillation of the supply. Although the detailed telemetry record might be somewhat different, the rationale of the mode definitions and transitions would not change materially if such a failure were considered; hence we will continue to refer to capacitor C1 in subsequent material.

power supply gradually leaked or diffused out of the module until its pressure reached a region favorable to corona breakdown between the leads or windings of the primary and secondary coils (see Figure 13). Then such breakdown occurred, yielding our "Mode I" condition and producing large transients on the common (return) line of the primary circuit, which were aggravated by the presence of the inductor and series resistor in that leg. These transients caused the capacitor C1 to open. As the corona breakdown condition continued, interaction with the materials of the transformer developed and reduced resistance paths, first intermittently and then more permanently, eventually producing the "Mode II" condition. Variation (with time) of the condition of these synthesized resistance paths produced the occasional reversion to Mode I observed on several later orbits. Clearly this is a theory, not a proven fact, although it is consistent with all the information available.

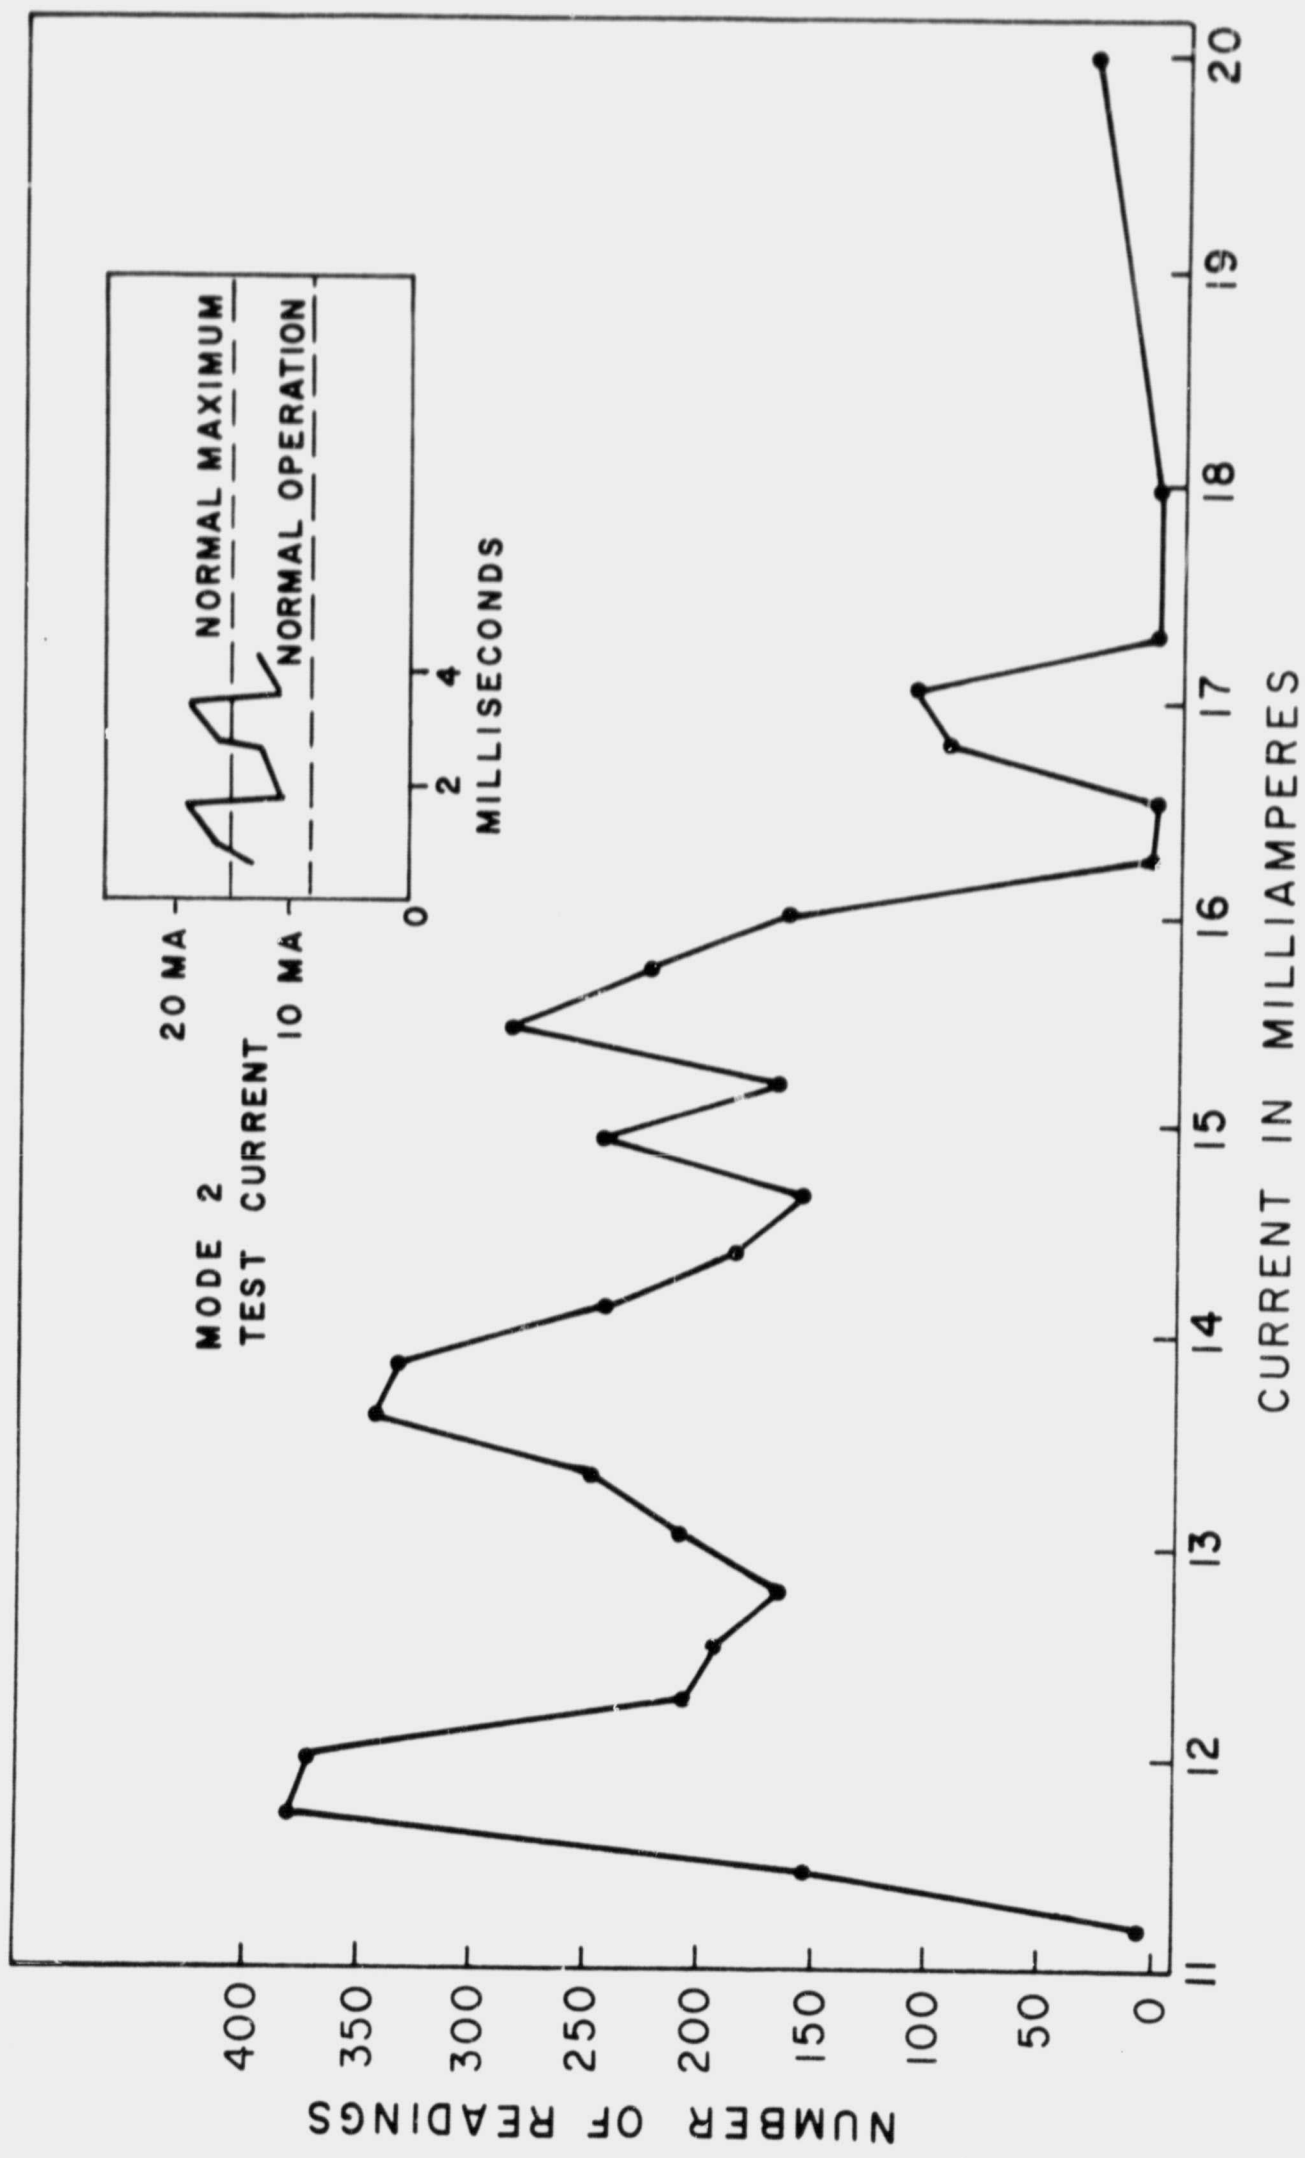
Figure 14— HV CURRENT READINGS (MODE 2)

The high voltage current readings from a total of 44 orbits (in January and February 1968) are plotted in Figure 14. During these orbits Mode II conditions prevailed in the instrument. Illustrated in the upper right corner of Figure 14 is a current waveform obtained in the prototype instrument with capacitor C1 open and a high voltage lead shorted to the common line.

As mentioned previously, the analog subcommutator data sample is a period of 160  $\mu$ sec., taken every 30.72 sec. For the purpose of this discussion it can be considered a brief sample (small compared to the period of the signal) and taken at random intervals. Although by no means conclusive, the sample distribution shown in Figure 14 can certainly be interpreted as a statistical sample of the waveform shown. Note that no readings were obtained below 11 ma (i.e., approaching the normal current range).

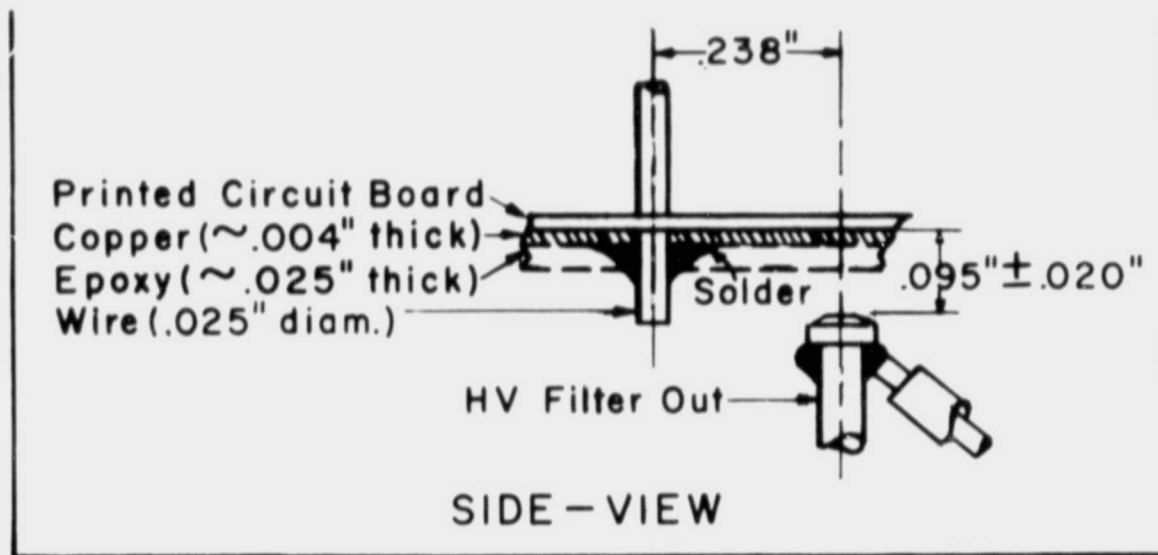
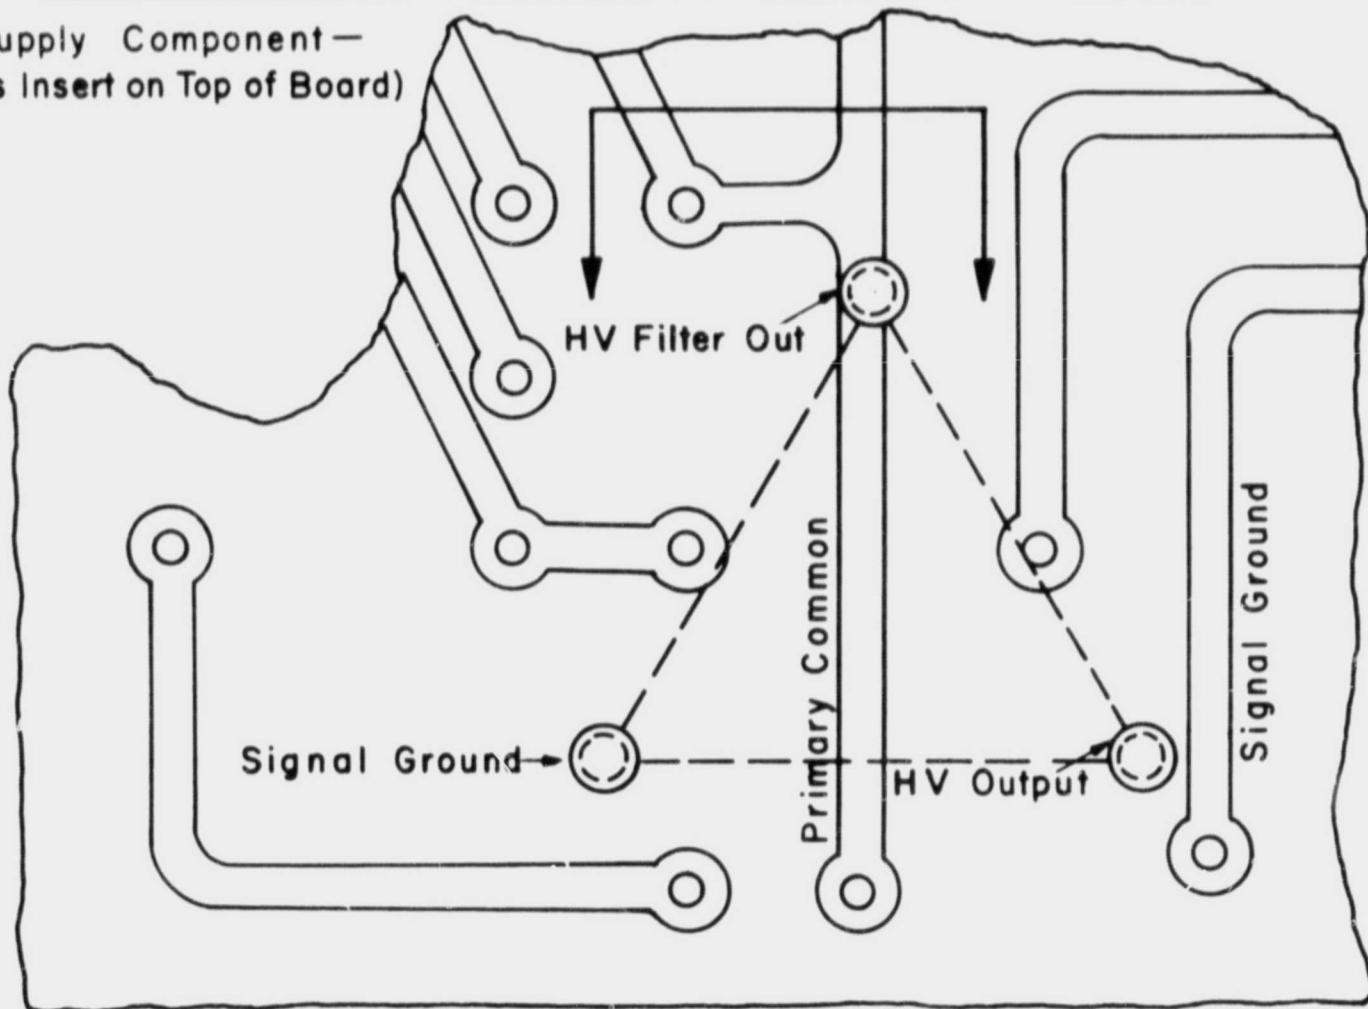
Figure 15 — HV PRINTED CIRCUIT

The other high voltage point in the flight connector is pin labeled the HV Filter out. The drawing in the upper part of Figure 15 shows a side view of this HV pin and it demonstrates the proximity of a wire connected to the primary common and to a pin from the low voltage filter module. One could speculate that outgassing within the power supply box and deterioration of the conformal epoxy coating may have produced conditions sufficient to sustain a corona discharge between the HV Filter out and an adjacent low voltage point on the primary common. However, the HV supply was vented and was not turned on until six days after launch to insure proper outgassing of the HCO instrument (this seems to be a remote possibility). Also, with this explanation of Mode I operation we lack a mechanism for the low resistance or short suspected of causing Mode II operation.
