# SOLAR SATELLITE PROJECT

INSTRUMENTATION AND FLIGHT  
PERFORMANCE OF HCO HIGH  
RESOLUTION WAVELENGTH  
SPECTROMETER

NASA AEROBEE 4.185 US  
NASA CONTRACT NSR-22-007-067

May 1969

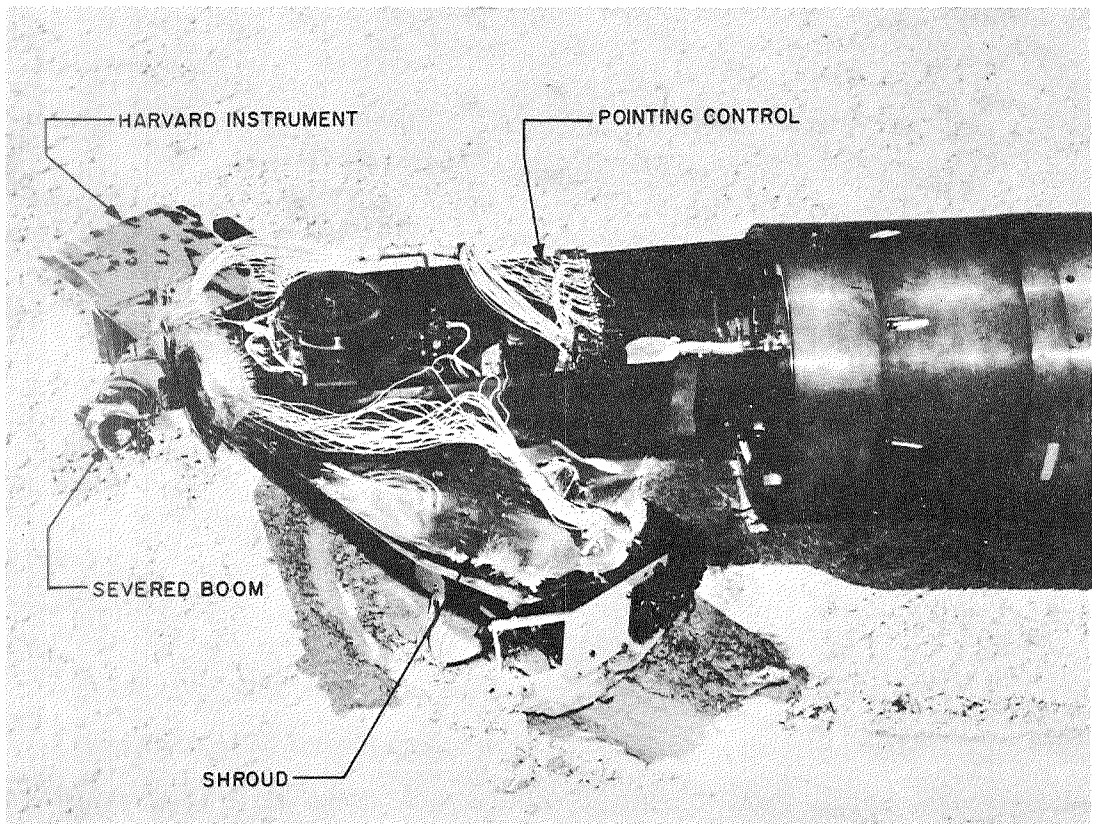
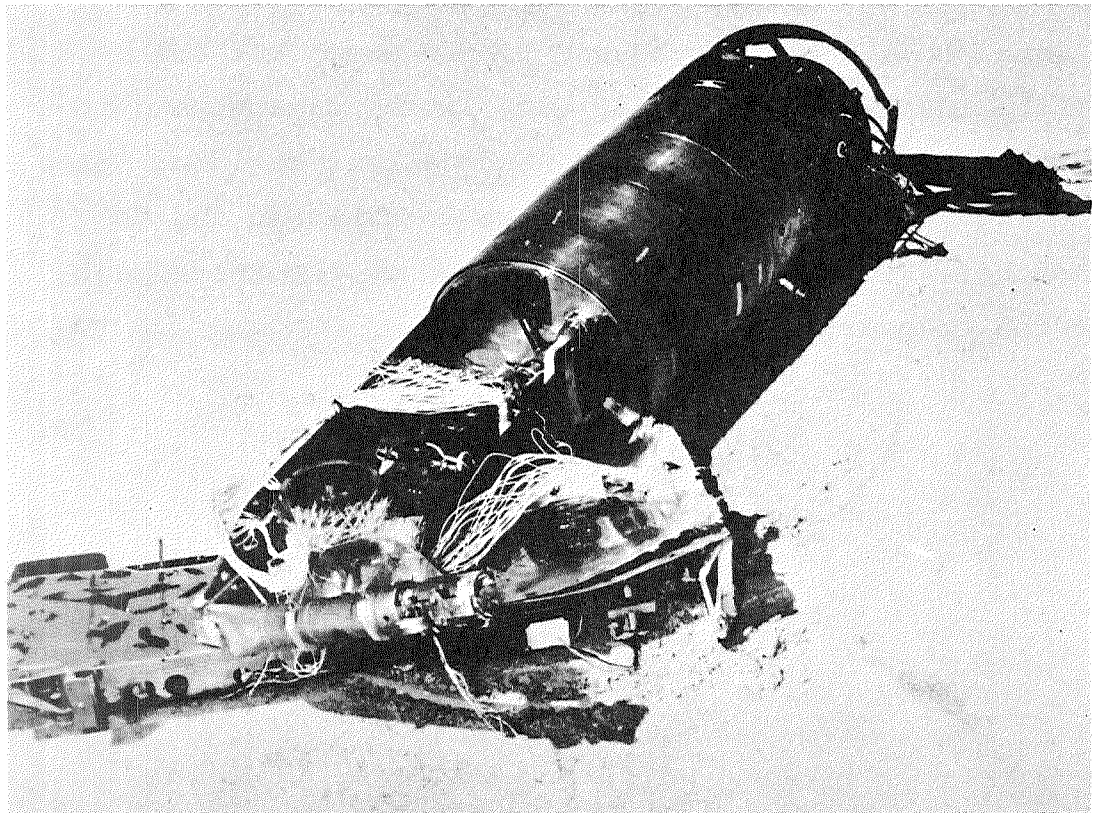
FIGURE I - INSTRUMENT AT RECOVERY

The instrument had broken out of the stowed position during reentry, probably on parachute deployment. Because of this, and because the nose cone did not come down, the instrument was subjected to surface heating, buffeting, and desert contamination. The fiberglass thermal shield was burned and ripped away, but the rest of the instrument exhibited very little damage when it was brought back to the Navy Headquarters building after the shot. The instrument will be refurbished and re-launched. (Figure 1 shows two views of the instrument at the recovery site.)

- A. The nose cone had not restowed and was separated from the pointing control prior to impact.
- B. The heat shield on the instrument was missing.
- C. The nose cone lift motor was missing
- D. The lift support tube had been bent at its base about 70 degrees during reentry or on impact.
- E. The instrument had broken out of the stowed position, probably on parachute deployment.
- F. There was enough heating during reentry to melt some vinyl tubing, cable clamps, spot ties and soldered electrical connections.
- G. There was no evidence of electrical arcing in the pointing control or instrument.

Examination of the nose cone assembly was made with two items very apparent. The first was that the joint between the lift tube and the upper nose cone casting was loose and the retaining roll pins had worked loose. This joint is assembled as a ring fit and the roll pins maintain position both laterally and longitudinally in the joint. The next point of examination was in the area of the upper casting on the lift support tube. This casting is a shrink fit to the support tube and is held in place with four steel dowel pins. The lift motor with its gear box and pinion gear is attached to this casting. The examination showed that this casting was loose on the support tube and two dowel pins were missing. One of the remaining dowel pins had moved far enough in toward the center of the casting to prevent passage of the nose cone tube when it attempted to drive down.

The nature of the damage and especially the loosening of the nose cone joint and the upper support tube joint showed that the nose cone must have been whipping violently while in the raised position. A correlating factor to this whipping motion was found in the flight data. It was determined during preflight ground tests that maximum nose cone motion, or its point of resonance, occurred with a rocket spin rate of 2.4 to 2.5 rps. From the flight data it was found that the rocket roll rate after the pointing control had acquired the sun was 2.48 rps. Hence, it could be expected that the nose cone motion due to vehicle roll rate was at the maximum.

5) To prevent yoke pins from loosening, the yoke has been redesigned.

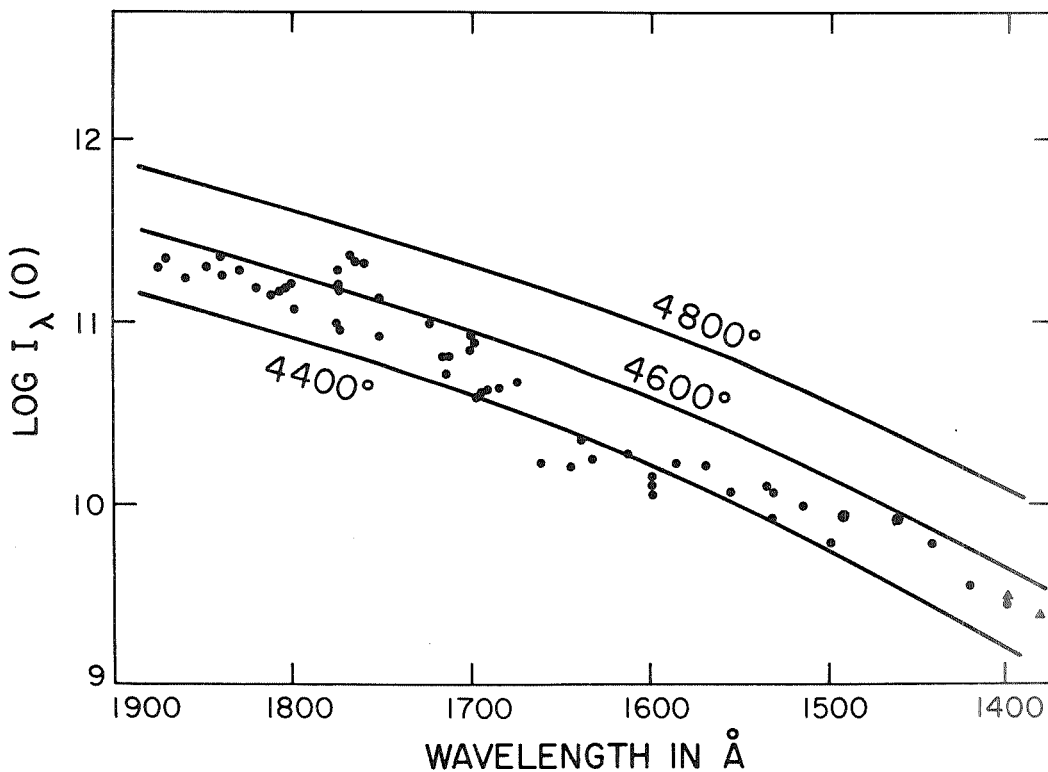
Figure A-1 shows the data ( $\log_{10}$  ergs/cm<sup>2</sup> sec cm steradian) plotted against wavelength. The solid curves represent the values obtained for an equivalent black body of temperature 4400°K, 4600°K, and 4800°K. Included on the graph are two values, indicated by triangles, from

our OSO-IV spectrometer-spectroheliometer (Goldberg et al, 1969). It was indeed encouraging to note that at 1400Å, the intensities from both instruments are in substantial agreement.

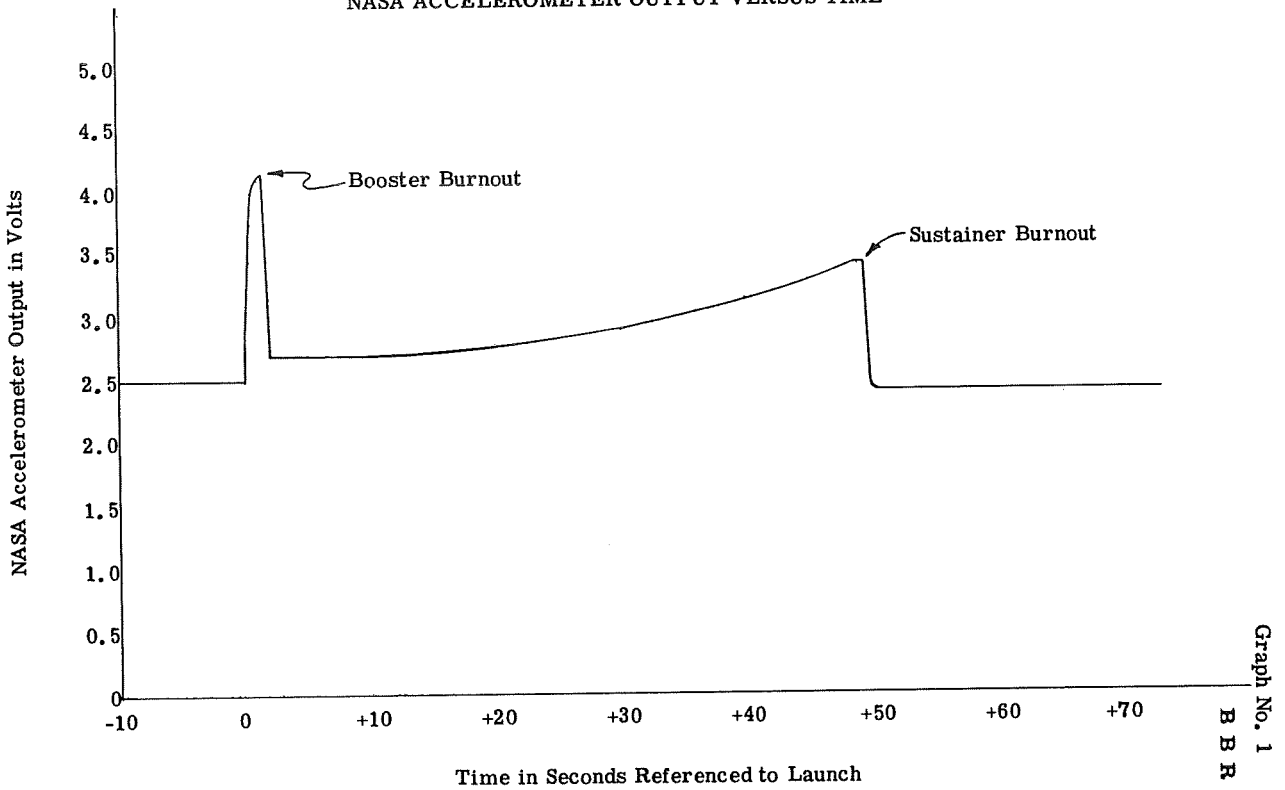
NASA 4, 185 US/SPC 324 D/B  
 NASA ACCELEROMETER OUTPUT VERSUS TIME

Graph No. 1 is a plot of the NASA accelerator output versus time from lift-off to T + 73 seconds. The data was on a shared telemetry channel which was switched at T + 73 seconds. The output is plotted as telemetered voltage since the transducer calibration was not available at BBRC. It should be also noted that the vehicle sustainer chamber pressure transducer did not operate properly during this flight and therefore no data are available.

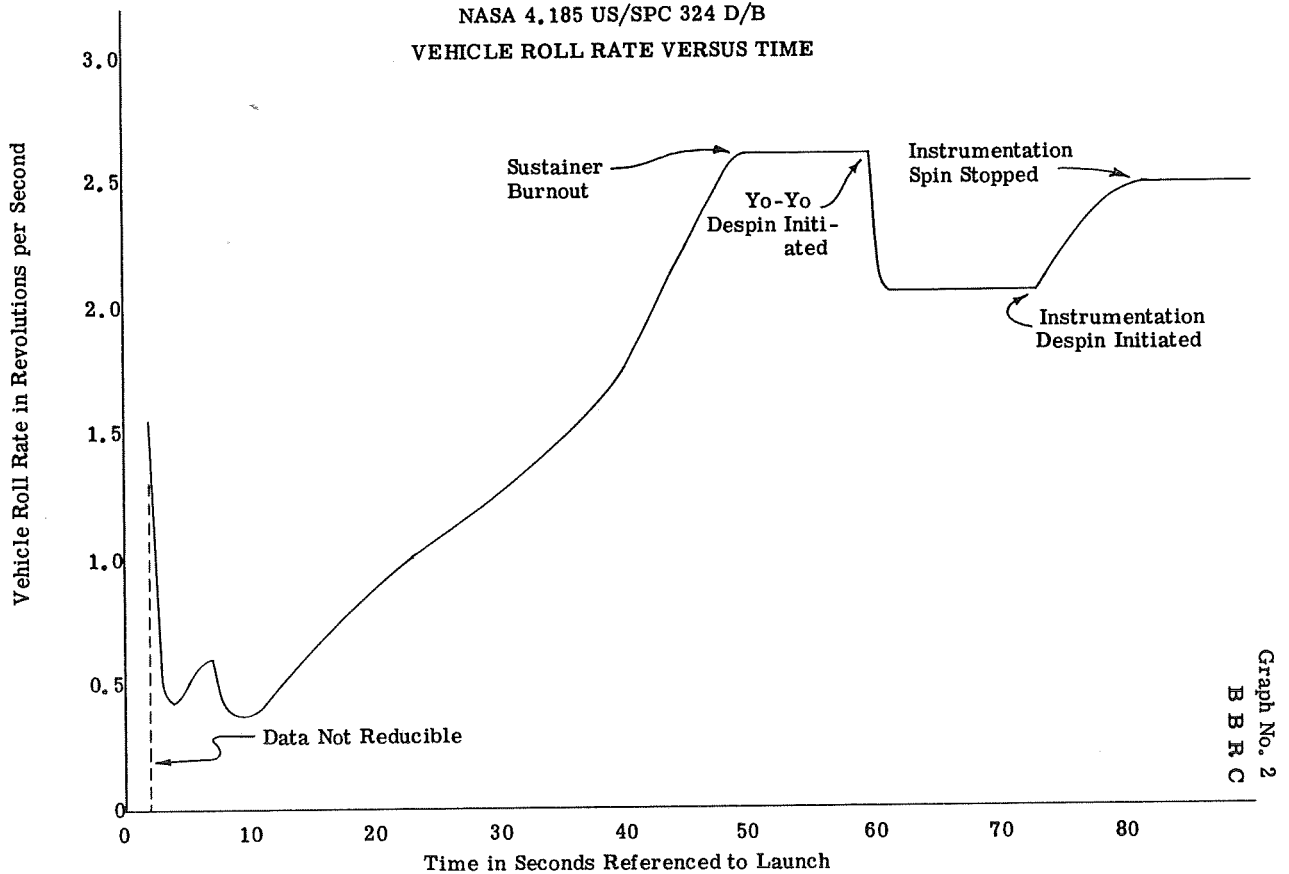
NASA 4, 185 US/SPC 324 D/B  
 VEHICLE ROLL RATE VERSUS TIME

BBRC claims that the vibrations caused by the spin rate of the rocket affected the pointing control. Preflight ground tests had determined that the maximum nose cone motion, or its point of resonance, occurred with a rocket spin rate of 2.4 rps to 2.5 rps. The flight plan called for a spin rate between 1.8 to 2.0 rps.

Flight data show the rocket spin rate to have been 2.5 rps after burnout, 2.0 rps after yo-yo release, and finally 2.48 rps after the apron stage was despun. There-

Graph No. 2 is a plot of the vehicle roll rate versus time from T + 2.0 seconds to T + 90 seconds. The roll rate of the vehicle at sustainer burnout was 2.60 rps, which was maintained until Yo-Yo despin initiation occurred at T + 59.7 seconds, despinning the vehicle to 2.05 rps. The despin of the upper payload section then increased the vehicle roll rate to the final figure of 2.48 rps.

4) Excessive vibration caused by rocket spin rate proved a problem during the last flight. Therefore, a different yo-yo despin system will be used on the

next rocket in order to control the spin rate and the vibration. The 30% yo-yo system used on the last flight will be replaced by a 50% yo-yo system.
