NASA CR-66814

COMPREHENSIVE REPORT
ON
NASA ROCKET MOTOR DEFECTS INVESTIGATION

VOLUME II - TABLES AND FIGURES

COMPREHENSIVE REPORT
ON
NASA ROCKET MOTOR DEFECTS INVESTIGATION
FROM AUGUST 1966 TO JUNE 1968
by R. B. Enie and C. R. Hitt, Jr.

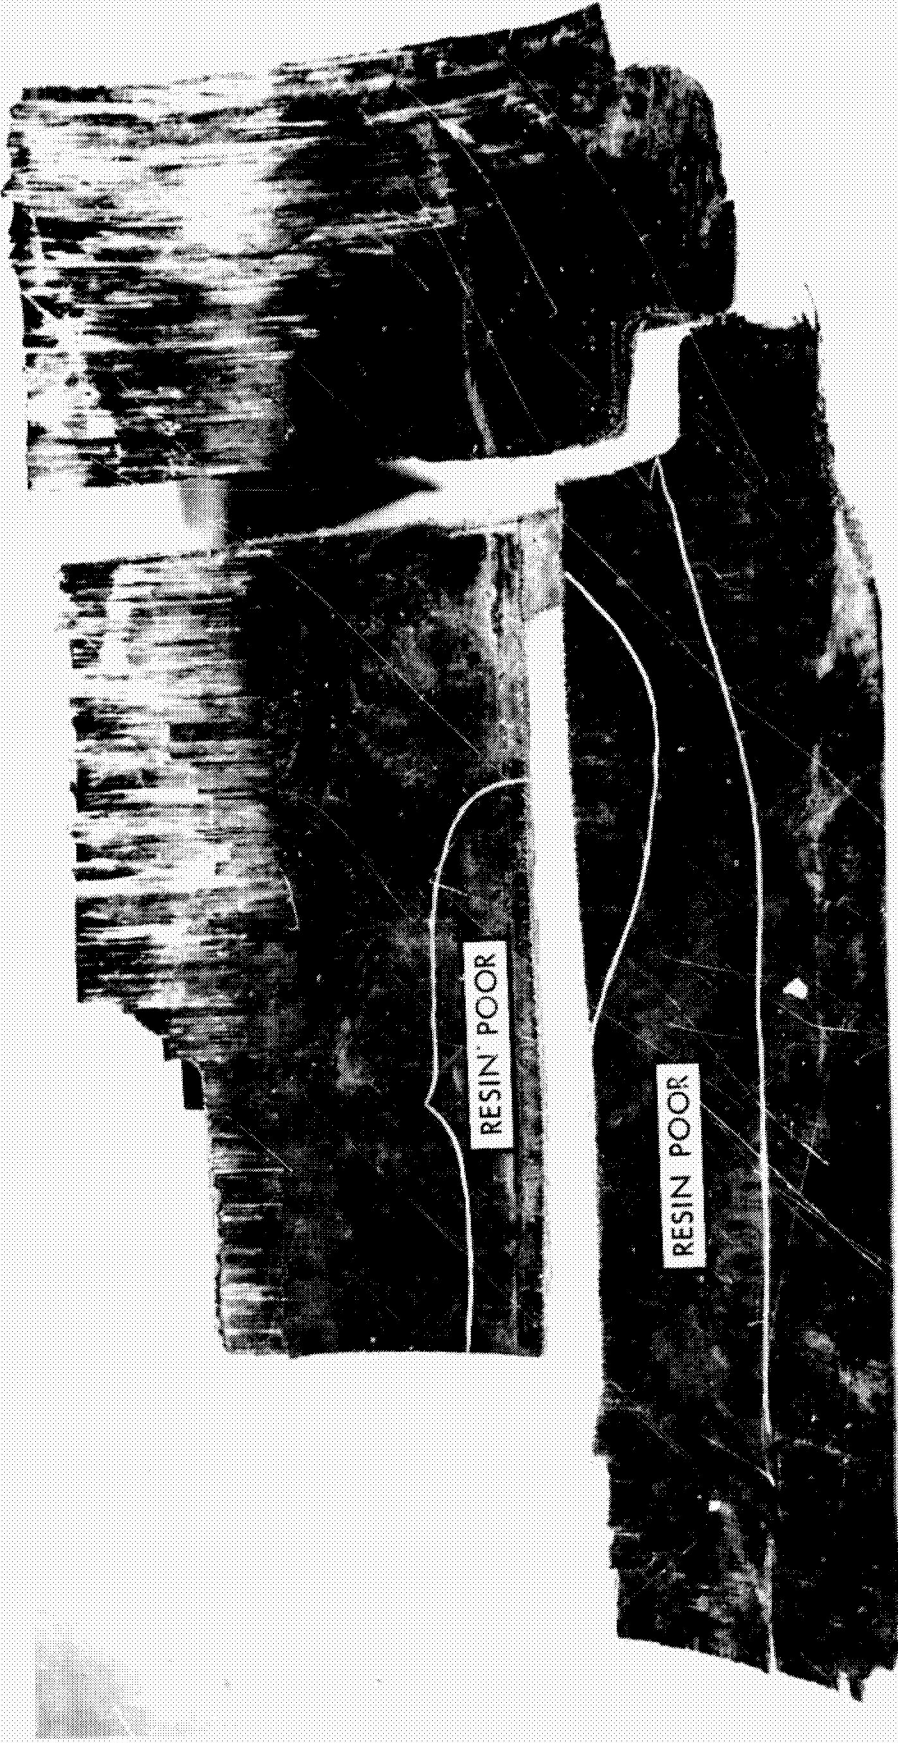
FIGURE 36A - TOP VIEW OF PATCH REPAIR ON NPP-425 (A6)

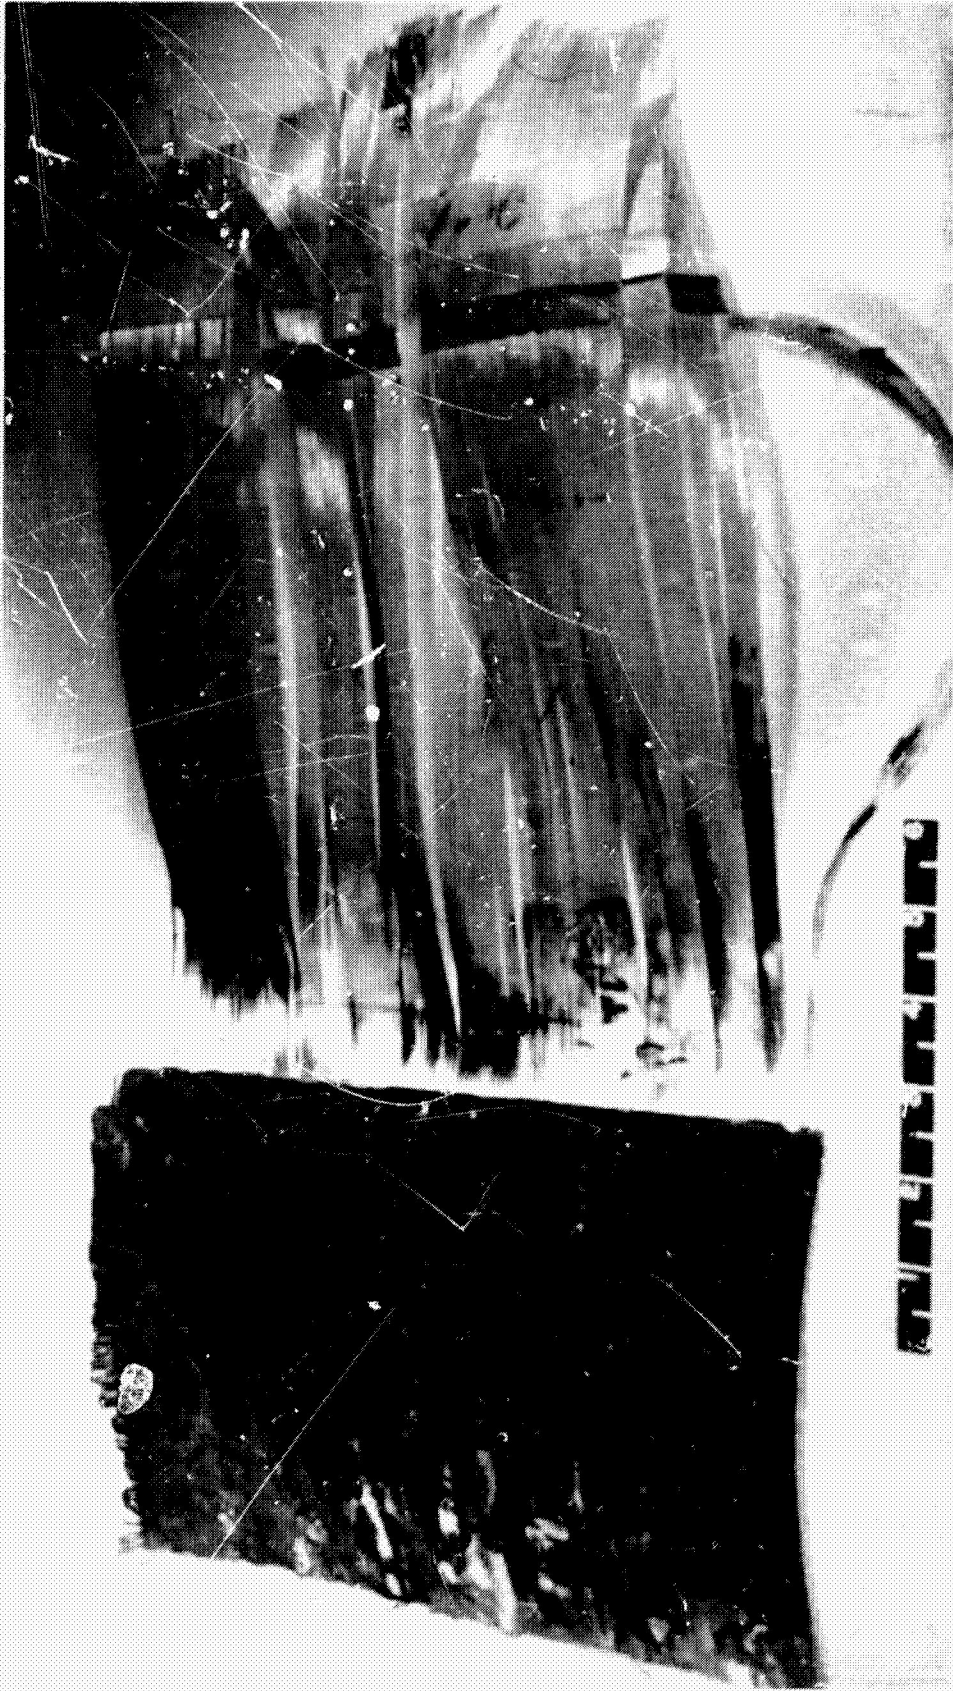
FIGURE 38 - POST-FIRING PICTURE OF Y-195 (A10)

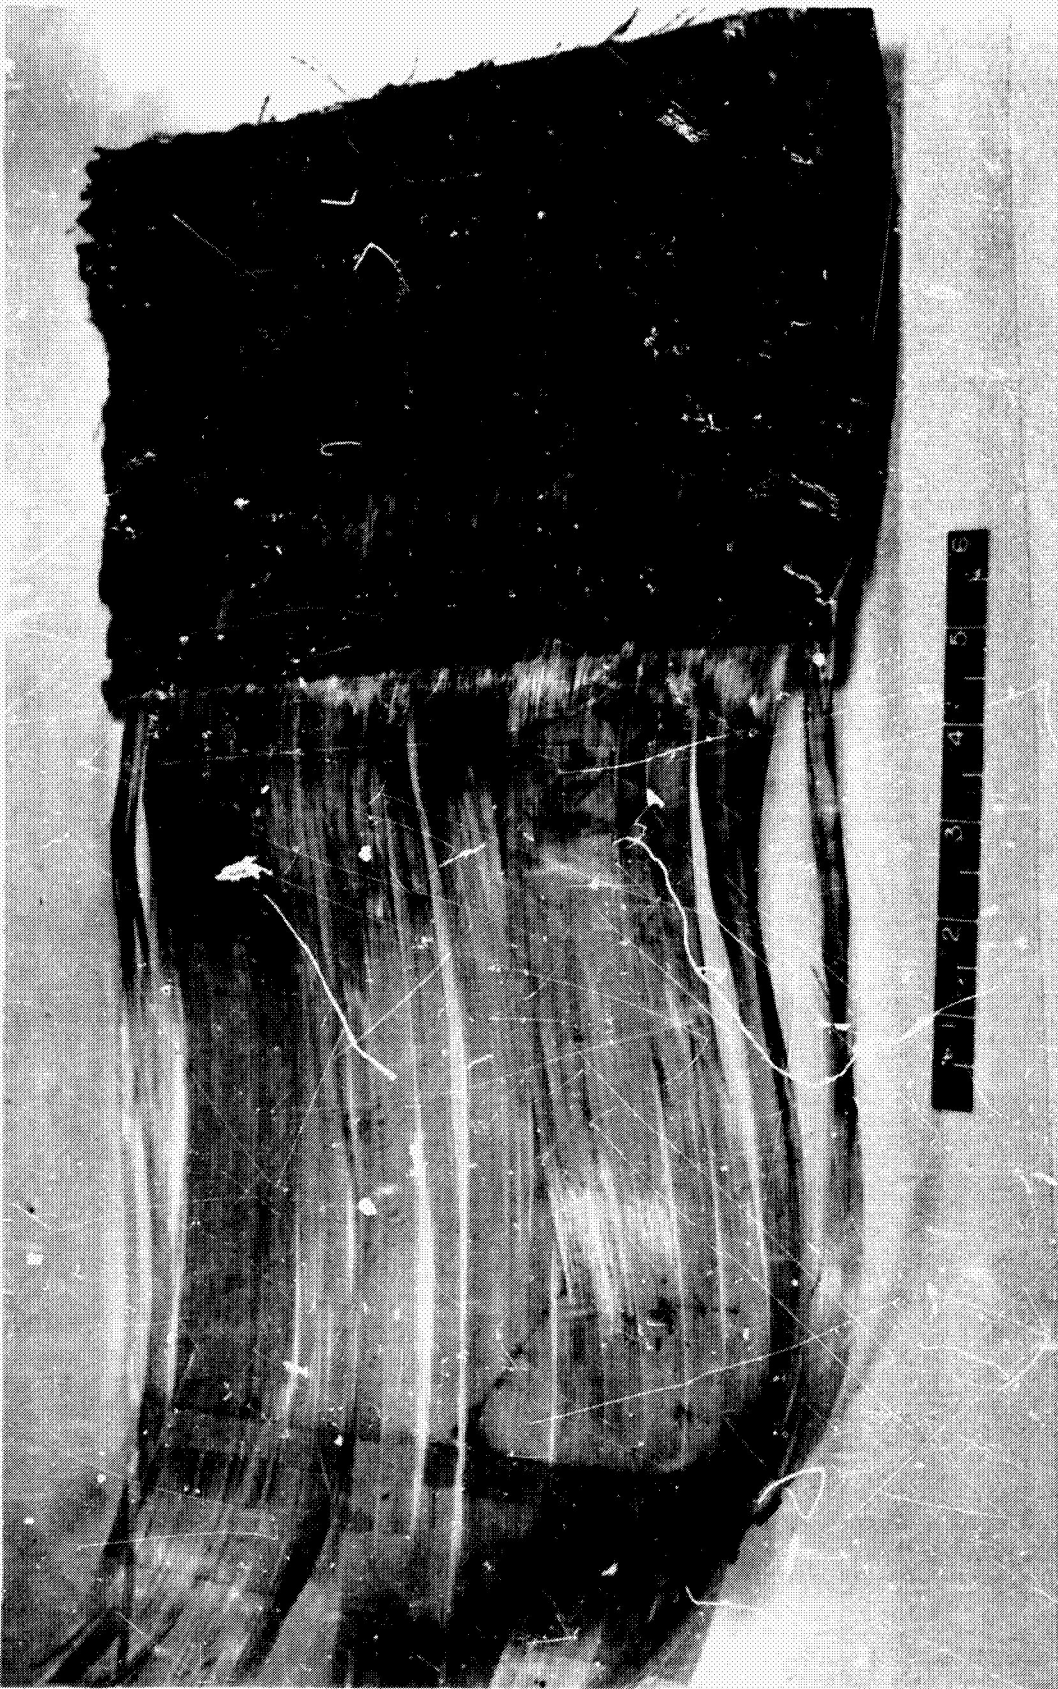
FIGURE 39 - TOP VIEW OF ONE-HALF OF THE PATCH REPAIR ON Y-195 (A10)

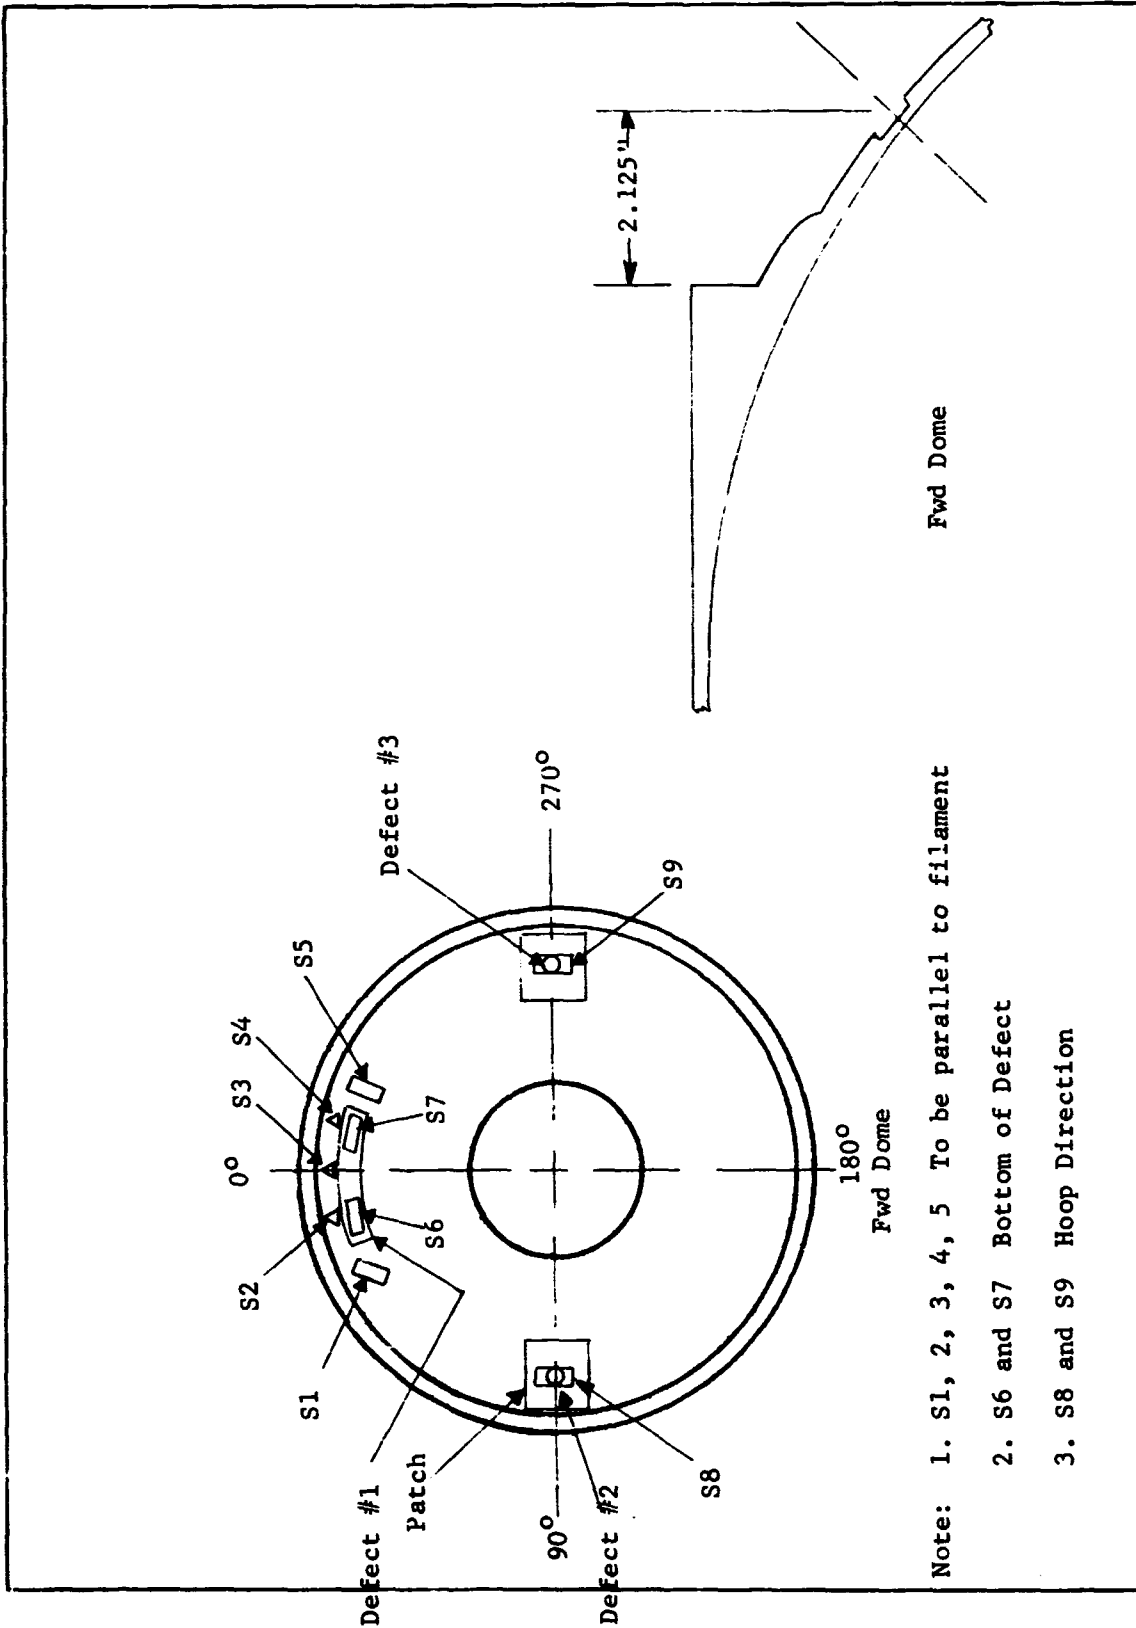
FIGURE 79 - POST-FIRE CYLINDRICAL DEFECTS ON NPP-257 (A5)

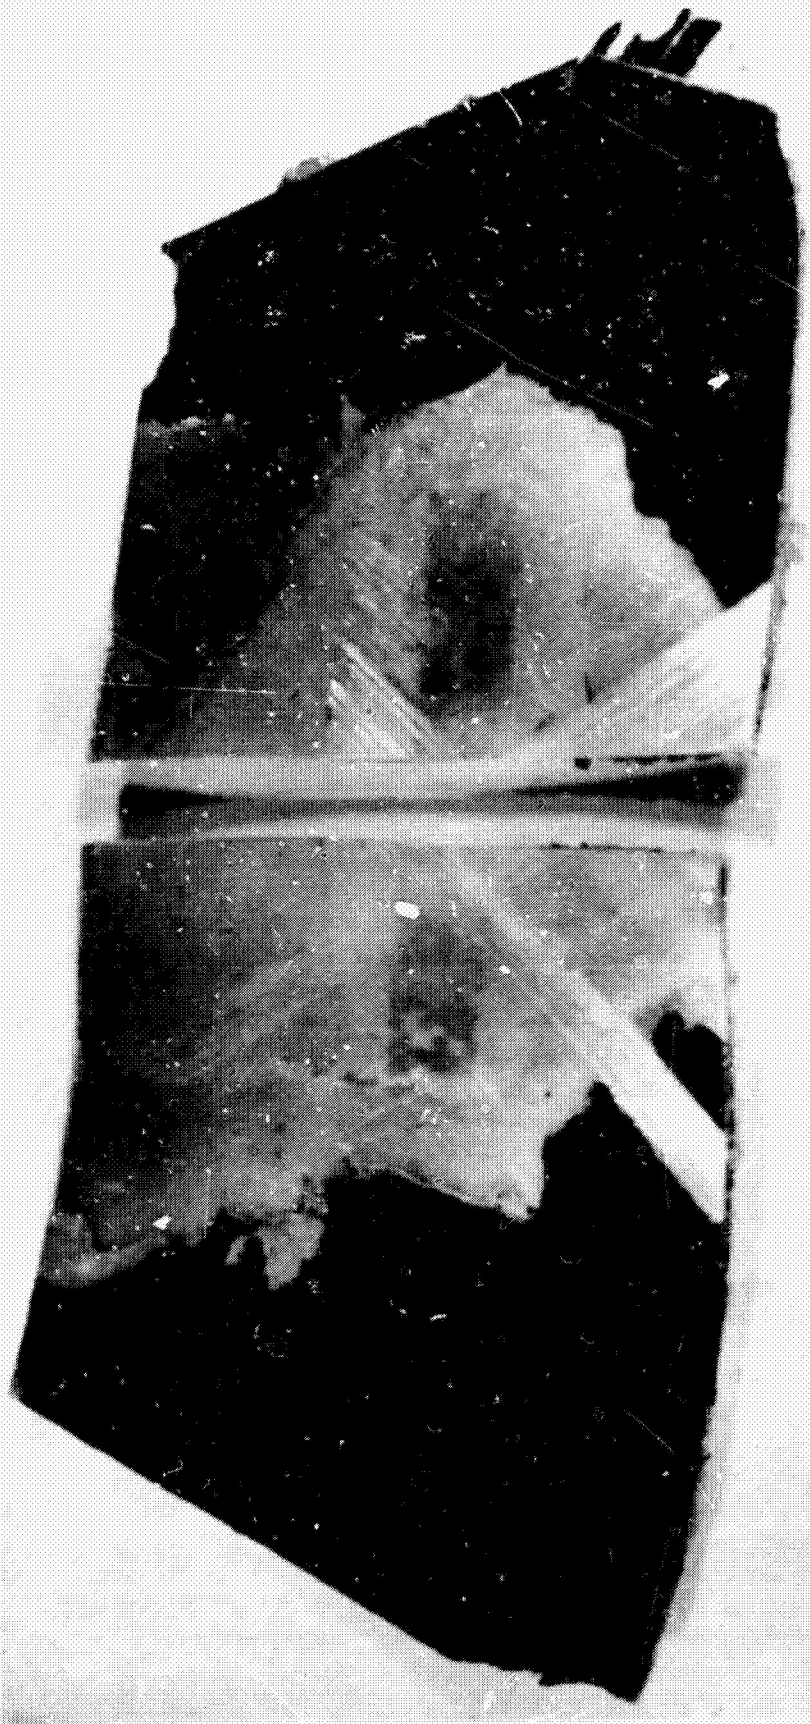
FIGURE 82 - TOP VIEW OF FORWARD DOME DEFECT ON NPP-454 (A6)

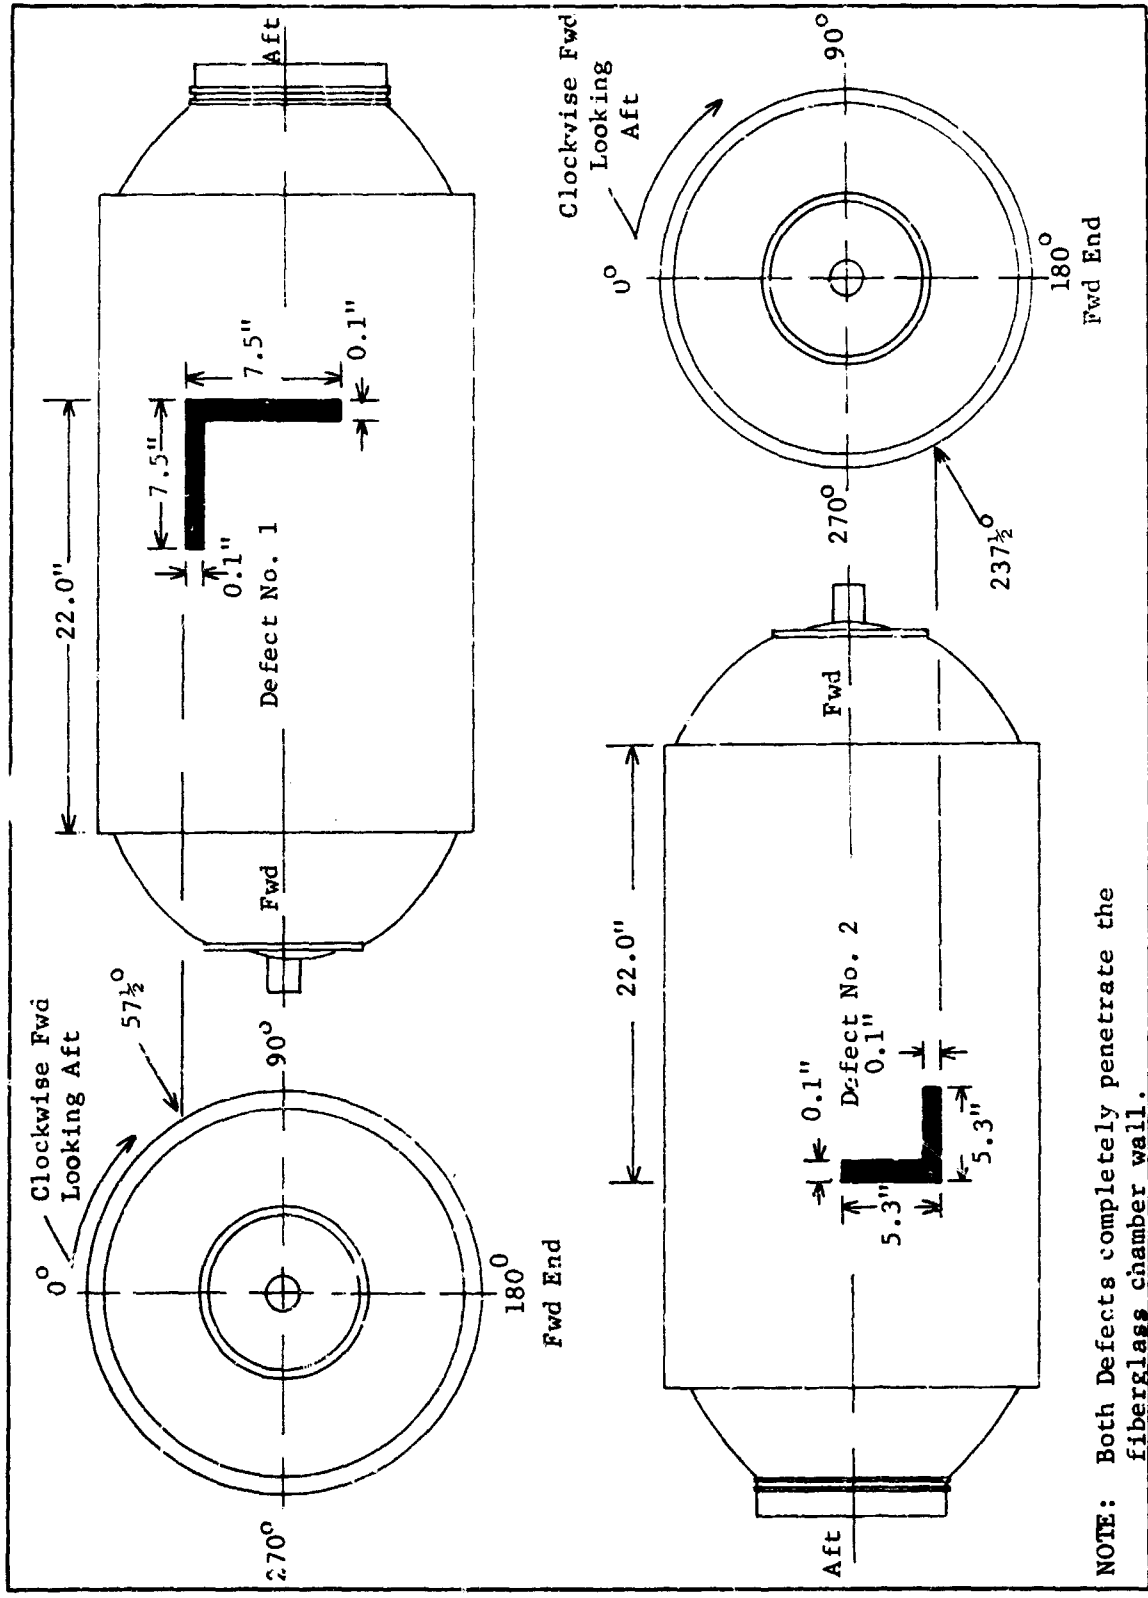
FIGURE 94 - DEFECT NO. 1 ON X248 A6 S/N - 453 - CYLINDRICAL SECTION

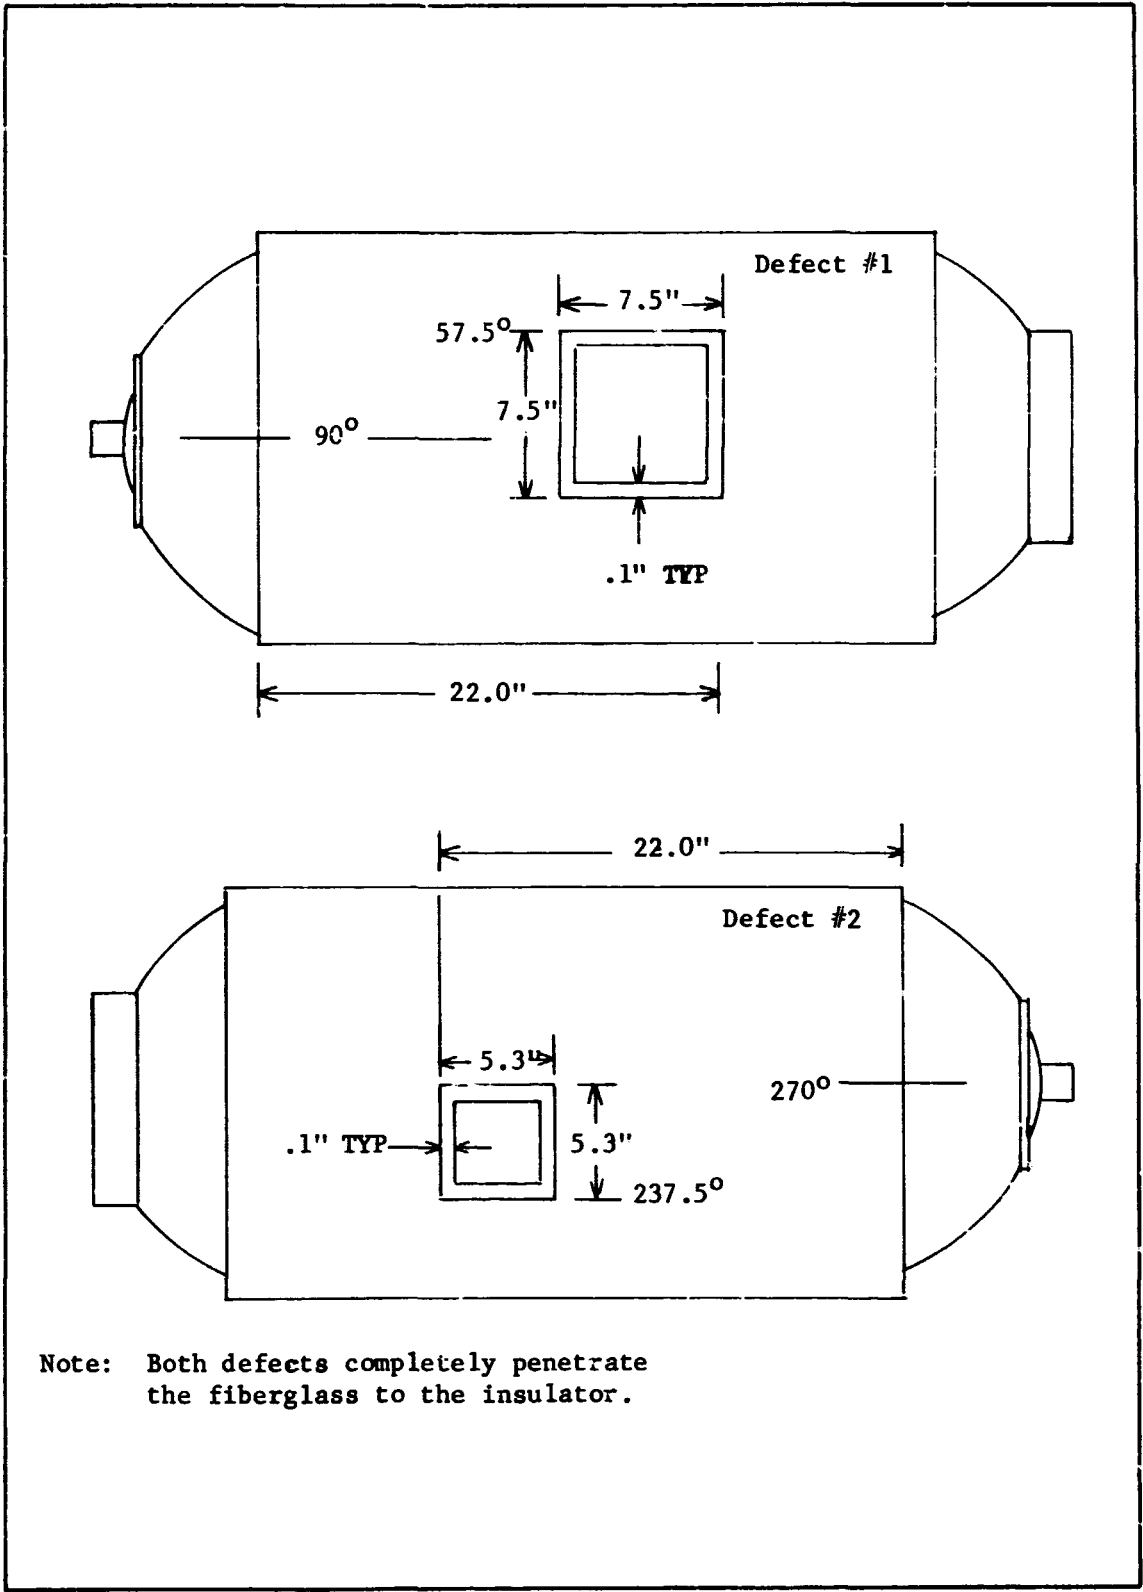
FIGURE 101 - DEFECT NO. 2 MACHINED IN X248 A6 S/N NPP- 463
