EIGHTH QUARTERLY REPORT
EVALUATION TESTING OF PROTECTIVE
COATINGS ON REFRACTORY METALS

September 1969

CONTRACT NAS 7-460

TRW SYSTEMS GROUP
One Space Park Redondo Beach California 90278

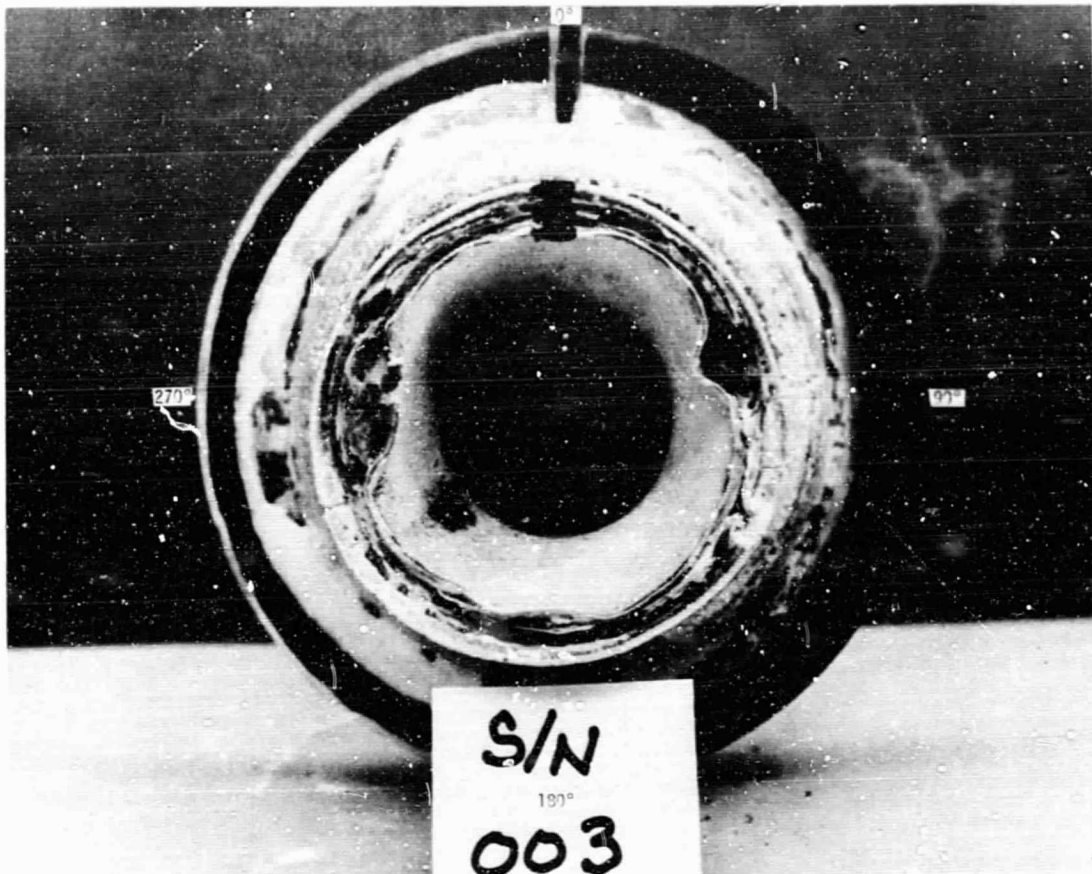
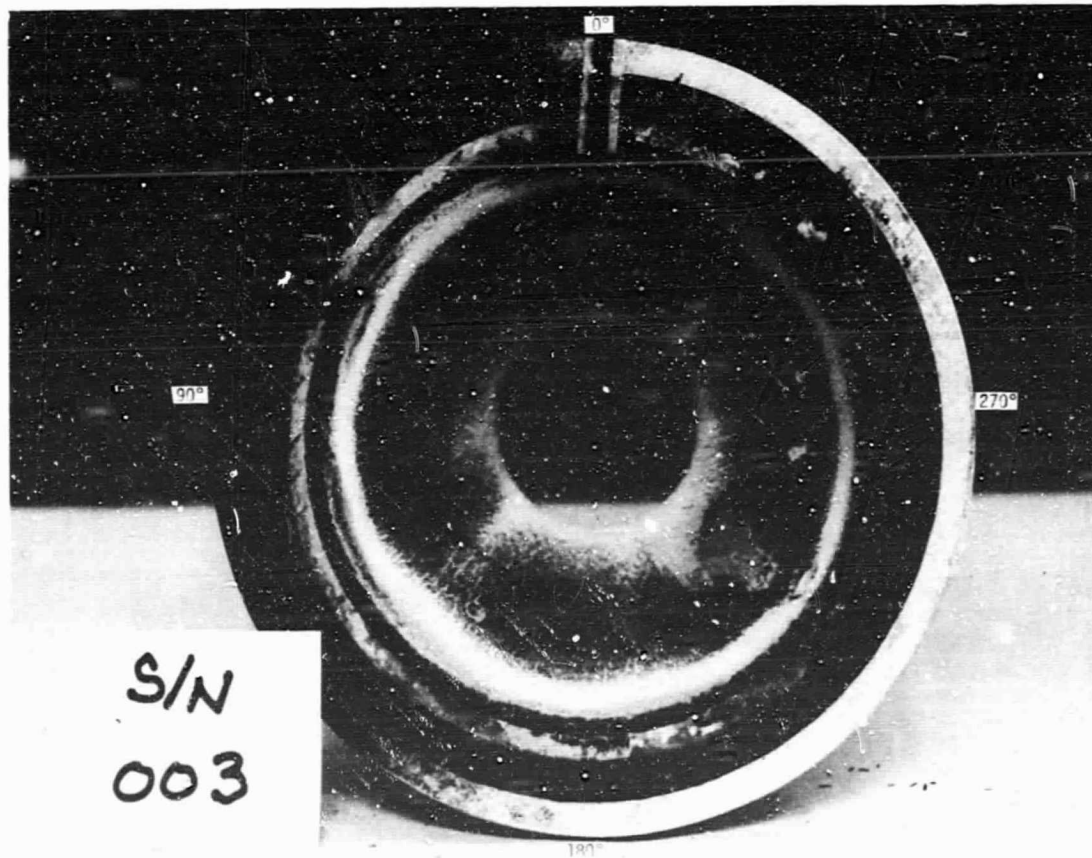
Figure 1. Post-Test Condition of S/N 003 - 1000 sec at 4500°F

| TASK | MATERIAL TYPE OR PURPOSE OF TESTS | TEST DESCRIPTION | | | | SPECIMEN FAILURE COMMENTS |
|--|---|---|---|---|---|---|
| S/N003 | HF-20Ta Clad, Ta Barrier | .854 | 145 | 1.20 | 144 | Nozzle in servicable condition after 1000 sec. duration at 4500°F. Gross clad separation at exit. Craters are starting to develop on convergent section inside & outside. |

| Test Specimen S/N | Coating | Target Combustion Temperature | Firing Time sec. | No. of Starts | Comments |
|---|---|---|---|---|---|
| 003 | Hf-20Ta Clad, Ta Barrier | 4500°F | 10 | 1 | Nozzle in serviceable condition. Gross clad separation at exit. Craters are developing on convergent section inside and outside |

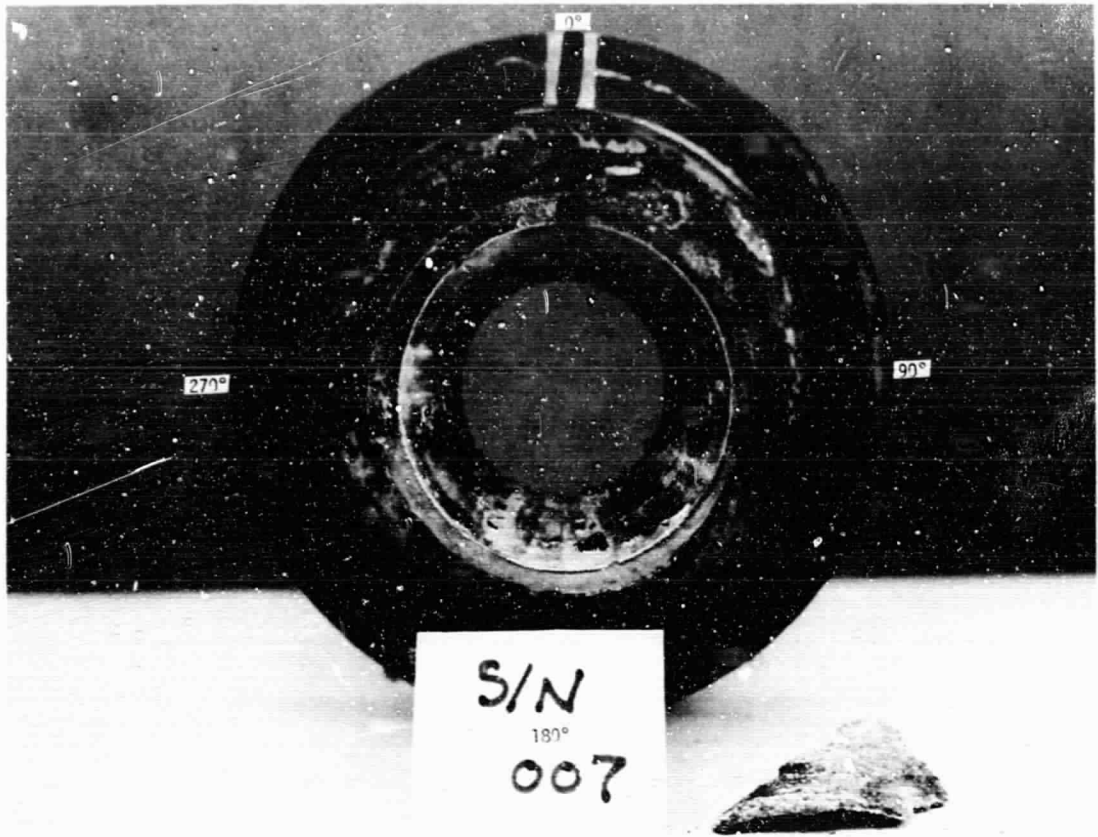
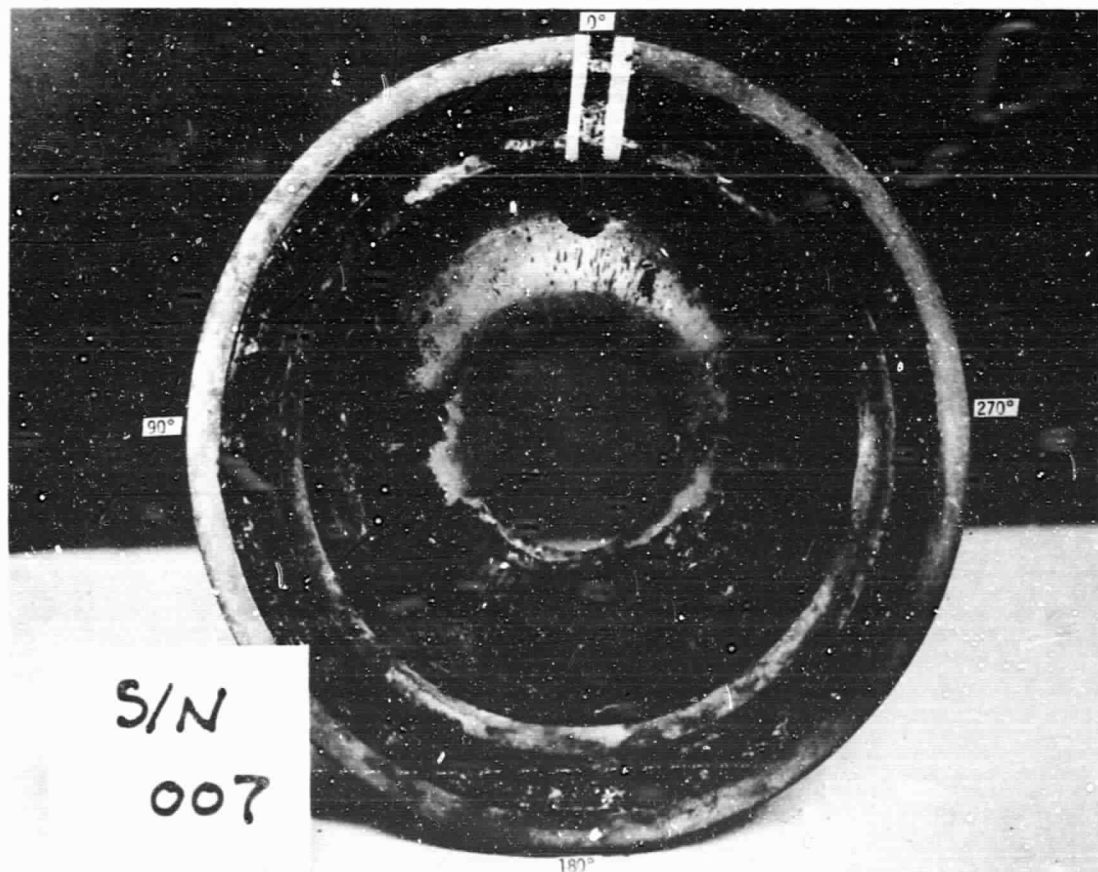
Figure 2. Post-Test Condition of S/N 007 - 63 sec at 4500°F

| TASK | MATERIAL TYPE OR PURPOSE OF TESTS | Target Combustion Temperature of 4000°F | | Target Combustion temperature of 4500°F | | SPECIMEN FAILURE COMMENTS |
|---|---|--|---|--|---|--|
| S/N 007 | Ir | .886 | 144 | 1.20 | 145 | Nozzle burnout at throat at 120° orientation after 63 sec. duration at 4500°F. Extensive substrate oxidation on inside and outside. Much of exterior coating has spalled off and remaining coating is badly cracked and blistered. |

| Test Specimen S/N | Coating | Target Combustion Temperature | Firing Time sec. | No. of Starts | Comments |
|---|---|---|---|---|---|
| 007 | Ir | 4500°F | 10 | 1 | Nozzle burnout at throat at 120° orientation. Extensive substrate oxidation on inside and outside. Much of exterior coating has spalled off and remaining coating is badly cracked and blistered. |

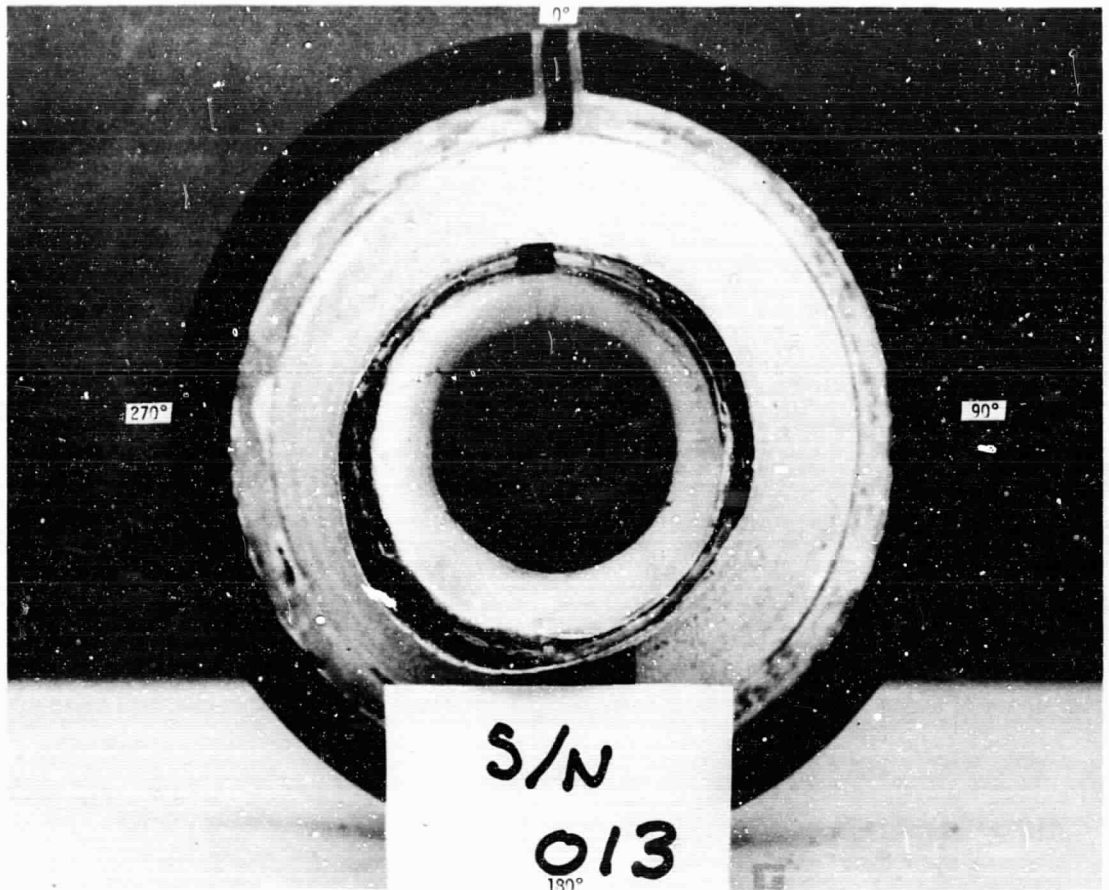
Figure 3. Post-Test Condition of S/N 013 - 1000 sec at 4500°F

| TASK | MATERIAL TYPE OR PURPOSE OF TESTS | Target Combustion Temperature of 4000°F | | Target Combustion temperature of 4500°F | | SPECIMEN FAILURE COMMENTS |
|---|---|--|---|--|---|--|
| S/N 013 | Hf-20Ta-clad, Cb barrier | 1.55 | 135 | 1.19 | 144 | Nozzle in good condition after 1000 sec. duration at 4500°F. Some clad separation at exit but otherwise cladding is intact. |

| Test Specimen S/N | Coating | Target Combustion Temperature | Firing Time sec. | No. of Starts | Comments |
|---|---|---|---|---|---|
| 013 | Hf-20Ta Clad, Ta Barrier | 4500°F | 5 | 1 | Nozzle in good condition. Some clad separation at exit but otherwise cladding is intact. |

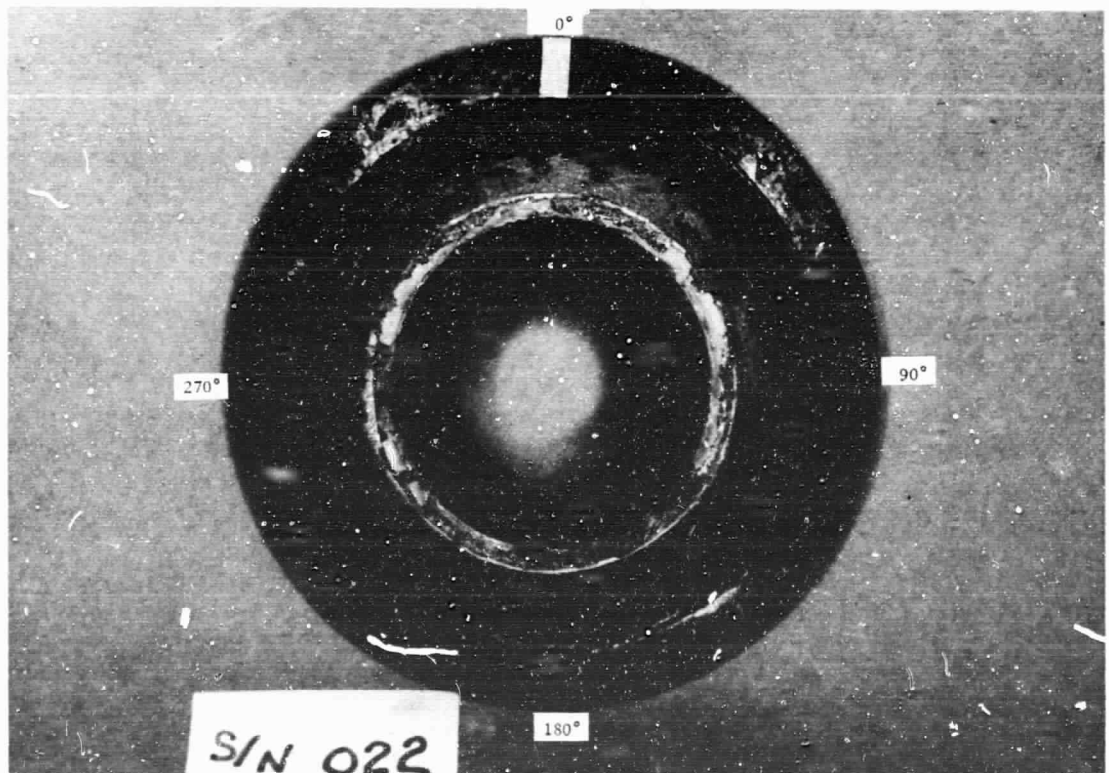
Figure 4. Post-Test Condition of S/N 022 - 480 sec at 4000°F

| TASK | MATERIAL TYPE OR PURPOSE OF TESTS | Target Combustion Temperature of 4000°F | | Target Combustion temperature of 4500°F | | SPECIMEN FAILURE COMMENTS |
|---|---|--|---|--|---|--|
| S/N 022 | Ir/Re | .85 | 144 | DNA | DNA | Extensive spalling of coating on exterior and subsequent oxidation of substrate after 480 sec. duration at 4000°F. Internal spalling of coating at throat. |

| Test Specimen S/N | Coating | Target Combustion Temperature | Firing Time sec. | No. of Starts | Comments |
|---|---|---|---|---|---|
| 022 | Ir/Re | 4000°F | 10 | 1 | Extensive spalling of coating on exterior and subsequent oxidation of the substrate. Internal spalling of coating at throat region from 170° to 260°. |

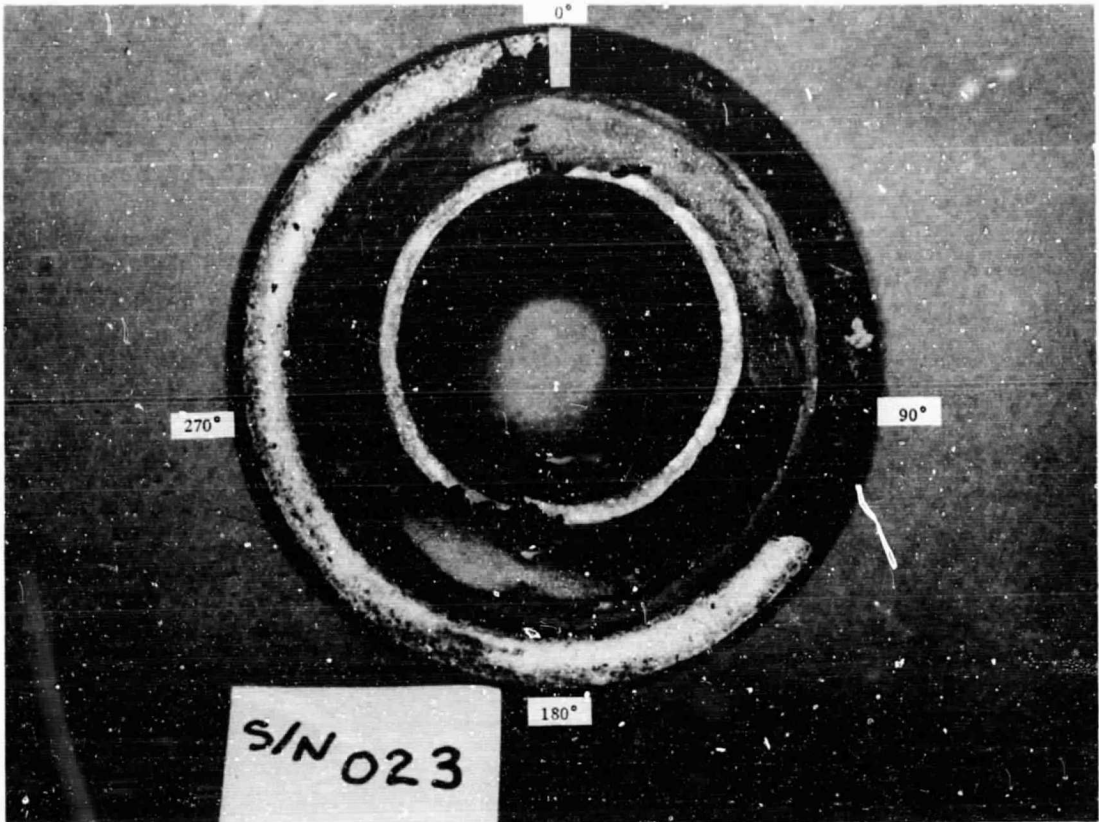
Figure 5. Post-Test Condition of S/N 023 - 670 sec at 4000°F

| TASK | MATERIAL TYPE OR PURPOSE OF TESTS | Target Combustion Temperature of 4000°F | | Target Combustion temperature of 4500°F | | SPECIMEN FAILURE COMMENTS |
|---|---|--|---|--|---|--|
| S/N 023 | Ir/Re | .89 | 151 | DNA | DNA | Nozzle burnout at throat at 200° orientation after 670 sec. duration at 4000°F. Gross coating spalling and oxidation of substrate on exterior. |

| Test Specimen S/N | Coating | Target Combustion Temperature | Firing Time sec. | No. of Starts | Comments |
|---|---|---|---|---|---|
| 023 | Ir/Re | 4000°F | 10 | 1 | Burnout downstream of throat at 200°. Gross coating spalling and oxidation of substrate on exterior. Internal coating surfaces are in good condition. |

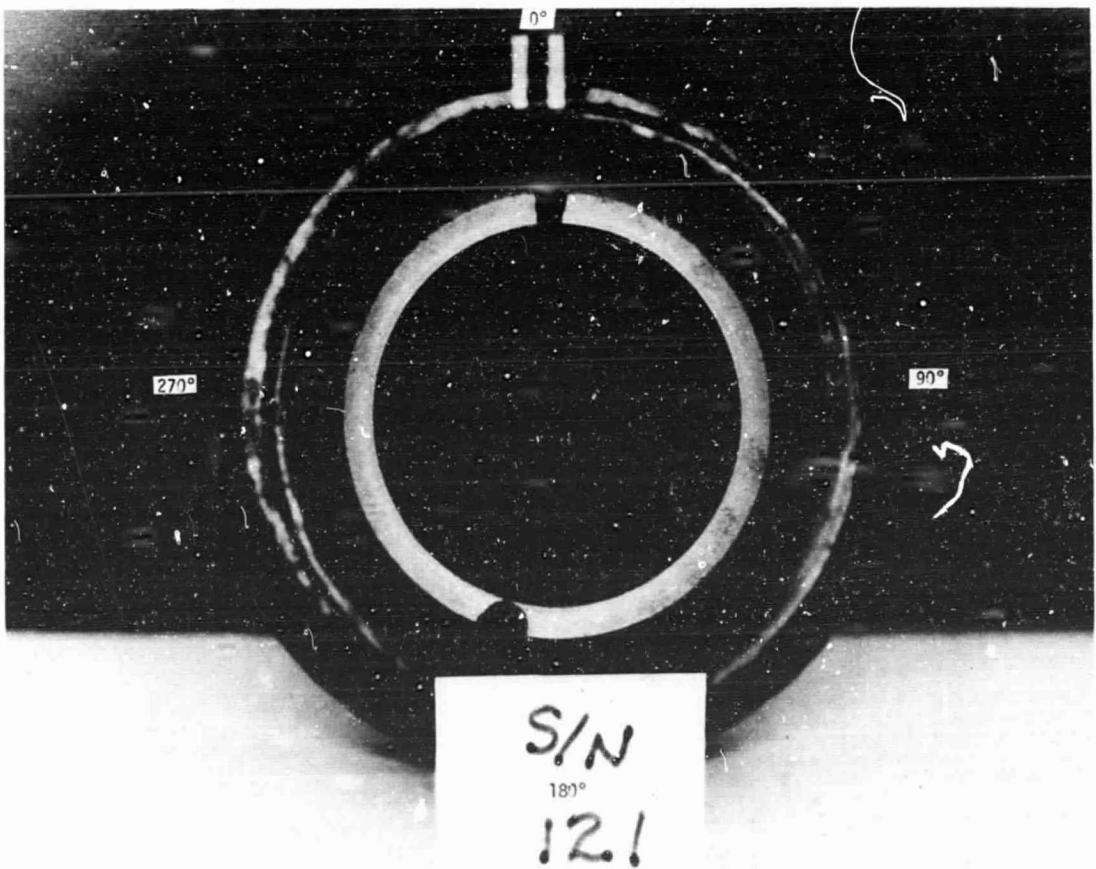
Figure 6. Post-Test Condition of S/N 121 - 1000 sec at 4500°F

| TASK | MATERIAL TYPE OR PURPOSE OF TESTS | Target Combustion Temperature of 4000°F | | Target Combustion temperature of 4500°F | | SPECIMEN FAILURE COMMENTS |
|---|---|--|---|--|---|--|
| S/N 121 | Molybdenum Disilicide | .85 | 143 | 1.20 | 145 | Nozzle in excellent condition after 1000 sec. duration at 4500°F. A nick in the coating at 225° orientation on the exit rim has been enlarged due to substrate oxidation. |

| Test Specimen S/N | Coating | Target Combustion Temperature | Firing Time sec. | No. of Starts | Comments |
|---|---|---|---|---|---|
| 121 | Molybdenum Disilicide | 4000°F | 10 | 1 | Nozzle in excellent condition. A nick in the coating at 225° orientation on the exit rim has been enlarged due to substrate oxidation. |

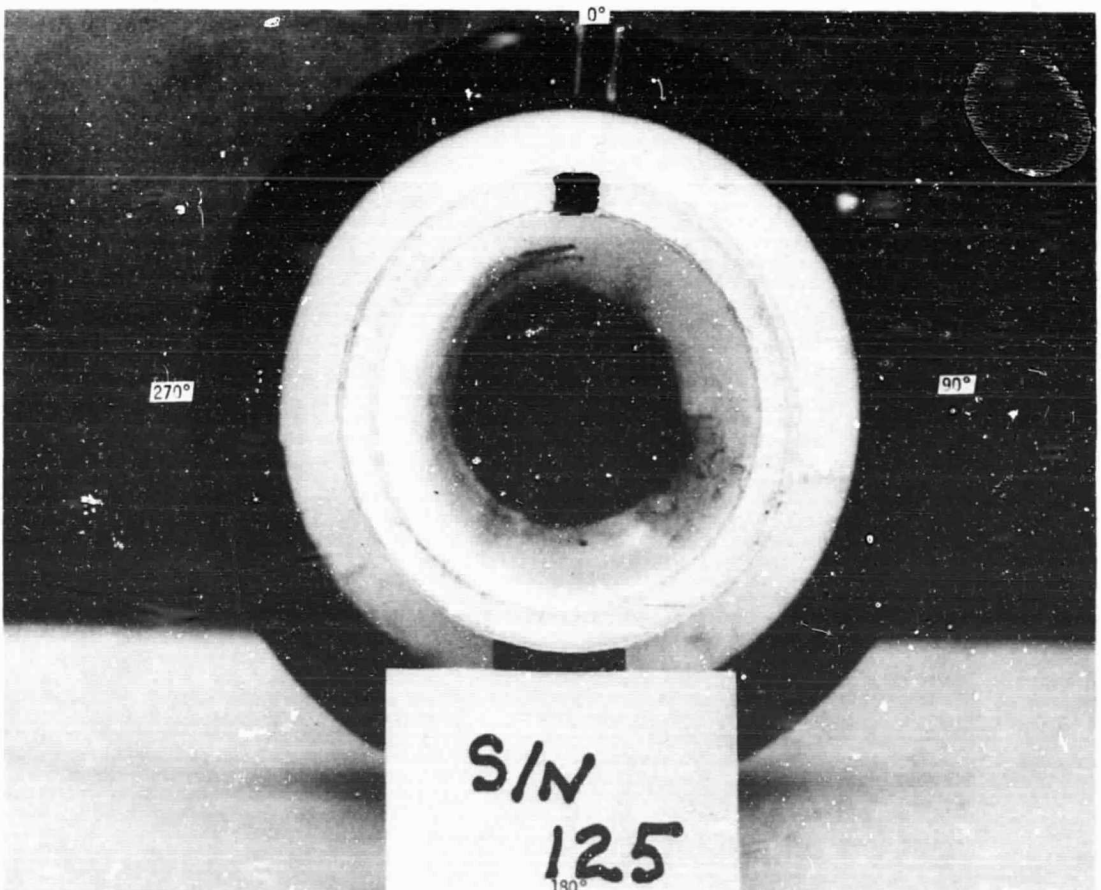
Figure 8. Post-Test Condition of S/N 125 - 845 sec at 4500°F

| TASK | MATERIAL TYPE OR PURPOSE OF TESTS | TEST DESCRIPTION | | | | SPECIMEN FAILURE COMMENTS |
|---|--|---|---|---|---|---|
| S/N 125 | Hf-20Ta-0.25 Si | .85 | 145 | 1.21 | 149 | Substrate oxidation initiated at 105° orientation at throat after 845 sec. duration at 4500°F. Flow of yellowish material from the oxidized area. Remaining coating has some surface spalling and cracks. |

| Test Specimen S/N | Coating | Target Combustion Temperature | Firing Time sec. | No. of Starts | Comments |
|---|---|---|---|---|---|
| 125 | Hf-20Ta-0.25 Si | 4000°F | 5 | 1 | Substrate oxidation initiated at 105° orientation at throat. Flow of yellowish material from the oxidized area. Remaining coating has some surface spalling and cracks. |

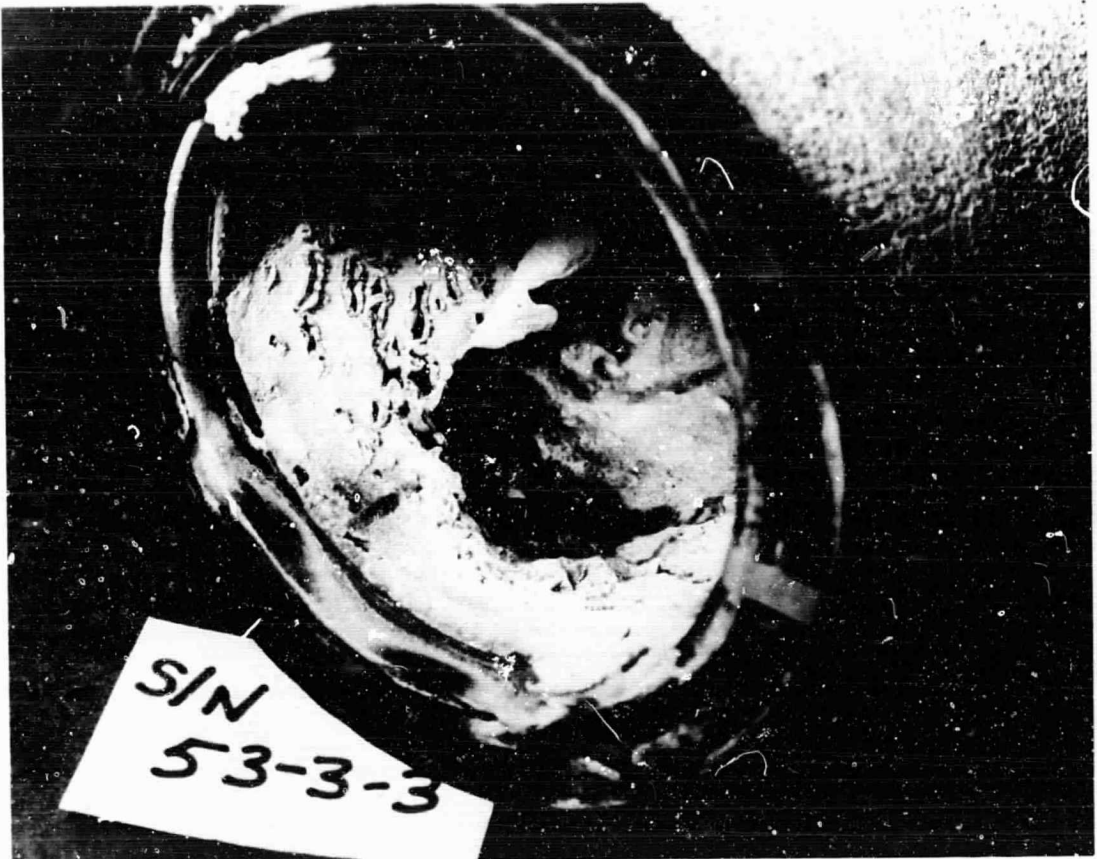
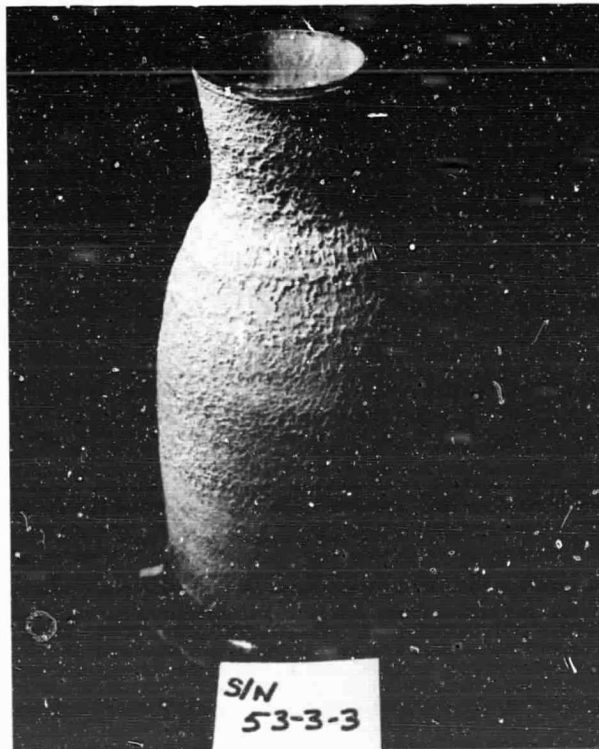
Figure 9. Post-Test Condition of S/N 53-3-3 - 478 sec at 4000°F

| TASK | MATERIAL TYPE OR PURPOSE OF TESTS | TEST DESCRIPTION | | | | SPECIMEN FAILURE COMMENTS |
|---|--|---|---|---|---|---|
| S/N 53-3-3 | Hf-20Ta Clad | .86 | 147 | DNA | DNA | Chamber burnout in barrel section at 245° orientation after 478 sec. duration at 4000°F. Heavily cratered and oxidized on interior for first 1.5 inch into the chamber barrel. |

| Test Specimen S/ls | Coating | Target Combustion Temperature | Firing Time sec. | No. of Starts | Comments |
|---|---|---|---|---|---|
| 53-3-3 | Hf-20Ta Clad | 4000°F | 5 | 1 | Chamber burnout in barrel at 24° orientation. Heavily cratered and oxidized on interior for 2.5 inch into the chamber barrel. |

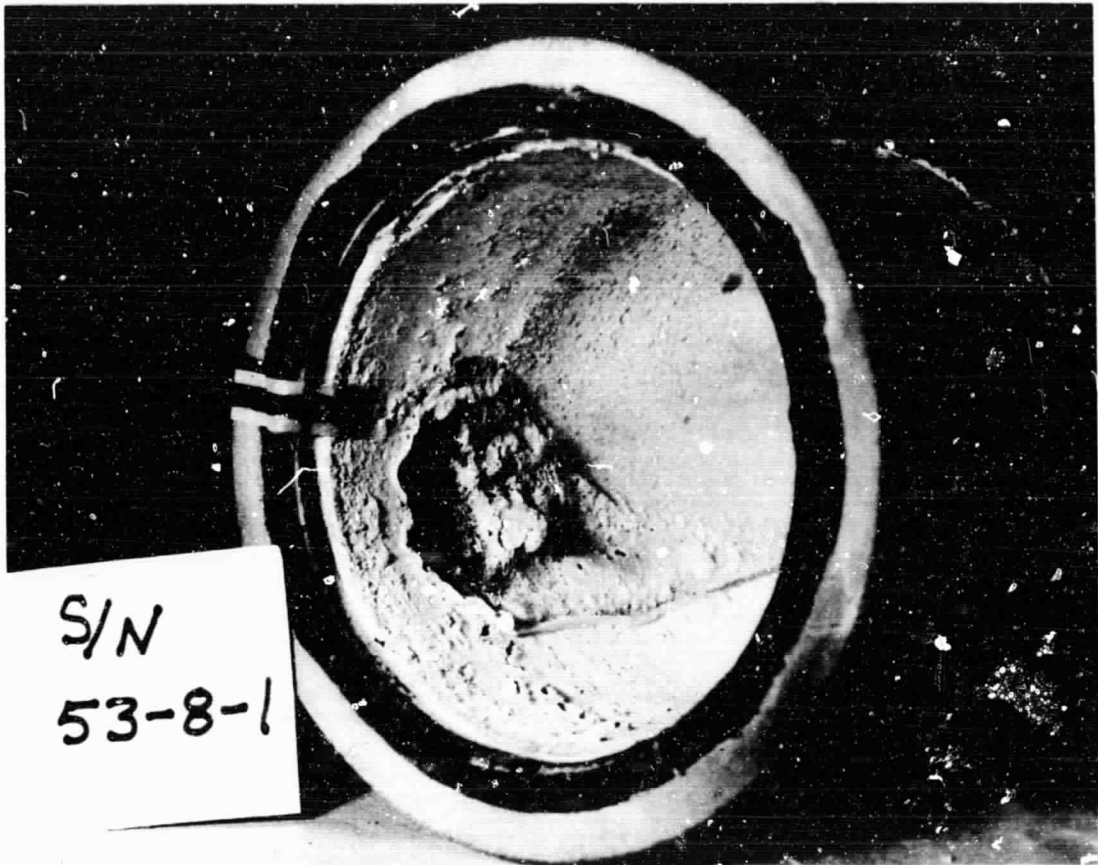
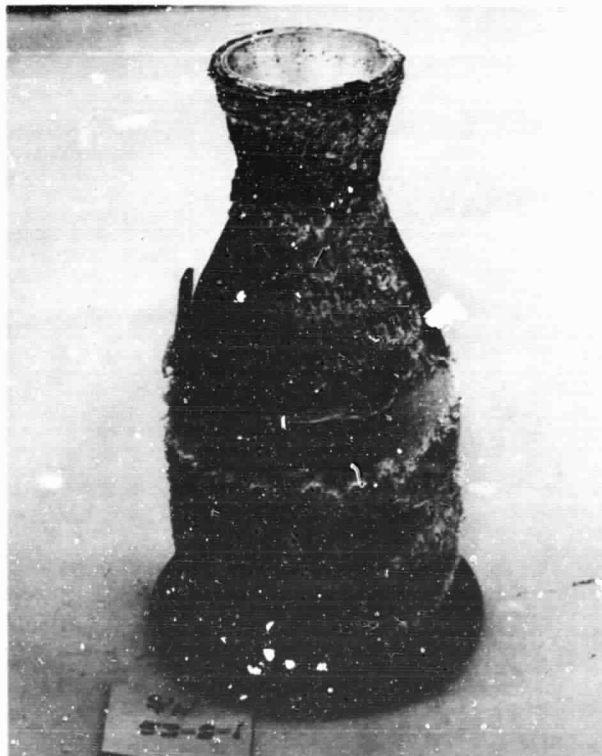
Figure 10. Post-Test Condition of S/N 53-8-1 - 88 sec at 4500°F

| TASK | MATERIAL TYPE OR PURPOSE OF TESTS | TEST DESCRIPTION | | | | SPECIMEN FAILURE COMMENTS |
|---|--|---|---|---|---|---|
| S/N 53-8-1 | Hf-20Ta Clad | .85 | 147 | 1.21 | 145 | Chamber burnout in barrel sections at 30° orientation after 88 sec. duration at 4500°F. Cratering on interior for first 1.5 inch into chamber barrel. Extensive spalling of exterior coating during cooldown after the test. |

| Test Specimen S/ls | Coating | Target Combustion Temperature | Firing Time sec. | No. of Starts | Comments |
|---|---|---|---|---|---|
| 53-8-1 | Hf-20Ta Clad | 4000°F | 10 | 1 | Chamber burnout in barrel at 30° orientation. Cratering on interior for 2.5 inch into chamber barrel. Extensive spalling of surface coating during cool down after the test. |

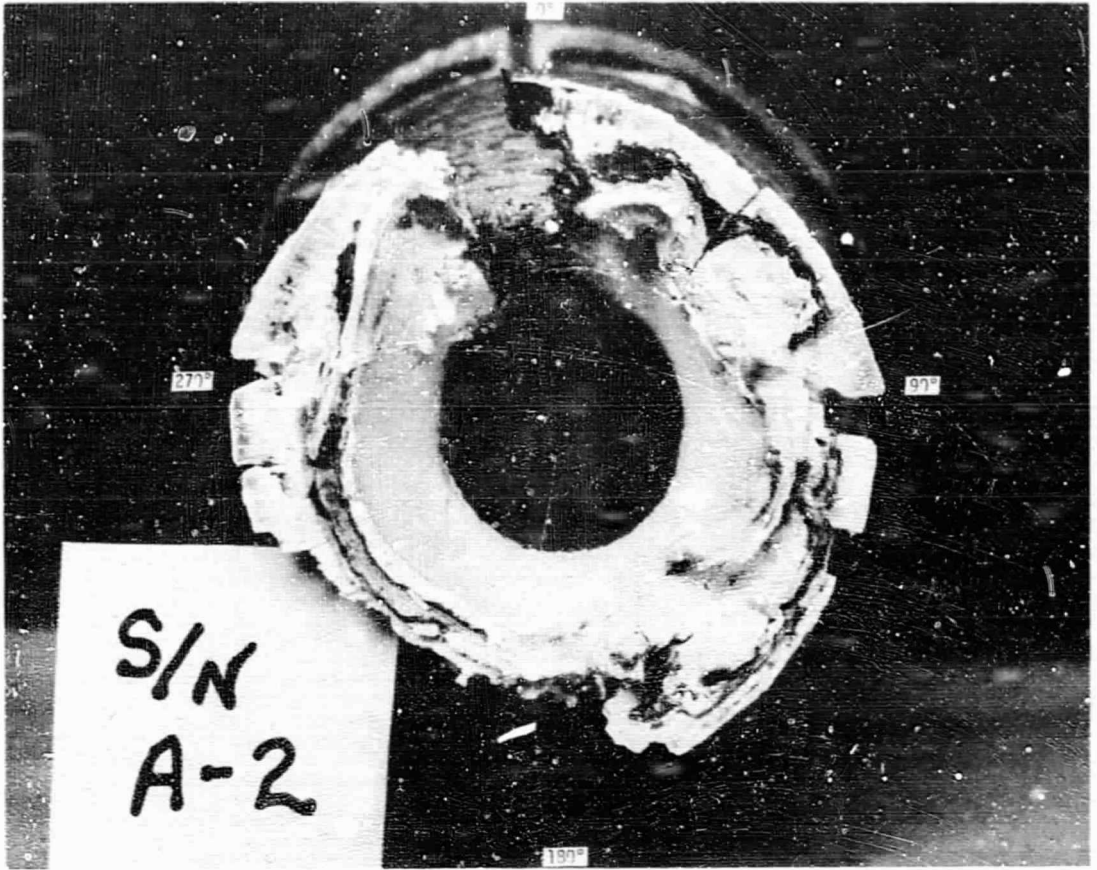
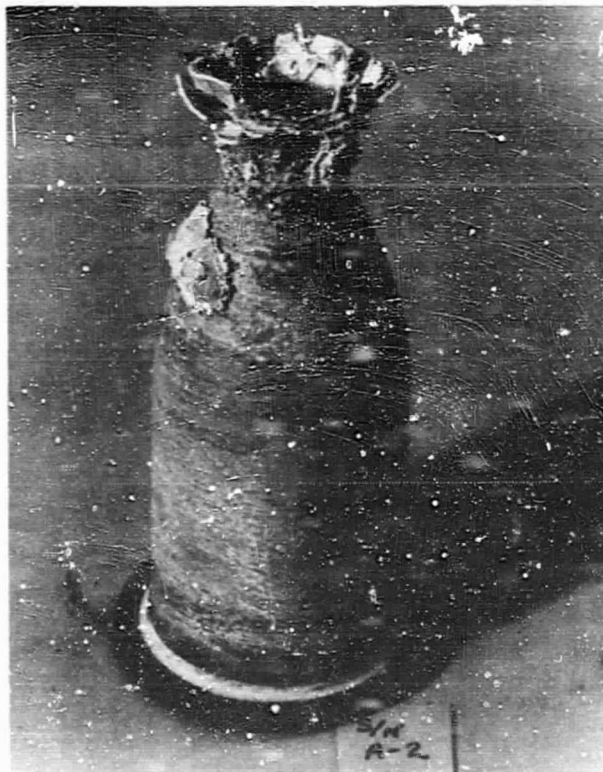
Figure 11. Post-Test Condition of S/N A-2 - 3937 sec at 4500°F

During the life firing tests of six selected chambers from Task IV, one of the Ha-20Ta clad chambers had notable success. Specimen S/N A-2 accumulated a total of 3937 seconds firing time at the maximum chamber temperature of 4500°F before failure. Included in this time was four engine start-ups from ambient temperature; the multiple engine starts being required for propellant re-tanking. The significance of this firing together with the success of the two Hf-20Ta clad nozzles from Task III is that it has demonstrated the practicality of fabricating a reliable Ha-20Ta clad specimen capable of providing long specimen life at elevated temperatures. The approximate specimen wall temperature during these firings was 3200°F. Although this temperature level may not be regarded as a severe test of the coating system when compared to its theoretical temperature limitation, it is reasonable to believe the Ha-20Ta clad system would also demonstrate long life at even higher wall temperatures. The premise for this conclusion is that prior experience during this program has indicated the fabrication techniques and/or controls used to achieve a uniform, defect-free coating is more crucial to the coatings success than the operating temperature.

| TASK | MATERIAL TYPE OR PURPOSE OF TESTS | TEST DESCRIPTION | | | | SPECIMEN FAILURE COMMENTS |
|---|--|---|---|---|---|---|
| S/N A-2 | Hf-Ta-Clad | DNA | DNA | 1.19 | 144 | Burn through at throat and tearing to the nozzle exit at 350° orientation after 3937 sec duration at 4500°F. Extensive clad separation and loss of substrate at exit. Crater formations on interior and exterior. Internal chamber barrel in reasonably good condition. |

| Test Specimen S/ls | Coating | Target Combustion Temperature | Firing Time sec. | No. of Starts | Comments |
|---|---|---|---|---|---|
| A-2 | Hf-Ta Clad | 4500°F | 10 | 1 | Burn through at throat and tearing to the nozzle exit at 350° orientation. Extensive clad separation and loss of substrate at exit. Crater formations on interior and exterior. Internal chamber barrel in reasonably good condition. |

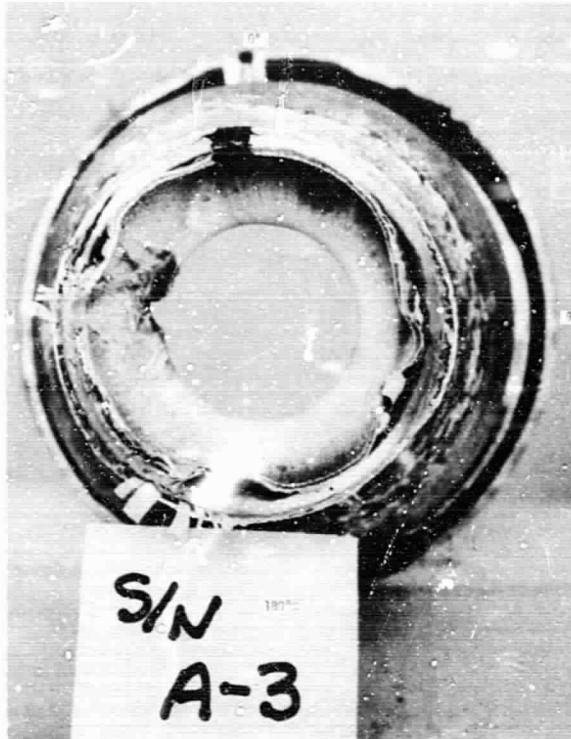
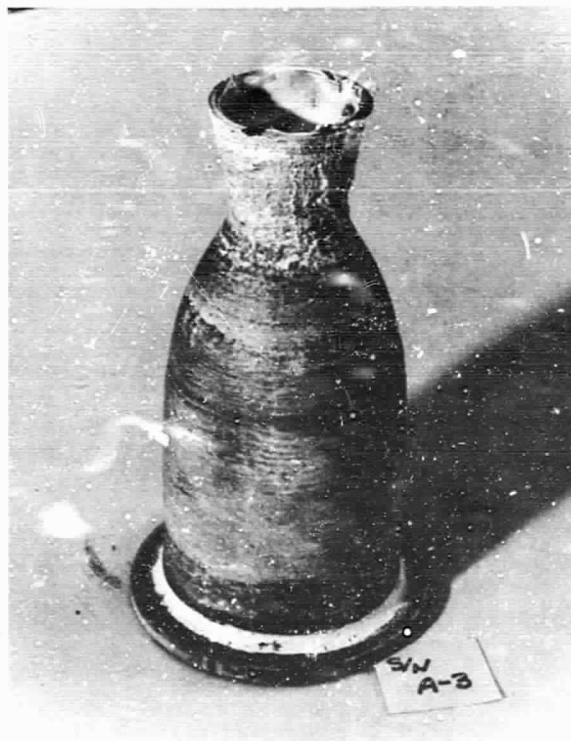
Figure 12. Post-Test Condition of S/N A-3 - 587 sec at 4500°F

| TASK | MATERIAL TYPE OR PURPOSE OF TESTS | TEST DESCRIPTION | | | | SPECIMEN FAILURE COMMENTS |
|---|---|---|---|---|---|--|
| S/N A-3 | Hf-Ta-Clad | DNA | DNA | 1.19 | 148 | Burn through at throat at 300° orientation after 587 sec. duration at 4500°F. Clad separation at exit. Some crater formation developing on outside and inside at throat. Internal chamber barrel in good condition. |

| Test Specimen S/ls | Coating | Target Combustion Temperature | Firing Time sec. | No. of Starts | Comments |
|---|---|---|---|---|---|
| A-3 | Hf-Ta Clad | 4500°F | 10 | 1 | Burn through at throat at 300° orientation. Clad separation at exit. Some crater formation developing on outside and inside at throat. Internal chamber barrel in good condition. |

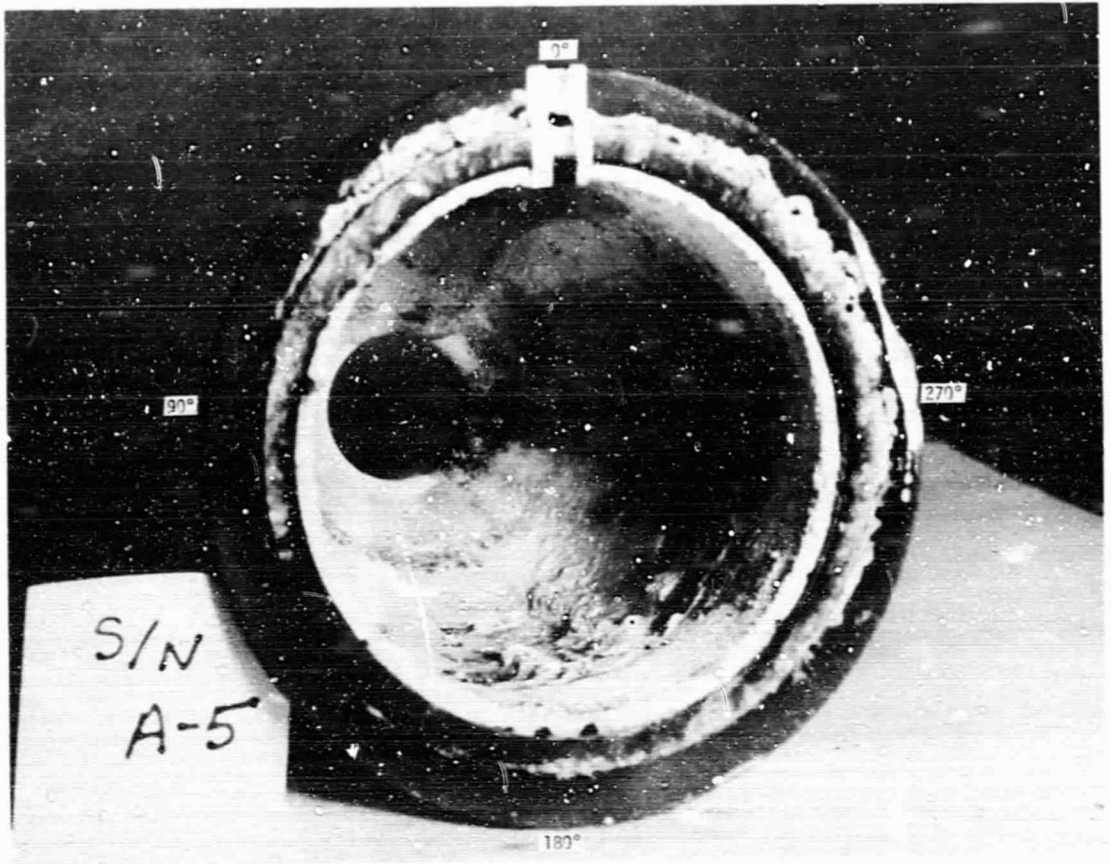
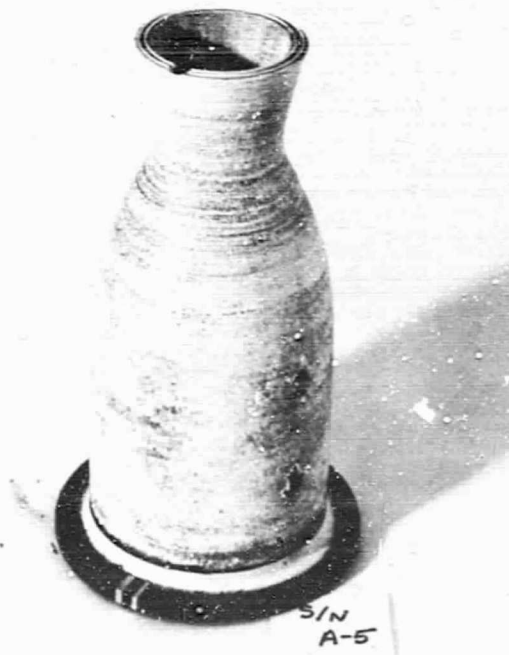
Figure 13. Post-Test Condition of S/N A-5 - 50 sec at 4500°F

| TASK | MATERIAL TYPE OR PURPOSE OF TESTS | TEST DESCRIPTION | | | | SPECIMEN FAILURE COMMENTS |
|---|---|---|---|---|---|--|
| S/N A-5 | Hf-Ta-W Clad | DNA | DNA | 1.20 | 145 | Chamber burnout in barrel at 280° orientation after 50sec. duration at 4500°F. Extensive cratering exposing oxidized substrate on interior of chamber barrel. Considerable flow of yellow/brown material from oxidized regions. Nozzle section and exterior in good condition. |

| Test Specimen S/ls | Coating | Target Combustion Temperature | Firing Time sec. | No. of Starts | Comments |
|---|---|---|---|---|---|
| A-5 | Hf-Ta-W Clad | 4500°F | 10 | 1 | Chamber burnout in barrel at 280° orientation. Extensive cratering exposing oxidized substrate on interior of chamber barrel. Considerable flow of yellow/brown material from oxidized regions. Nozzle section and exterior in good condition. |

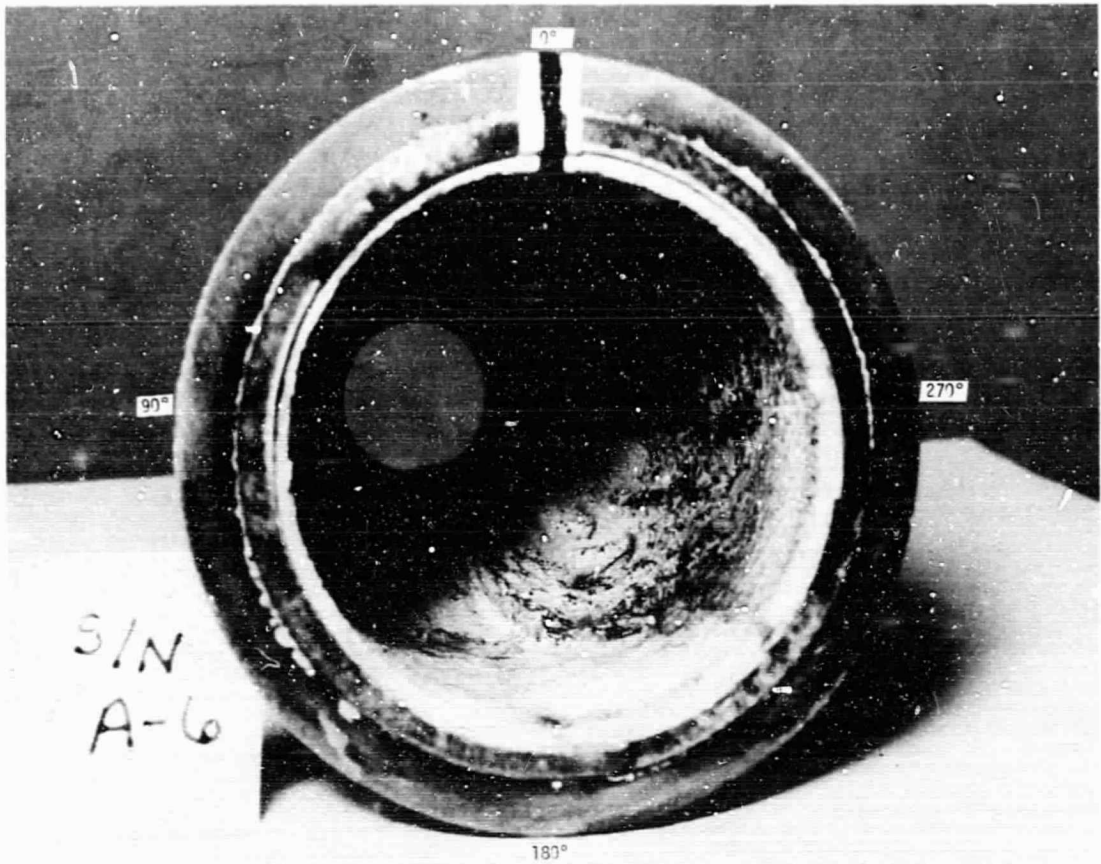
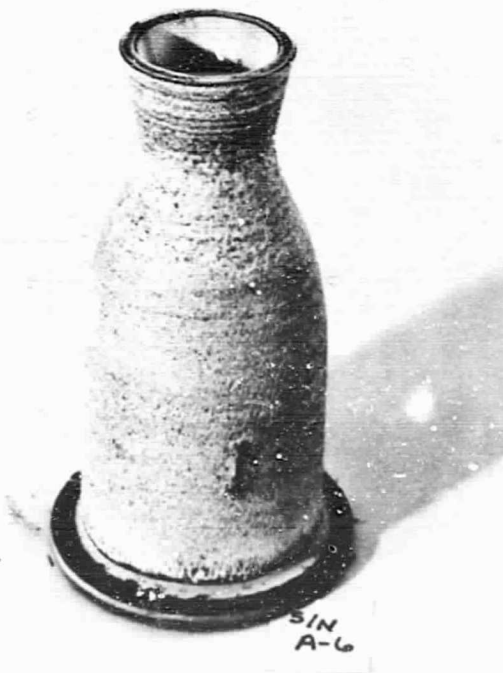
Figure 14. Post-Test Condition of S/N A-6 - 63 sec at 4500°F

| TASK | MATERIAL TYPE OR PURPOSE OF TESTS | TEST DESCRIPTION | | | | SPECIMEN FAILURE COMMENTS |
|---|---|---|---|---|---|--|
| S/N A-6 | Hf-Ta-Mo Clad | DNA | DNA | 1.20 | 145 | Chamber burnout in barrel at 230° orientation after 63 sec duration at 4500°F. Extensive substrate oxidation on interior of chamber barrel. Considerable flow of grey material from oxidized regions. Nozzle section and exterior in good condition. |

| Test Specimen S/ls | Coating | Target Combustion Temperature | Firing Time sec. | No. of Starts | Comments |
|---|---|---|---|---|---|
| A-6 | Hf-Ta-Mo Clad | 4500°F | 10 | 1 | Chamber burnout in barrel at 230° orientation. Extensive substrate oxidation on interior of chamber barrel. Considerable flow of gray material from oxidized regions. Nozzle section and exterior in good condition. |

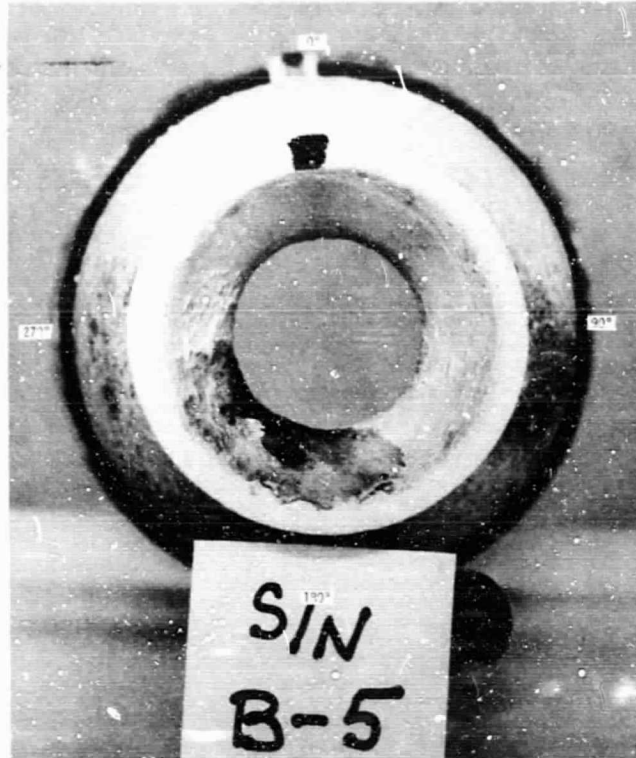
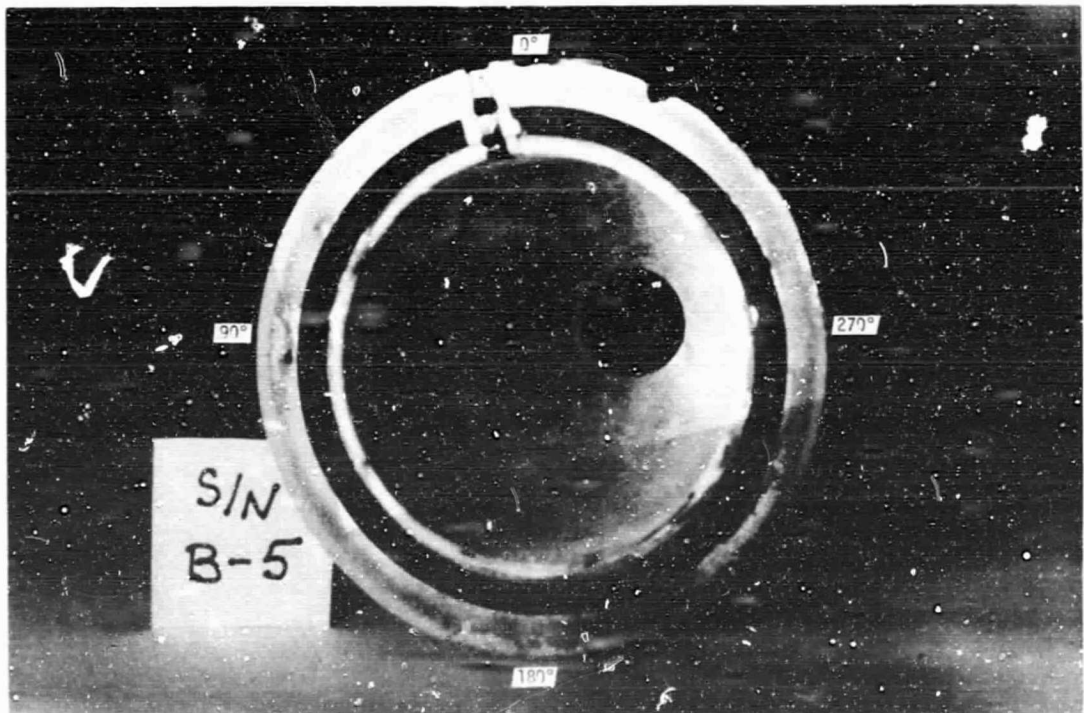
Figure 15. Post-Test Condition of S/N B-5 - 634 sec at 4500°F

| TASK | MATERIAL TYPE OR PURPOSE OF TESTS | TEST DESCRIPTION | | | | SPECIMEN FAILURE COMMENTS |
|---|---|---|---|---|---|--|
| S/N B-5 | Hf-Ta-Slurry | DNA | DNA | 1.21 | 150 | Substrate oxidation in throat region at 220° orientation after 634 sec. duration at 4500°F. Large blister formation downstream of throat on outside at 230°. Remaining coating in good condition. |

| Test Specimen S/ls | Coating | Target Combustion Temperature | Firing Time sec. | No. of Starts | Comments |
|---|---|---|---|---|---|
| B-5 | Hf-Ta Slurry | 4500°F | 10 | 1 | Substrate oxidation in throat region at 220° orientation. Large blister formation downstream of throat on outside at 230°. Remaining coating in good condition. |

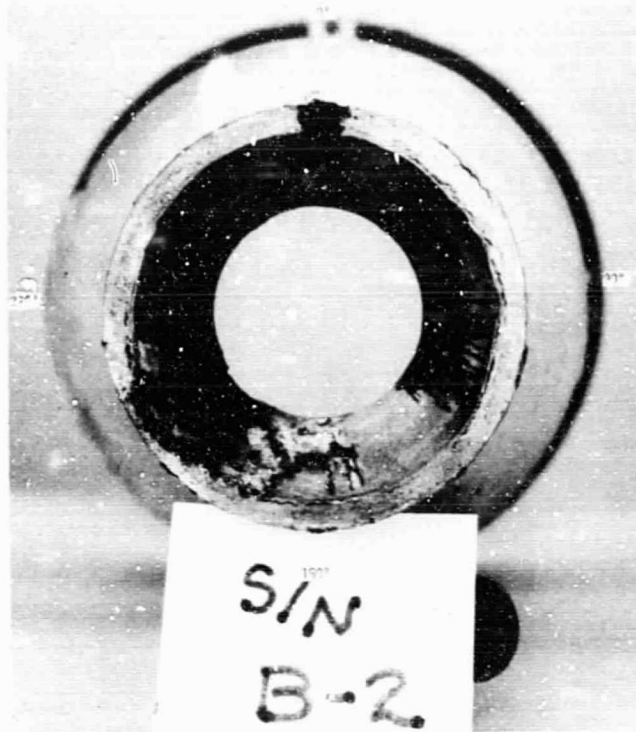
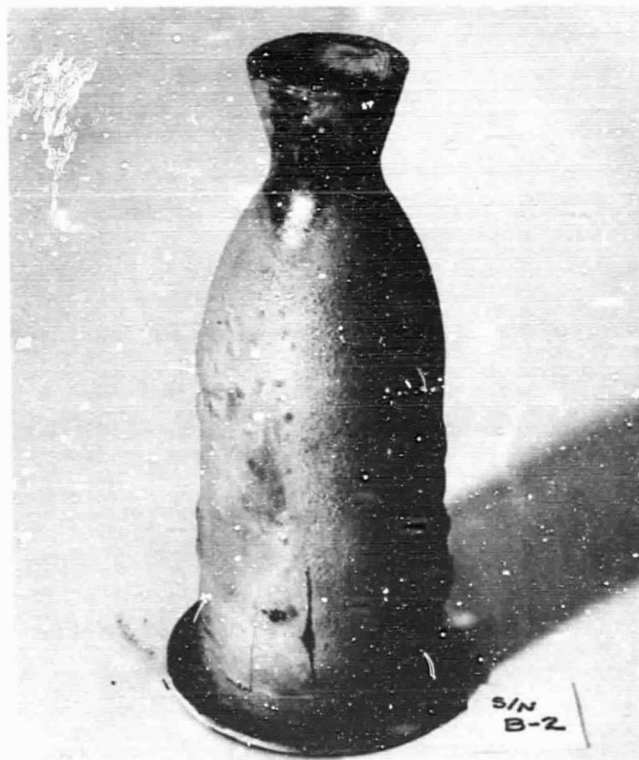
Figure 16. Post-Test Condition of S/N B-2 - 57 sec at 4500°F

barrel section. This leakage was detected during the pressure check made prior to the firing. Similar but more extensive leakage was detected on the unfired identical specimen (S/N B-4). The leakage in these two chambers may have been through cracks in the substrate which were not detectable during the pre-test metallurgical examination. The differences noted in the firing durations for the various Hf-Ta clad specimens again points out the importance of having proper fabrication techniques and/or controls in providing a reproducible, uniform, and defect free coating; and consequently, long specimen life.

| TASK | MATERIAL TYPE OR PURPOSE OF TESTS | TEST DESCRIPTION | | | | SPECIMEN FAILURE COMMENTS |
|---|---|---|---|---|---|--|
| S/N B-2 | Ir-Re-90Ta-10W | DNA | DNA | 1.20 | 145 | Burn through at throat at 220° orientation after 57 sec duration at 4500°F. Many deep longitudinal cracks in chamber barrel. Some cracks completely through the specimen. Prior to the test the specimen had gas leakage through the chamber walls. Heavy blister formations on exterior barrel section. |

| Test Specimen S/ls | Coating | Target Combustion Temperature | Firing Time sec. | No. of Starts | Comments |
|---|---|---|---|---|---|
| B-2 | Ir-Re | 4500°F | 10 | 1 | Burn through at throat at 220° orientation. Many deep longitudinal cracks in chamber barrel. Some cracks completely through the specimen. Prior to the test, the specimen had gas leakage through the chamber walls. Heavy blister formations on exterior barrel section. |
