EIGHTH QUARTERLY REPORT
EVALUATION TESTING OF PROTECTIVE
COATINGS ON REFRACTORY METALS

September 1969

CONTRACT NAS 7-460

TRW SYSTEMS GROUP
One Space Park Redondo Beach California 90278

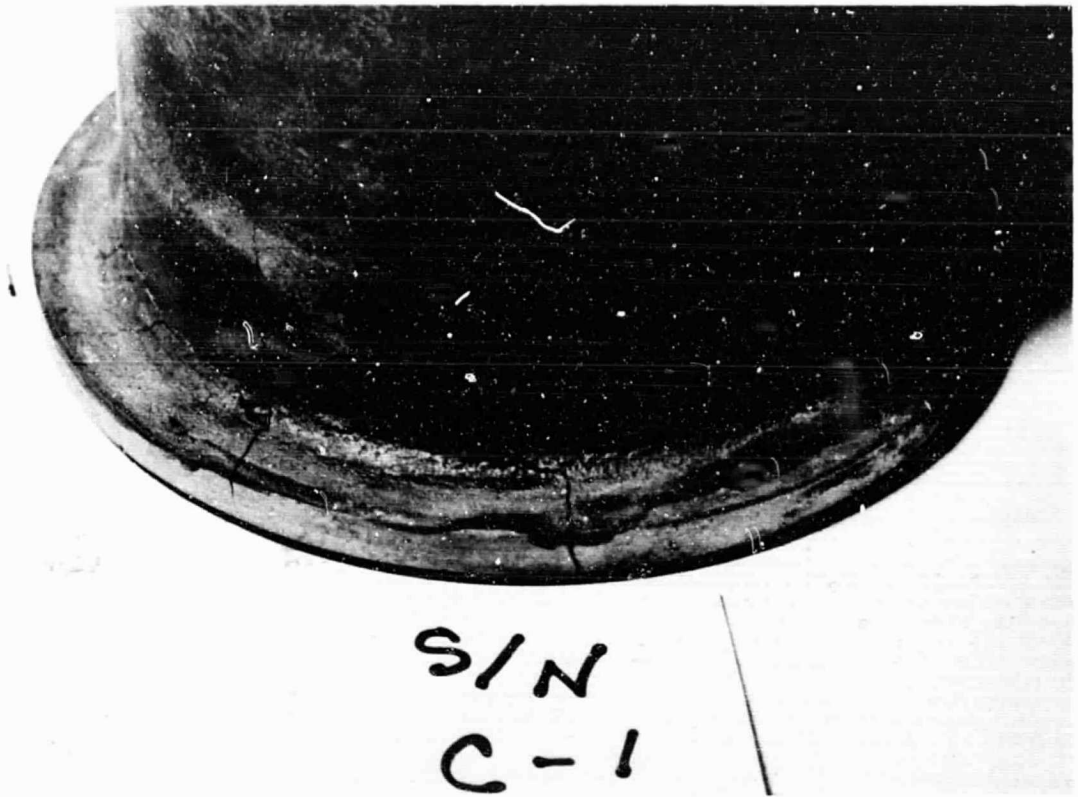
Figure 17. Cracked Flange Area on S/N C-1

During the Task IV chamber tests an attempt was made to test one of the Ir-Re coated tungsten chambers (S/N C-1 and C-11); however, both chambers cracked at the junction of the flange to the chamber barrel as they were being installed. Cracking occurred at a bolt torque value of approximately 25 in.-lb. Photographs of the cracked areas are shown in Figures 17 and 18.

| TASK | MATERIAL TYPE OR PURPOSE OF TESTS | TEST DESCRIPTION | | | | SPECIMEN FAILURE COMMENTS |
|---|---|---|---|---|---|--|
| S/N C-1 | Re-Ir-W | DNA | DNA | DNA | DNA | Specimen could not be tested due to cracks developing at the flange during installation. |

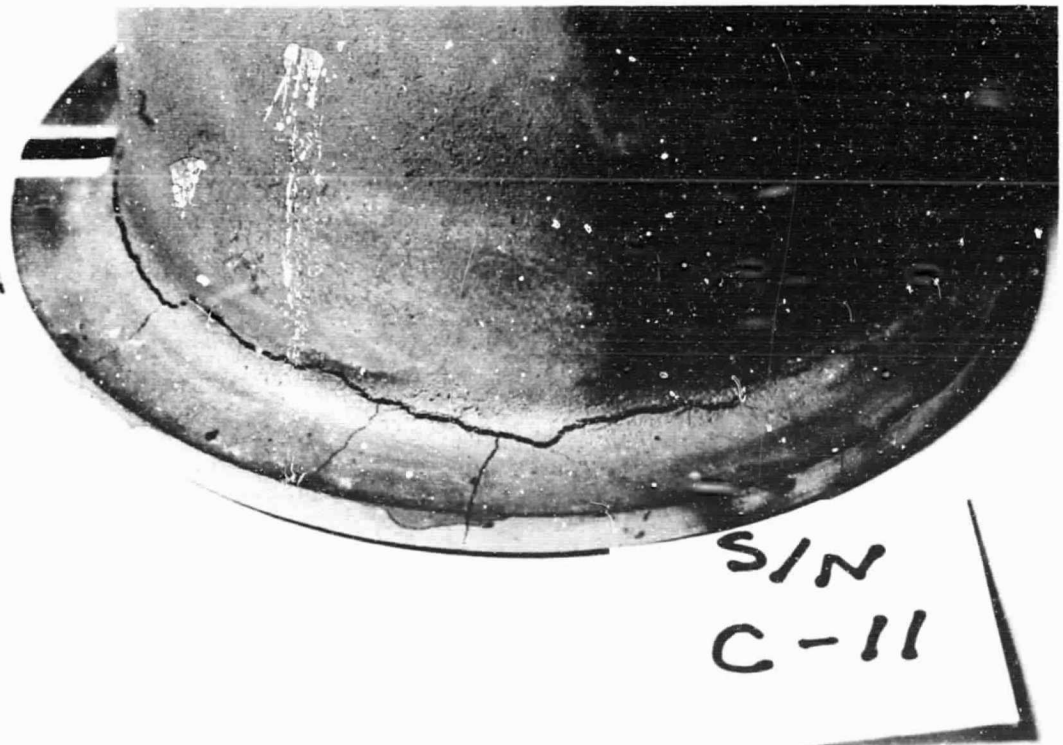
Figure 18. Cracked Flange Area on S/N C-11

| TASK | MATERIAL TYPE OR PURPOSE OF TESTS | TEST DESCRIPTION | | | | SPECIMEN FAILURE COMMENTS |
|---|---|---|---|---|---|--|
| S/N C-11 | Re-Ir-W | DNA | DNA | DNA | DNA | Specimen could not be tested due to cracks developing at the flange during installation. |
