HYDRAZINE ELECTROLYSIS CELL
SAFETY LIMITS TESTS

SUMMARY REPORT
TASKS VII AND VIII
JPL CONTRACT No. 951720
3 JUNE 1969

HUGHES AIRCRAFT COMPANY
SPACE SYSTEMS DIVISION
EL SEGUNDO, CALIFORNIA

CALIFORNIA INSTITUTE OF TECHNOLOGY
Jet Propulsion Laboratory
4800 Oak Grove Drive
Pasadena, California

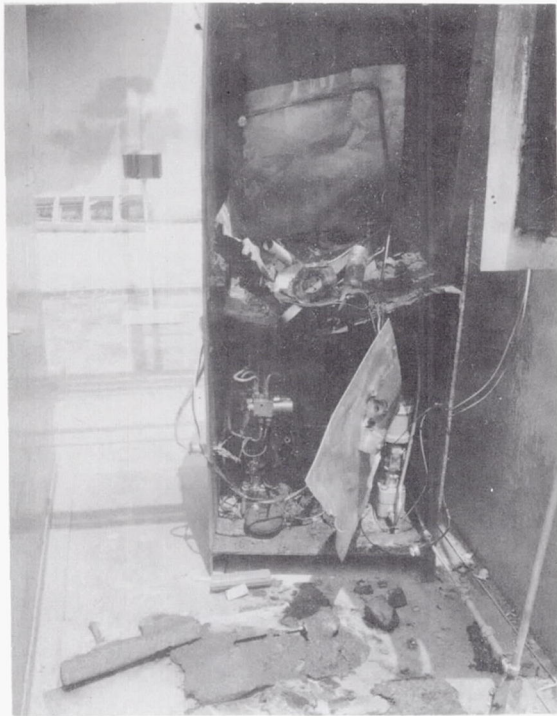
FIGURE 9

TEST CHAMBER
AFTER FAILURE

- a. The outer enclosure of the electrode module was bulged out locally at its lower edge from a high internal pressure. This was a very local condition. The remainder of the part was still round and relatively undamaged except for the top edge being torn out at the attachment screw hole.
- b. The inner enclosure of the electrode module was collapsed inwardly at its lower end from an external force. Some metal was missing from along one side of the lower edge.
- c. The lower 1 to 2 inches of the anode were shattered into many small fragments, but the remainder of the part was still intact.
- d. Many pieces of the cell were found scattered on the hillside up to 20 feet away. Some of these showed damage from heat, while others did not.

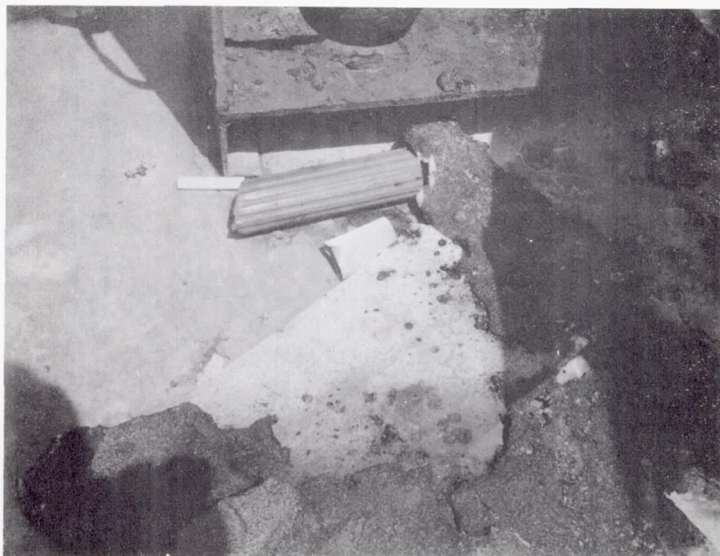
FIGURE 10

ANODE AND OTHER PARTS
AT BASE OF TEST
CHAMBER

2. Anode - Found on ground just below chamber with lower 1 to 2 inches missing. Fragments of anode were found scattered on hillside up to approximately 20 feet from chamber.

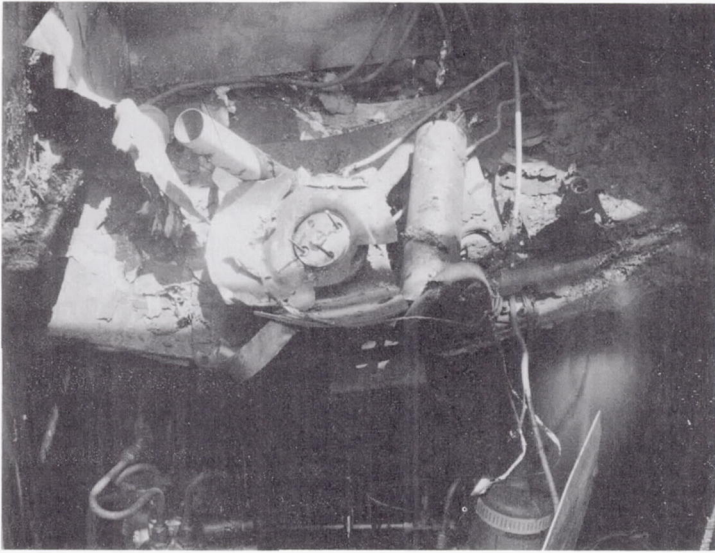
FIGURE 11

TANK FLANGE,
INNER AND OUTER
ELECTRODE ENCLOSURES

6. Inner Shell - Lower end (about 3" length) was collapsed inward from an external force. At bottom edge, 3/4" was missing over 180° of circumference. Inside surface was very clean in lower end of part; upper part slightly discolored inside. Outside surface was badly blacked from fire except top 2" to 4".

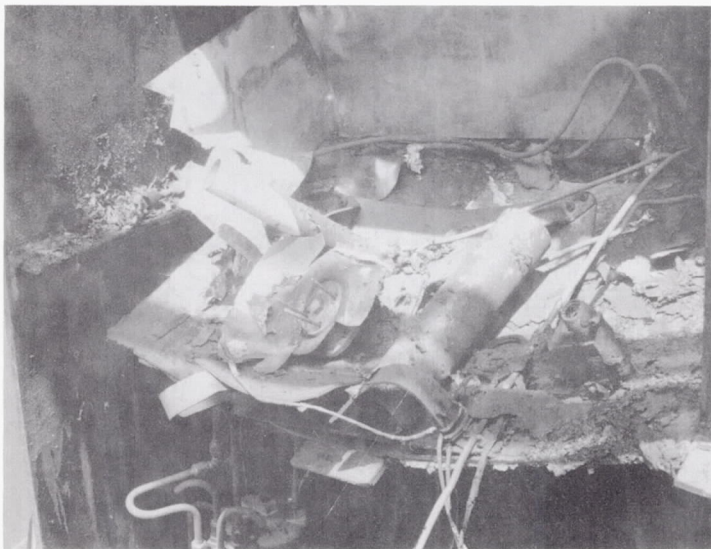
FIGURE 12

PARTS OF ELECTROLYSIS
CELL REMAINING
IN TEST CHAMBER

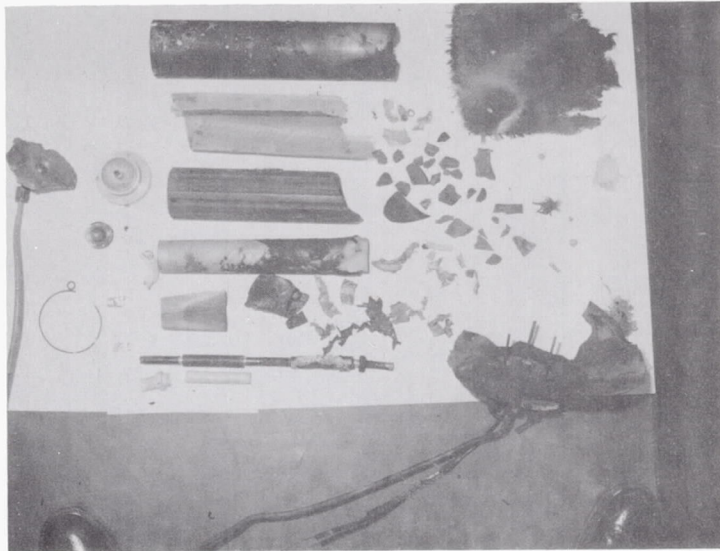
FIGURE 13
ELECTROLYSIS CELL PARTS
AND FRAGMENTS

The available evidence indicates that a reaction sufficiently violent to damage the aluminum inner and outer enclosures and shatter the lower end of the anode occurred between the inner and outer enclosures. Based on the orientation of the parts, the location of the reaction was established near to the bottom of the cell and also near the surface of the main body of liquid in line with the cathode connector.

A cathode screen hot-spot is the only mechanism that fits all the evidence. It accounts for low resistance in a near-short condition; it explains the additional gas generation above prediction and why it increases with higher power; it explains the two current surges as shorts; and it explains the failure occurring during the second day rather than the first day, since the area in question is above the assumed propellant level in the electrolysis cell as evidenced by the failed hardware description.

The most probable cause of the near-short condition is the loose edge wires on the screen digging into or between the loose weave of the wick. This condition has occurred at least once before when a low resistance (5 ohms) was recorded. At normal cell power levels it would not be a serious problem. Most of the power dissipation would occur at this point. When the liquid level was above this point, as in Test 713-2, it apparently kept the temperature under control, but the temperature was still high enough to decompose hydrazine. When the liquid level was dropped for Test 713-3 this area quickly heated out of control. (5 minutes above 40 volts) The wick retained liquid to allow current flow.
