NAPTC-AED-1869

NAVAL AIR PROPULSION TEST CENTER
 AERONAUTICAL ENGINE DEPARTMENT
 NAVAL BASE, PHILADELPHIA, PA. 19112
 NAPTC-AED-1869 5 APR 1968

ROTOR BURST PROTECTION PROGRAM
 INITIAL TEST RESULTS

PHASE IV - FINAL REPORT
 PROBLEM ASSIGNMENT NASA DPR R-105

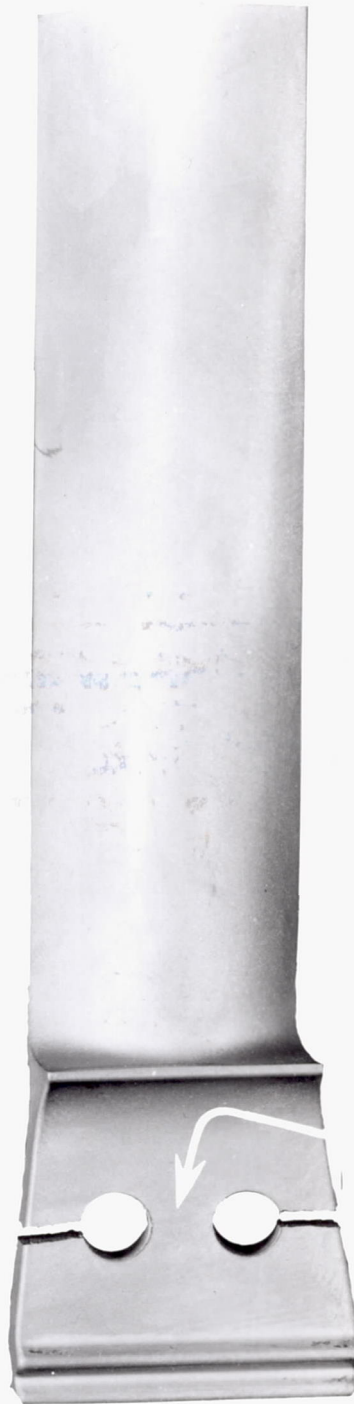
42. Blade failures at predicted speeds were induced by modifying the blade as shown in plate 8. This consisted of reducing the area normally required to support the centripetal load generated during rotation. A straight-forward centripetal force analysis was used $\sigma_u A = (W/g) \bar{r} \omega^2$ to determine the burst speed. We found that the simplest and most accurate way to get the values of W (the weight) and \bar{r} (the centroid) for a particular blade was to determine them experimentally.

Failure Section

MODIFIED TURBINE BLADE

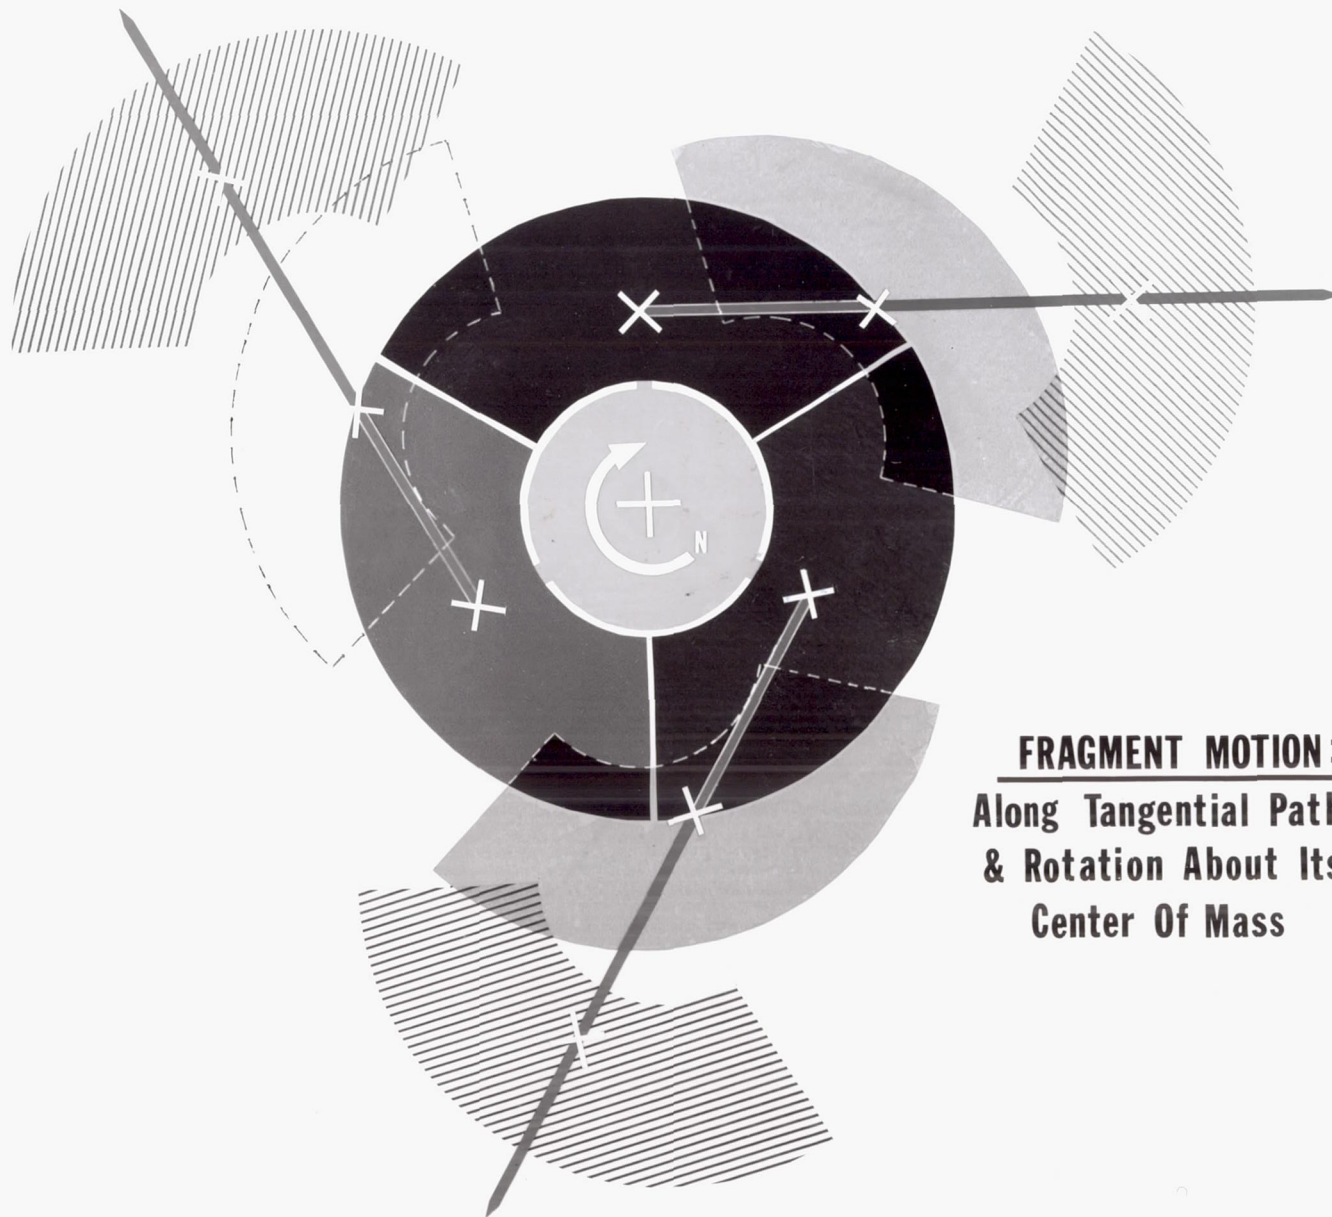
54. A flat, uniformly thick, disk was modified to fail at 10,000 rpm and produce three annular sectors and a hub section. The failure occurred at 12,100 rpm and produced two annular sectors and one fragment composed of the third annular sector connected to the hub section. Pictures 2-1, 2-5, 2-9, and 2-13 of test No. 2 are shown on plate 14. There is a time interval of 200×10^{-6} seconds between each picture. The ring that the fragments are passing through is a photo triggering strip. It is made of a plastic film and presents negligible resistance to the fragments. The arrow in the pictures indicates the direction of disk rotation. Fragments A and B are seen to behave very much as illustrated on plate 15; i.e., the fragment rotates about its own center of mass as it travels along a tangential path.

IDEAL TRI-HUB DISK BURST

FRAGMENT MOTION:
Along Tangential Path
& Rotation About Its
Center Of Mass

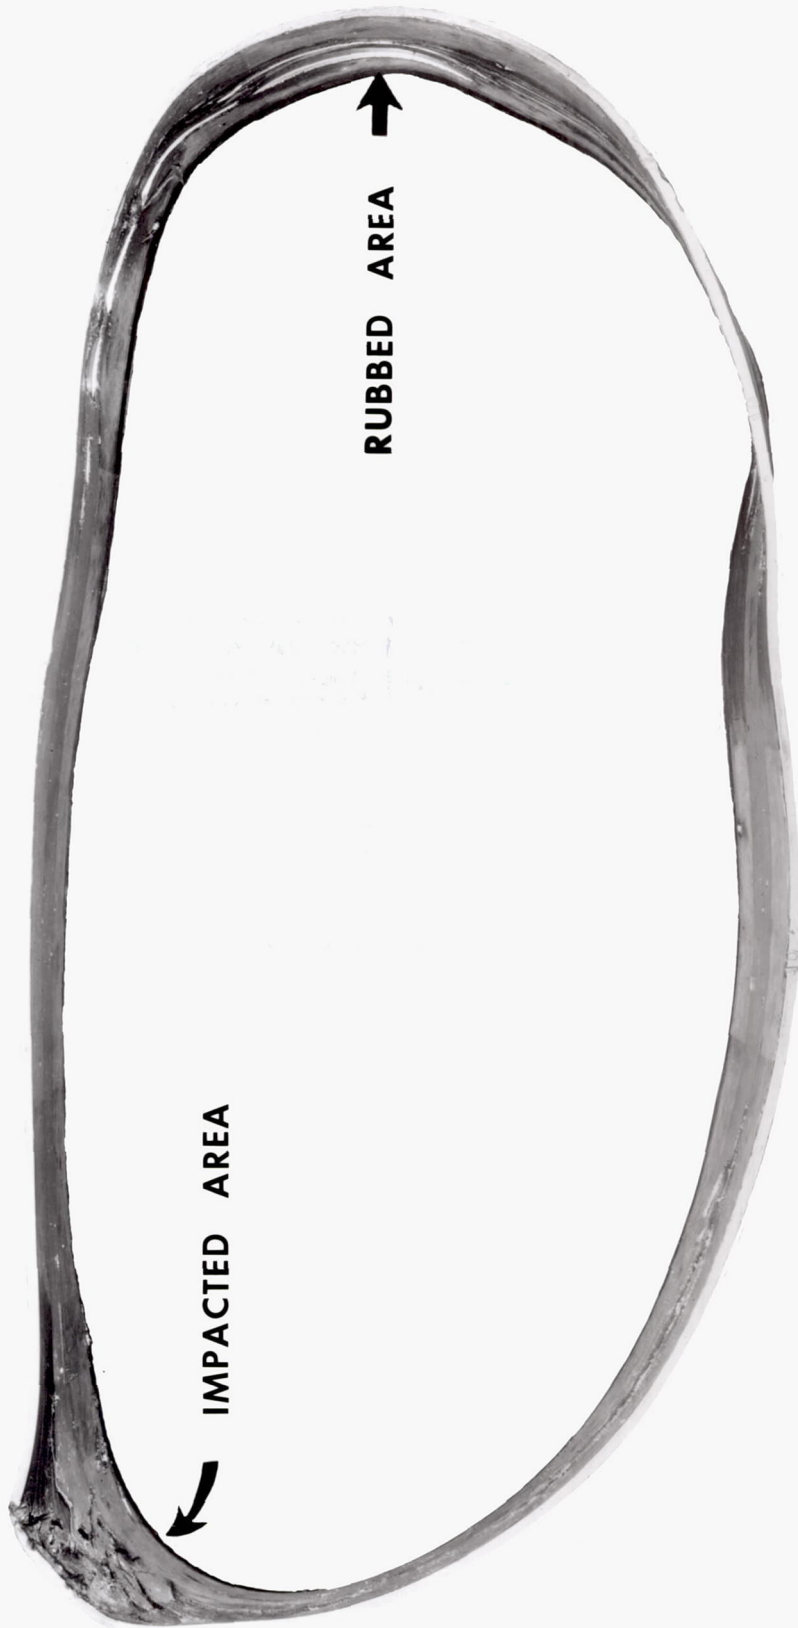
58. Plate 18 shows blades numbered 2, 3, and 4 leaving the rotor and impacting the ring. Examination of the entire set of test No. 10 photographs indicates that blades 2, 3, and 4 rub against the inwardly displaced section of the ring (approximately 4 to 2 o'clock position) prior to blade failure. Pictures 10-35 and 10-38 show blades 3 and 4 rubbing the ring. It is suggested that this rubbing established a stress condition in the blades such that the last three blades all failed at the same position and struck the ring in a small concentrated area.

POST-TEST NO. 10
CONTAINMENT RING

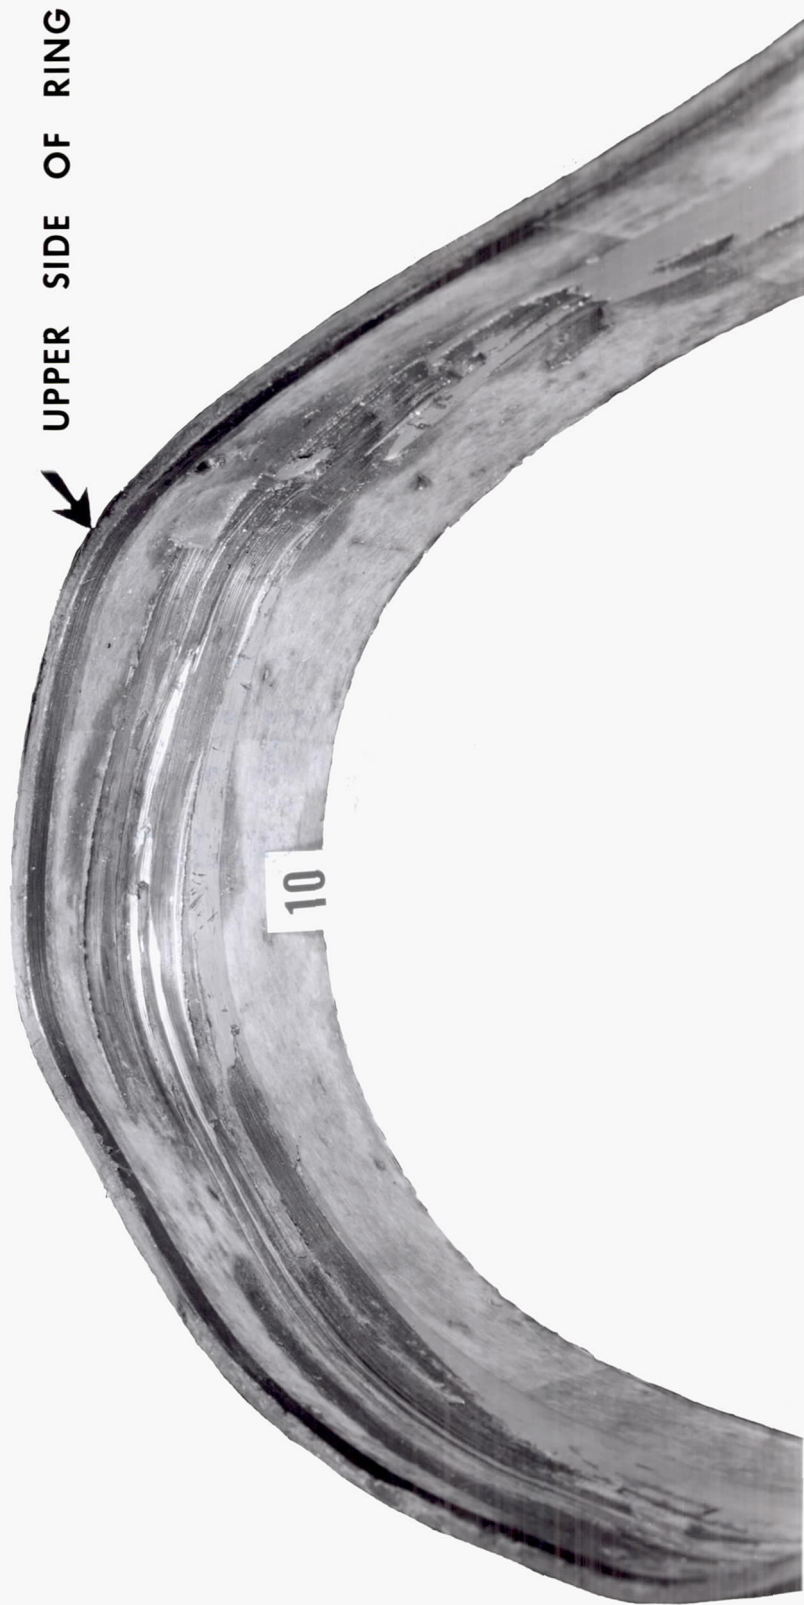
POST-TEST NO. 10
CONTAINMENT RING-RUBBED AREA DETAIL

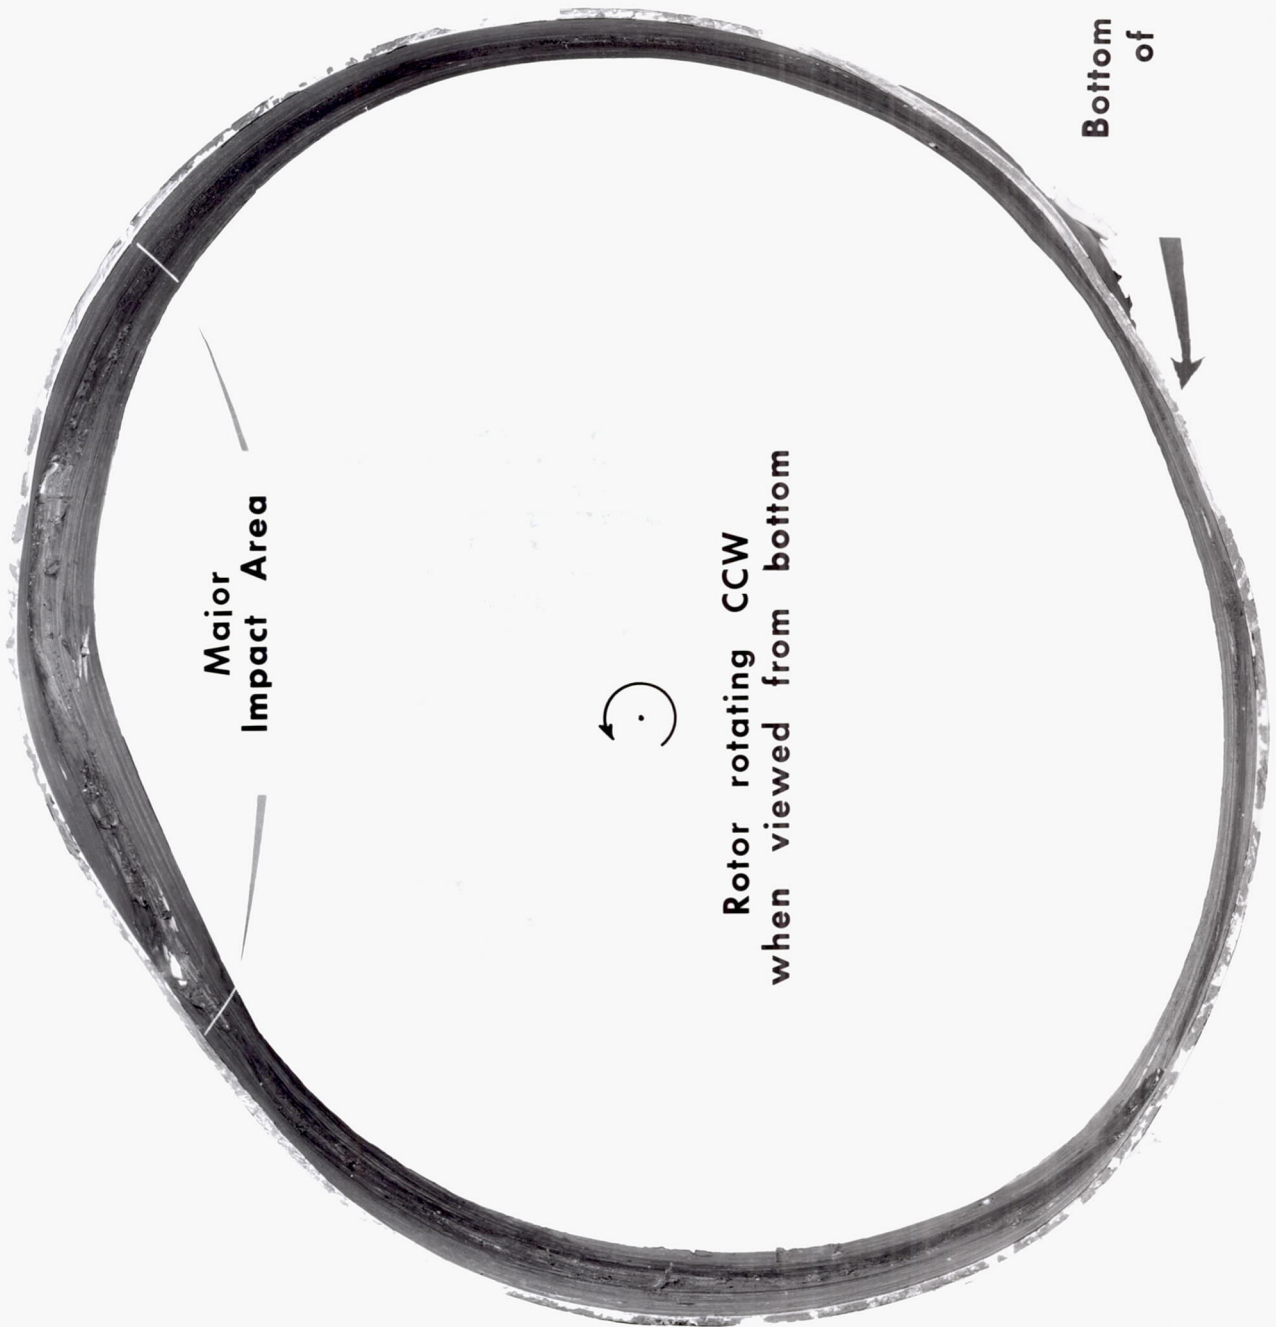
POST-TEST NO. 11 CONTAINMENT RING

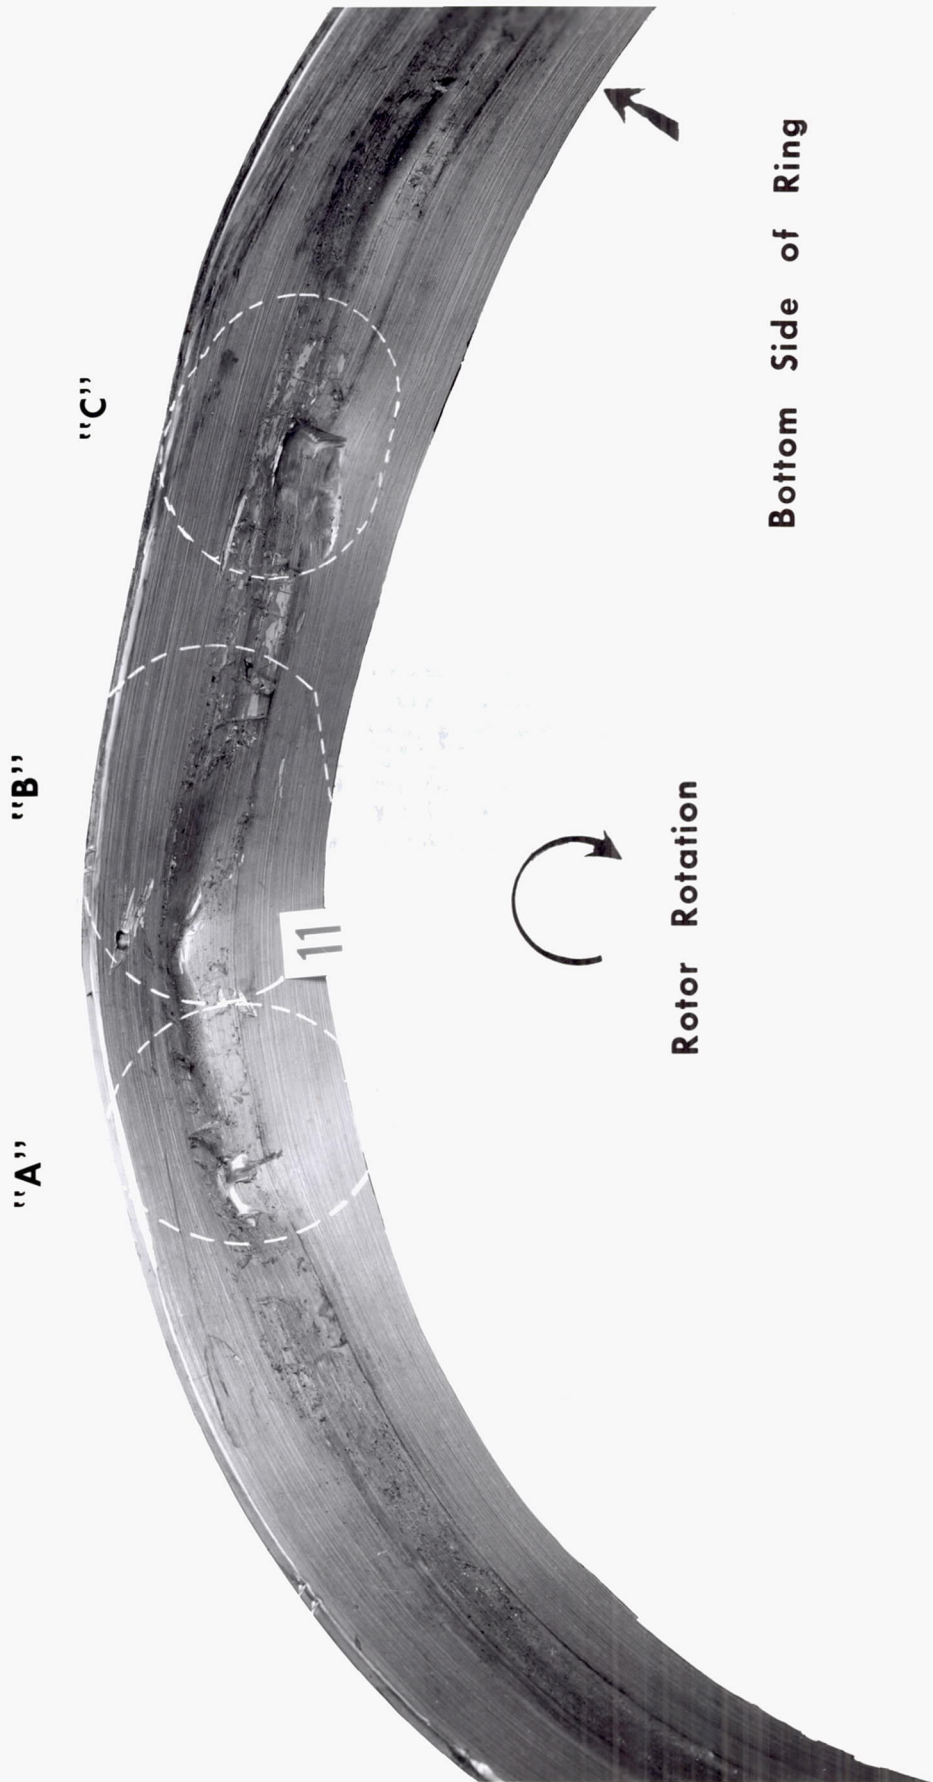
POST-TEST NO. 11
CONTAINMENT RING-DETAIL OF IMPACTED AREA

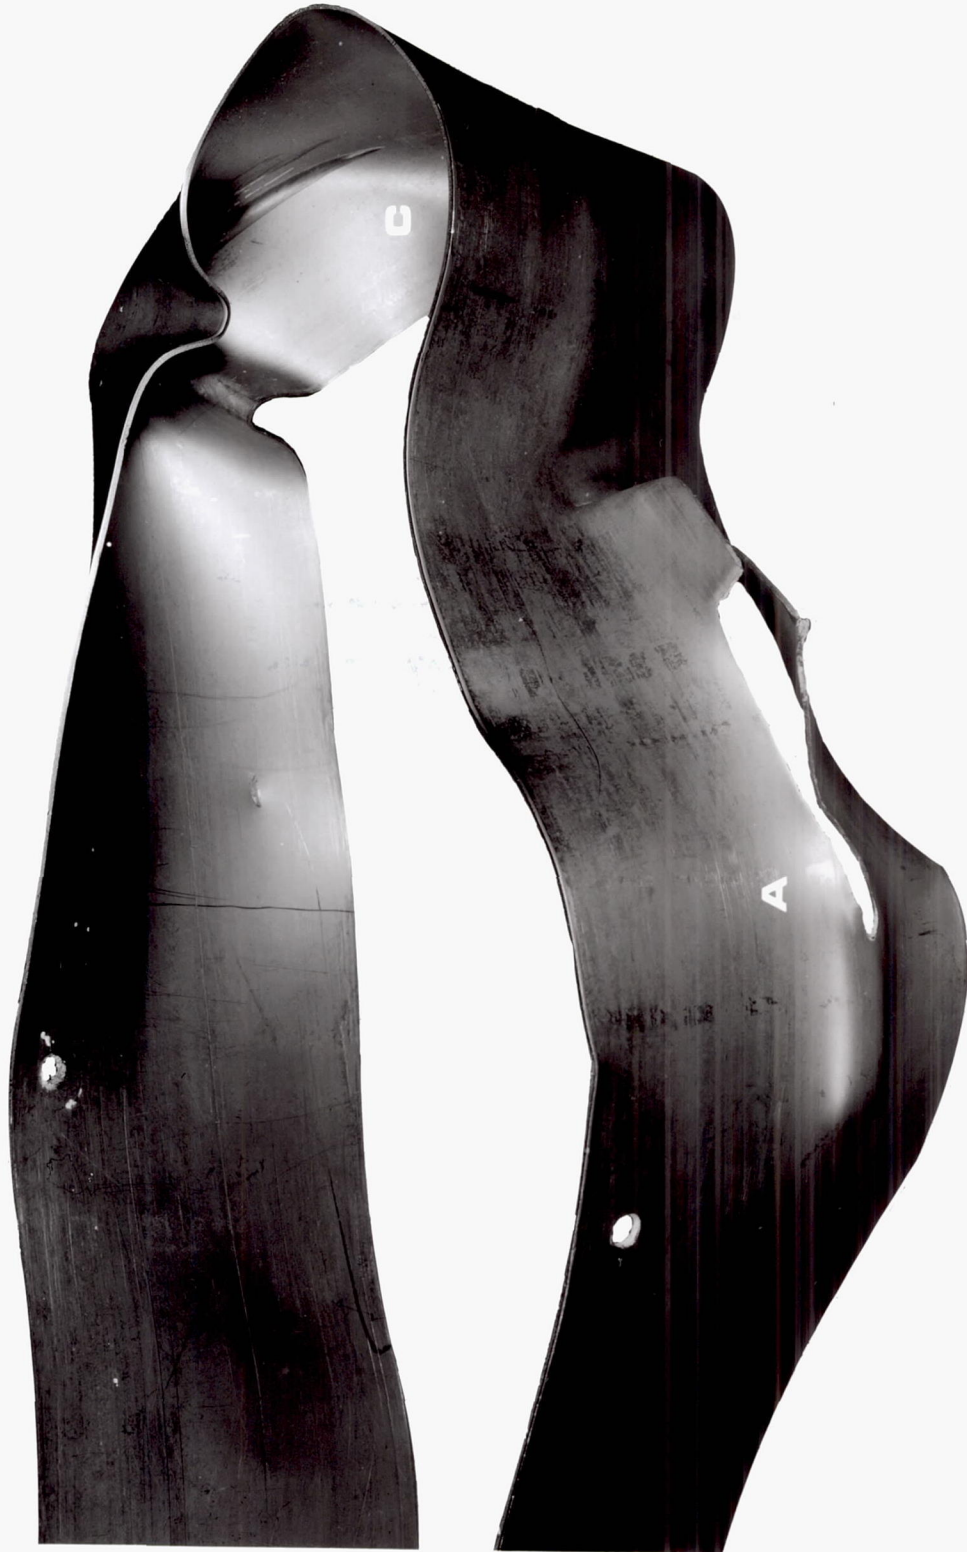
POST-TEST NO. 4
CONTAINMENT RING- FRAGMENT A IMPACTED AREA

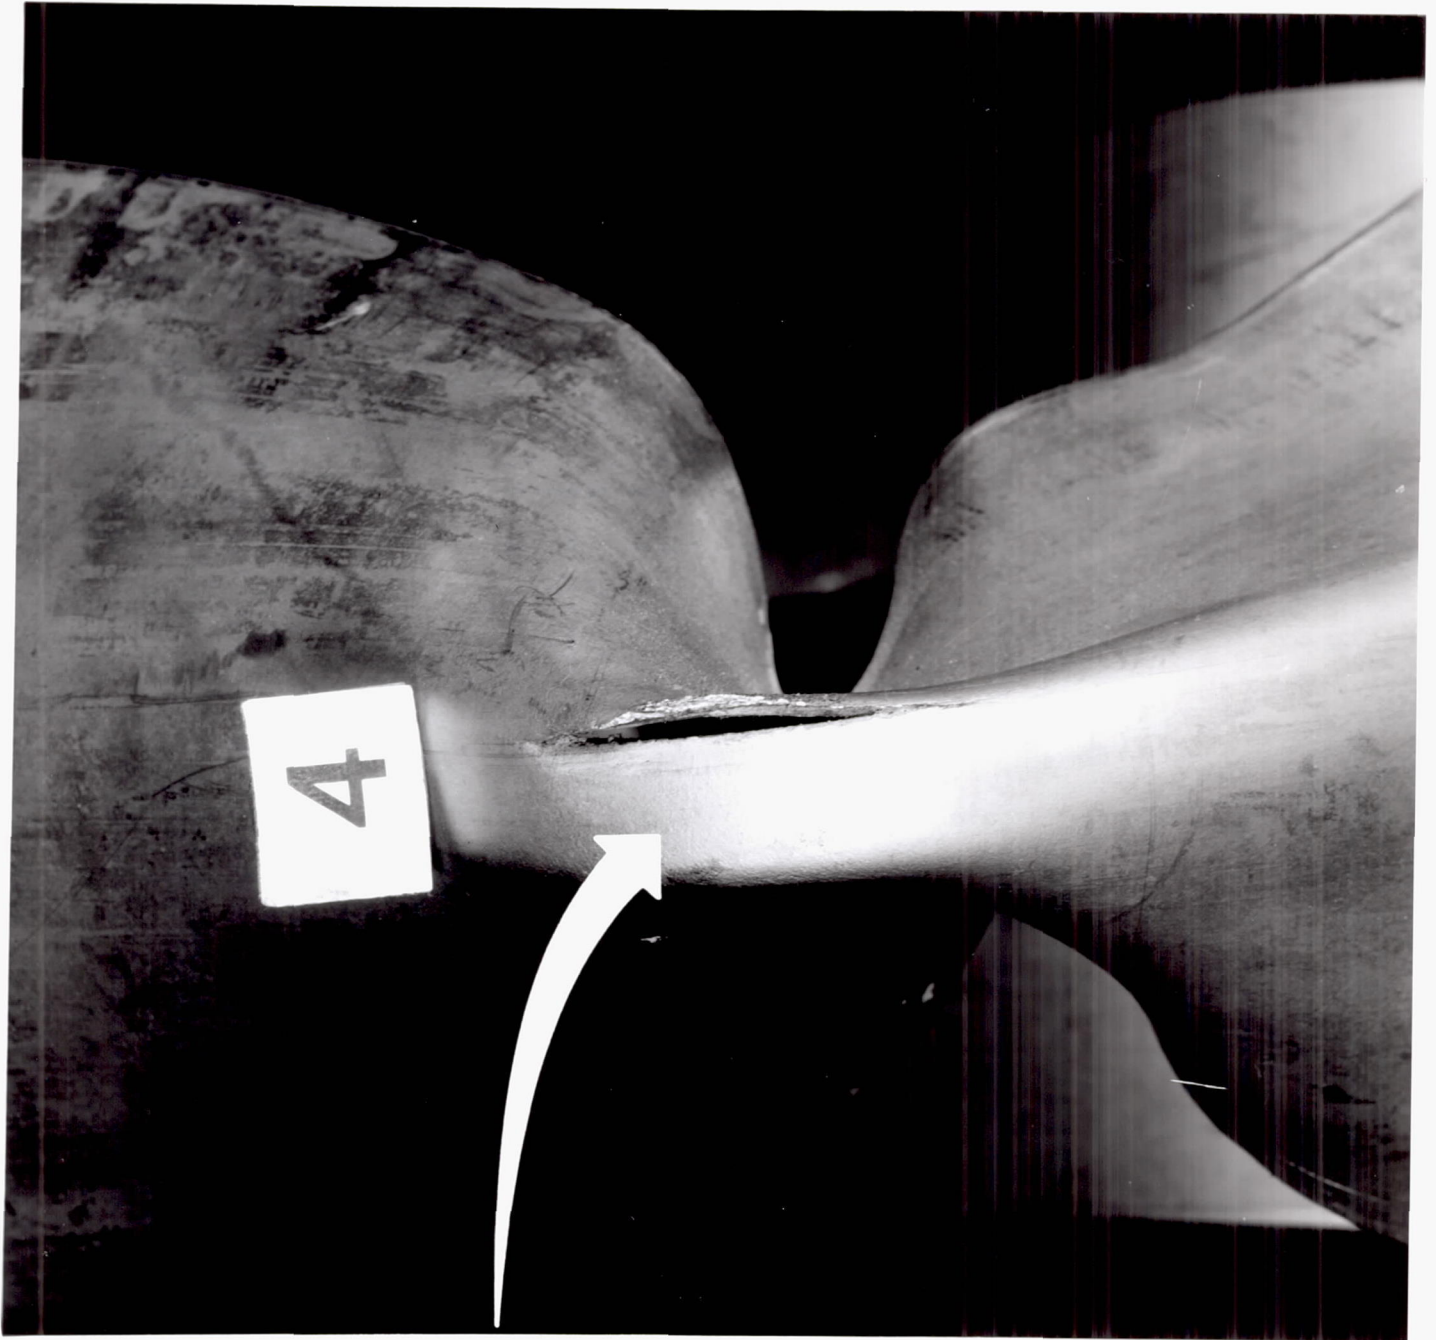
POST-TEST NO. 4
CONTAINMENT RING-
FRAGMENT C IMPACTED AREA

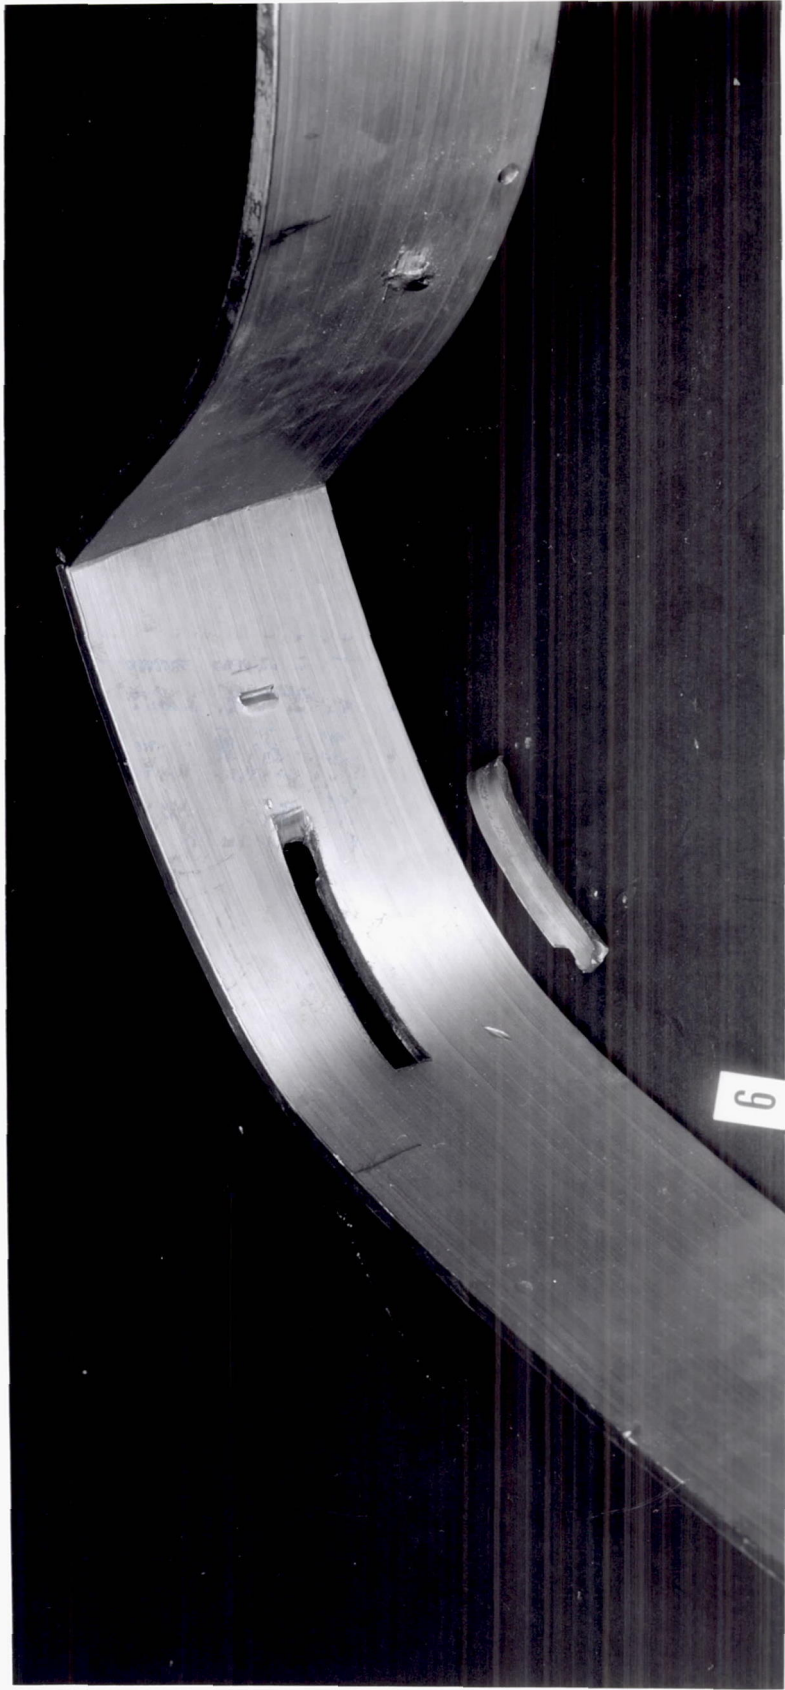
FRAGMENT C IMPACTED AREA
POST-TEST NO. 6 CONTAINMENT RING

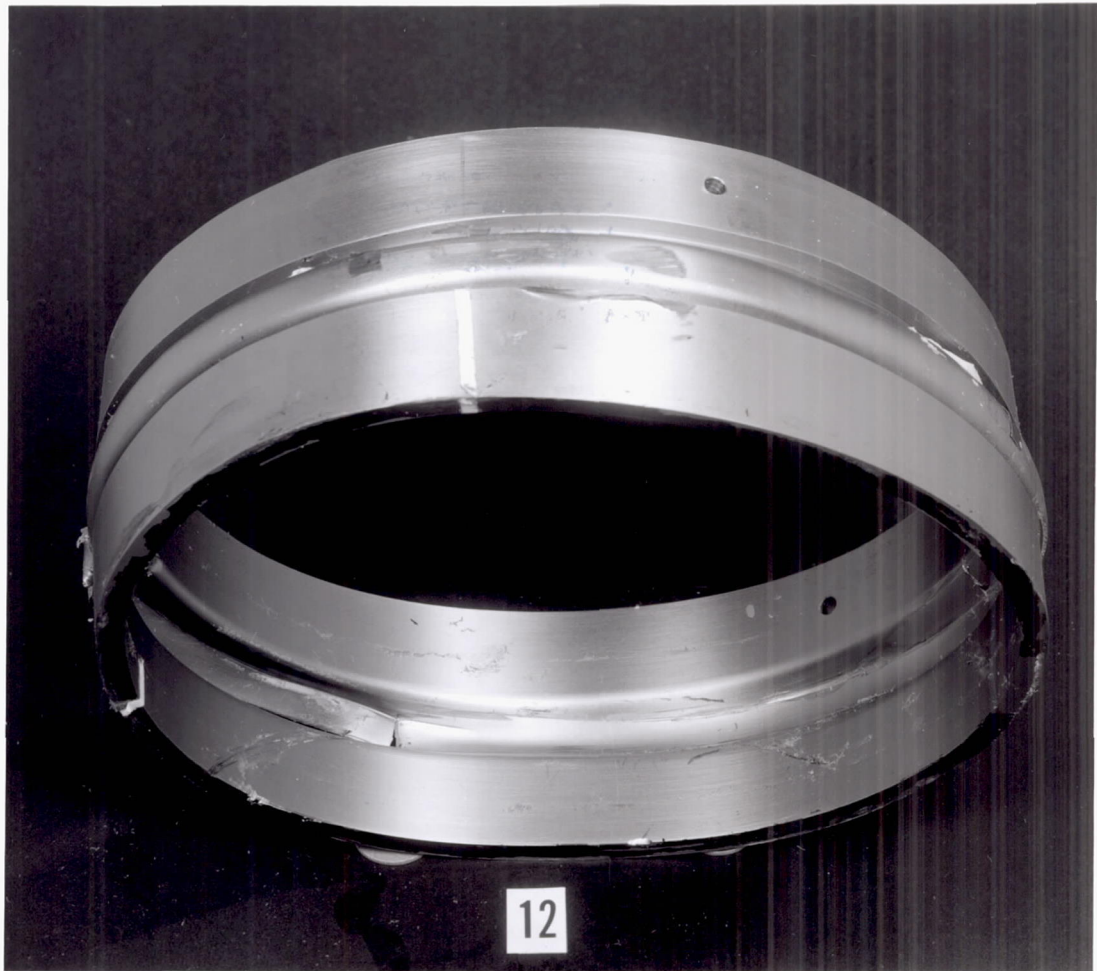
POST-TEST NO. 12 CONTAINMENT RING
BULGED-OUT CENTER SECTION

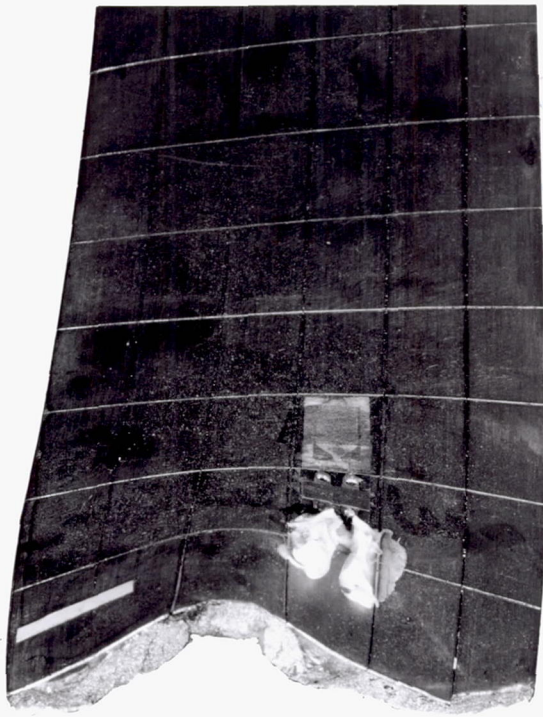
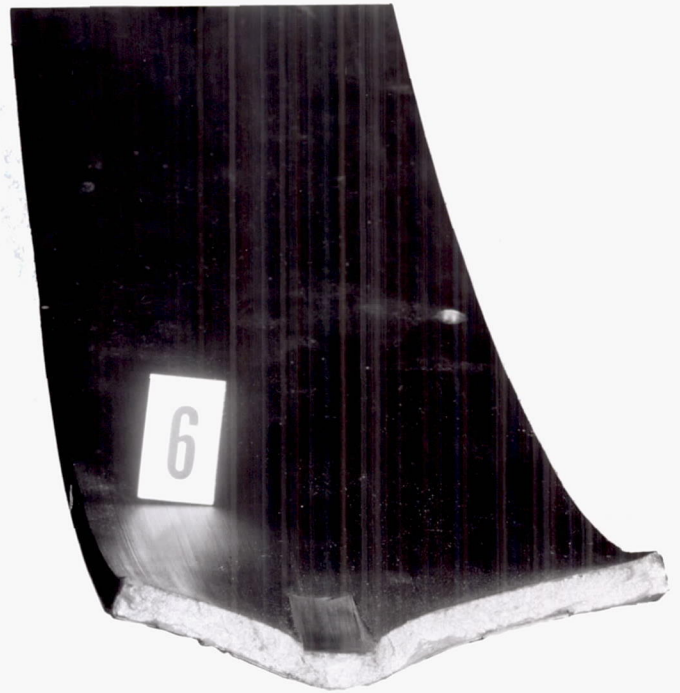
POST-TEST NO. 6 CONTAINMENT RING
FRAGMENT A IMPACTED AREA

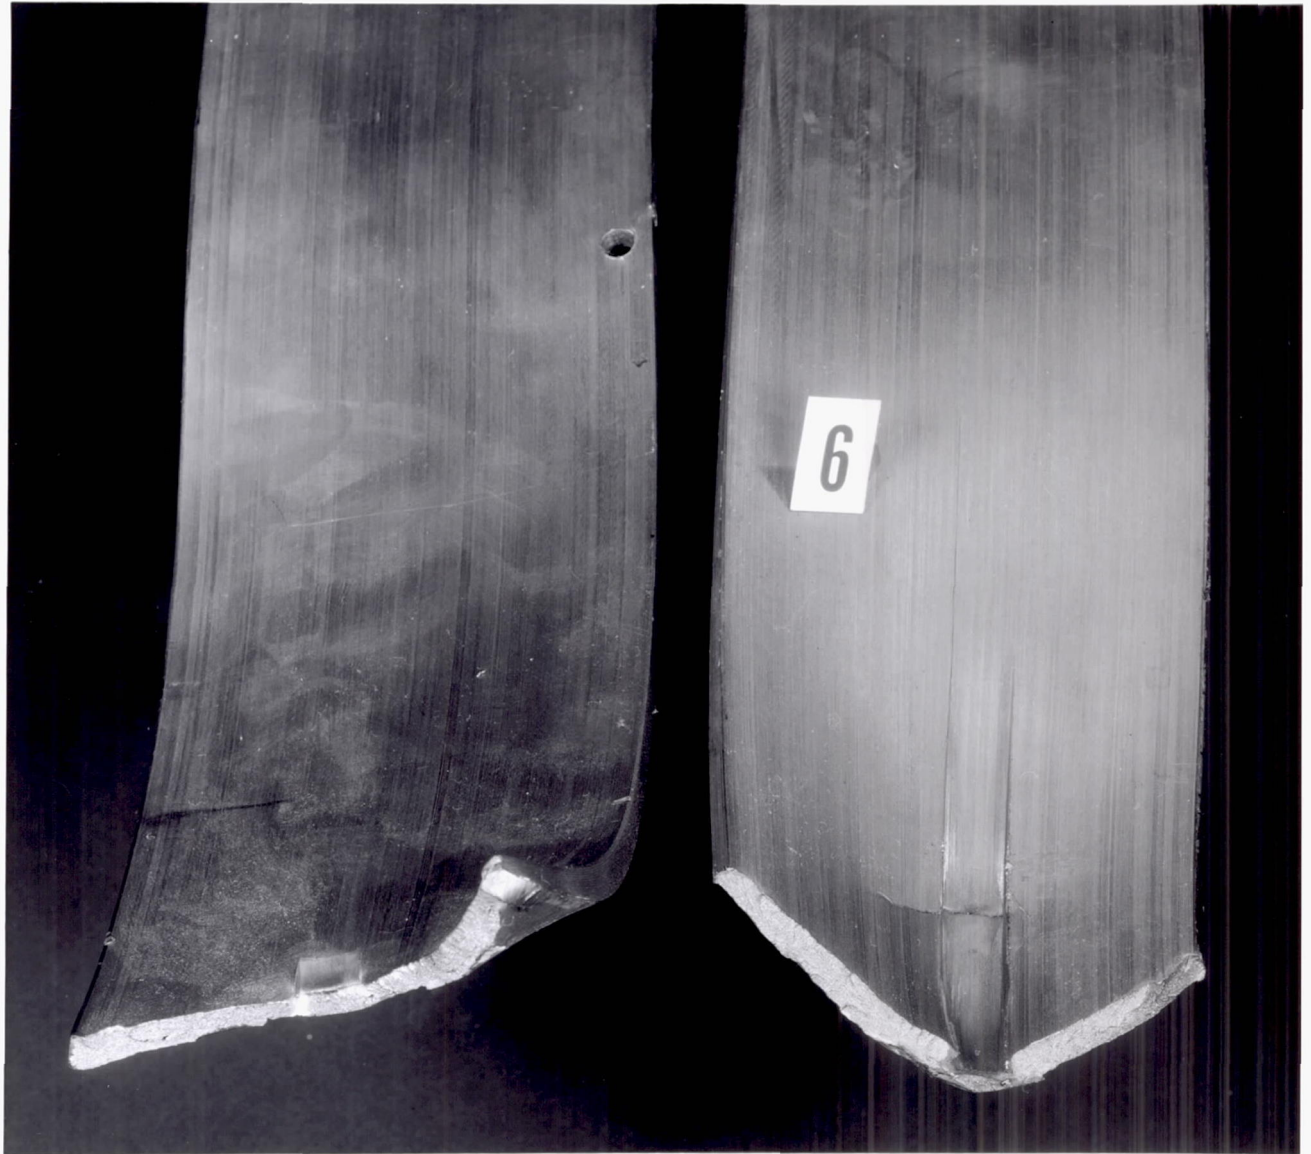
POST-TEST NO.6 CONTAINMENT RING
FRAGMENT B IMPACTED AREA

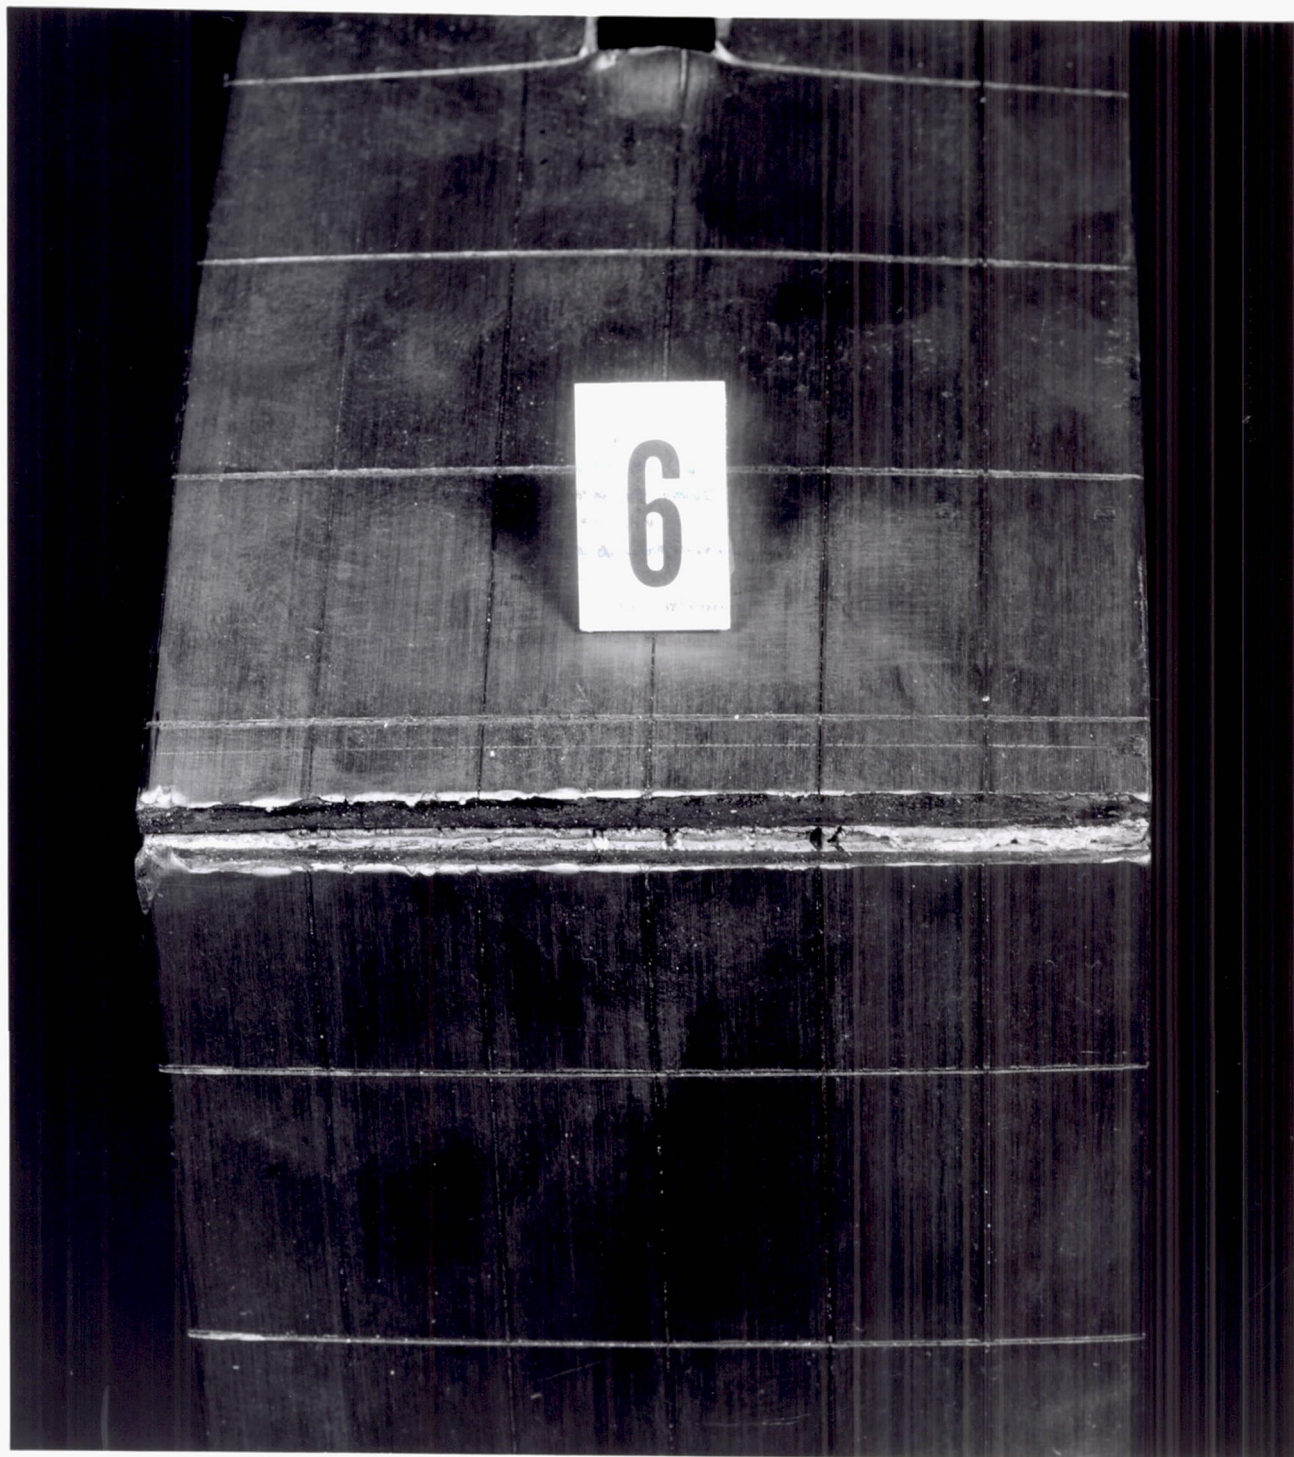
POST-TEST NO. 6 CONTAINMENT RING
FRAGMENT C IMPACTED AREA

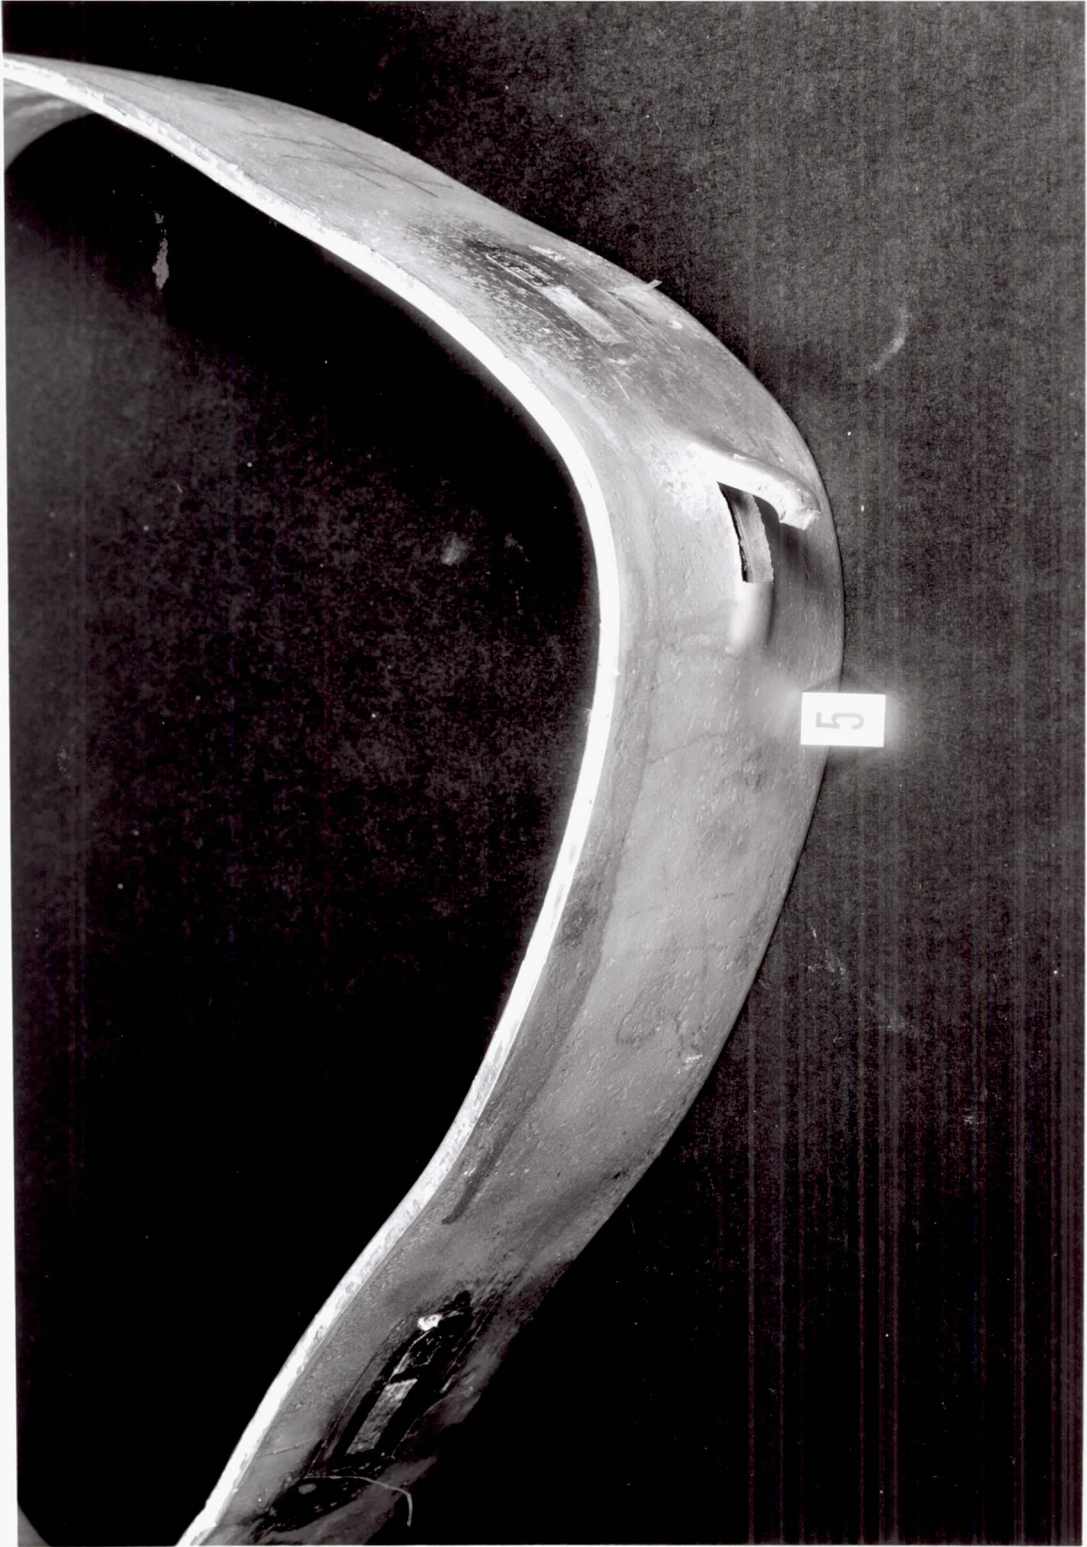
POST-TEST NO.5 CONTAINMENT RING
PERFORATED AREA

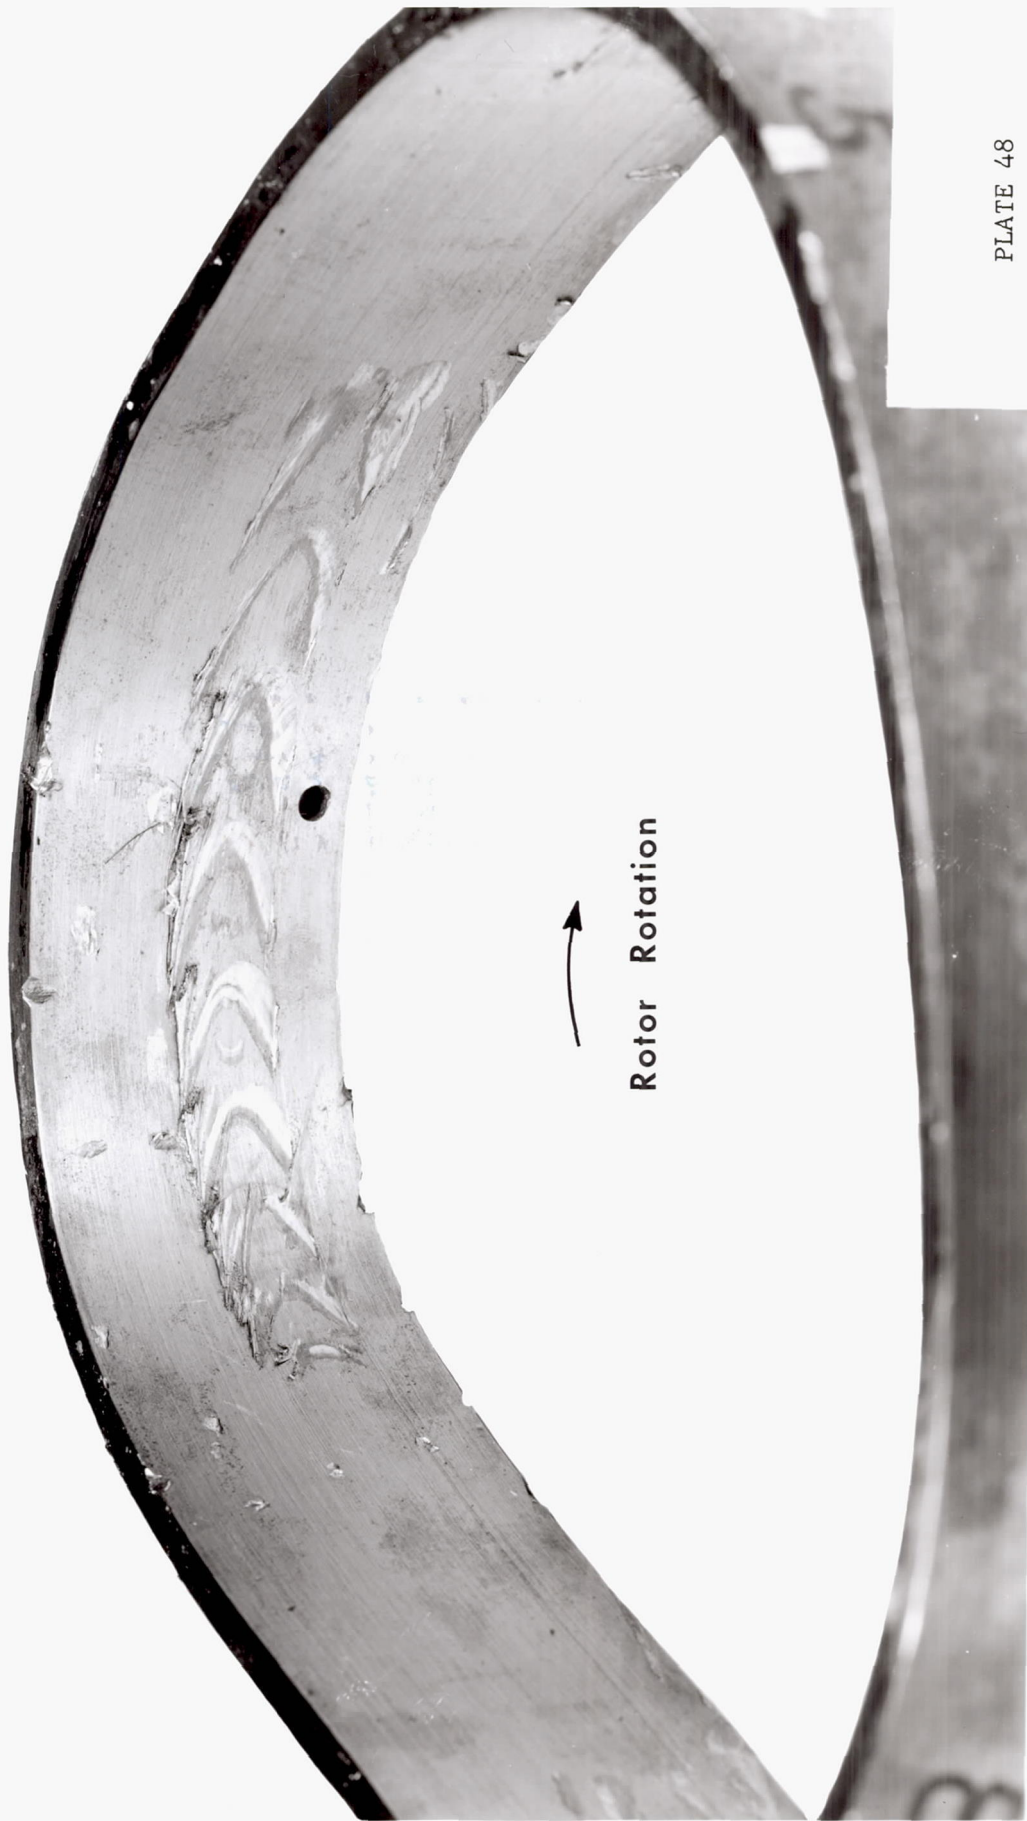
POST-TEST NO. 20
FRAGMENT INDENTATION OF INSIDE
SURFACE OF CONTAINMENT RING
