NAPTC-AED-1869

NAVAL AIR PROPULSION TEST CENTER
 AERONAUTICAL ENGINE DEPARTMENT
 NAVAL BASE, PHILADELPHIA, PA. 19112
 NAPTC-AED-1869 5 APR 1968

ROTOR BURST PROTECTION PROGRAM
 INITIAL TEST RESULTS

PHASE IV - FINAL REPORT
 PROBLEM ASSIGNMENT NASA DPR R-105

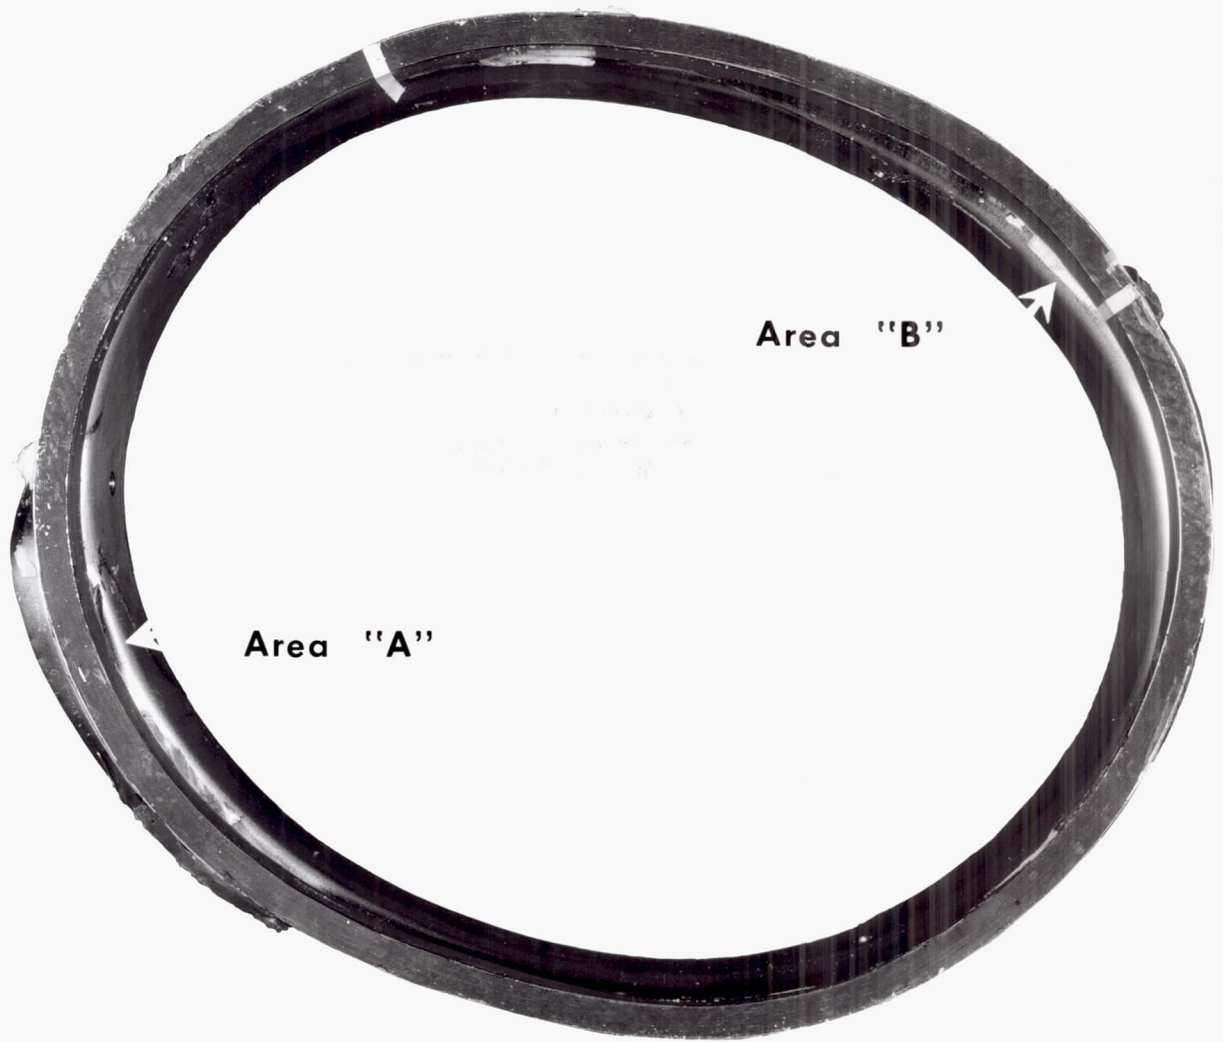
POST-TEST NO. 20
CONTAINMENT RING DISTORTION

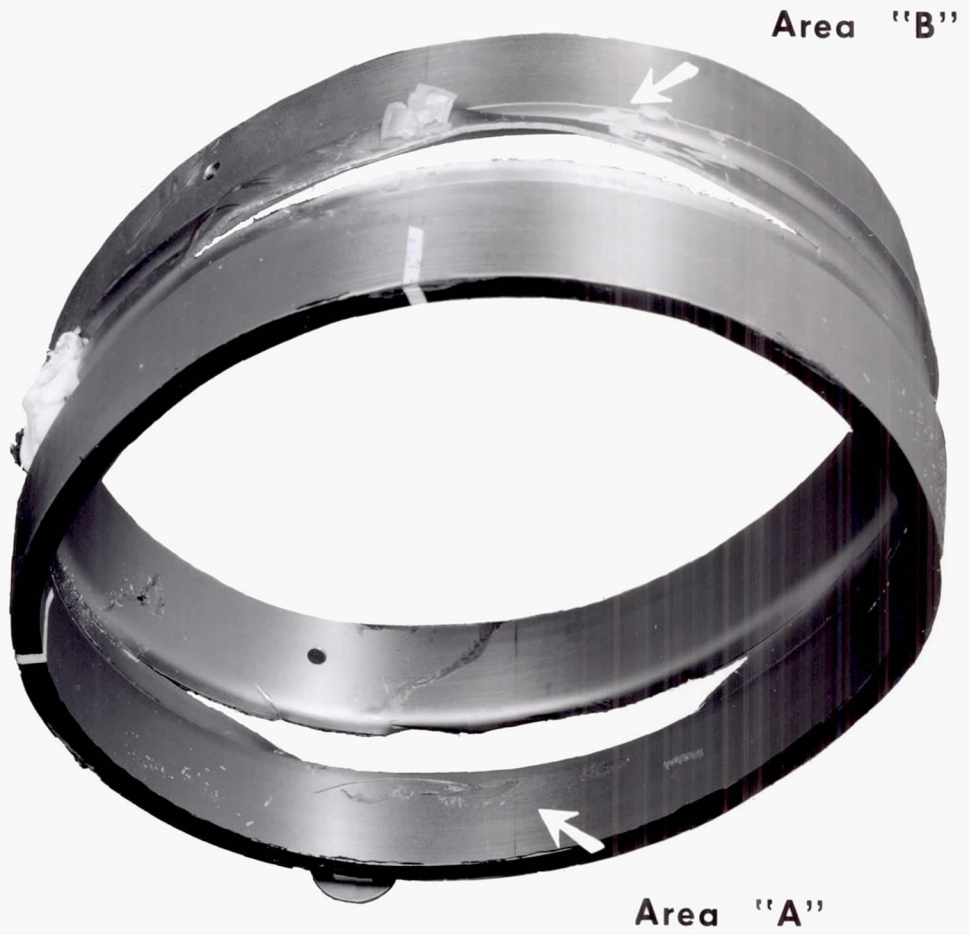
POST-TEST NO. 13
CONTAINMENT RING DETAIL OF OPENINGS

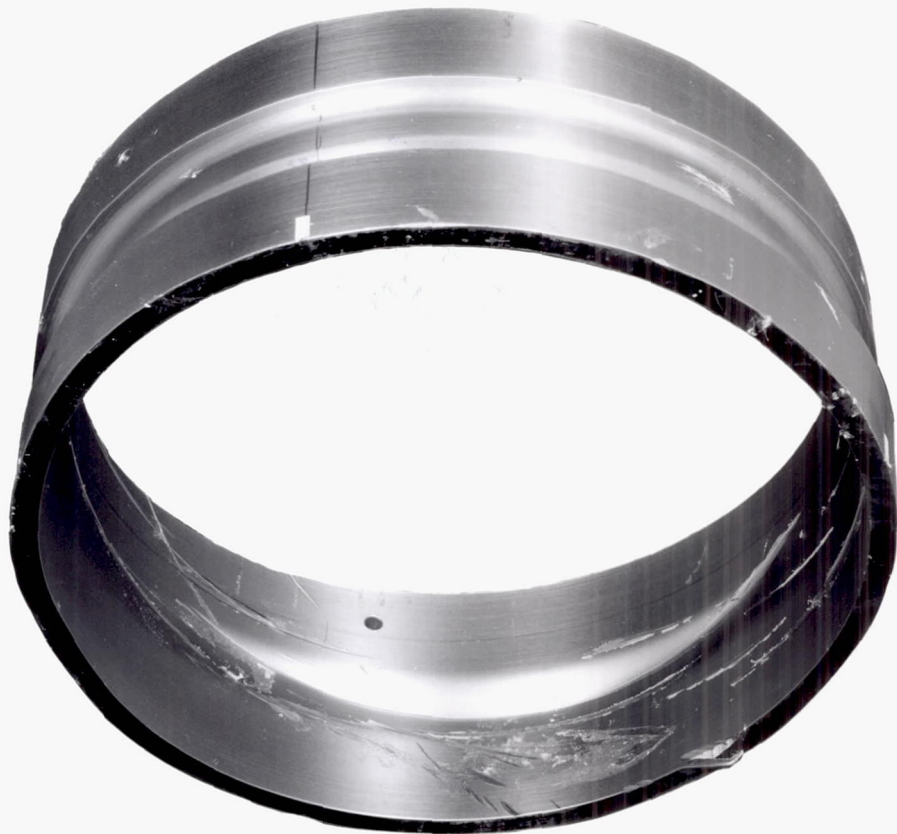
POST-TEST NO. 15
CONTAINMENT RING INDENTATION DETAILS
