27. RESULTS FROM STUDIES OF HIGHWAY GROOVING AND TEXTURING BY SEVERAL STATE HIGHWAY DEPARTMENTS

By Larry G. Mosher
Clipper Manufacturing Company

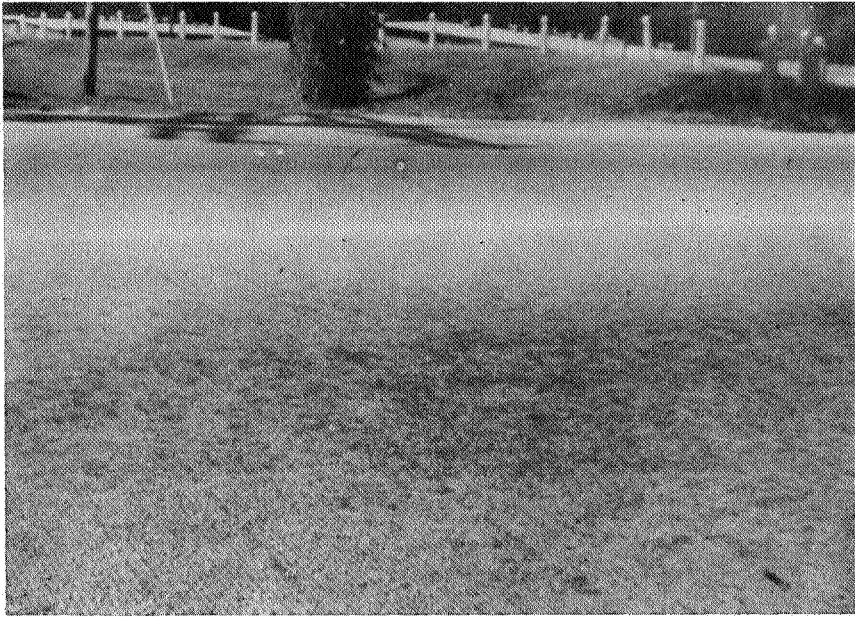
Much concern has been expressed about grooves in asphalt pavement losing their effectiveness by the flowing back together of this flexible material, particularly during hot weather. This result has been observed under certain conditions when a fairly new asphalt pavement or a pavement with a low aggregate content has been grooved. This condition seems predominant at locations subjected to power steering of the vehicle while it is stopped. Older asphalt pavement with high aggregate content seems to hold up very well. The pavement in St. Louis, Missouri, has been subjected to two summers and one winter of intersection traffic and looks almost as good as it did when the grooves were placed there 18 months ago. (See fig. 9.)

Figure 9.- Grooved pavement in St. Louis, Missouri.
