## 18. PAVEMENT GROOVING AT JOHN F. KENNEDY INTERNATIONAL AIRPORT

By I. J. Dornfeld and James P. Muldoon

Port of New York Authority

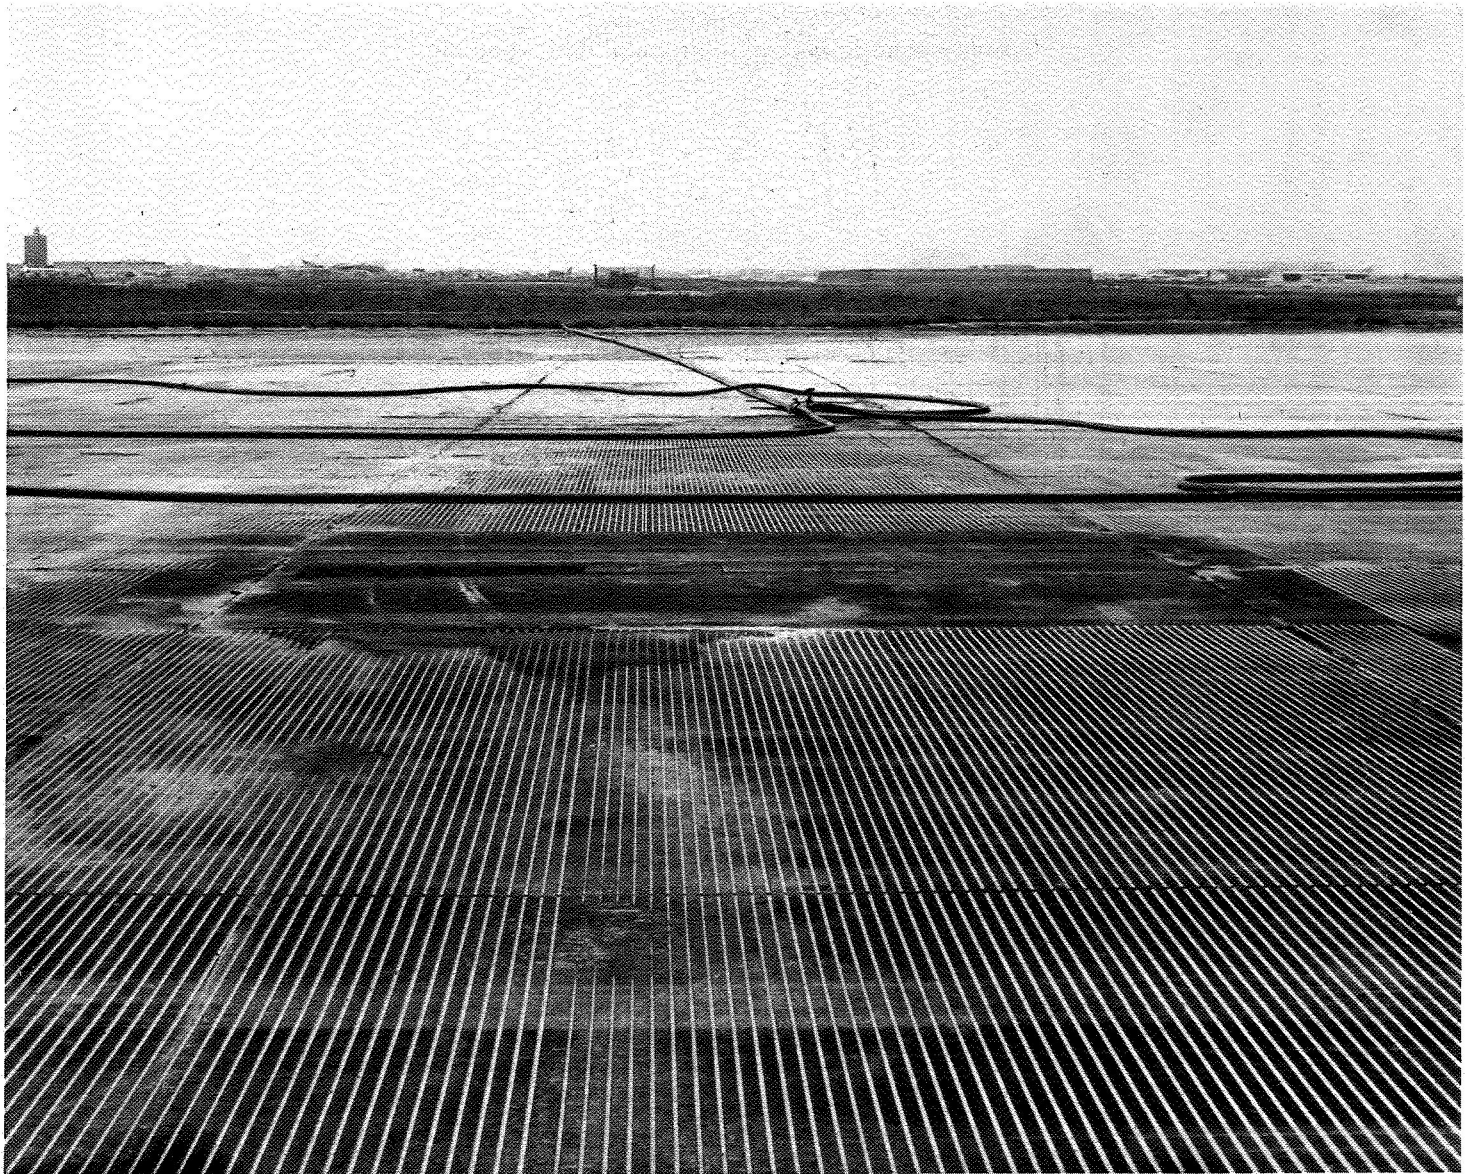
While it was recognized that grooving might be limited to the area in which hydroplaning was most likely to occur, the exclusion of any one portion of the runway was difficult to justify. The fact that the runway was used extensively in both directions extended the area of potential hydroplaning, leaving only relatively small areas at each end of the runway free of this problem. It was therefore decided to groove the entire runway, omitting only the concrete slabs that contained the Elfaka light units (see fig. 2) which, at that time, were the principal components of both the centerline and touchdown in-pavement lighting systems. (The centerline Elfakas have since been replaced by newer pancake-type fixtures.) Also omitted was the outer 5 feet of the runway pavement on each side to facilitate the turnaround of the cutting equipment without damage to shoulder pavement or runway edge lights.

Figure 2.- Grooved runway with ungrooved slabs containing Elfaka light units.

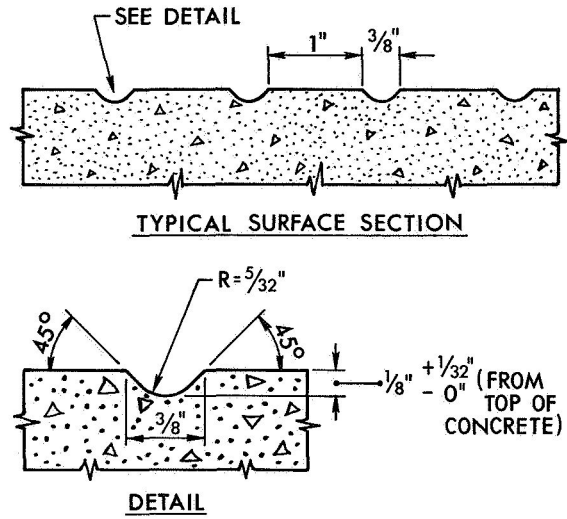
rectangular groove in withstanding spalling caused by the freezing of entrapped water, since its shape would permit the expanding ice to move up and out of the groove rather than bear against the sides. The tests, while not extensive, did confirm the superiority of the V-groove in this respect. It was also believed that the V-groove would offer greater resistance to spalling or raveling during construction, as well as in an operating environment, by virtue of its lack of right-angled edges. The V- or sinusoidal-shaped groove illustrated in figure 3 was therefore chosen.

Figure 3.- Cross section of runway grooves.

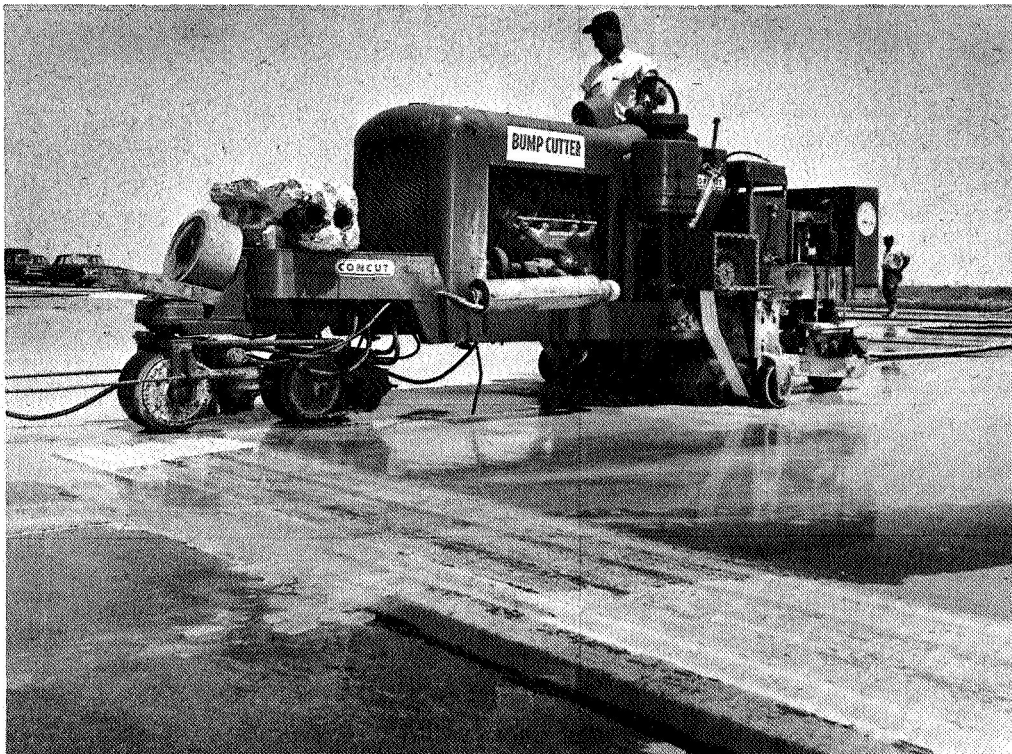
The contract for the work was awarded in early 1967 to Master Waterproofers, the lowest of three bidders, in the amount of \$157 490, or about \$0.13 per square foot. The contractor started work on May 1, 1967, and used two groove cutters manufactured by Concut, Inc., of El Monte, California. These machines, one of which is shown in figure 4, were self-propelled and employed a 38-inch-wide rotating drum with diamond-impregnated cutting elements to establish the groove pattern. The production of each machine was somewhat less than the 20 000 square feet per day that can be anticipated on highway work because of the numerous turnarounds required in a transverse grooving operation, as contrasted with the longitudinal highway operation, as well as the requirement to vacate the work area whenever required by the aeronautical operation.

Figure 4.- Groove cutting at John F. Kennedy International Airport.

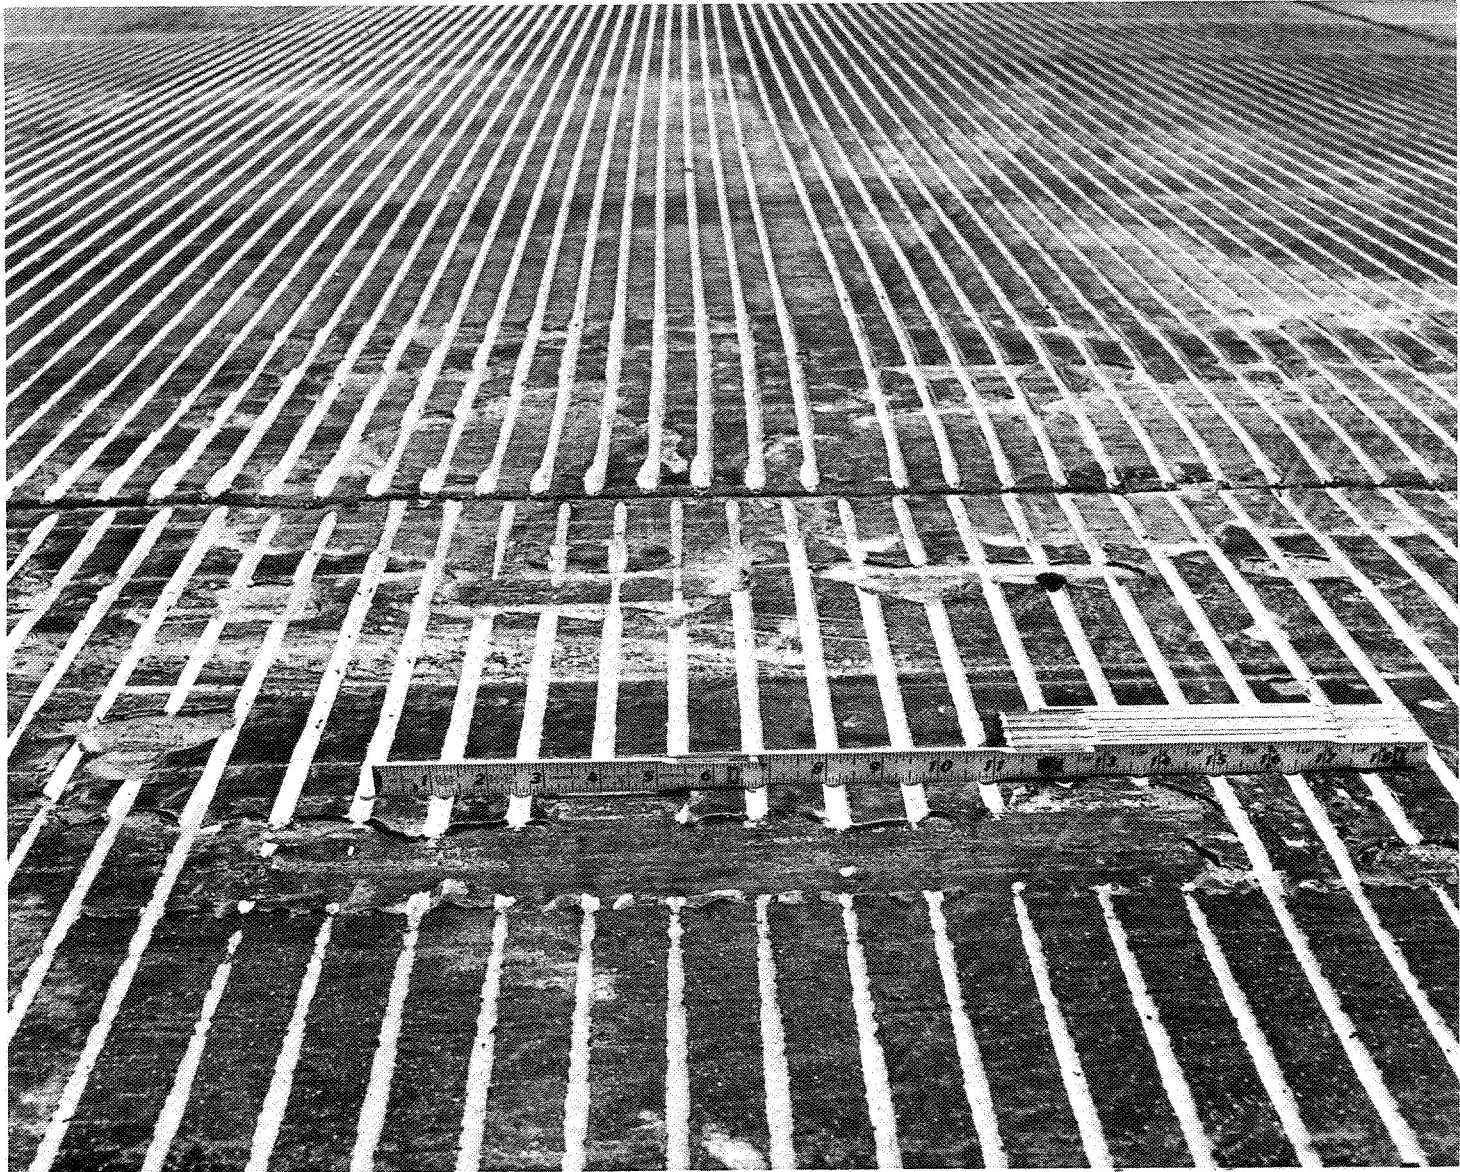
Another problem to be considered in the grooving of runways that accommodate a high volume of landings is the handling of paint buildup. With the number of operations on both runways 4R and 22L, the accumulation of rubber deposits can require the repainting of the threshold portion of each runway as often as four times a year. In some areas, the buildup of sandwiched layers of paint and rubber deposits exceeded the 1/8-inch groove depth. In these areas, large sections of the surface tended to peel off after the grooving operation, leaving ungrooved spots. This condition is depicted in figure 5. The best remedy for this problem was found to be the grinding off of these build-ups prior to the grooving operation with a "Bump Cutter" manufactured by Concut.

Figure 5.- Ungrooved areas left by peeling of paint and rubber deposits.
