15. A SURVEY OF THE EFFECT OF GROOVED RUNWAY OPERATIONS ON THE WEAR OF COMMERCIAL AIRLINE TIRES

By James M. Petersen

Thompson Aircraft Tire Corporation

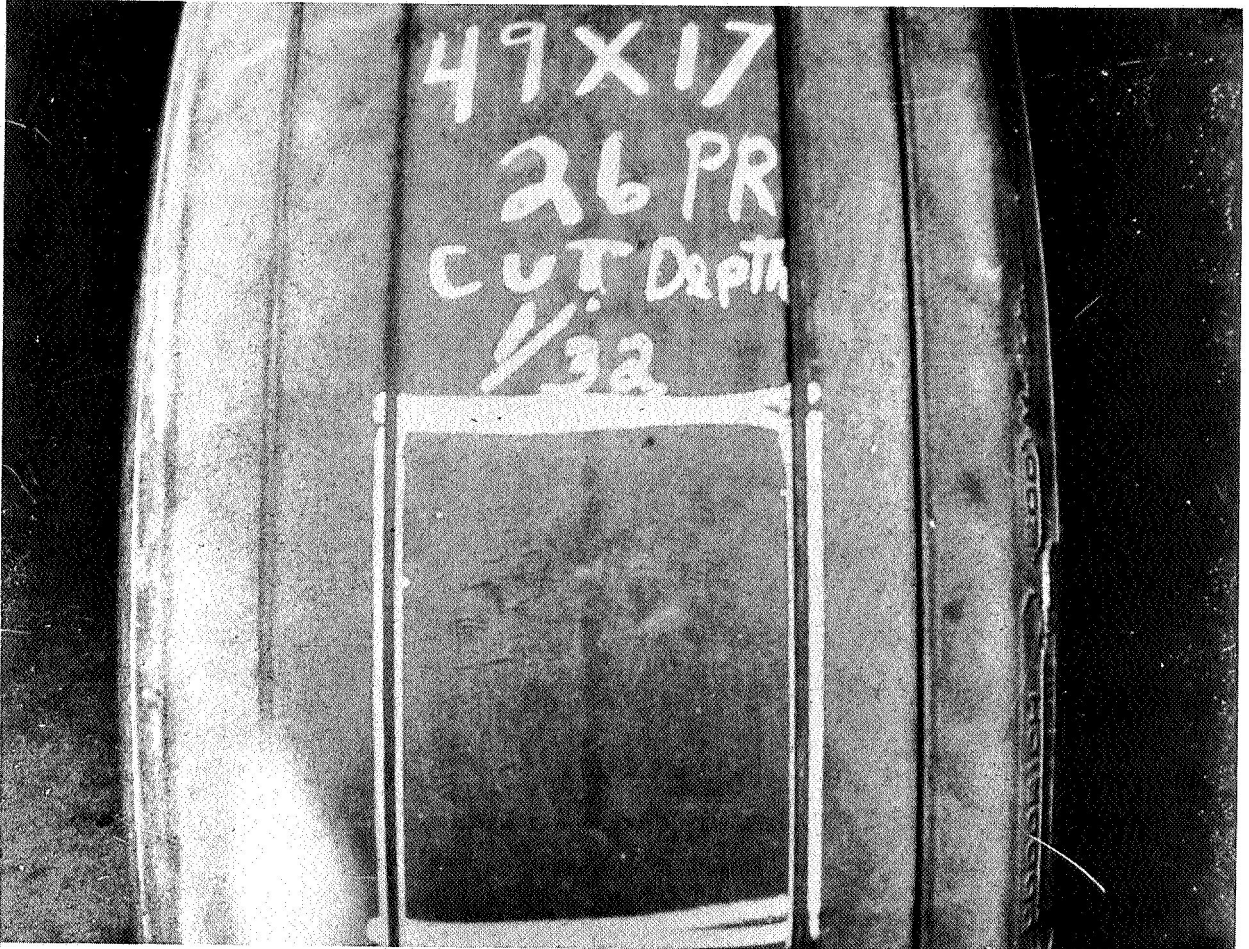
Figure 1.- 49 × 17/26 ply rating tire.

Photographs of 49 × 17 commercial aircraft tires showing examples of chevron cutting are presented as figure 1. This type of cutting is rather superficial and was not the cause of tire removal. Since the tires have been observed for indication of grooved runway effects other than the chevron cuts, no other common wear characteristic has been noted. As can be seen in the photographs, the chevron cuts in some tires appear to have been worn away by normal operations. From the observations the commercial
