13. SOME EXPERIENCE WITH TIRE WEAR AND DAMAGE ON GROOVED RUNWAYS

By Robert H. Hout

Hill Air Force Base

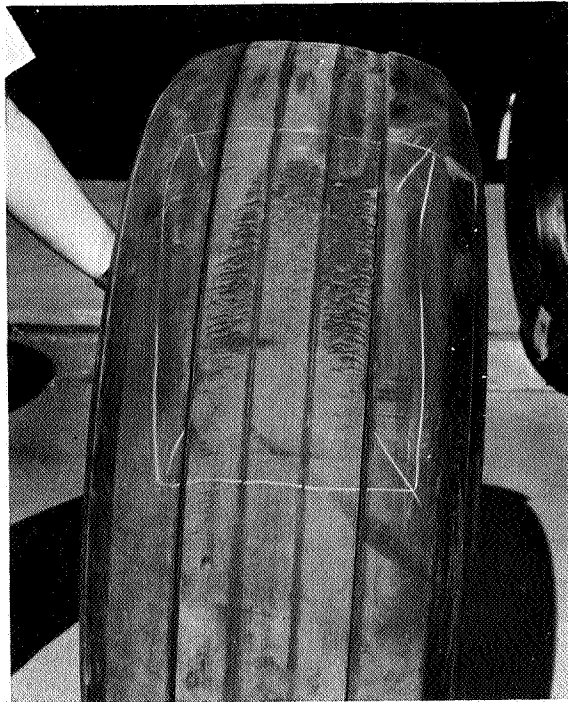
Figure 1

Some recent published reports are claiming extensive improvements in traction with no tire damage during braking on grooved runways at slip ratios up to and well beyond peak braking. Contrary to these published reports, the Air Force is experiencing considerable damage, such as depicted in figures 1, 2, and 3, to cargo- and bomber-type aircraft tires. Considerable damage is also being inflicted on tires on some aircraft that are performing only touch-and-go training missions. This damage is being experienced on both new and retreaded tires.
