DOCUMENT NO. T5-6539-103

TITLE ANALYSIS OF TOOLING BOSS WELD FAILURE IN THE LOWER BULKHEAD  
OF THE S-IC-S FUEL TANK

MODEL NO. SATURN V/S-IC CONTRACT NO. NAS8-5608

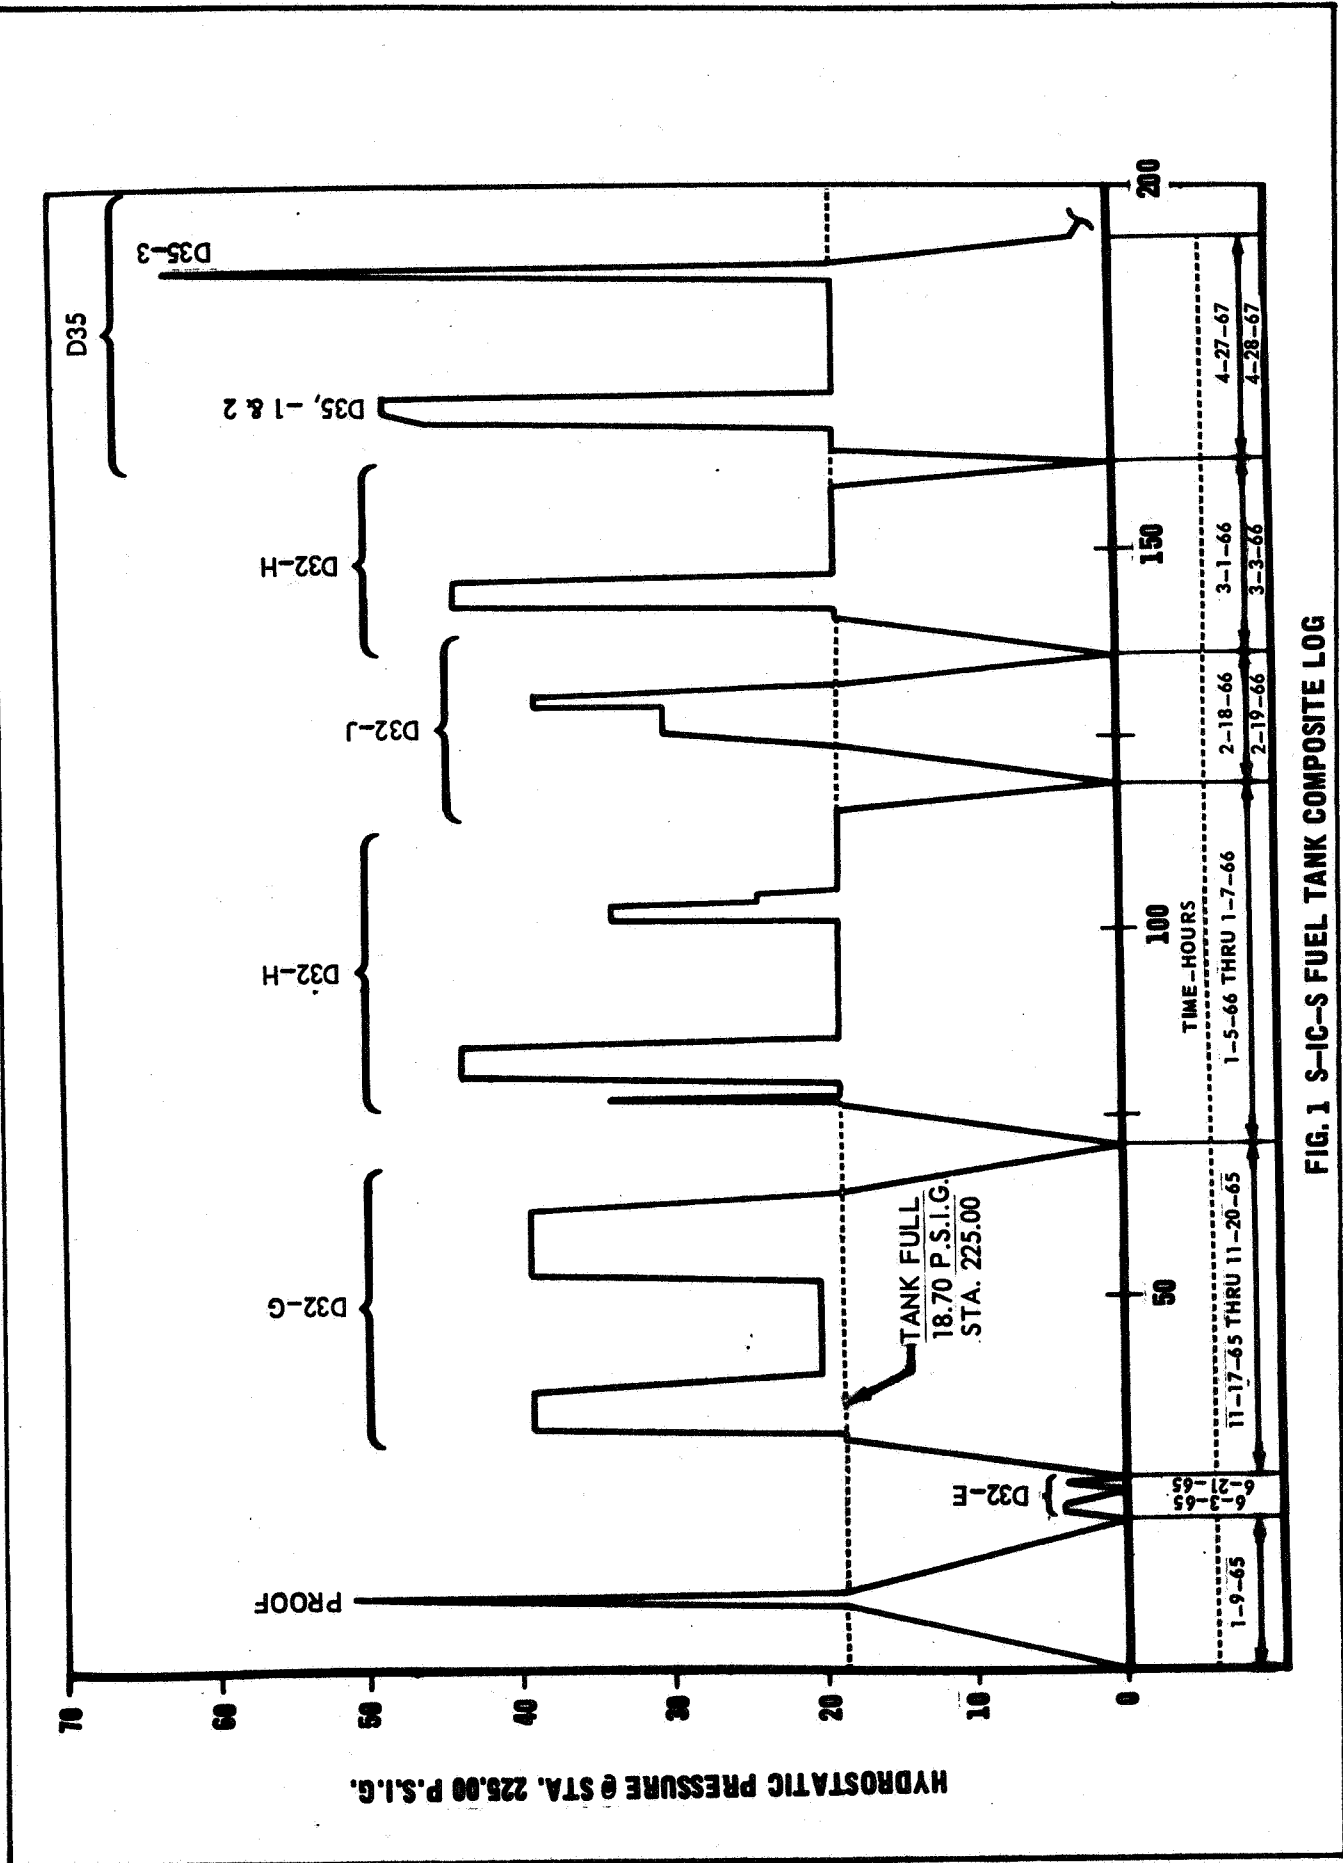
FIG. 1 S-IC-S FUEL TANK COMPOSITE LOG

Figure 1 is a testing log for the S-IC-S Fuel tank as reported in D5-11973 "S-IC Stage Major Structural Test Program"

The presence of much porosity in the weld and the use of extreme heat during multiple repair welding lowered the properties of the weldment to such an extent that it could not withstand the Ultimate Test Pressure of 62.5 psig after pressure cycling as shown in Figure 1. It is probable that the condition of this weld was unique to the S-IC-S Fuel Tank.

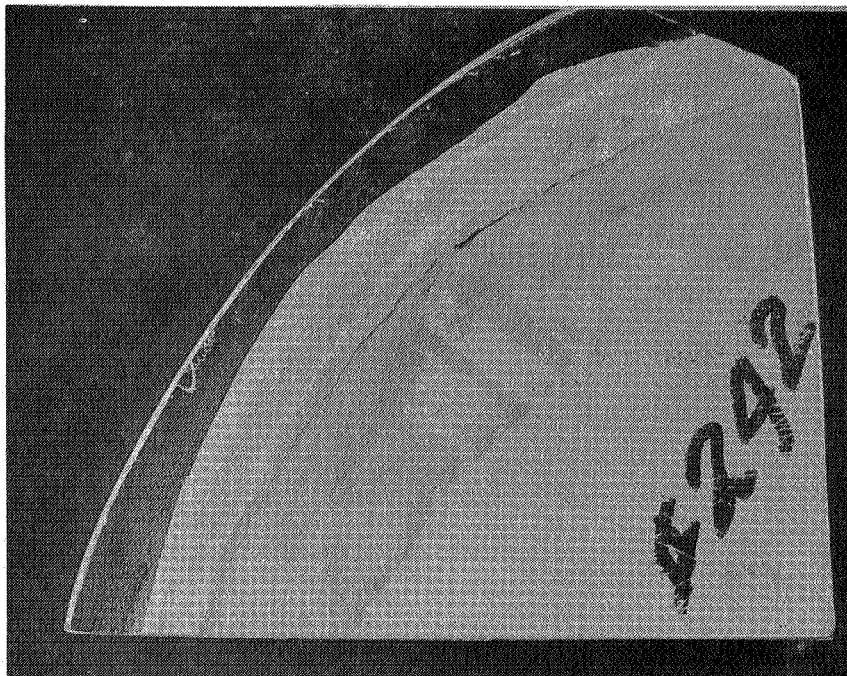
FIGURE 2 - WELD SPECIMEN FROM TOOLING BOSS 1X

The weld specimen used in this analysis, Figure 2, was located in the tooling boss weld as shown in Figure 3. After x-raying the specimen, the fracture was broken open Figure 4 and the faces examined using a wide field stereoscope. Figure 5 shows two areas containing corrosion products and debris typical of the entire fracture length. Fracture origin could not be determined because of this condition. The x-ray indication of the crack was so massive that it obscured any other possible defects, Figure 6.

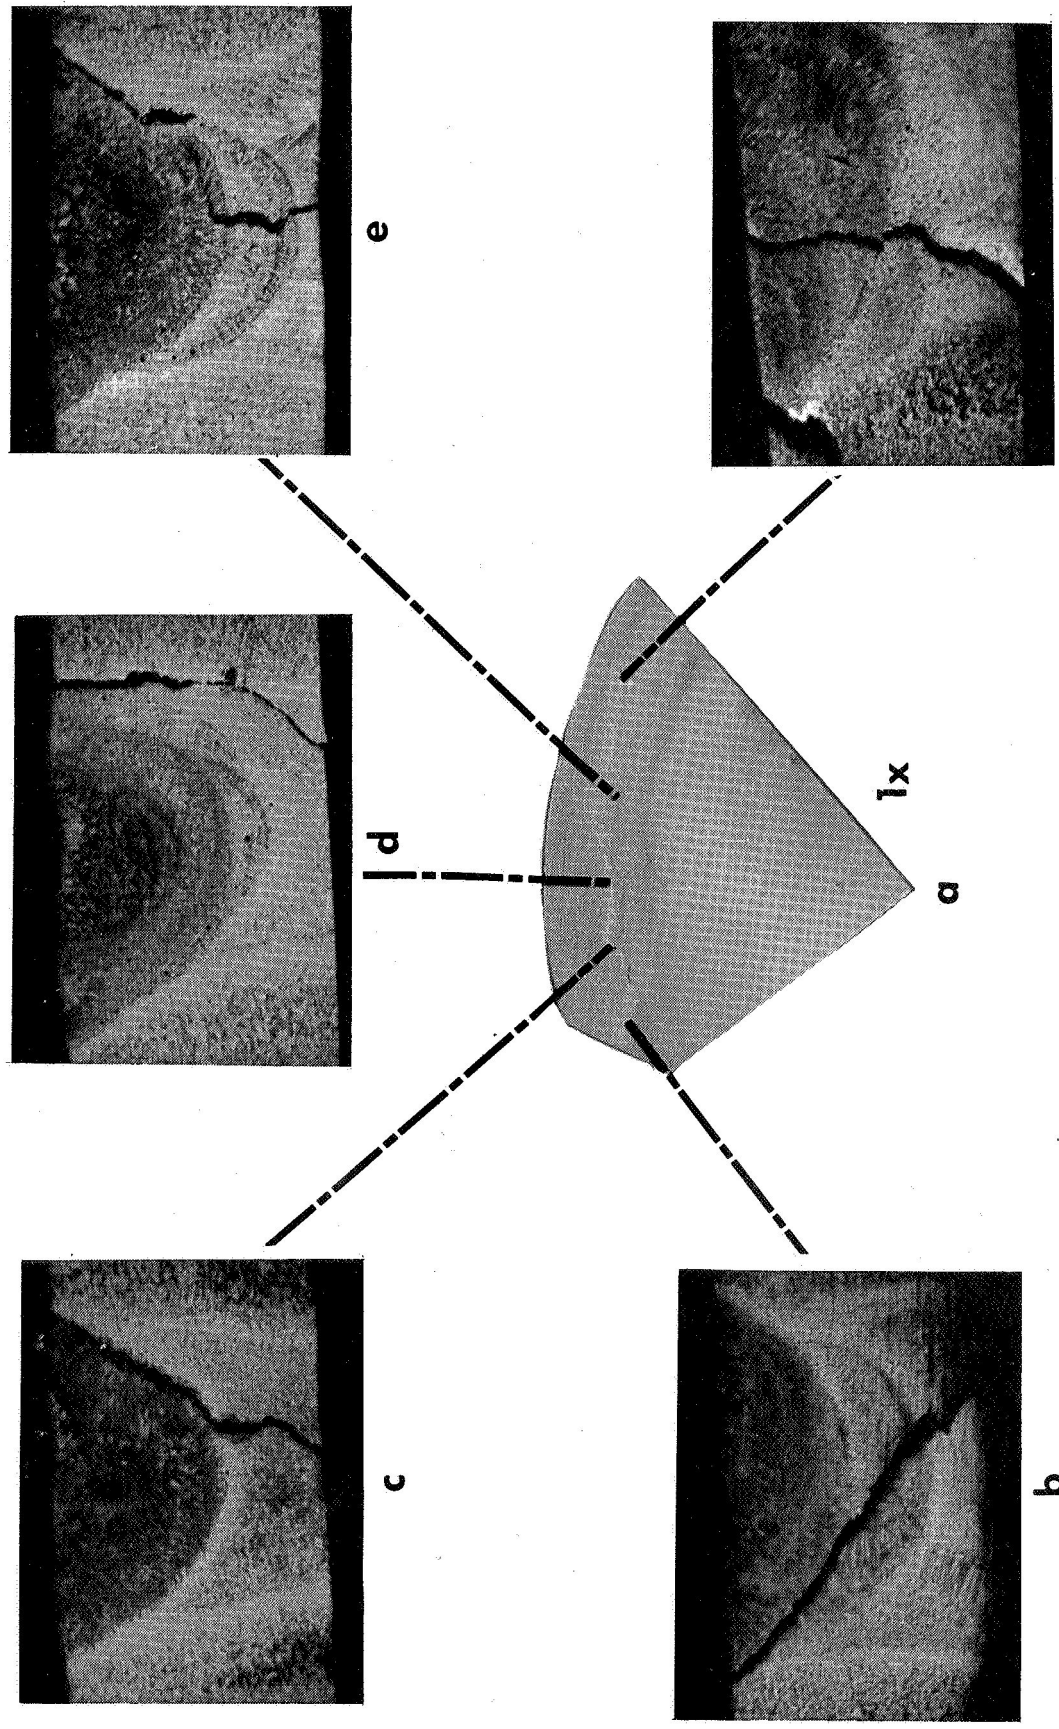
Fig.7 Macrographs of weld at several locations

The weld specimen was sectioned as shown in Figure 7a and the macrographic findings are illustrated by Figures 7b through 7f inclusive. It can be noted that the weld has been repaired one or more times dependent on location and considerable porosity is evident in figures nos. 7d, e and f. The conditions present in the right end of the weld suggest that the fracture origin occurred between 7d and 7f.

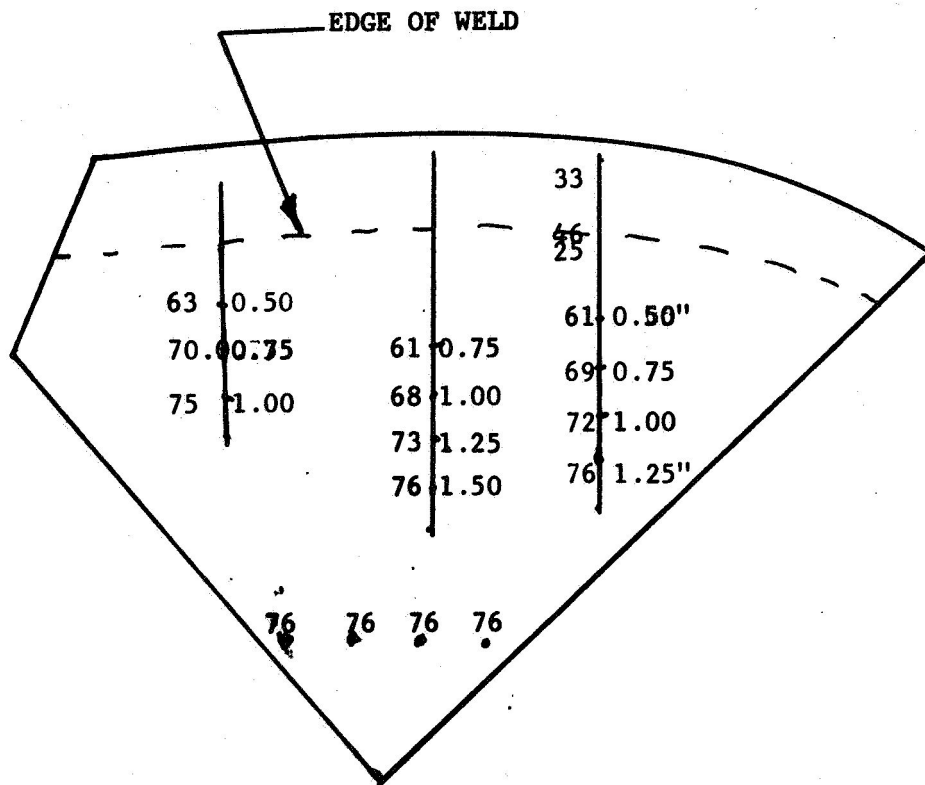
FIGURE 8 - HARDNESS READINGS R<sub>b</sub>

Hardness tests at four locations were made from the center-line of the weld out into the base metal to determine at which point base metal properties were recovered. Figure 8 contains the results of four traverses and reveal that recovery,  $R_c$  76, is between 1.25 and 1.50 inches from the weld. This indicates that extreme heat was used in making the weld and weld repairs which in conjunction with the aforementioned porosities, lowered the mechanical properties of this weldment sufficiently to allow failure under Ultimate Test Pressure conditions.
