MCR-67-15 (Issue 5)

STERILIZABLE LIQUID PROPULSION SYSTEM

Fifth Quarterly Progress Report

MARTIN MARIETTA CORPORATION

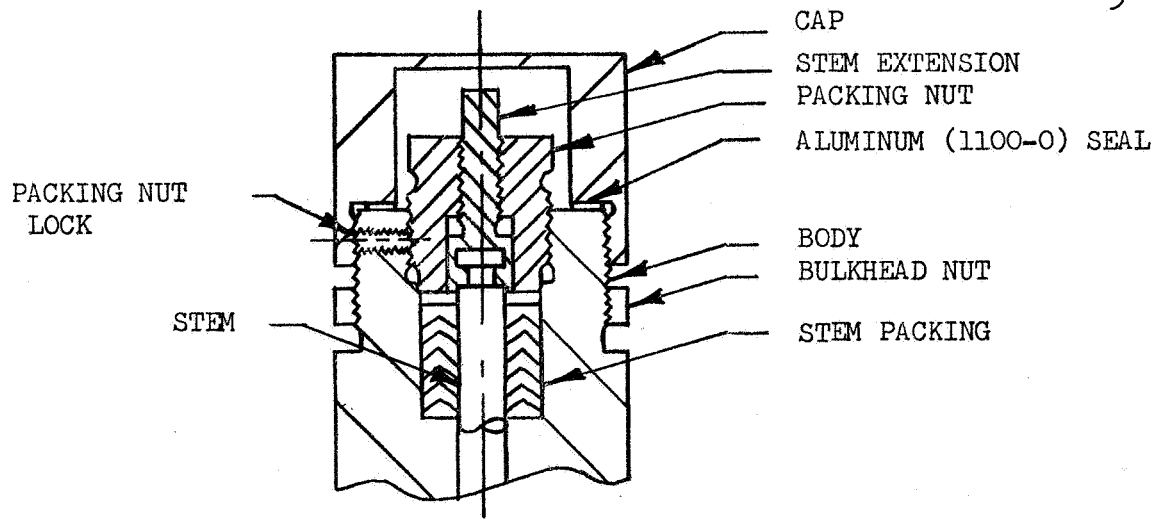
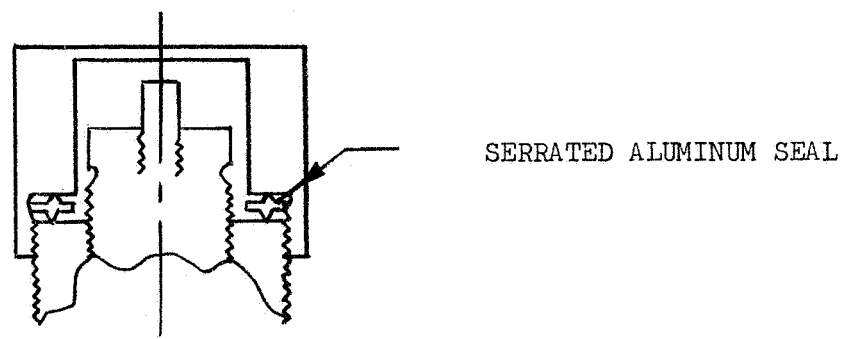
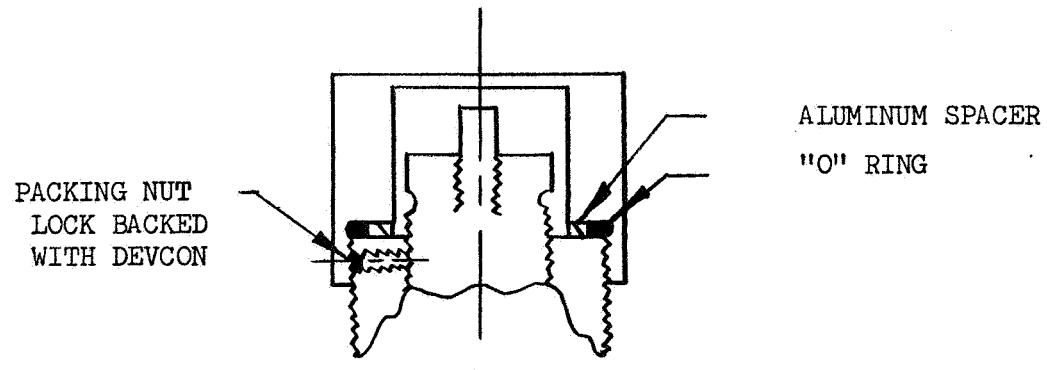
Figure 1 HAND VALVE STEM CAP SEAL CONFIGURATIONS

As the program has progressed and component problems have occurred during testing, design changes have been made where possible to the module components. At the completion of component testing, a leakage problem had been experienced with the hand valve. Stem leakage and leakage through the stem cap seal were above the allowable of 1×10^{-8} scc/sec of He at 1000 psi. A program was initiated to improve the stem cap seal, Figure 1a, since some leakage of the Teflon stem packing must be expected with operation. As a first step the 1000 aluminum alloy gaskets were annealed to the soft condition (1100-0) and maximum allowable torque was applied to the cap. The test unit still leaked under these conditions. Examination of the unit indicated a combination of effects were probably preventing the use of a metallic seal. Surface finish on the valve body and inside the cap along with "out-of-parallel" seal surfaces were the main contributors.

At this time other approaches were tried, Figure 1b and 1c. Soft aluminum seals with single and double serrations and a combination "O" ring and aluminum spacer ring were used. The aluminum seals with serrations did not solve the problem because of the surface finishes involved. The combination "O" ring and spacer ring, however, proved to be tight under hand torques. Several installations were tried in two different test units with no leakage detected in either case. The valves were soaked in an oven at approximately 250°F for 24 hours followed by a mass spectrometer leak check using helium at 950 psig with no indication of leakage. The "O" rings selected for the installation were of Viton rubber, good for operating temperatures up to 400°F. This material, while not completely compatible with the

An additional problem which had occurred involved leakage from the stem packing nut lock device, Figure 1c. This locking device consists of a Teflon plug backed up by a set screw. During the stem cap seal tests this lock frequently leaked. As a repair for the two valves in test, a new Teflon plug was cut and installed with the set screw. The screw was torqued into the body until it was well below the external body threads. The cavity behind (on the outside of) the set screw was packed with Devcon WR. Devcon WR is a suspension of metal particles in an epoxy resin and is generally used as metal patching compound. Although the epoxy resin is probably not compatible with either the fuel or oxidizer, it was used due to the particular application. The area of possible contact is the clearance area between the set screw threads and the valve body. In addition only a dilute mixture of propellant vapor and air trapped in the cap volume would contact the material. Although some degradation might take place at the surface, complete breakdown is not anticipated. This modification which proved to be adequate for the test units was also added to the module valves.

The valve was reassembled using thin (.010) Teflon gaskets on each surface of the soft aluminum gasket. Although leakage was decreased considerably, it was not eliminated. In addition the Teflon sheet was extruded from between the aluminum washer and the valve body and the valve cap. This extrusion process would probably continue until virtually no Teflon remained between the metal surfaces at which time the seal loading would be equal to the compressive yield strength of the Teflon. With heating and cooling, this seal load would be reduced until the seal would be ineffective.

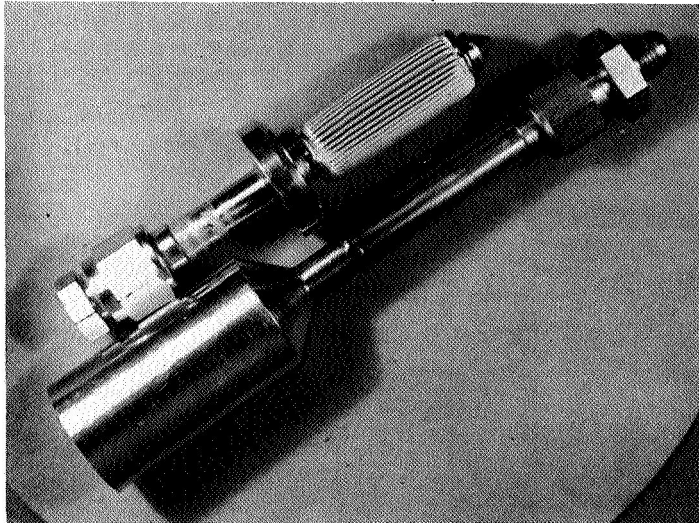
Figure 11 Component Test Filter Disassembly

The unit was cut open (see Figure 11) and examined. No dirt was evident on the inlet side and no separation was visible along the welded joints or on the screen surface.

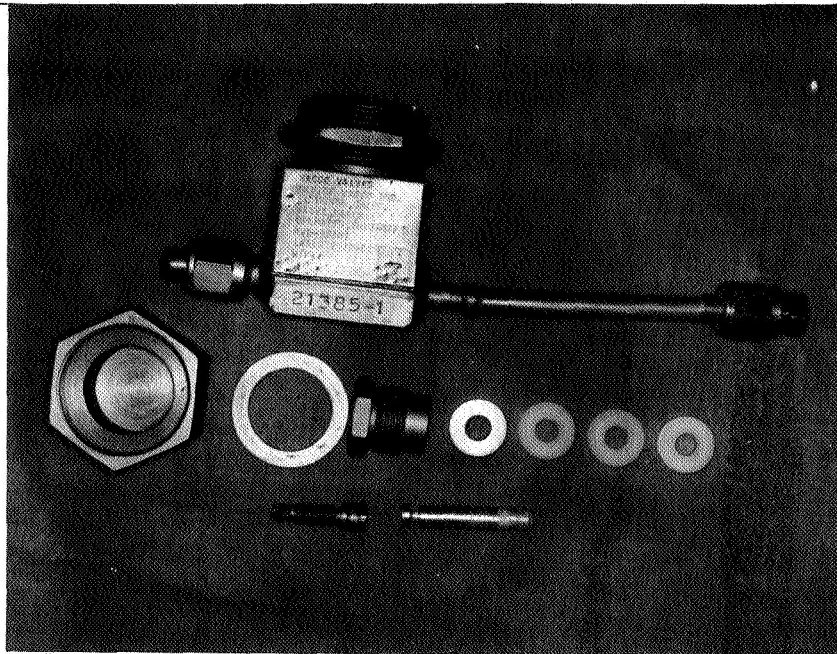
Fig. 13 Hand Valve Disassembly

Disassembly of the valve, Figure 13, disclosed a very heavy coating of white, powdery, aluminum oxide on the exposed portion of the poppet. This was most severe on the 1100-0 poppet nose, see Figure 14. The oxidation of the anodized body was very slight.

The heavy oxide coating was anticipated because material tests under Task III did show reaction between aluminum alloys and the oxidizer at sterilization temperatures. Future designs should consider all titanium construction.

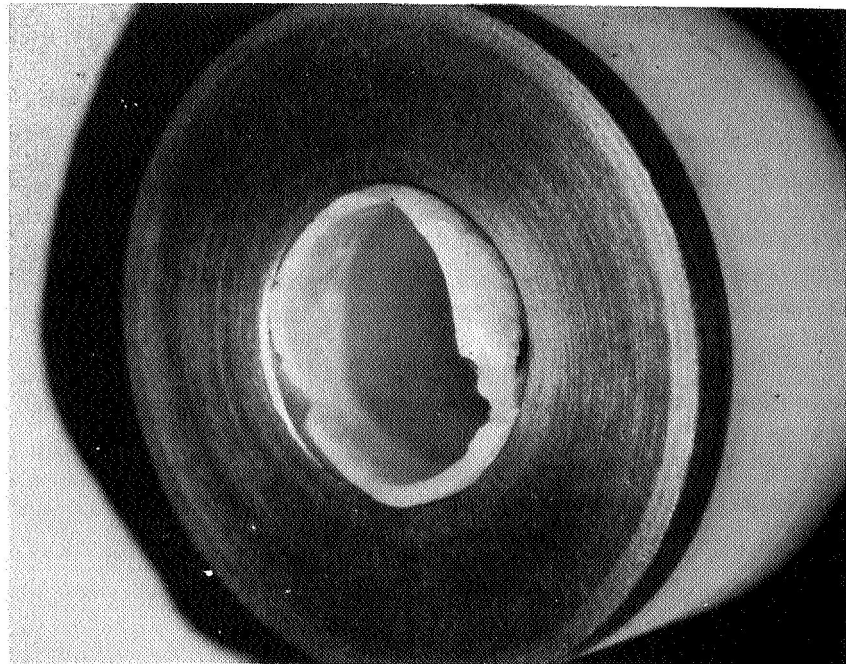
Fig. 15 Hand Valve Stem Seal Chevrons

The Teflon packing extrusion could have caused the external leakage reported in the post-sterilization tests results by permitting a relaxation of the sealing force. The diametral clearance between stem and washer is excessive and future tests could determine maximum clearance versus gland nut torque over extended periods at sterilization temperatures.

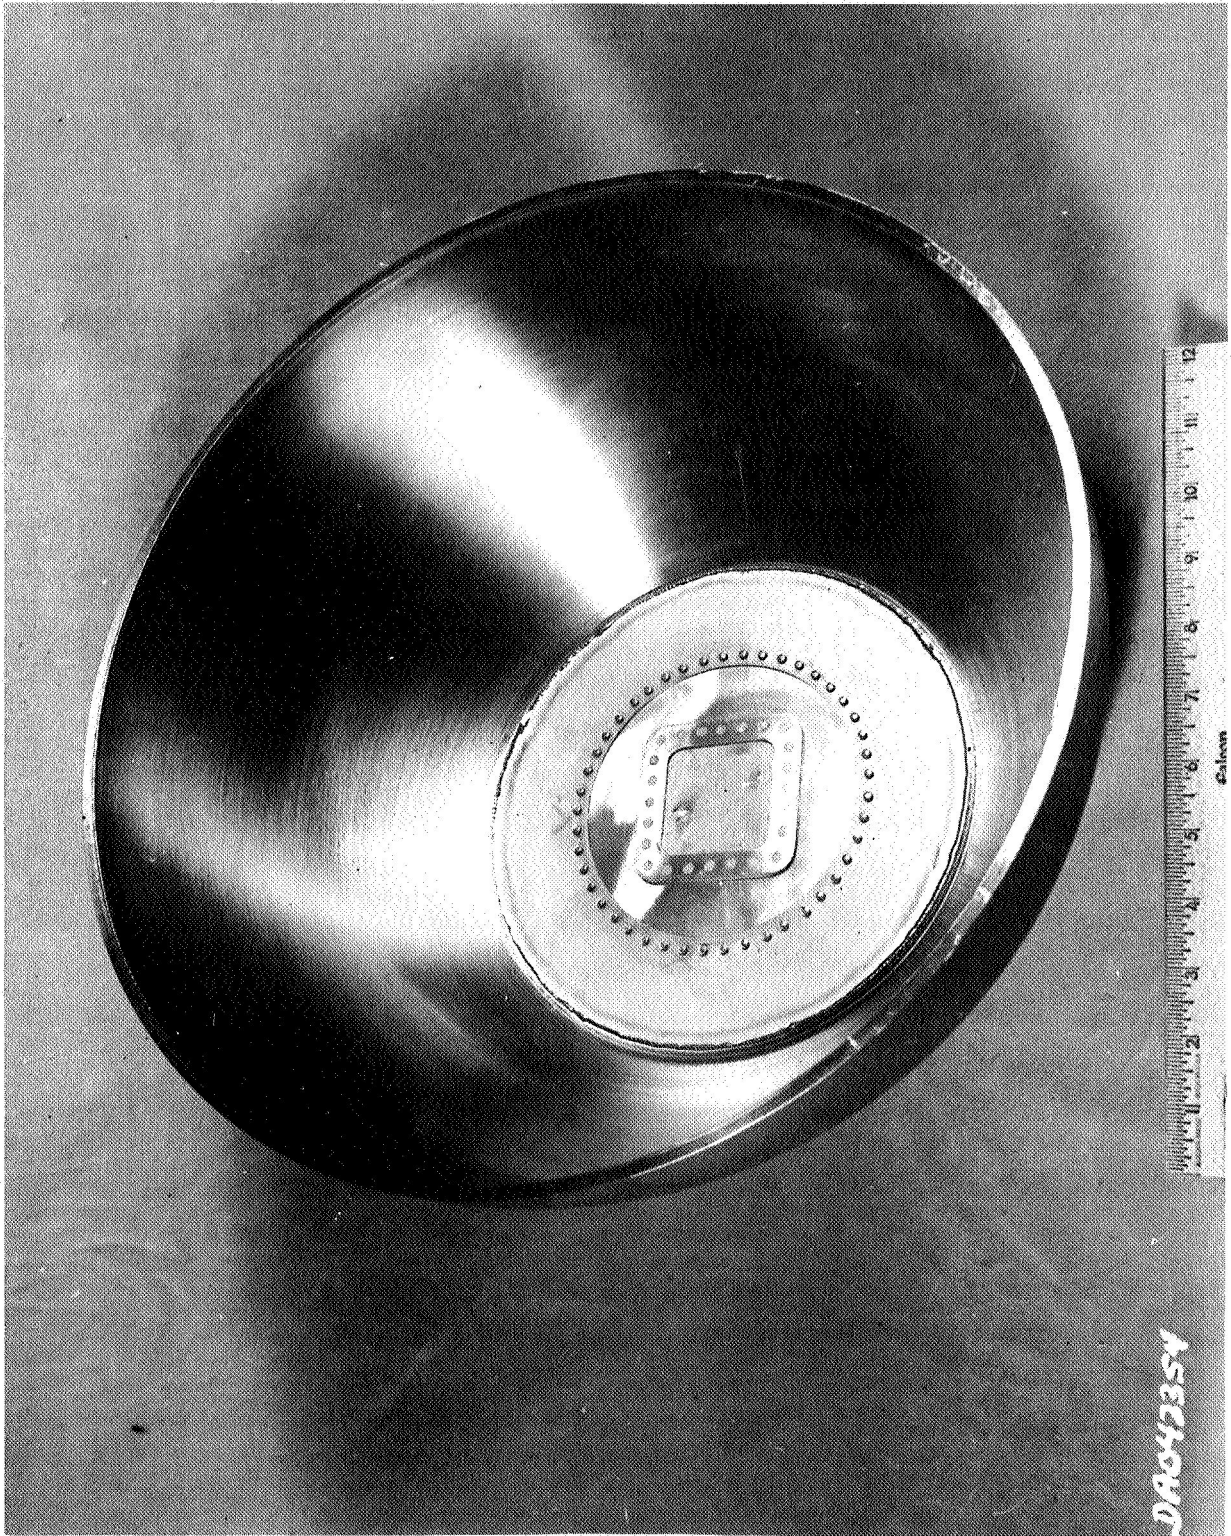
Figure 21 Fuel Tank Screen Trap Assembly

Upon completion of the expulsion tests, the fuel tank was decontaminated and then cut in two at the girth weld. After cleaning, the lower half containing the screen trap, see Figure 21, was subjected to a leak and bubble test. The weld joint proved to be intact and the first leak appeared at the outer row of rivets, where the titanium is riveted to the stainless steel trap, see arrows Figure 22. This leak started at 5 inches of H₂O pressure. The screen started bubbling at 8 inches² of H₂O pressure. The indication here was both at the sandwich connection edge and through the screen.

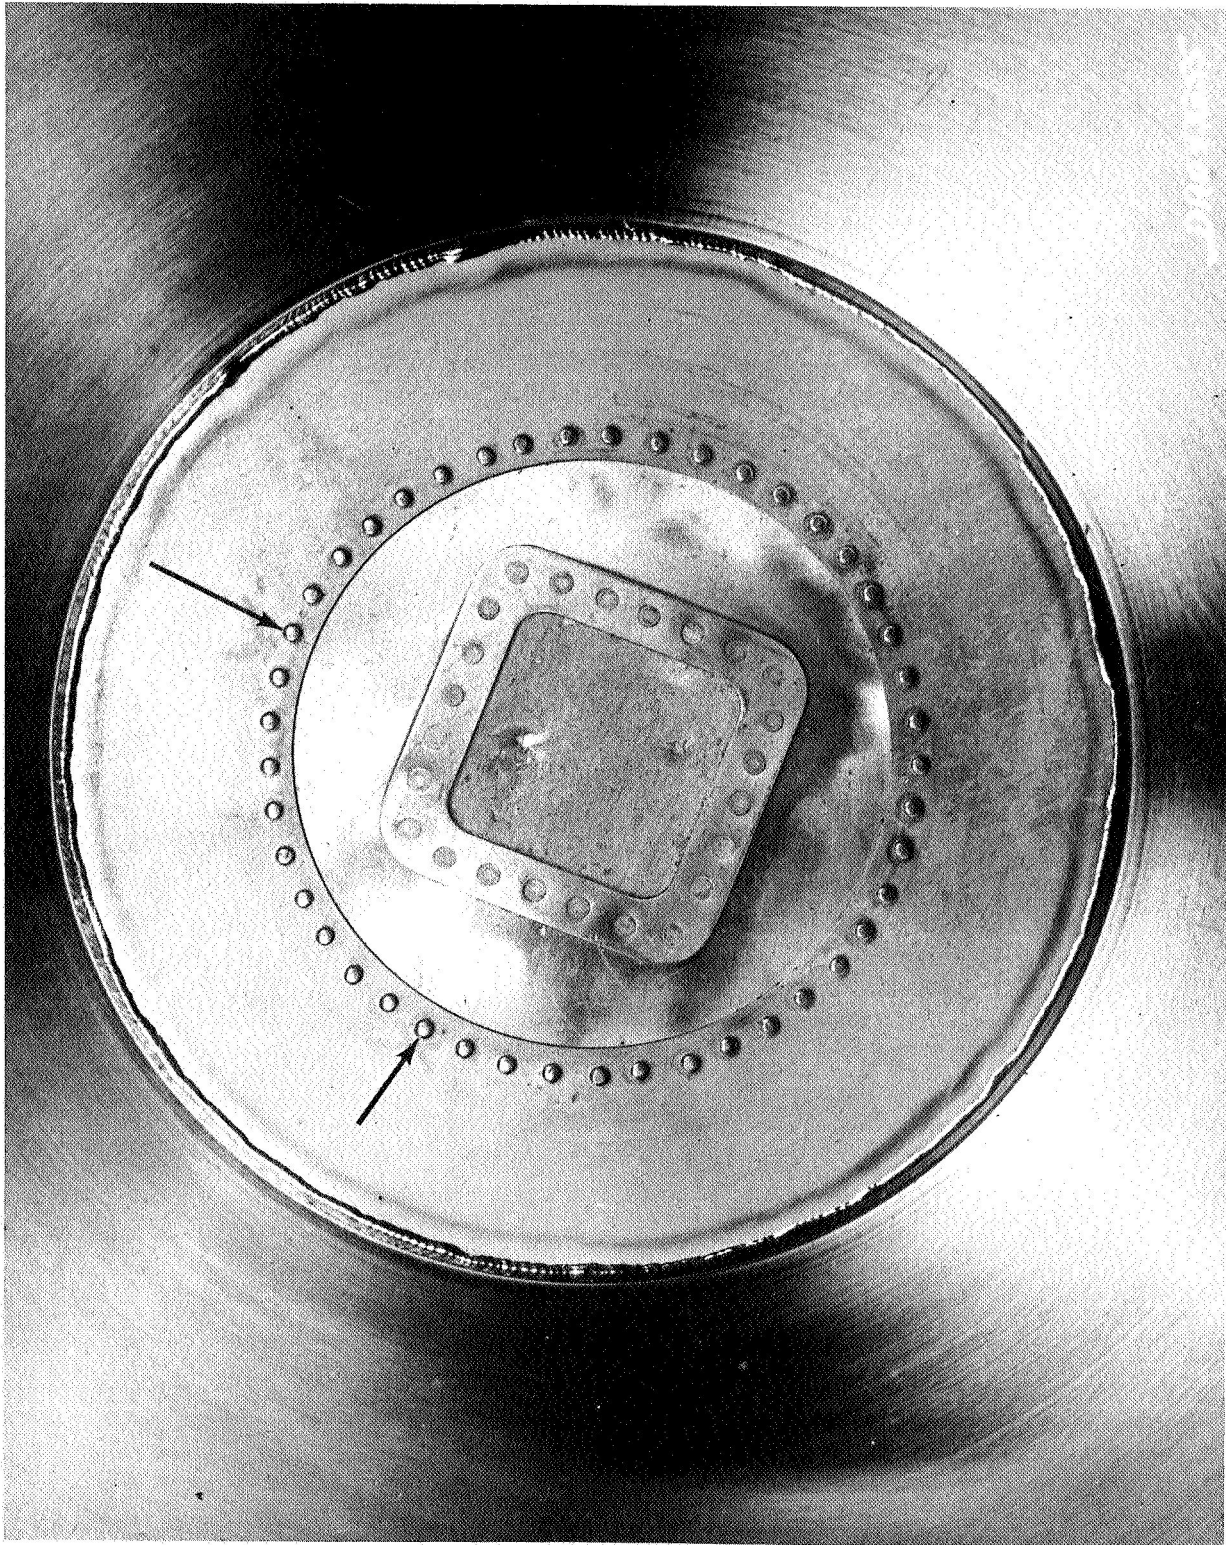
Figure 22 Fuel Tank Screen Trap Leakage Points

The screen trap was then separated from the tank half and a hole drilled in the upper plate to permit gas pressure injection. The trap unit was then subjected to a bubble check. Leaks started at the closure plate riveted connection, see Figure 23, at 1½ inches of H₂O pressure.

The above test indicates that the screen trap was functioning properly although the bubble point was lower than when installed; therefore, some other factor was responsible for the two-phase flow indicated earlier.

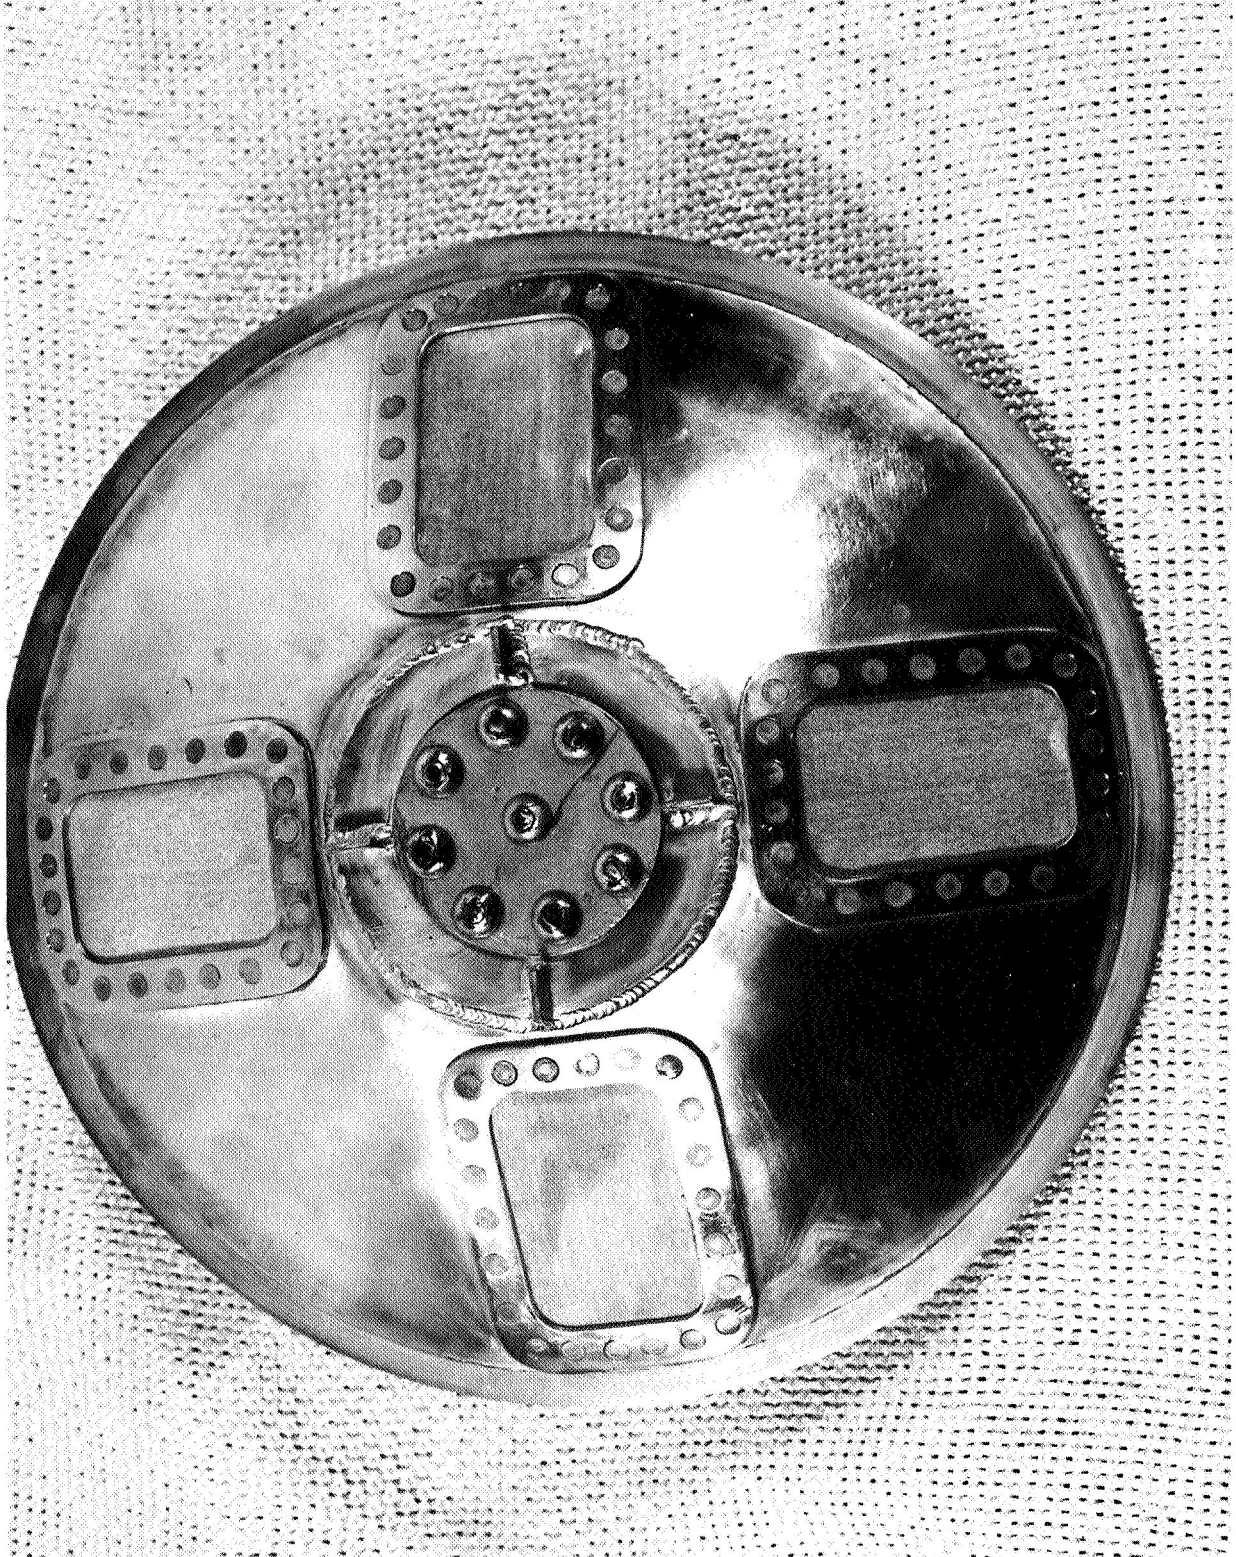
Figure 23 Screen Trap Assembly

An examination of the trap and tank assembly indicated that there was an area in suspect, namely, the flow area between the smaller diameter base of the cone frustrum and the tank wall. It appears that on fabrication, this area was smaller than had been anticipated due to shop tolerances. If this area should provide a restriction in excess of the bubble point of the trap closure plate rivets ($1\frac{1}{2}$ " H_2O) then the two-phase flow would indeed occur.

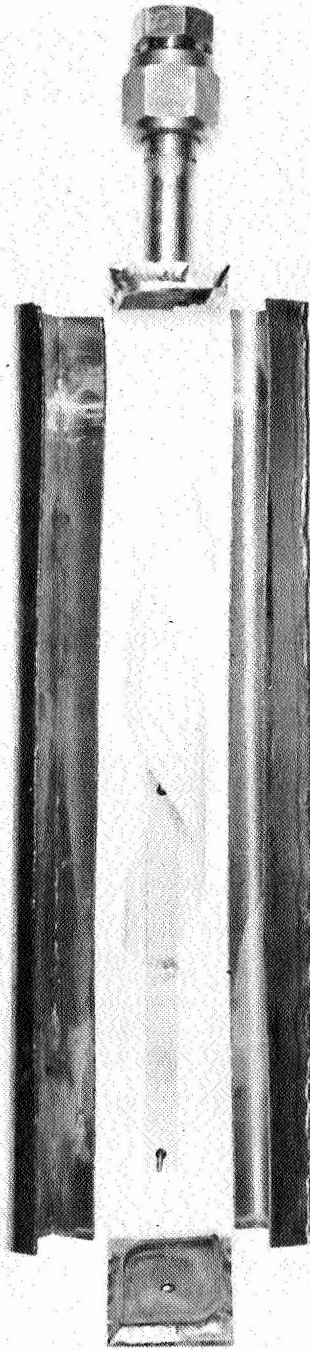
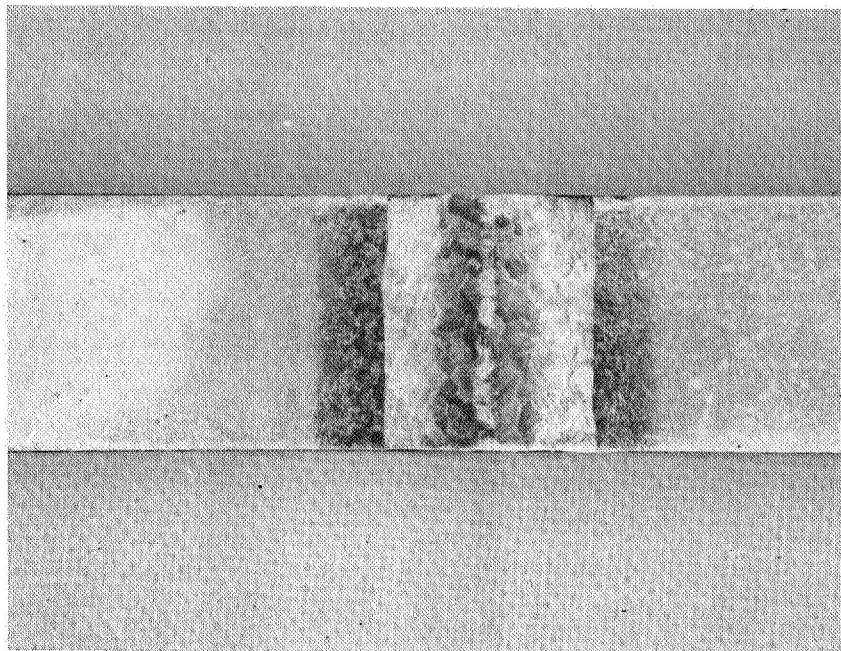
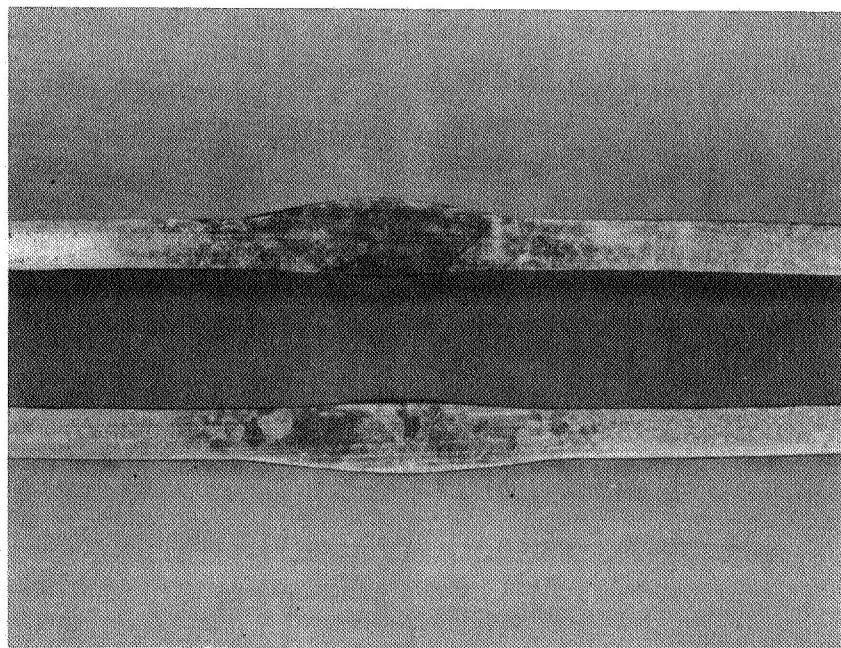
Fig. 37 Sectioned Titanium Assembly with Stressed Specimen of Titanium and Teflon Specimen

1. The discoloration of the titanium is believed to be the result of increased oxide thickness on the surface of the titanium. The increased oxide is probably the result of the exposure to 275°F where it would not be unreasonable to expect additional oxidation of the titanium to occur. Although no attempt was made to determine the increase in oxide thickness, it is believed to be in the order of angstroms. As expected, examination of polished cross-sections using light microscopy techniques up to 2000X revealed no discernable differences between oxide thicknesses on unexposed titanium and the most discolored areas of the exposed titanium.

2. The presence of the teflon in the titanium assembly was not believed to have influenced the formation of the discolored surfaces on the titanium.
3. The presence of the discoloration on the titanium has no detrimental affect on the properties of the titanium.
4. The presumed formation of titanium oxide in increasing thicknesses from exposure to N_2O_4 at sterilization temperatures would logically progress² at a decreasing rate with an increase in oxide thickness because of the protective nature of titanium oxide.
